**Assessment of Automated Technologies in Texas for Pavement Distress  
Identification, Texture, and Cross Slope Measurement**

**Thesis**

**The University of Texas at Austin**

**May 2014**

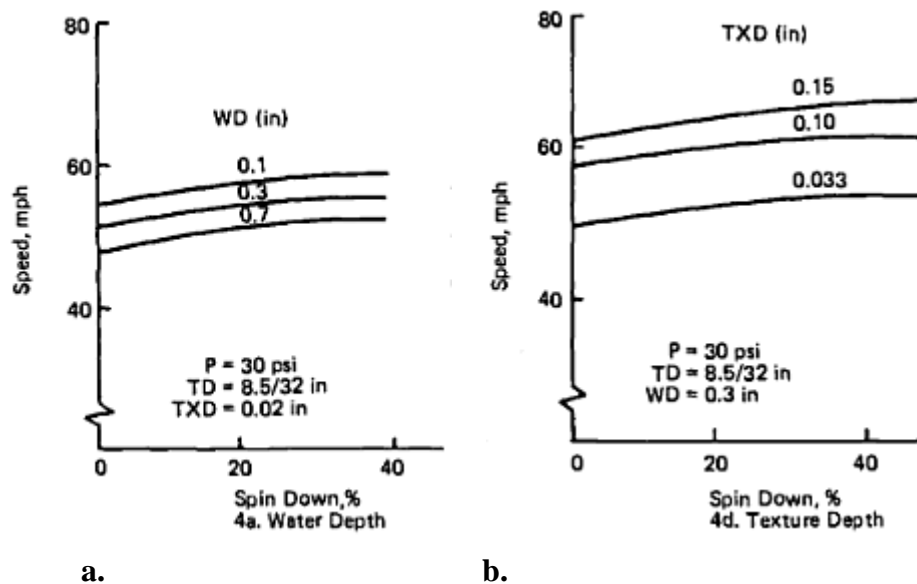
Figure 2.7: Influence a) water depth and b) texture depth on hydroplaning speed (Balmer & Gallaway, 1983).

rut depth is tolerated for smaller cross slopes); and (4) traveling speed should be reduced below 50 mph on wet pavement to decrease occurrence of dynamic hydroplaning.

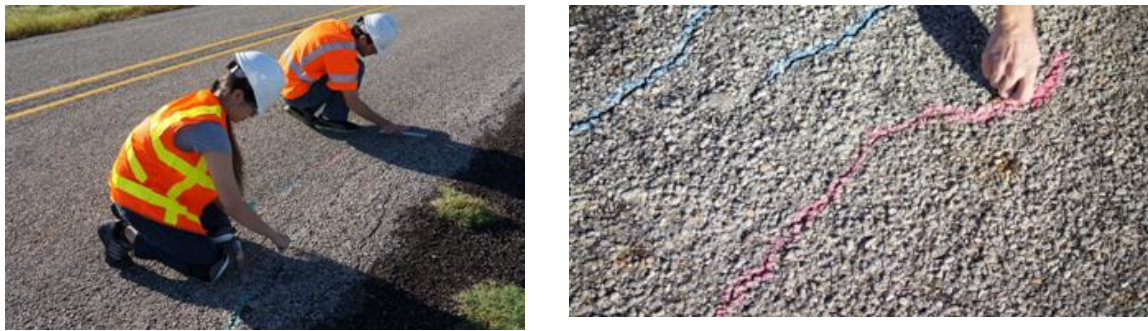
Cracks were marked with 3 chalk colors depending on crack widths (red < 3mm, blue 3-6mm, green >6mm). Each Team member had a ruler marked in millimeters to check crack widths when necessary. Figures 3.31-3.33 show the crack coloring process.

Figure 3.31: Marking section with colored chalk (FM 1063)

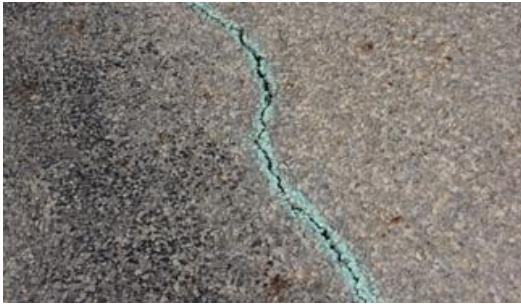
Figure 3.32: Crack marked in green (FM 1331)

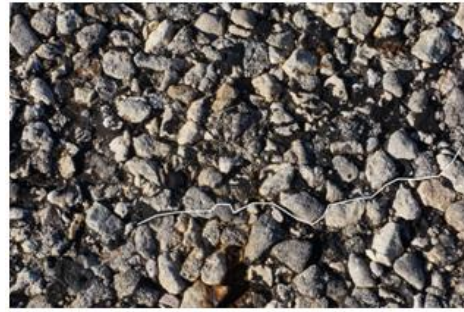
Figure 3.33: Phantom cracks marked in white (FM 1063)

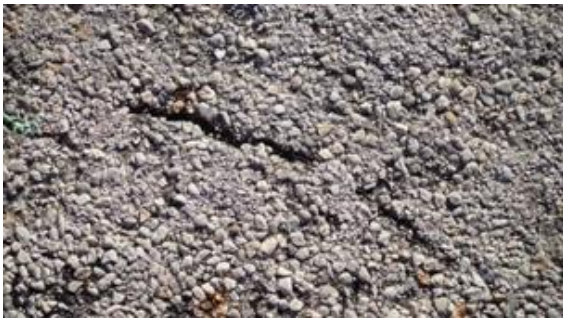
Figure 3.34: Phantom cracks created by loss of aggregates (FM 1063)

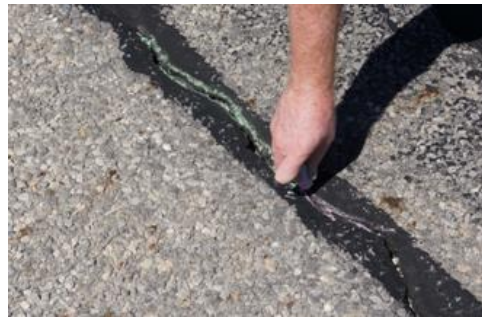
Figure 3.35: Cracks within sealed cracks (FM 1331).

Sealed cracks also exhibited open cracks of various widths (Figure 3.36).

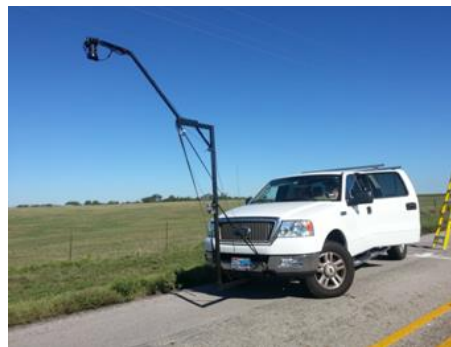
and green line, and the images of these lines drawn by chalk were highlighted darker on the computer. Figures 3.38, 3.39, and 3.40 show the installation of the camera mounting system, laptop computer connection to the digital camera, and the vehicle with the camera mounted and ready for crack map image collection.

Figure 3.39: Vehicle ready for taking crack map pictures

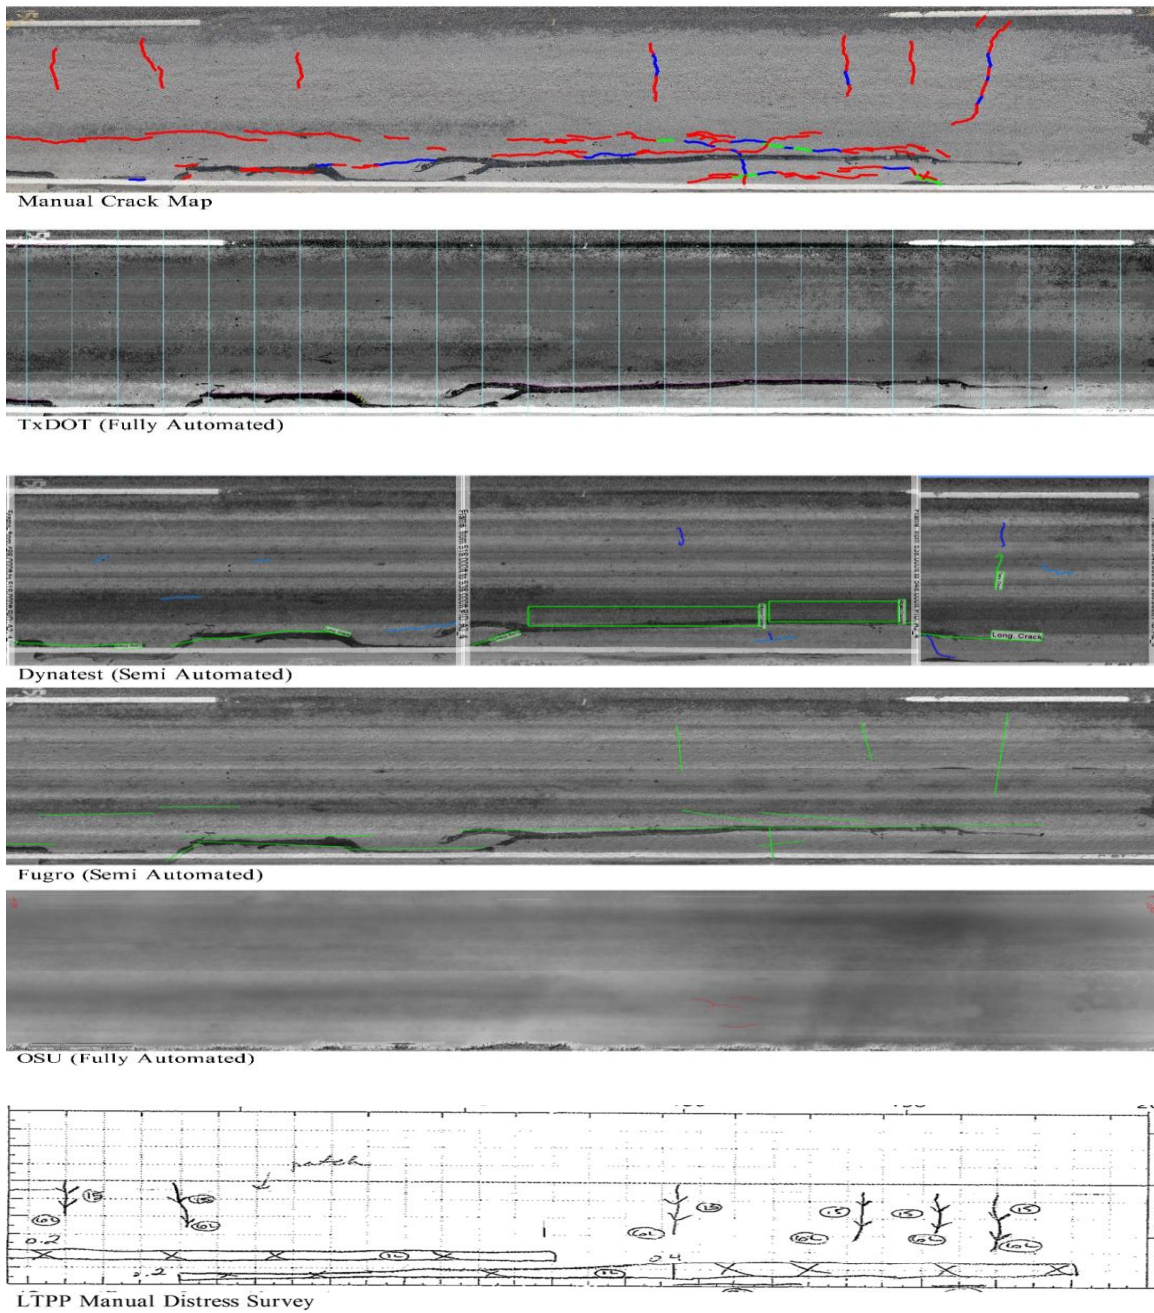
Figure 7.2: Crack maps for Section AutoDC2\_FM3177-1 (Serigos et al., 2014)

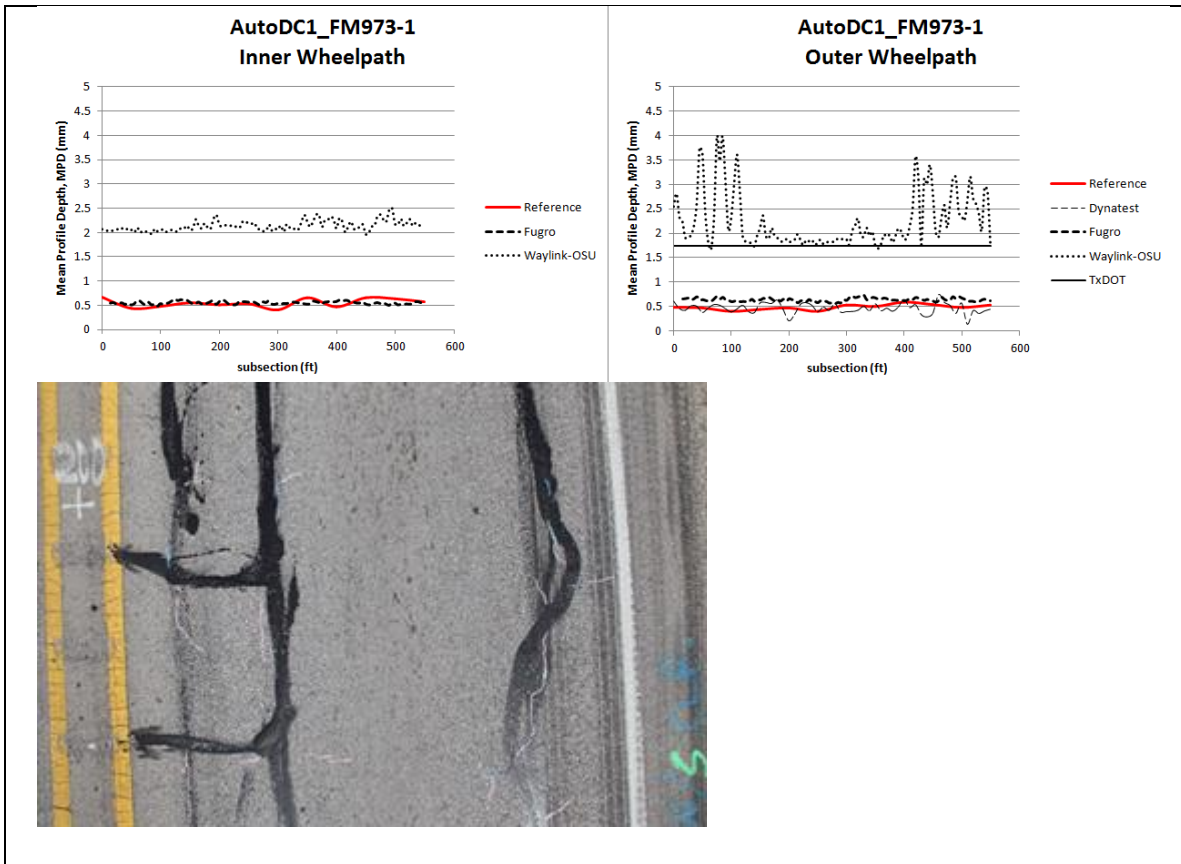
Figure A1: Inner and outer wheelpath texture graphs for AutoDC1\_FM973-1 with image close-up of the pavement section

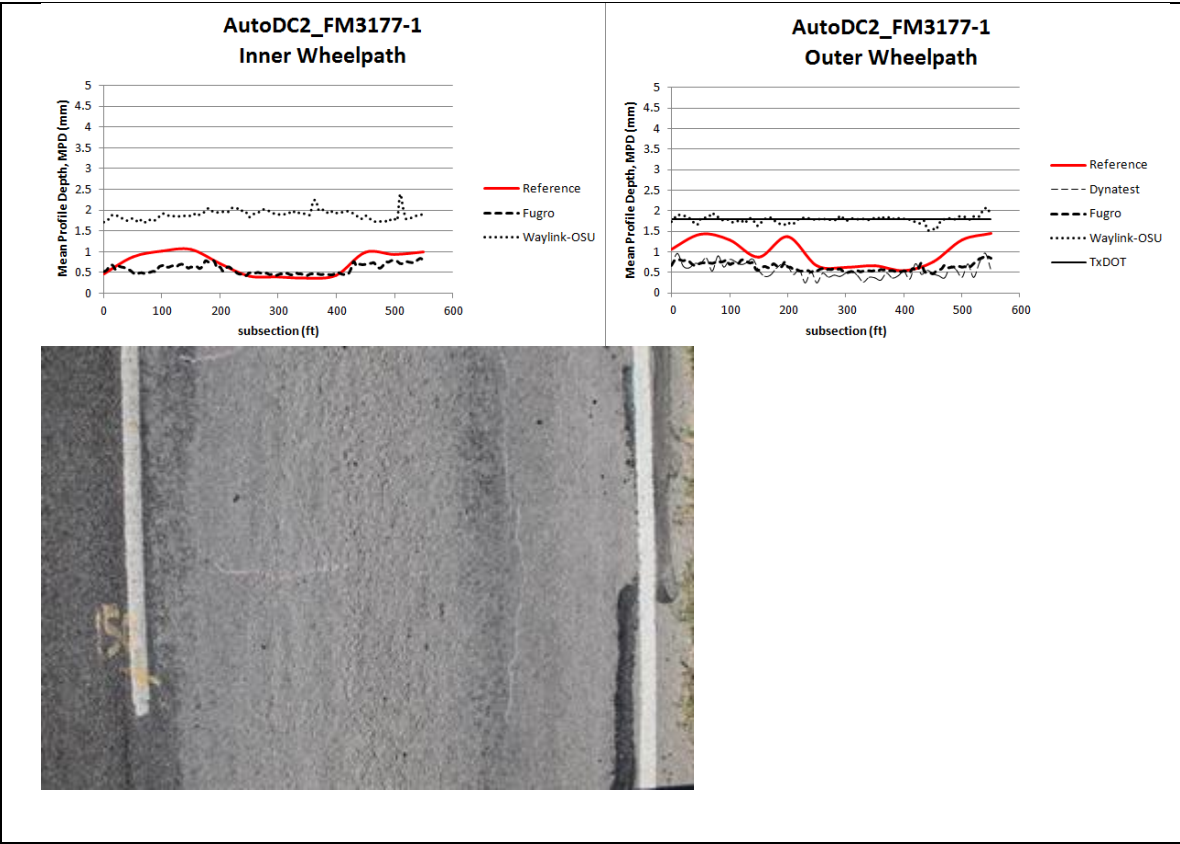
Figure A2: Inner and outer wheelpath texture graphs for AutoDC2\_FM3177-1 with image close-up of the pavement section

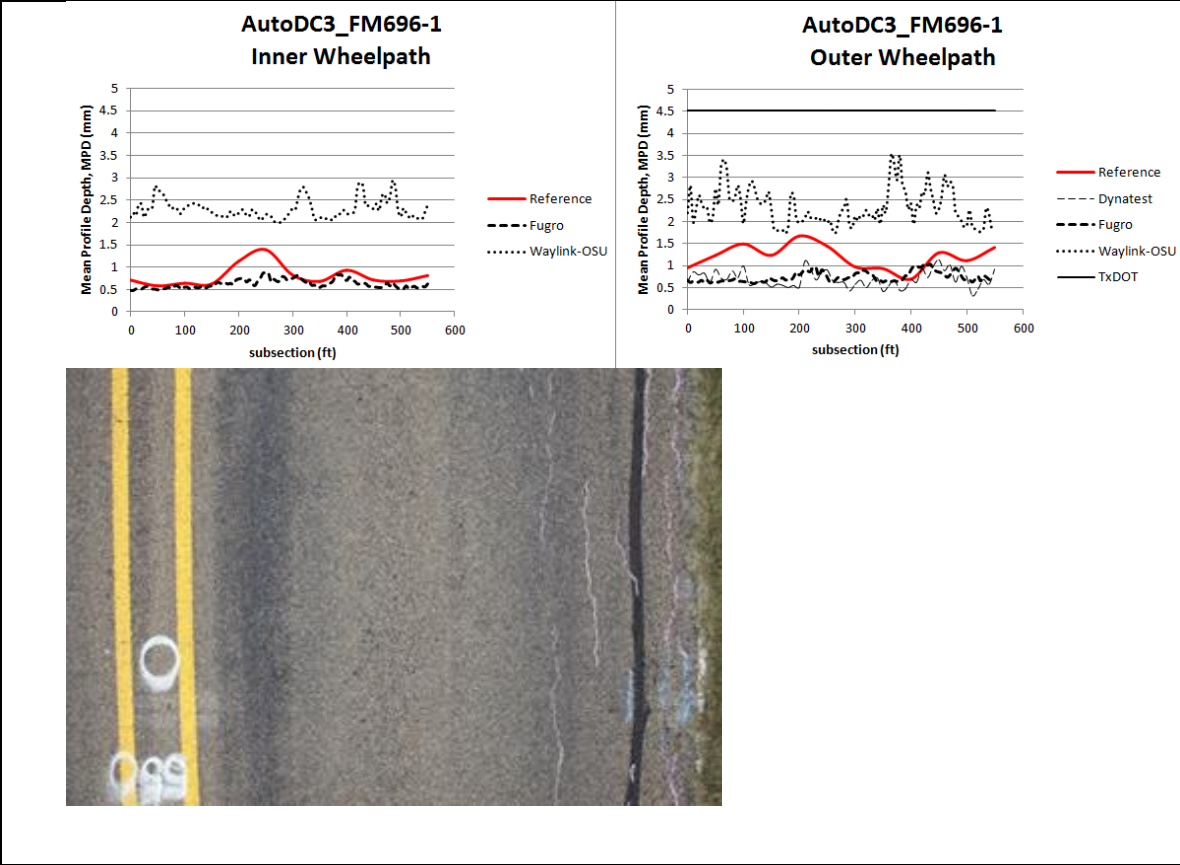
Figure A3: Inner and outer wheelpath texture graphs for AutoDC3\_FM696-1 with image close-up of the pavement section

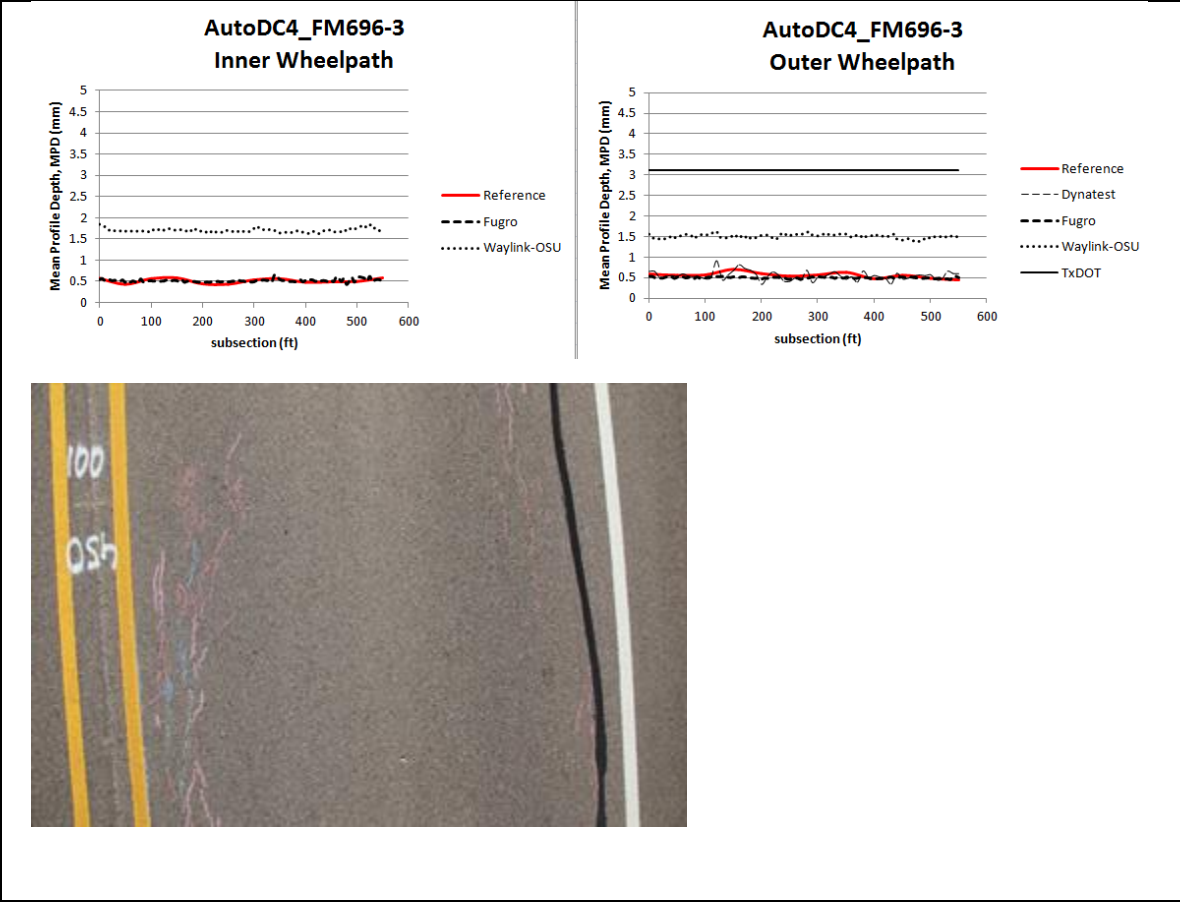
Figure A4: Inner and outer wheelpath texture graphs for AutoDC4\_FM696-3 with image close-up of the pavement section

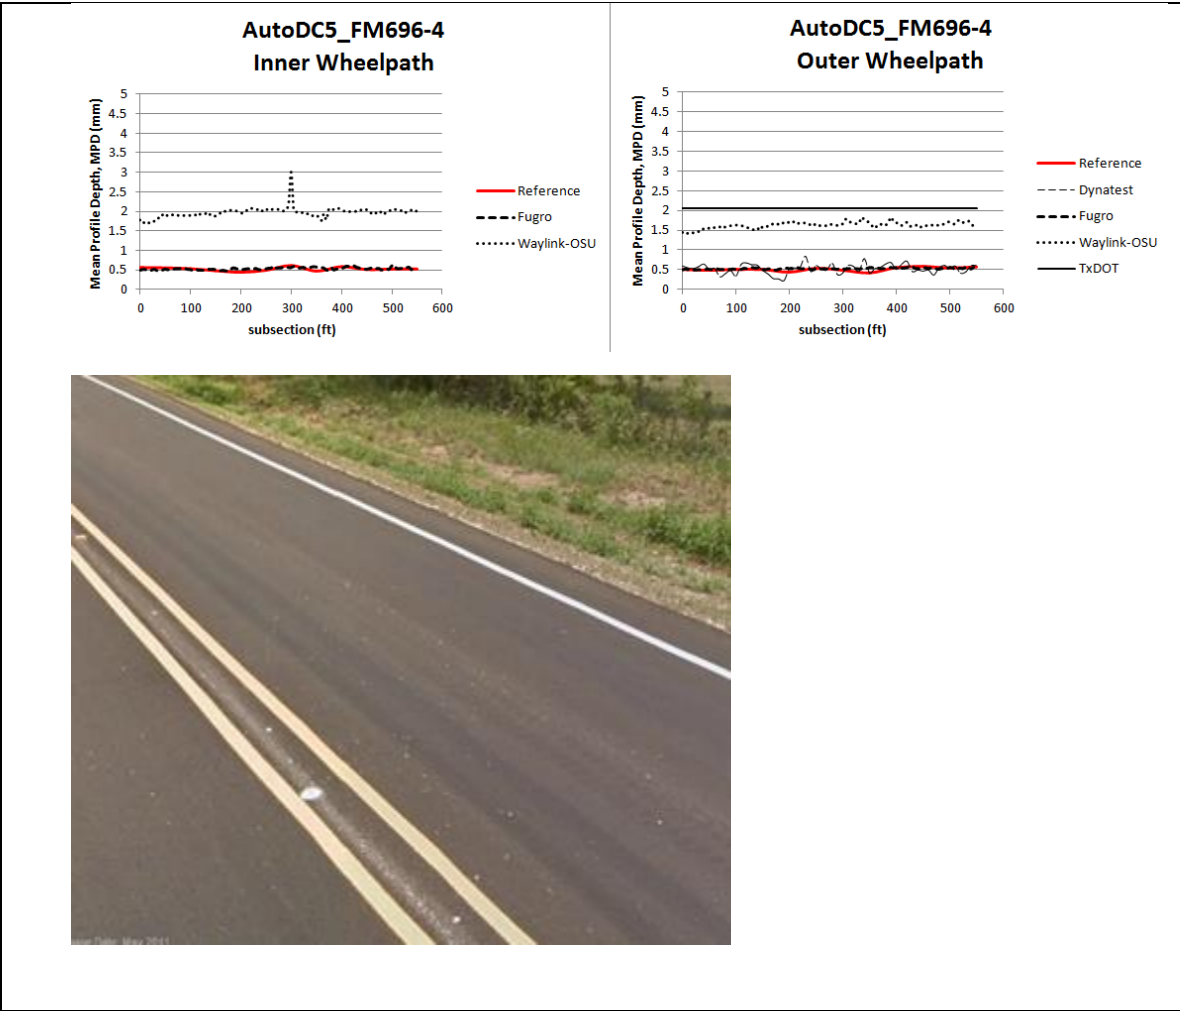
Figure A5: Inner and outer wheelpath texture graphs for AutoDC5\_FM696-4 with image close-up of the pavement section

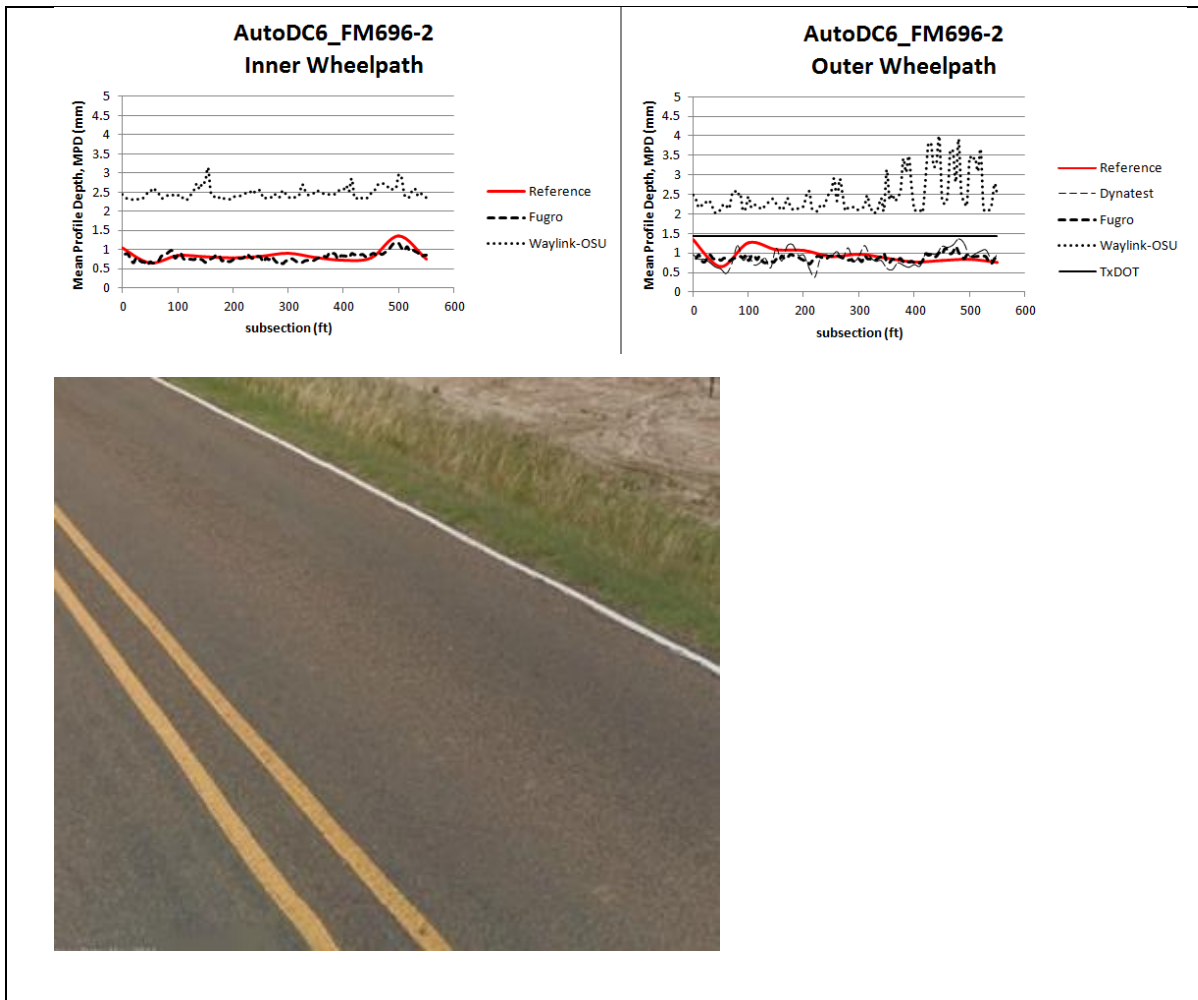
Figure A6: Inner and outer wheelpath texture graphs for AutoDC6\_FM696-2 with image close-up of the pavement section

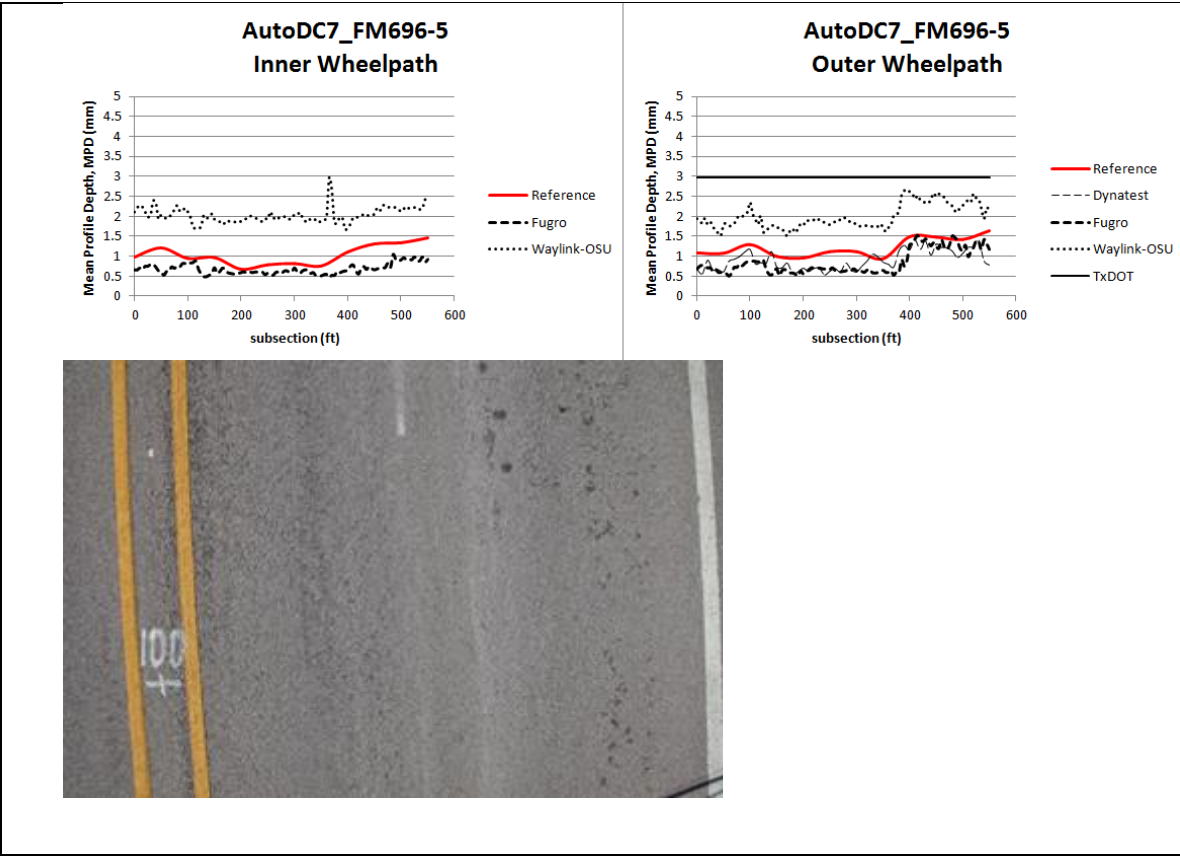
Figure A7: Inner and outer wheelpath texture graphs for AutoDC7\_FM696-5 with image close-up of the pavement section

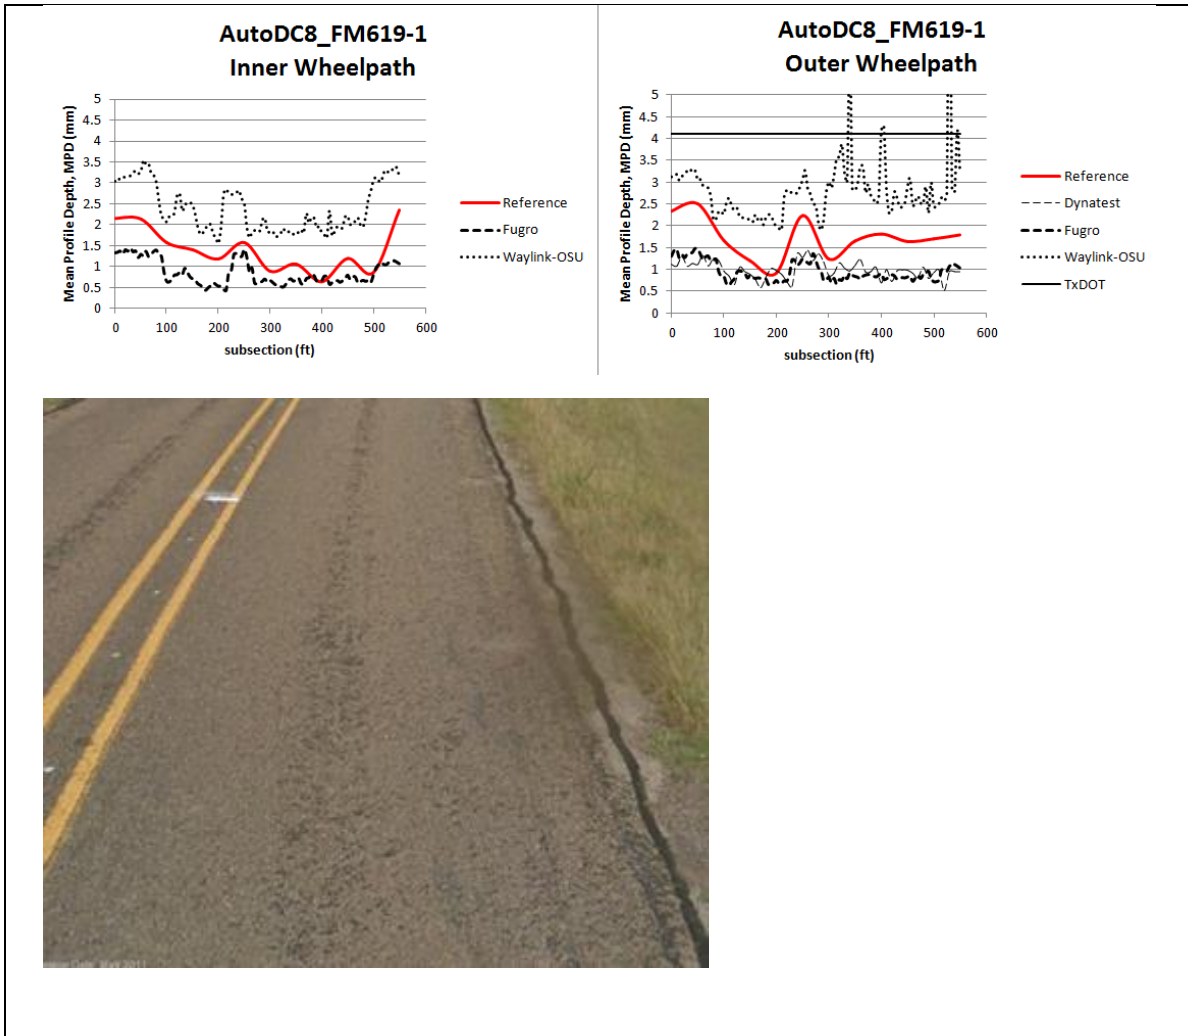
Figure A8: Inner and outer wheelpath texture graphs for AutoDC8\_FM619-1 with image close-up of the pavement section

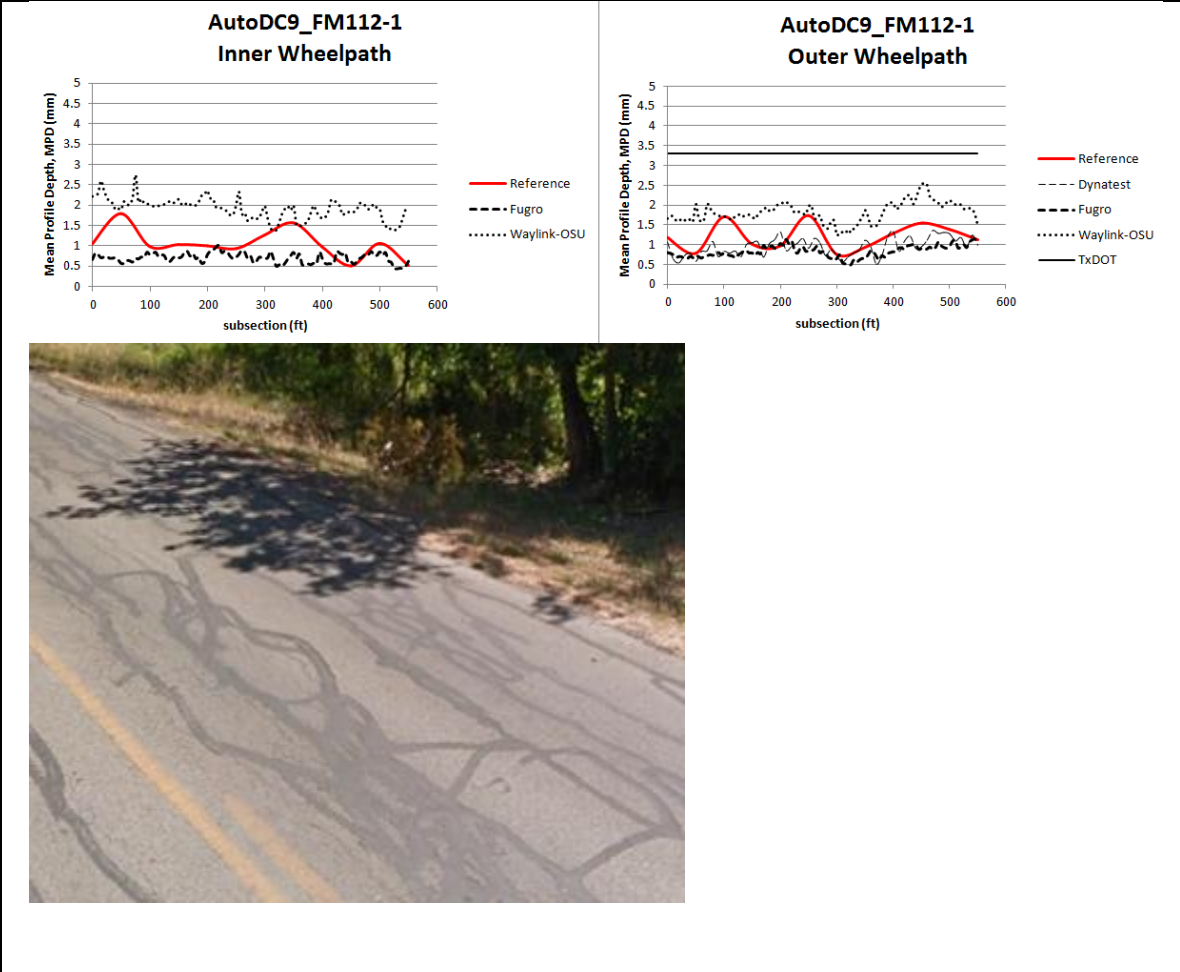
Figure A9: Inner and outer wheelpath texture graphs for AutoDC9\_FM112-1 with image close-up of the pavement section

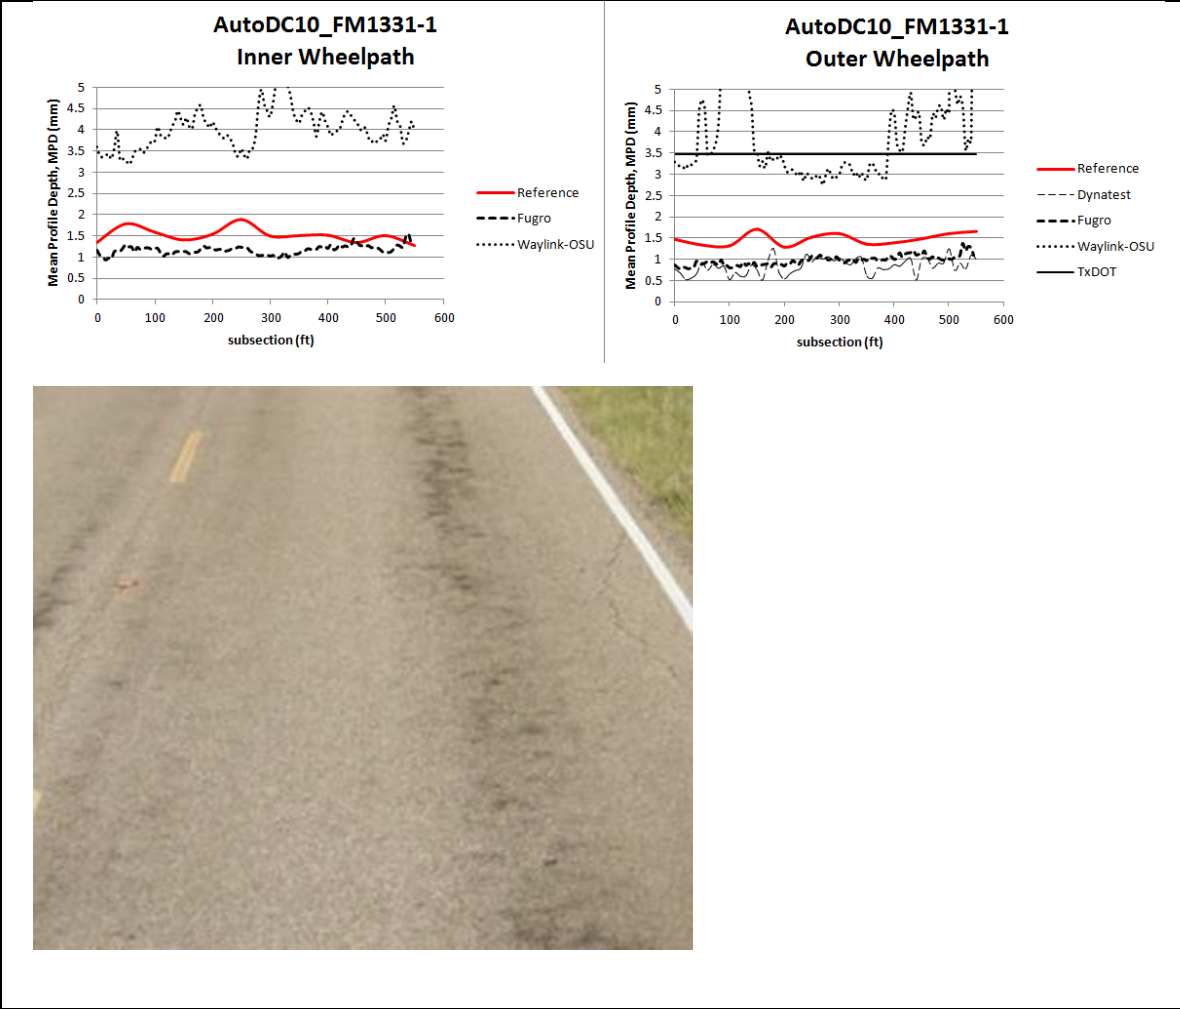
Figure A10: Inner and outer wheelpath texture graphs for AutoDC10\_FM1331-1 with image close-up of the pavement section

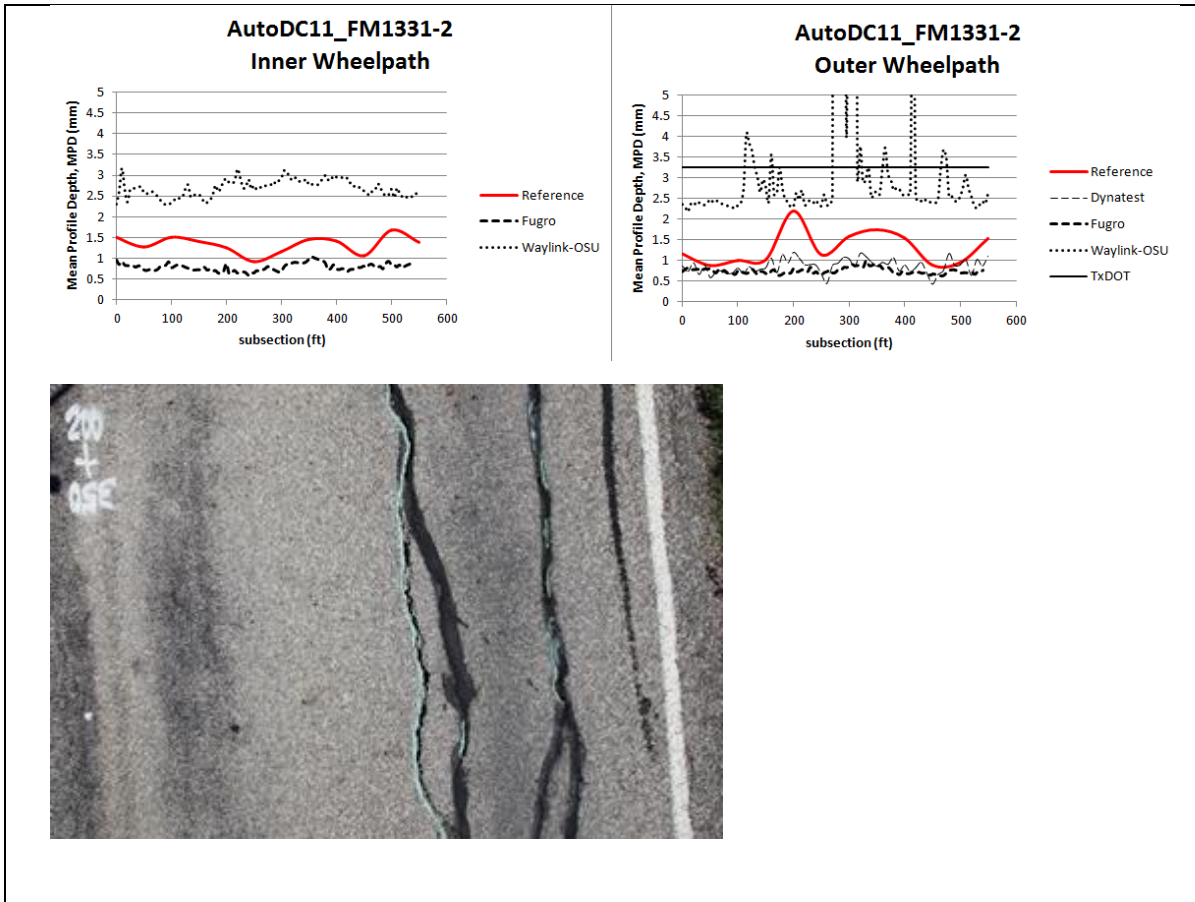
Figure A11: Inner and outer wheelpath texture graphs for AutoDC11\_FM1331-2 with image close-up of the pavement section

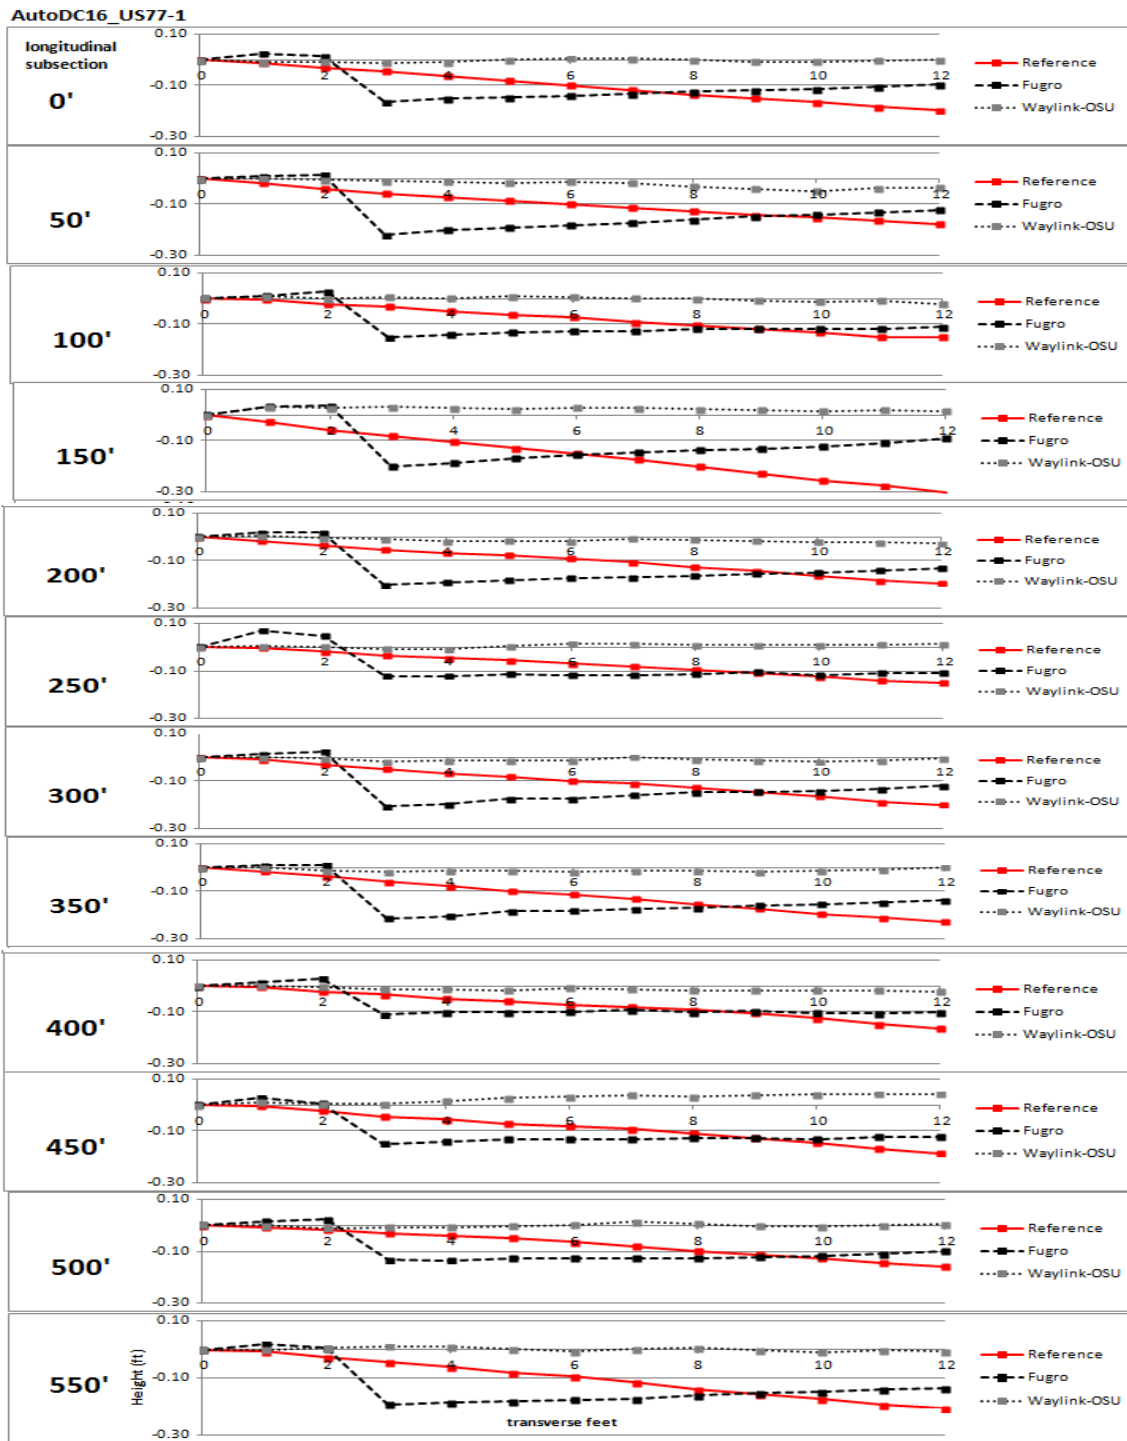
Figure E16: Cross slope for every transverse foot of every 50-ft. subsection for AutoDC16\_US77-1

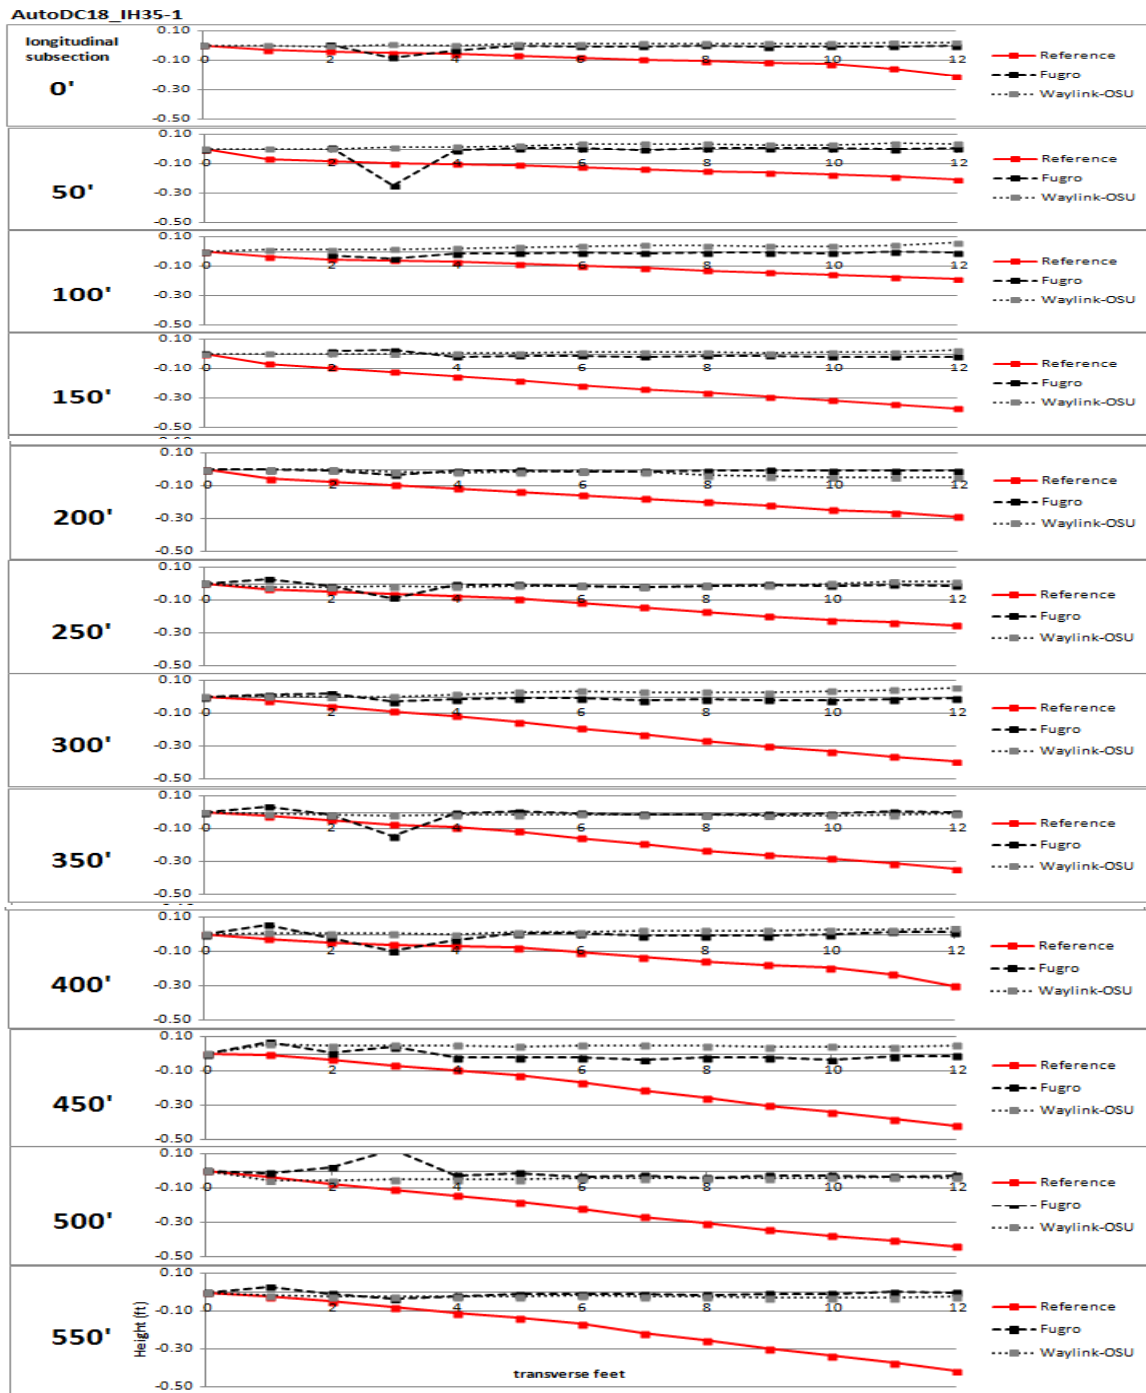
Figure E18: Cross slope for every transverse foot of every 50-ft. subsection for AutoDC18\_IH35-1
