**Nineteenth Century Concrete in Seguin, Texas: Construction Materials
& Techniques**

Thesis

The University of Texas at Austin

August 2014

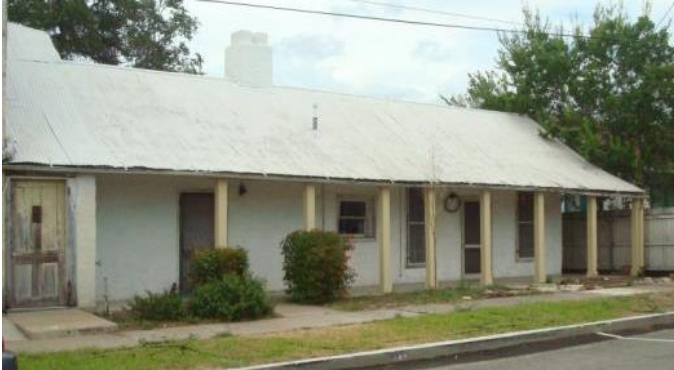
Figure 2.1: Magnolia Hotel, Author's image, September 12, 2013.

The Magnolia Hotel was originally constructed in 1838 by James Campbell as a modest log structure, but was sold in 1845 to Joseph Johnson who is said to have constructed the concrete addition. It was during this time that the structure was operated as a hotel and no longer as a residence. Sometime after the concrete portion of the hotel was completed, a two-story wood frame addition was constructed on the northern part of the lot. Over the next thirty years, the hotel changed ownership multiple times and no longer operated as a hotel in the early 1900s. After ten years of vacancy, the structure was re-opened as a boarding house, but was not listed as the Magnolia Hotel. The 1885 Sanborn shows it on block 26.³⁰ The concrete portion of the hotel is rectangular in form and is the southernmost part of the building.

The concrete structure has eight inch thick walls.³¹ The floor plan has been remodeled and is no longer indicative of the hotel plan. It has a pitched roof with wide overhang that protects the concrete walls. The exterior is now covered in smooth white stucco. The original material is visible from the interior in a narrow passageway from the concrete structure to the wood framed structure where a small area of exposed material is located by the window in the hallway.

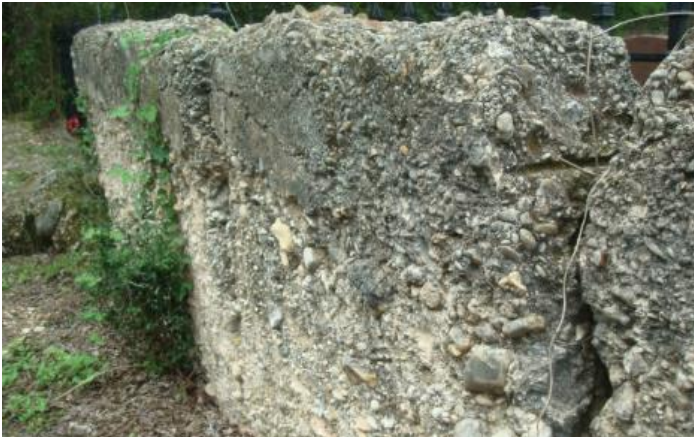
Figure 2.2: Riverview Cemetery Wall, Author's image, September 19, 2013.

Not much is known of the Riverview Cemetery perimeter walls. It appears that they once surrounded the cemetery, most likely offering protection from animals that might have disturbed the graves. The cemetery was too far from downtown to be included in the Sanborn maps, but was said to have been constructed in the 1850s.³² Only small sections of the cemetery walls still exist; most of them have fallen. The walls

are approximately four feet tall and have an average thickness of twelve inches. Much of the binder has eroded exposing large aggregate and any evidence of a previously applied stucco is not present.

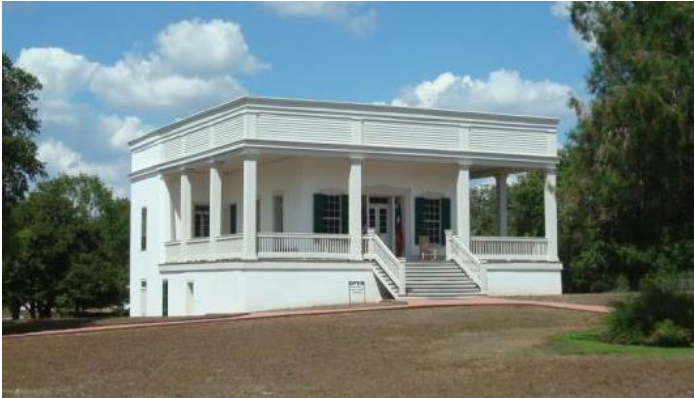
Figure 2.3: Sebastopol, Author's image, September 12, 2013.

Sebastopol was constructed in 1854 and is the best known of the concrete structures in Seguin. This can be attributed in large part to its publicized restoration by Texas Parks and Recreation in the 1970s-1980. The structure itself was a residence from 1854 to the 1960s, and changed ownership several times. Its construction and design are attributed to German immigrant, Tobias Meiniger. The most famous owner and resident was Seguin's mayor, Joseph Zorn. The structure was documented with measured drawings in the 1930s as part of the Historic American Building Survey and the first steps towards its preservation were through the advocacy of the Seguin Conservation Society in the 1960s.

walls. The roof is reported to function as a water collection and cooling system by storing water on the roof and diverting some of it to a basement cistern. The exterior walls are covered in smooth white stucco, and the rooms upstairs are plastered. The only access points to original concrete materials are found in the basement interpretive areas. From here, the concrete walls are exposed and pour lines are visible. The walls are approximately fifteen inches in thickness and were poured in one foot lifts. It must be noted that some of the exterior facing walls were deteriorated to such a point that they were demolished and reconstructed. Samples were extracted from the basement spaces from areas that were representative of original material.

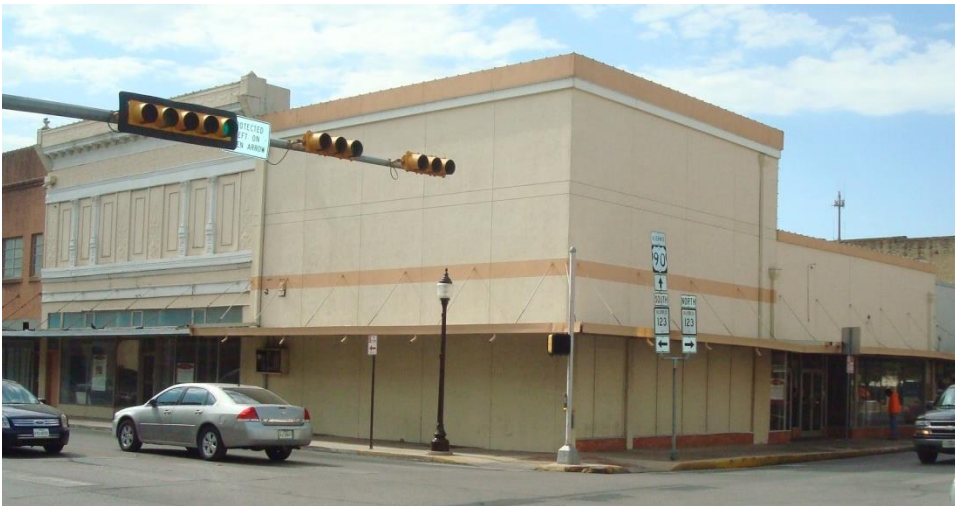
Figure 2.4: Moses Campbell Commercial Building, Author's image, May 1, 2014. The photo was taken from the southeast corner of the E. Court St. and N. Austin St. intersection. The Moses Campbell Commercial Building is the corner structure. The adjoining buildings to the west and to the north were renovated in the mid to late 20th century to join the Moses Campbell building. The concrete wall is located between the Campbell building and the building to the north.

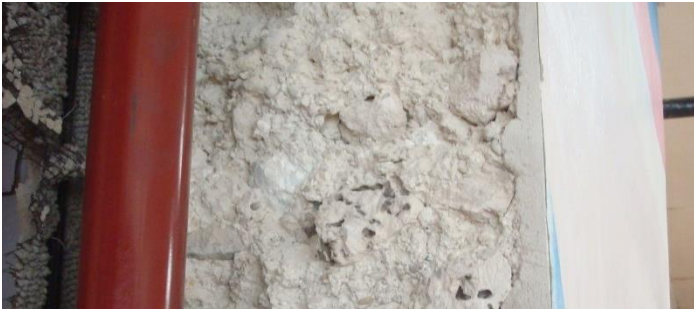
Figure 2.5: Moses Campbell Commercial Building, Author's image, September 19, 2013.

The Moses Campbell Commercial Building was constructed for Moses Campbell in 1853-1856. Located on the northwest corner of Austin and Court Streets, the second story served as the offices for the *Seguin Journal*, a weekly newspaper. In the 1880s the structure was remodeled and much of its concrete material was replaced with brick from the factory of August Dietz. At this time the building served as the law office for John Ireland. In the 1885 Sanborn map, the building is shown on the southeast corner of block 36 and has only one concrete wall depicted. A renovation of the building in the early 2000s exposed the concrete wall, which has been left exposed. The building is currently vacant.

of the building. The wall had 20th century sheetrock applied to both sides, but was presumably covered in a period plaster when first constructed.³³

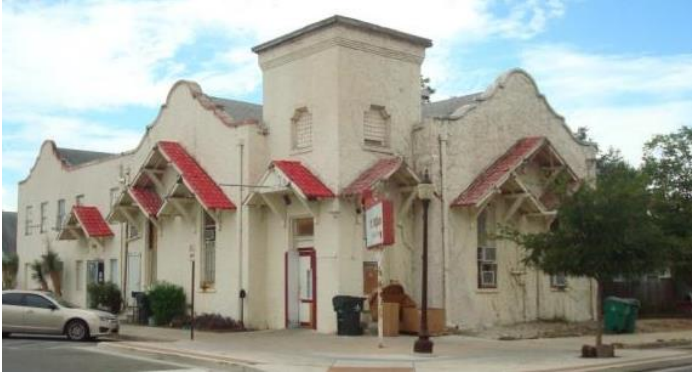
Figure 2.6: Old Baptist Church, Author's image, September 12, 2013.

The Old Baptist Church was constructed on block 23 from 1876-1878 by the Baptist congregation. The building operated in a religious capacity from its construction to c. 1960. From then until 2005 the building was used as a print shop; after this time the building served a dual purpose of apartment house on the south end and a food bank on the north end. The original structure was rectangular in plan, as can be seen in the 1885 Sanborn map.³⁴ Around the turn of the century, a small wooden addition was made on the northwest side of the building. The last renovation, completed c.1900-1910, included a large addition connected to the south end of the original structure. The addition was a wood framed structure covered in cement stucco to appear similar to the original concrete portion of the building.

The original structure has walls approximately fifteen inches in thickness. The exterior of the building is covered in pebble finish replacement stucco that imitates the appearance and character of the original concrete material after the binder has eroded. Sections of the stucco have become detached, exposing the original concrete and making the pour lines easily visible. The pour lines appear to be consistent with one foot lifts, but are only exposed in small sections.

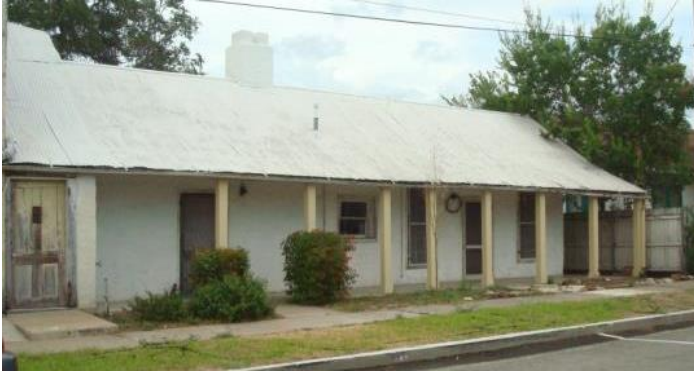
Figure 4.1: Magnolia Hotel, Author's image, September 12, 2013.

The Magnolia Hotel was constructed in two phases: the first structure is to the north and is woodframe construction; the second is to the south and is constructed of Seguin concrete. The graphic shows the basic footprint of the structure as it stands today. Due to recently completed renovations, the exterior and most of the interior of the structure have been covered in stucco with no exposed areas; however, the small hallway connecting the woodframed and concrete portions of the building has an area of exposed original concrete material. A small board-covered window has an exposed area of approximately 15”x 5” at its greatest height and width, respectively.

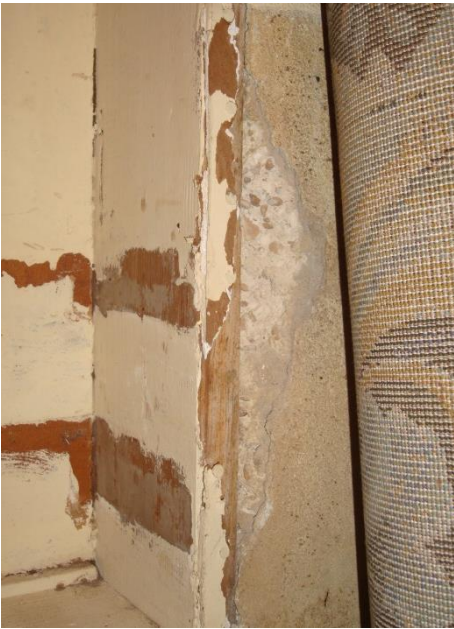
Figure 4.2: Window frame & exposed concrete, Author's image, September 12, 2013. The photo shows the small exposed area adjacent to the window frame that allowed for sample extraction.

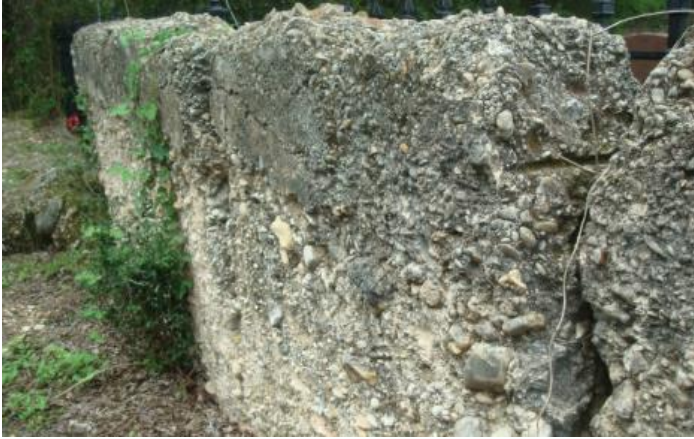
Figure 4.4: Riverside Cemetery Wall, Author's image, September 19, 2013.

were extracted from the area closest to the expansion joint on the outer portion of the wall and were taken from both the upper and lower portion of the wall in the described area.

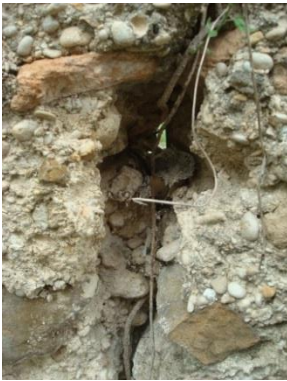
Figure 4.5: Riverside Cemetery Wall, Author's image, September 19, 2013. This image shows the areas where two wall sections are joined. Samples were extracted just to the outside of this joint.

The Riverside Cemetery walls once surrounded the cemetery, but now only exist in isolated sections. The cemetery walls were most likely constructed in sections that were connected with a mortar-like material. Even though some sections of the cemetery walls stand in their original locations, others lie fallen in single sections. The standing walls are approximately four feet high, with an average thickness of fifteen inches. Stucco loss and binder erosion have exposed large aggregate that projects from the wall surface. The upper two feet of the walls have evidence of biological growth. Samples

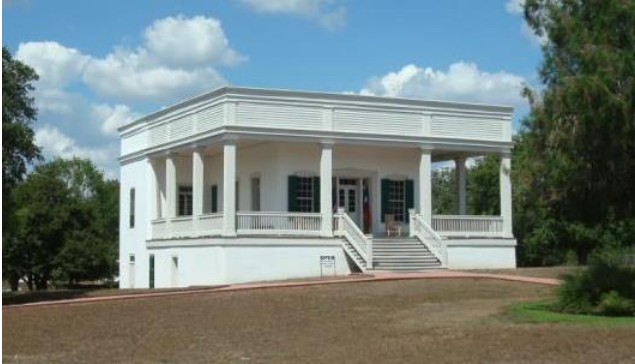
Figure 4.6: Sebastopol, Author's image, September 12, 2013.

Sebastopol has a raised plan with a basement that is accessible from three sides. During the 1980s restoration the exterior of the structure was restuccoed, but portions of the interior of the basement were left exposed for interpretive purposes. In this space, full heights of the concrete walls are left exposed making the pour lines easily visible. The walls are approximately fifteen inches in thickness and were poured in one foot lifts. Some of the exterior walls were deteriorated to such a point that they were demolished and reconstructed with in-kind materials.

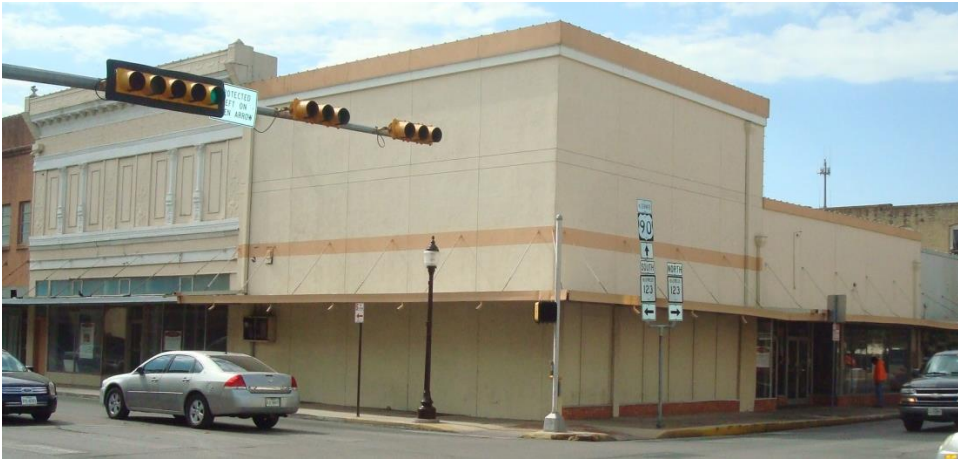
Figure 4.7: Moses Campbell Commercial Building, Author's image, September 19, 2013.

Most of the structure that is known as the Moses Campbell Commercial Building is constructed of brick; however, a small portion of original concrete material survives. There is one concrete wall within the structure located toward the southeast corner of the building. This wall was re-discovered during a renovation of the building in the early 2000s and has been left exposed during its vacancy. The wall is fifteen inches in thickness, with the pour lines easily visible. Wood spreaders from the original formwork are still embedded in the wall and are only seen due to the incidental wall exposure. Although this wall has combined caliche block and concrete construction, it is included because it shows an alternative method used in Seguin concrete construction. This wall is the only structure where concrete is seen in cross section.

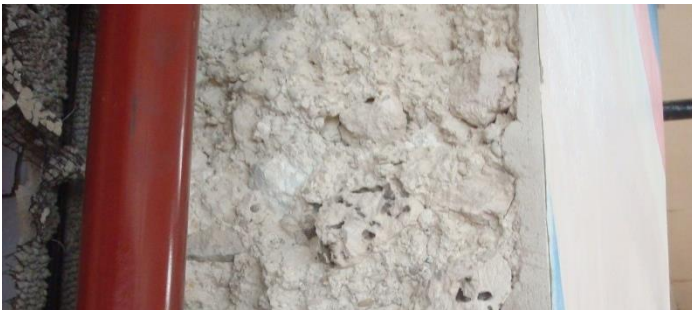
Figure 4.8: Wall section, Moses Campbell Commercial Building, Author's image, September 19, 2013.

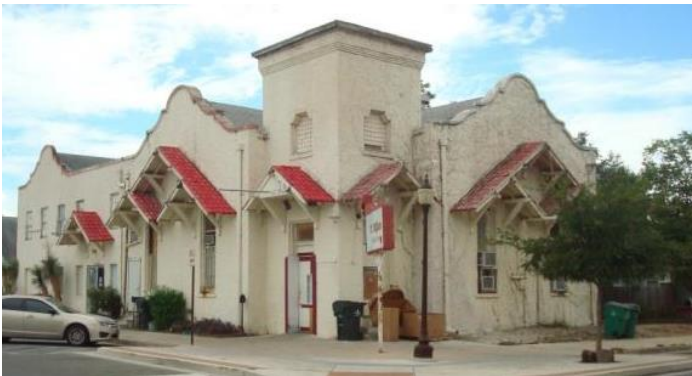
Figure 4.10: Old Baptist Church, Author's image, September 12, 2013.

The Old Baptist Church's original concrete structure was a rectangular plan, but has a later wood-framed addition on the northwest side of the building. The addition is a wood framed structure covered in stucco that appears similar to that of the original concrete portion of the building. The original structure has walls that are approximately fifteen inches in thickness. The exterior of the building is covered in pebbled non-

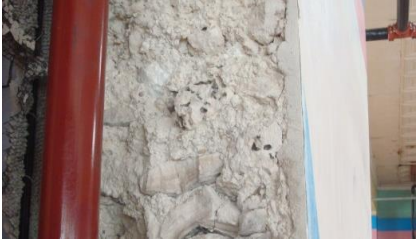
AI1, AI2	Structural wall within the commercial building, lower half is caliche blocks, upper portion is concrete; interior, chalking present
Old Baptist Church 1880

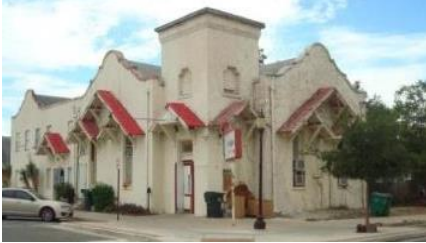
BE1, BE2, BE3, BI1	Concrete material is from the exterior and interior, differing weathering conditions, but chalking is present throughout
Riverview Cemetery Wall c.1850

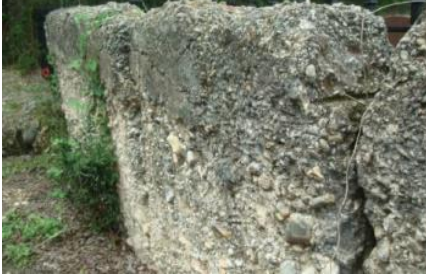
CE1, CE2	Material is exposed to exterior; chalking; no evidence remaining of stucco
Magnolia Hotel c. 1847

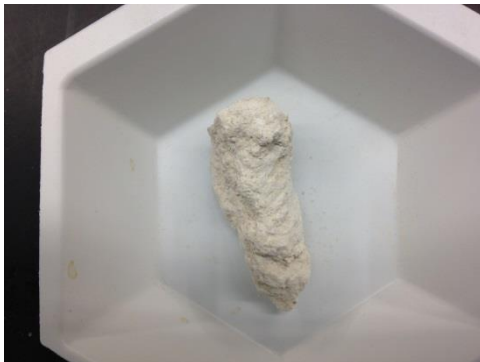
AI2

AI2: The sample was extracted on the western section of the wall. It is light brown-gray in color with trace amounts of white chunks that appear to be lime. The material has large aggregate that is gray in color.

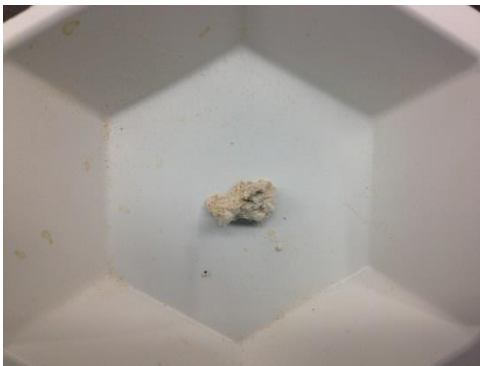
BE1 & BE2: These samples were collected from the exterior of the Old Baptist Church. The second floor of the south elevation could be accessed from the roof of an addition. The area had substantial loss of stucco and the original concrete material was exposed. Exact wall thickness could not be determined from the exterior, but distinct pour lines were 12" apart. The samples were extracted from the exposed area on the wall, BE1 was from the upper portion and BE2 was from the lower. It is light brown-gray in color. The material has large aggregate intact in the sample.

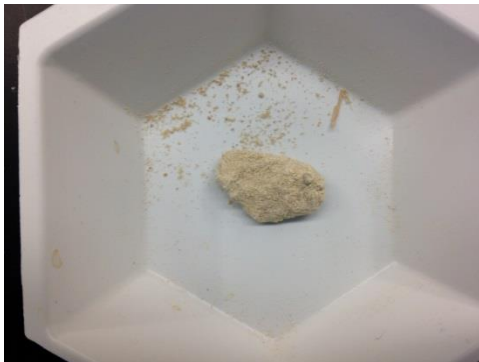
BE3

BE3: This sample was collected from the exterior of the Old Baptist Church. There is a two story tower located on the Northeast of the structure, prior to our visit, a large portion of the tower's stucco detached and was saved for our investigation. The stucco is made of 20th century cement and wrapped the corner of the tower. When it detached, it had a large portion of original material adhered to the inner surface. This material is identified as original by its characteristics of chalky binder and coarse aggregate and the evidence of distinct pour lines at 12" intervals. Exact wall thickness could not be determined from this section. The sample was extracted from the exposed area. It is light brown-gray in color. The material has large aggregate intact within the sample.

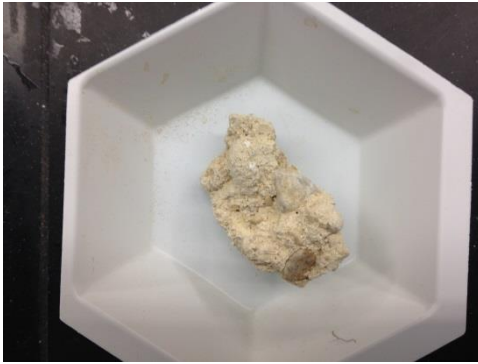
B11

B11: This sample was collected from the interior of the Old Baptist Church. Inside of the northeast tower is a small entryway with an accessible junction box. When the cover is removed, the wall thickness can be measured. The wall has an approximate width of 15". The sample was extracted from the exposed area. It is light gray/ chalky white in color. The material has large aggregate that is intact in the sample.

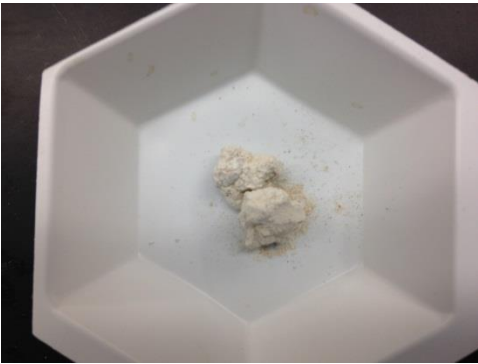
CE1

CE1: In the southernmost part of the cemetery, two sections stand while others have fallen over but otherwise remain intact. The walls are 15" in thickness, but do not have visible pour lines. The sample was extracted from the lower portion of a connection joint on the east elevation. It is light gray in color with a yellow tinge. The material has large aggregate intact in the sample.

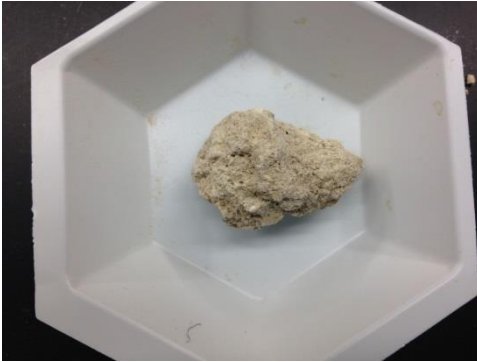
CE2

CE2: In the southernmost part of the cemetery, two sections stand while others have fallen over but otherwise remain intact. The walls are 15” in thickness, but does not have visible pour lines. The sample was extracted from the upper portion of a connection joint on the east elevation. It is light gray in color with a yellow tone. The material has large aggregate intact in the sample.

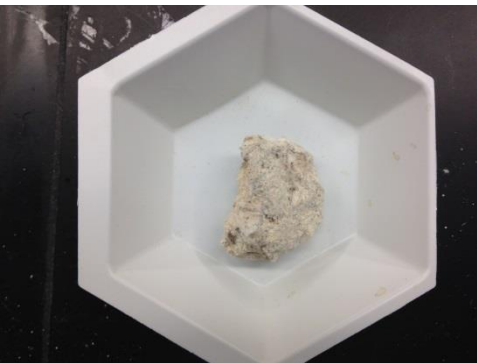
MI1

MI1: This sample was collected from the interior of the Magnolia Hotel. The hotel was constructed in two phases, the first being a one story concrete structure with a later two-story wood framed addition to the north. The later addition served as the primary hotel, while the concrete portion of the hotel became servant’s quarters. The one story structure was recently renovated, only a portion of the wall material was exposed next to a window in the corridor that attached the concrete structure to the wood frame structure. The walls are 8” in thickness, but pour lines could not be determined. The sample was extracted from the exposed area on the west facing interior elevation. The material was friable and crumbled upon extraction. It is light gray in color with a yellow tone. The material has large aggregate that is intact in the sample.

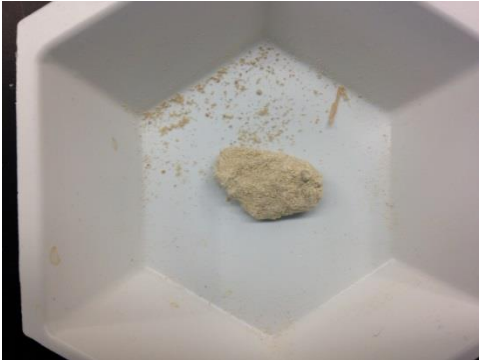
S11

S11: This sample was collected from the interior of Sebastopol. The sample was extracted from the east wall in the western interpretation room. Has what appears to be either gypsum or chalking. It is light brown-gray in color. Its large aggregate is no longer intact within the sample.

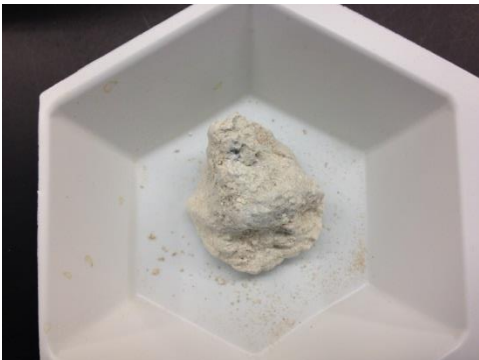
S12

S12: The sample was extracted from the east wall in the center room. Has what appears to be either gypsum or chalking. It is light brown-gray in color with large aggregate that is intact within the sample.

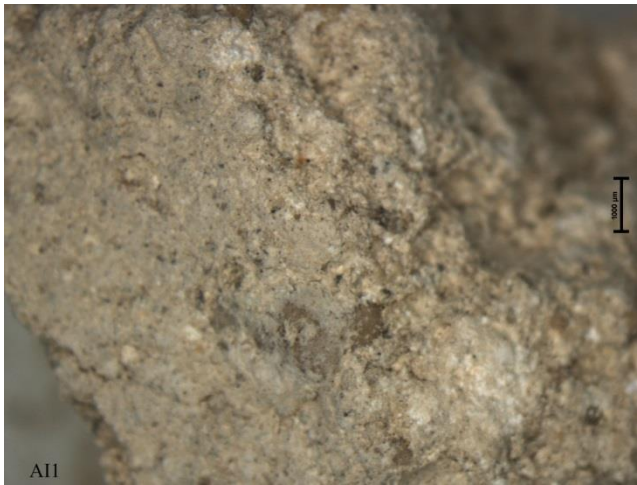
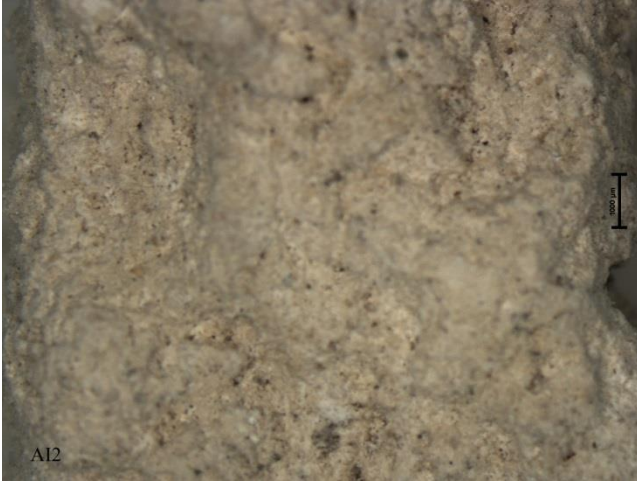
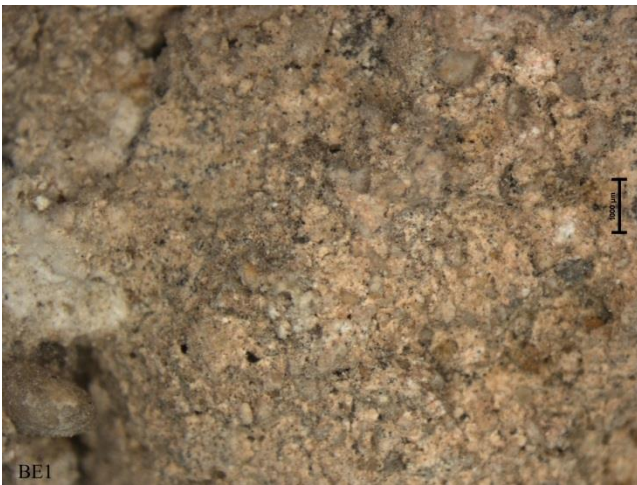
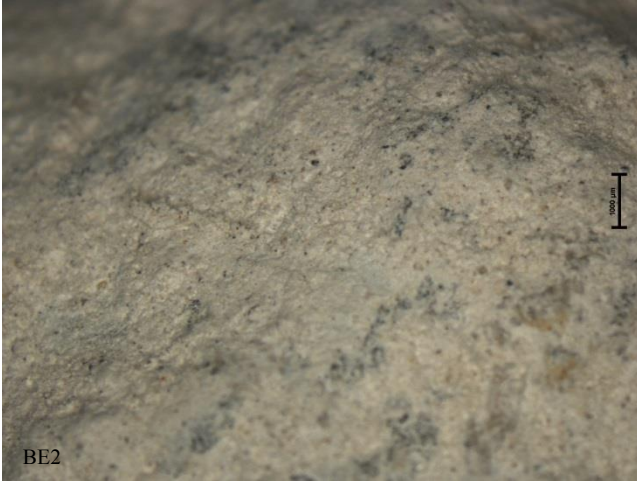
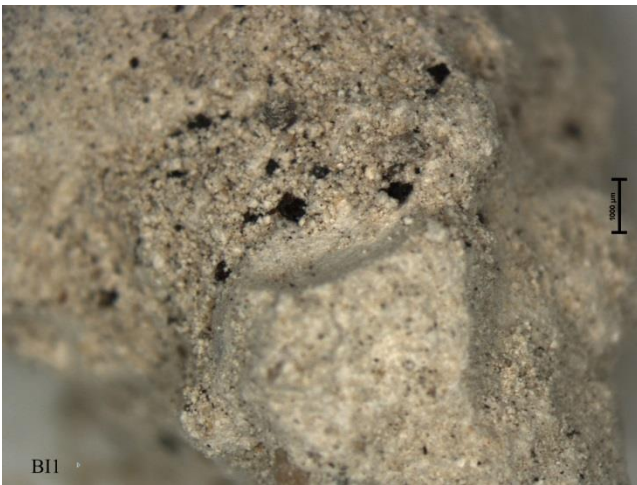
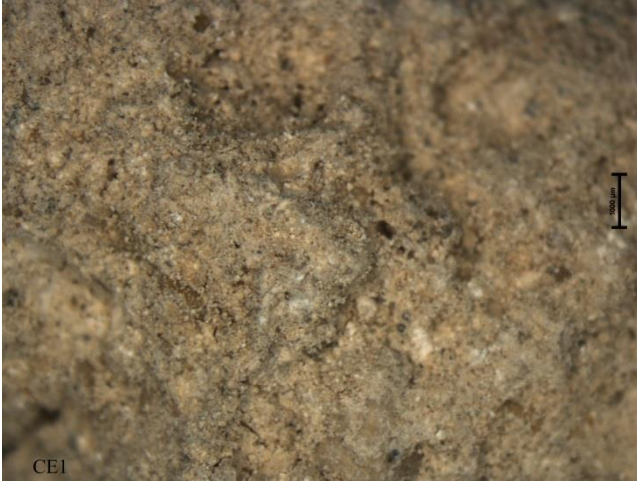
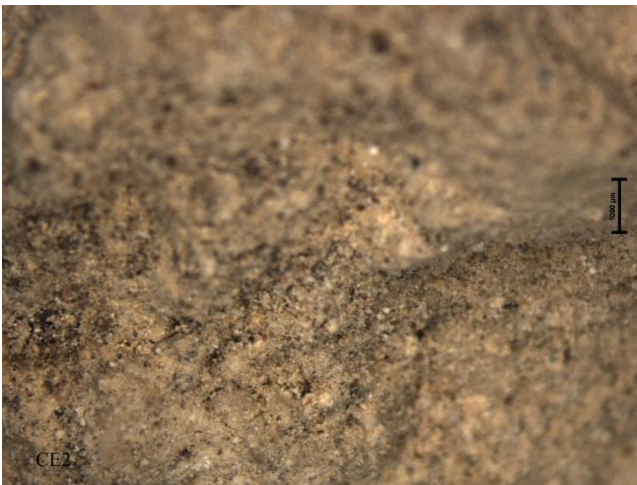
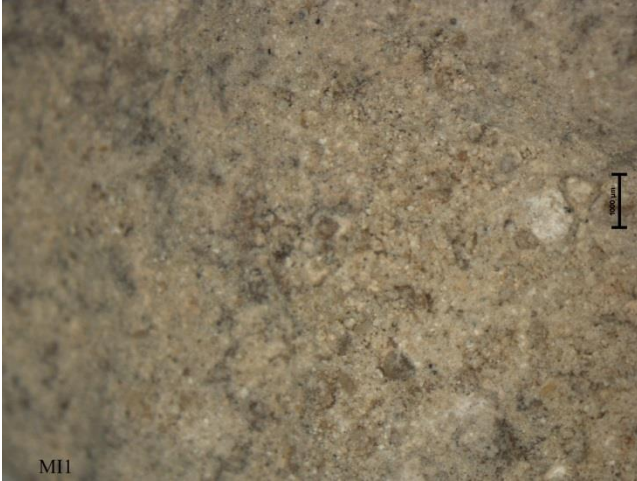
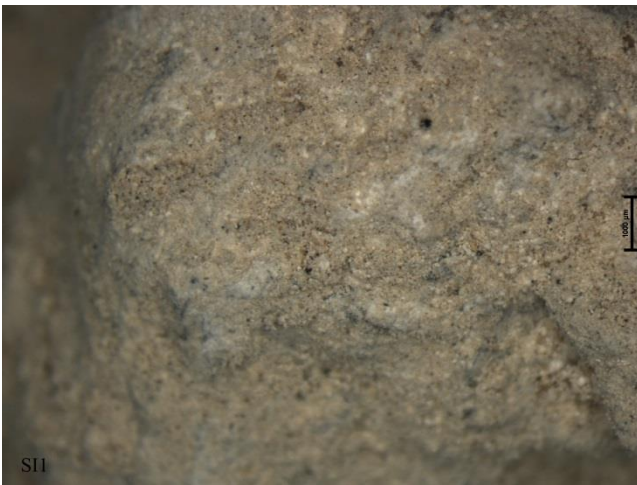
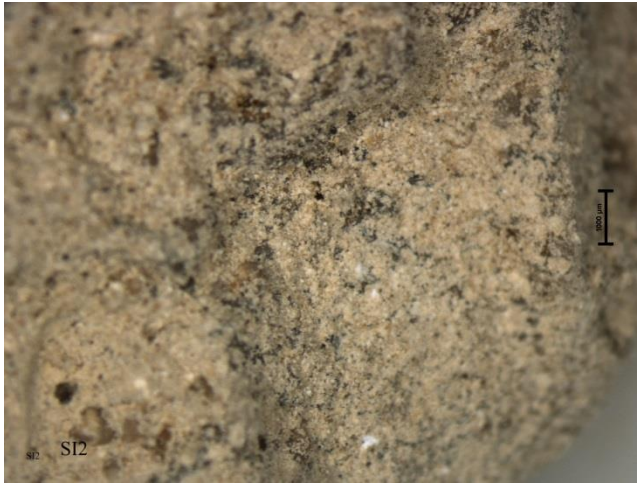
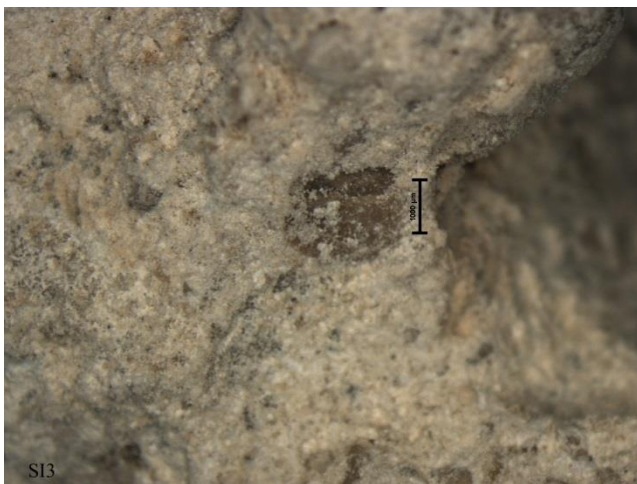
The following photomicrographs show each intact sample under magnification. You are able to see the physical properties of the binder and aggregate in each image. The black spots that appear in some of the samples are likely to be charred bits from the calcining process. The green-brown color present on some of the samples is biological growth.

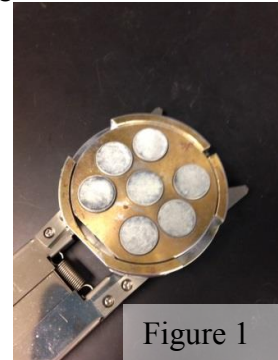
Figure 1

Sample Preparation: To analyze the cement composition, the binder had to be isolated from the aggregate prior to analysis. Each sample was pulverized using a ceramic mortar and pestle, separated using a 3” diameter sieve set, material collected in pan and sieve screen no. 100 & 200 were again pulverized, separated a second time in a standard sieve set, and material caught in the pan (less than 75 µm) was used for analysis. This method was the best way to isolate the binder with the equipment available. Once the samples were prepared, they were applied to specimen stubs using carbon tape and placed in the specimen holder (fig. 1).
