Tribological characterisation of
turbocharger
turbine sealing rings
in heavy duty diesel engines

**Mechanical Engineering, master's level
2018**

Luleå University of Technology
Department of Engineering Sciences and Mathematics

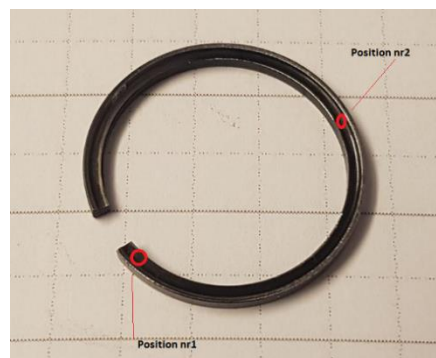
Figure 5. Position 1 and 2 respectively where the sealing ring surface analyses had been done.

The sealing rings was also surface analysed. The surface analysis had been done with Light Optical Microscope, 3D Surface Profiler and Electron Microscope. The sealing rings have a gap as it can be seen in Figure 5 below. Due to the ring gap, the worn surface of the sealing rings differs along the length. Therefore, the analysis of the sealing rings had been done at two different positions as shown in Figure 5 below.

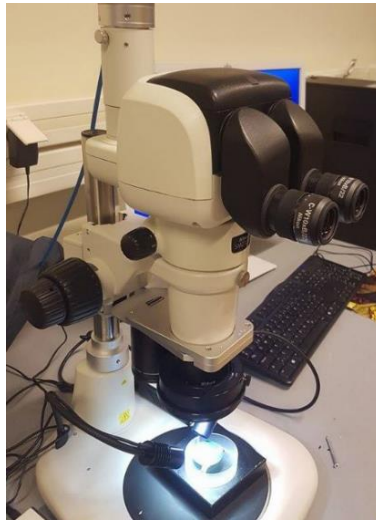
Figure 16. The Light Optical Microscope, Nikon SMZ1270.

The LOM that had been used to do the analyses is *Nikon SMZ1270*, which is a microscope that can magnify the image up to 80 times. The software that had been used to take the pictures with is *NIS-Elements D*.

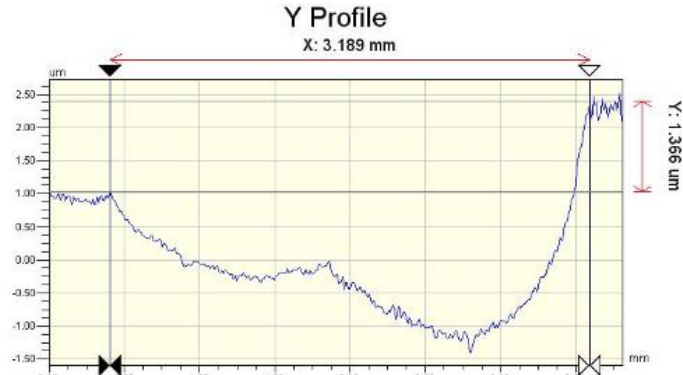
Figure 19. Example of wear measurement across discs wear track.

The wear of the discs were evaluated by 3D optical profile measurements instead. The 3D optical profile is taken at four different points at the wear track. It is taken five to six measurements across the wear track.

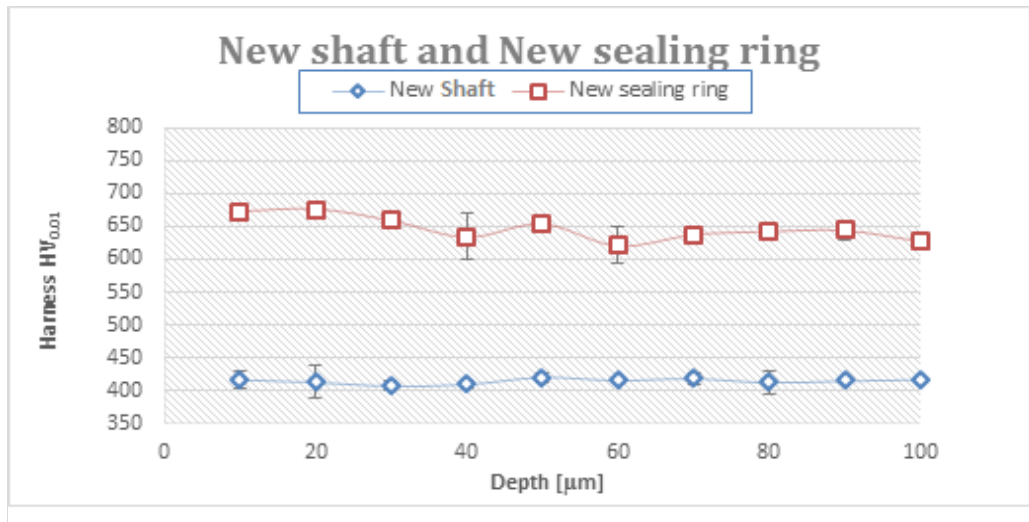
Figure 34. Hardness values of the new samples.

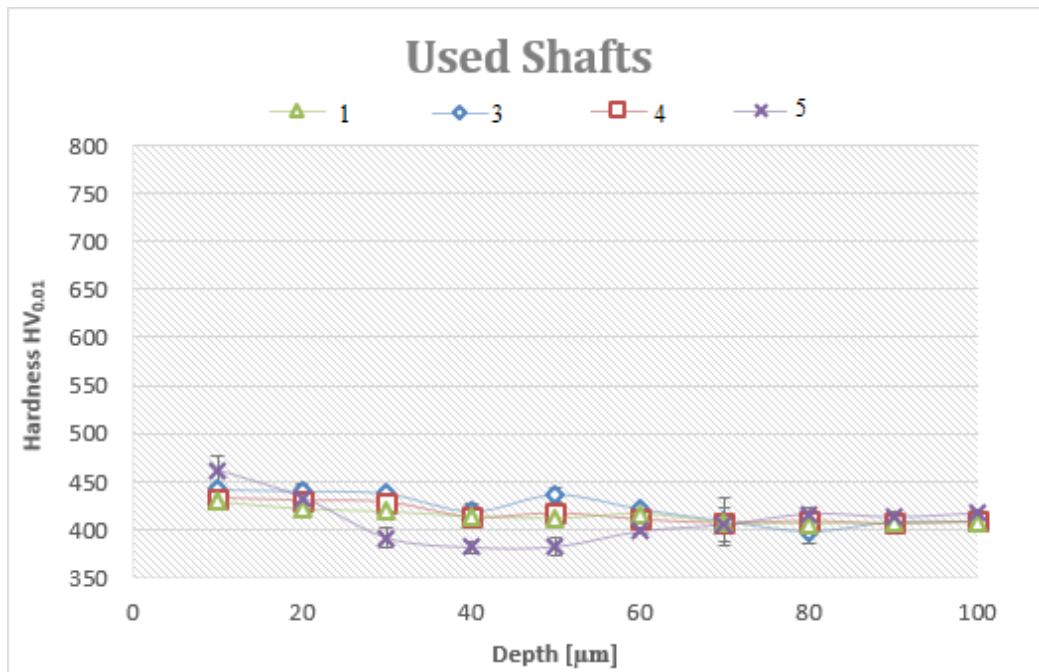
Figure 35. Hardness of used shafts.

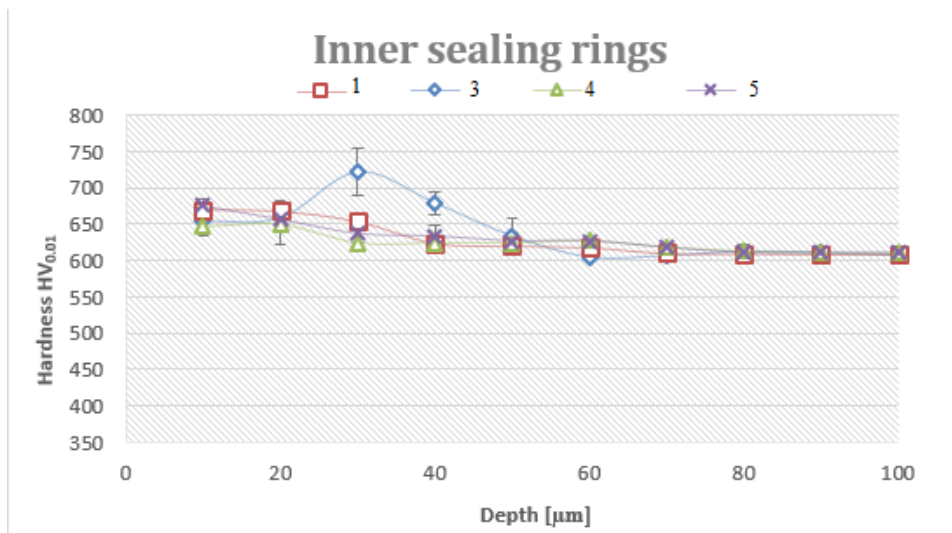
Figure 36. Hardness of inner sealing rings.

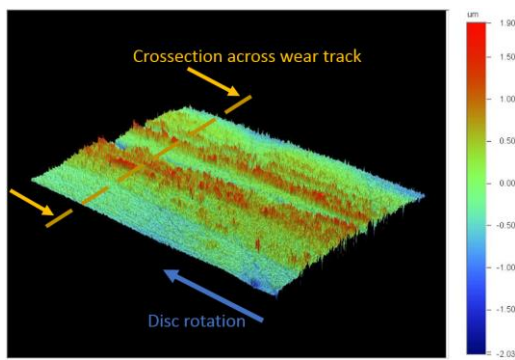
Figure 55. Surface of the disc after test, low load high speed HT.

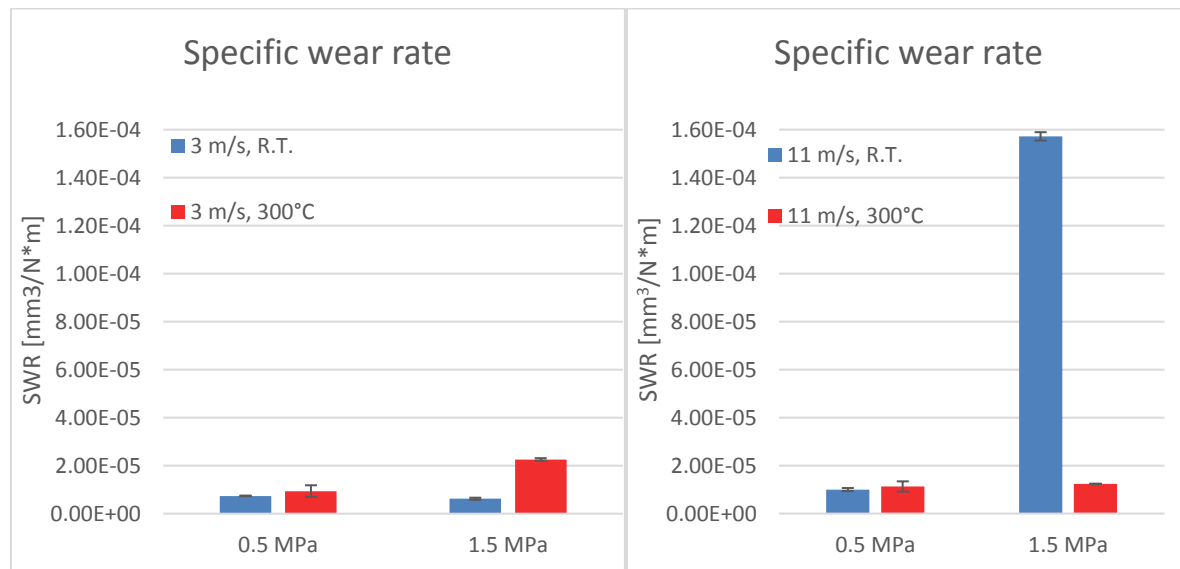
Figure 60. Result of specific wear rate.

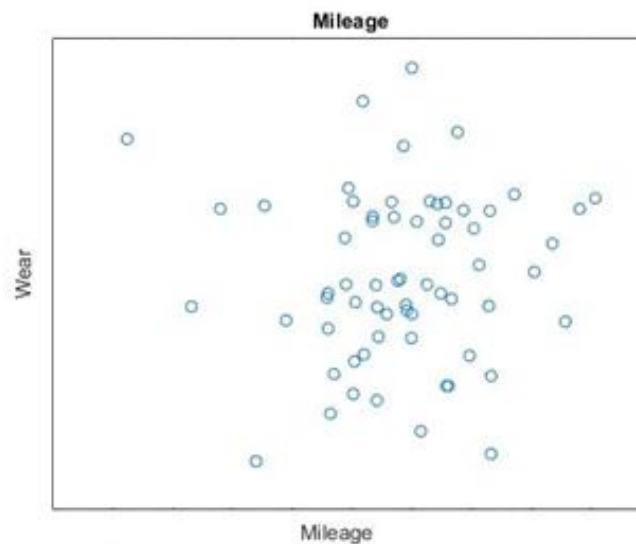
Figure 68. Wear of inner sealing ring in customer trucks.

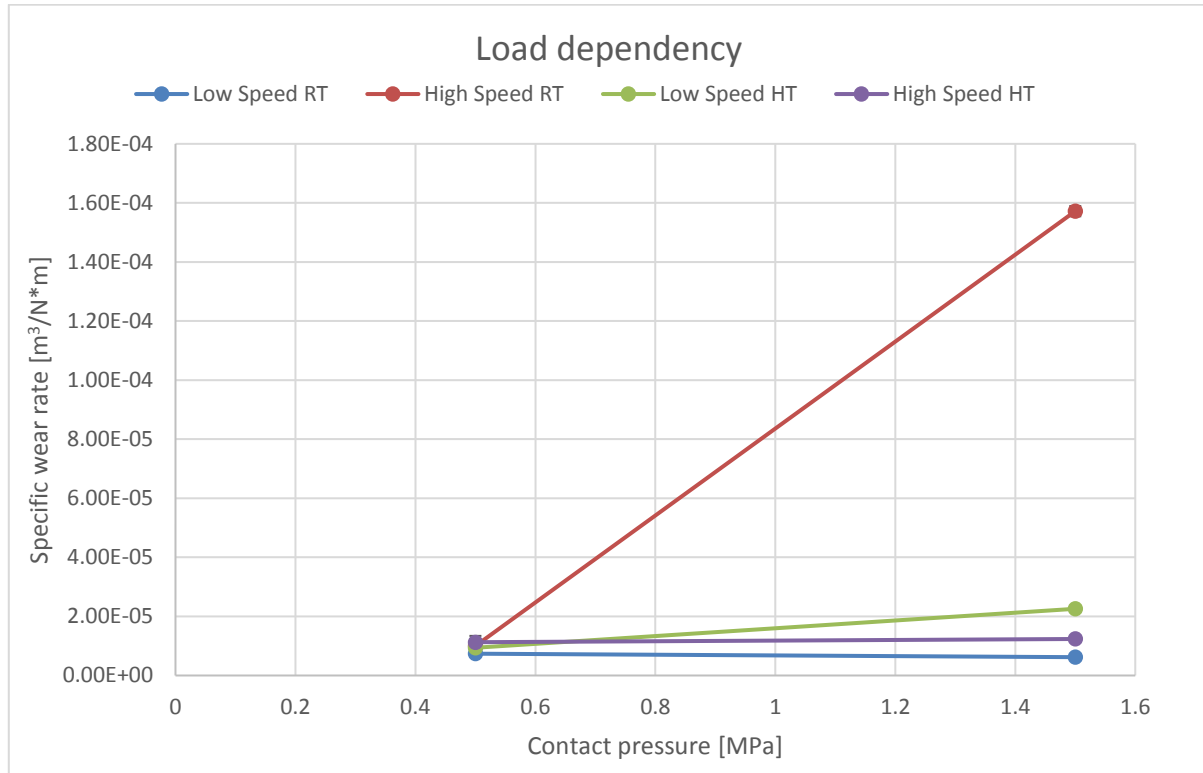
Figure 75. Specific wear rate of carbon steel AISI 4140 as function of load.

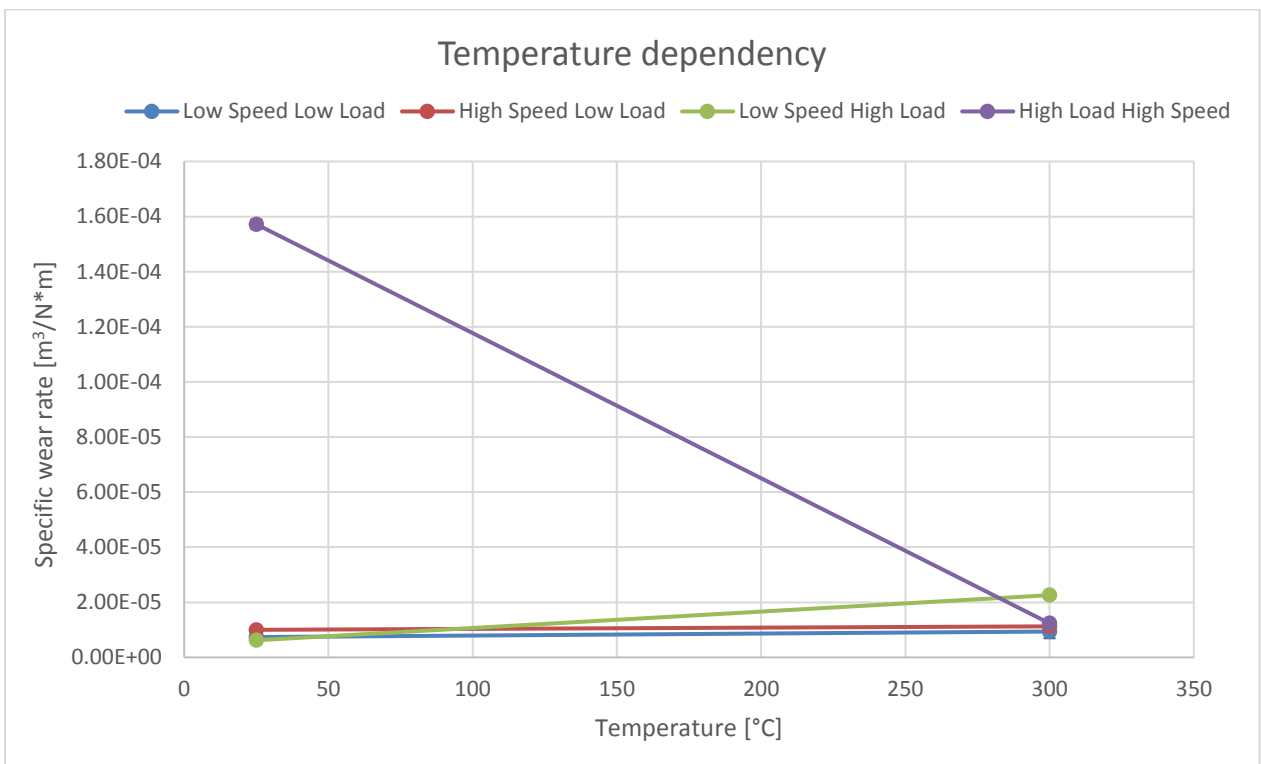
Figure 77. Specific wear rate of carbon steel AISI 4140 as function of temperature.
