The Japan Sea Central Region Tsunami of May 26, 1983
A Reconnaissance Report

Committee on Natural Disasters
Commission on Engineering and Technical Systems
National Research Council

NATIONAL ACADEMY PRESS
Washington, D.C. 1984

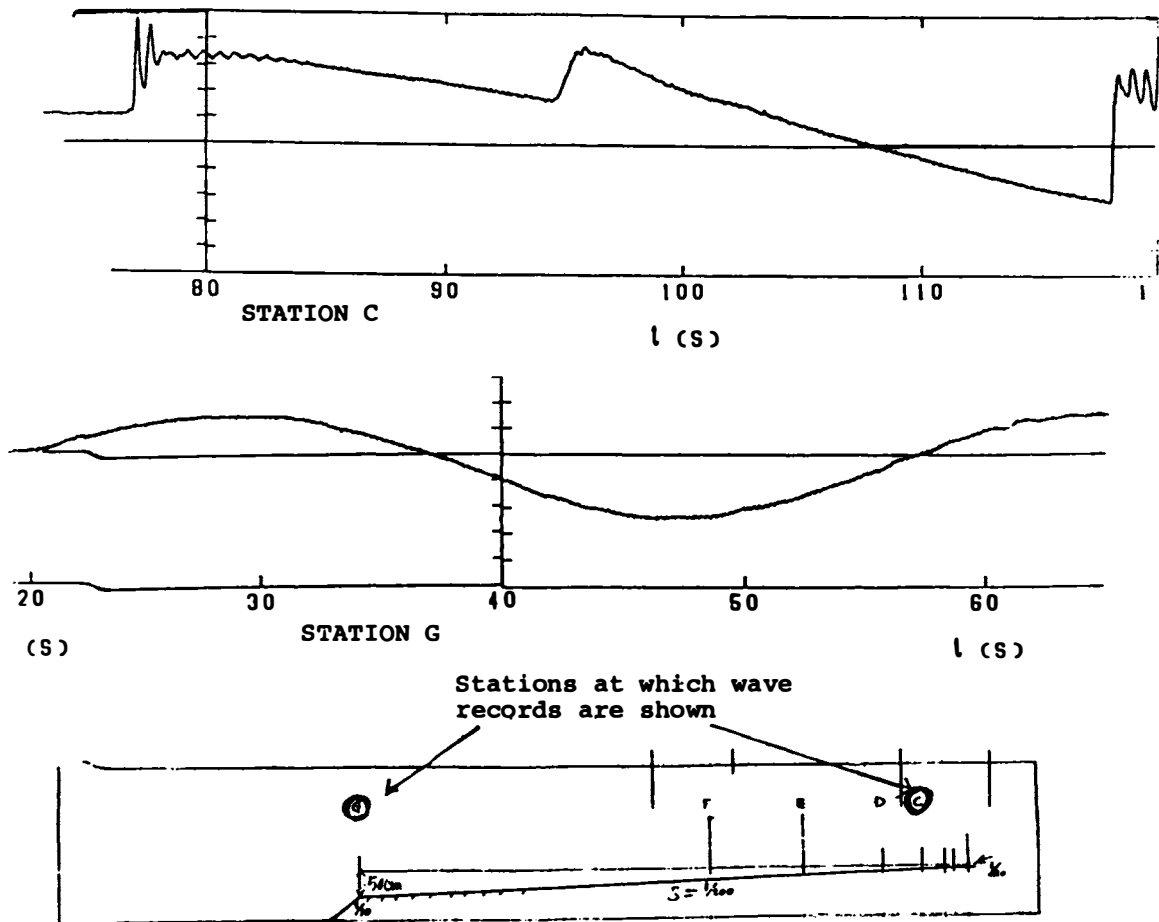
FIGURE 7   The experimental arrangement and a sample of the mea-
surements at stations G (beginning of continental slope) and C
(near shoreline).   Source: Port and Harbour Research Institute,
Ministry of Transportation.

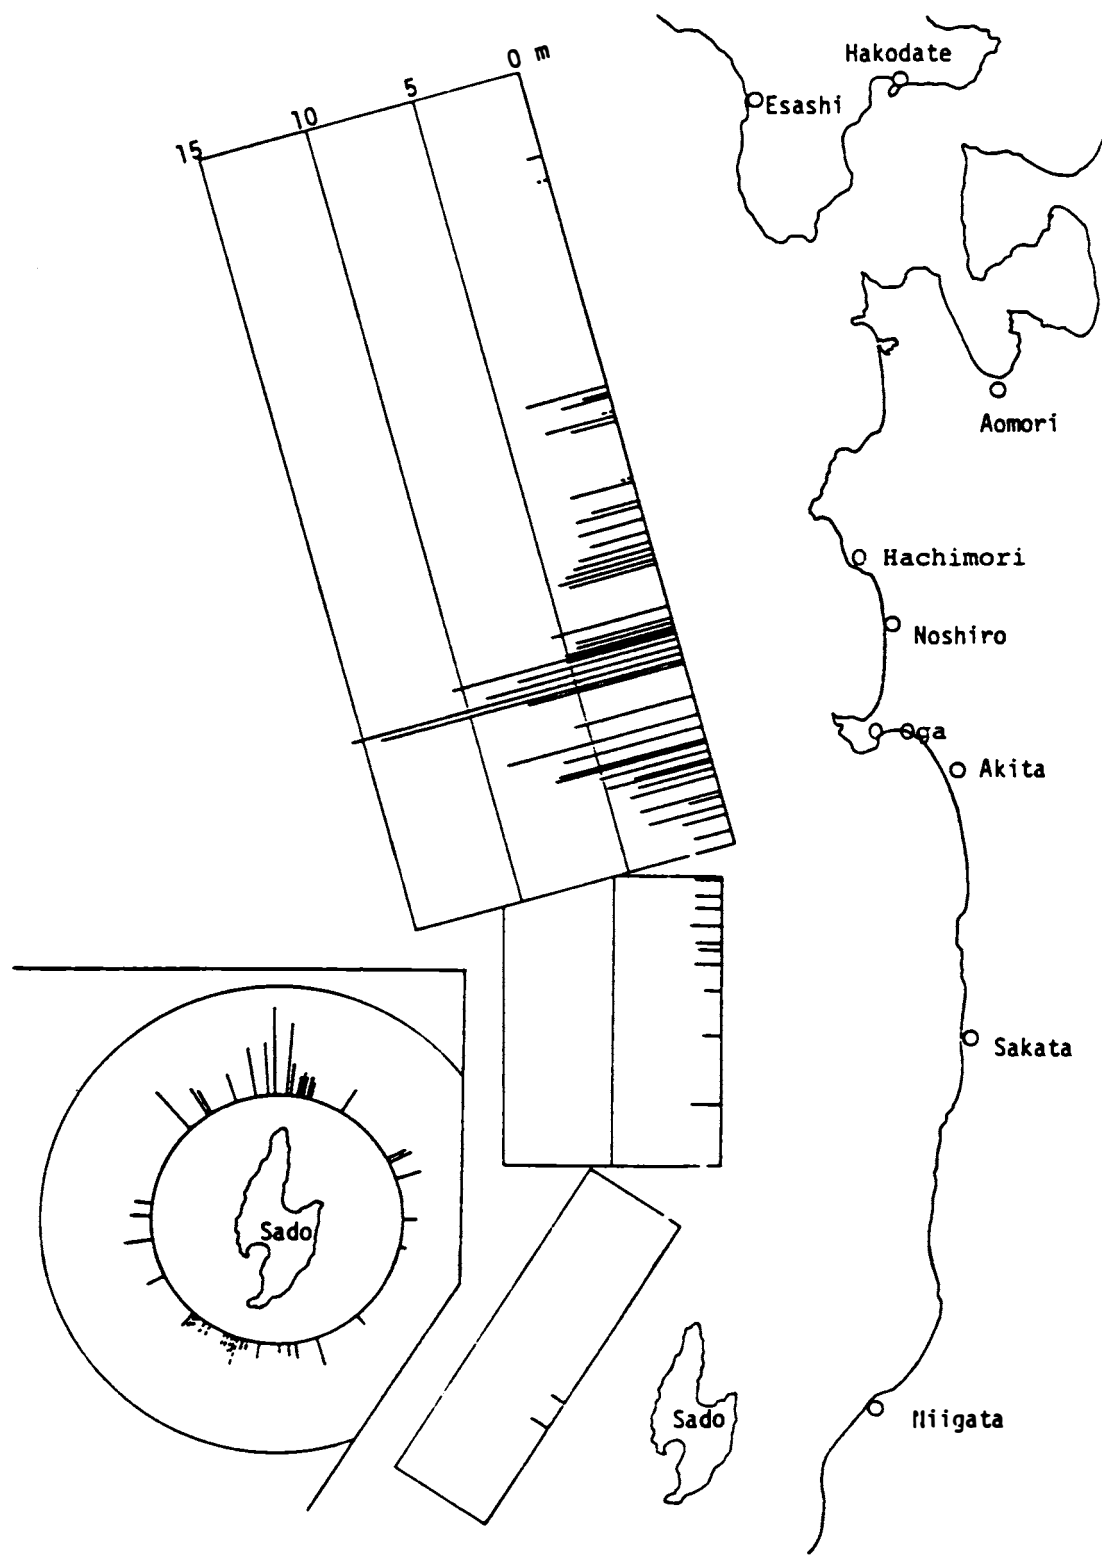
Japan coast and Sado Island. Clearly, most of the impact occurred north
of the Oga Peninsula, where a maximum run-up of 14.9 m was recorded.
More detailed results by Nobuo Shuto and his colleagues at Tohoku
University demonstrated a significant reduction in run-up for areas

FIGURE 11   Run-up measurements along the Japan coast.   Source: Shuto, 1983a.

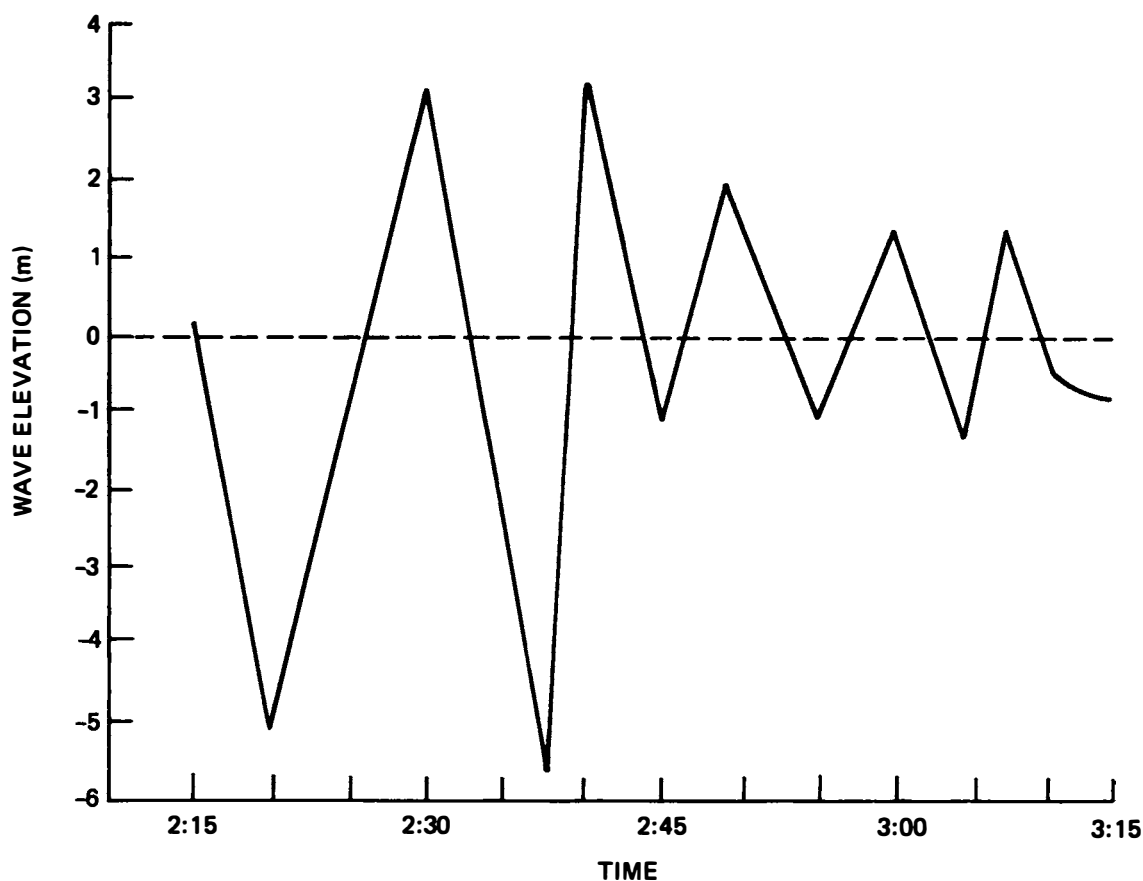
Significant wave run-up was also observed along the Korean coast.
Figure 12 gives a visual recording of run-up and run-down elevations
taken in the Port of Imweon by an observer from the Korea Maritime and
Port Administration. A maximum run-up of 3.2 m was followed by a
run-down of -5.6 m. Most of the impact of the tsunami in South Korea

FIGURE 12 Visual observations of tsunami elevations at Imweon,
South Korea. The run-ups were measured on the wall of a build-
ing; the run-downs were measured at the wall of a dock. Source:
Korea Maritime and Port Administration.

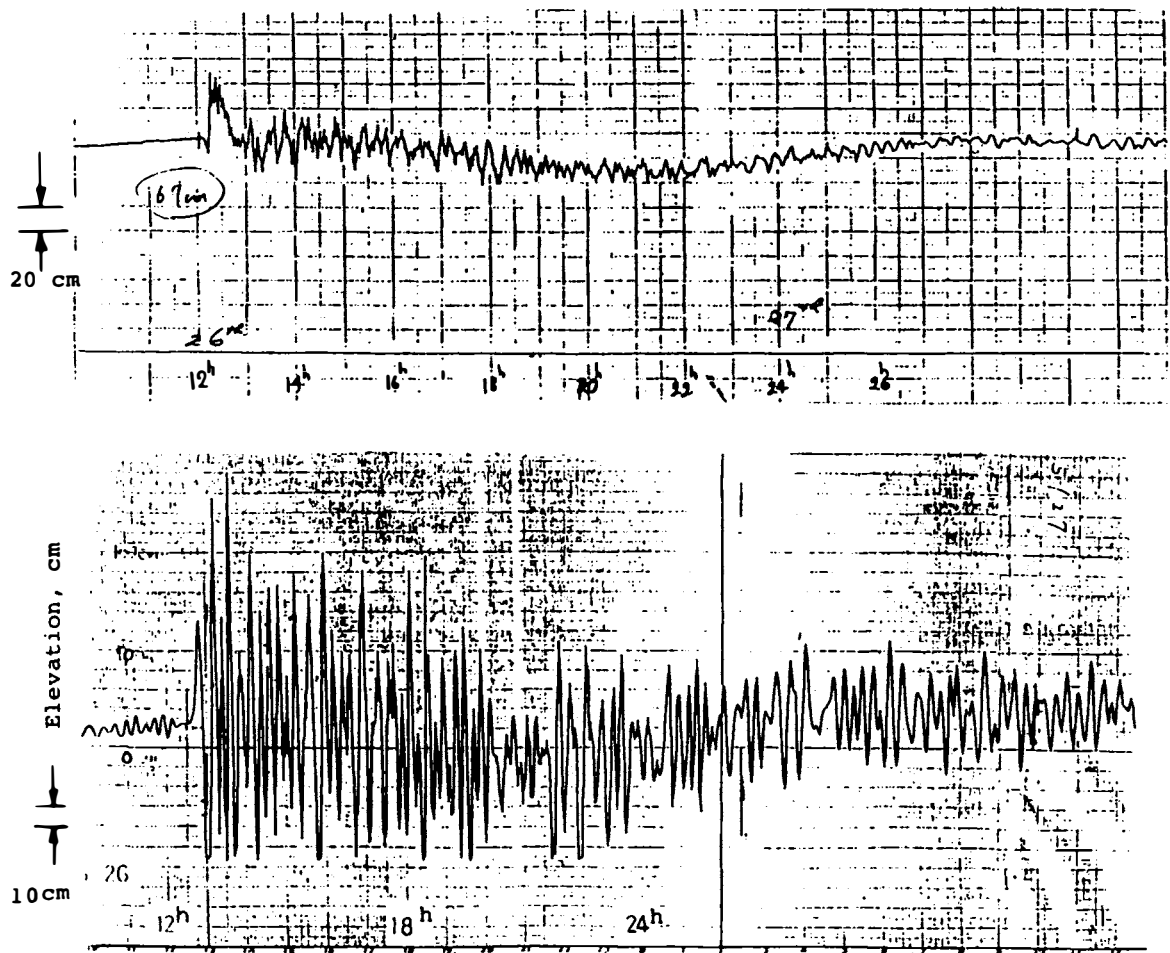
FIGURE 13 Tide gauge records. Top: Oga Aquarium. Bottom: Iwanai Harbor.

Nevertheless, for purposes of information two tide gauge records have been included (see Figure 13). The 10-minute wave period can be seen in the top chart of Figure 13. The bottom chart, however, indicates that there were approximately 20 waves within a six-hour interval, which implies periods of about 18 minutes. This longer wave period could be due to the effects of the harbor's response.
