LANDSLIDE OF APRIL 25, 1974 ON THE MANTARO RIVER, PERU

report of inspection

Kenneth L. Lee
University of California, Los Angeles

J. M. Duncan
University of California, Berkeley

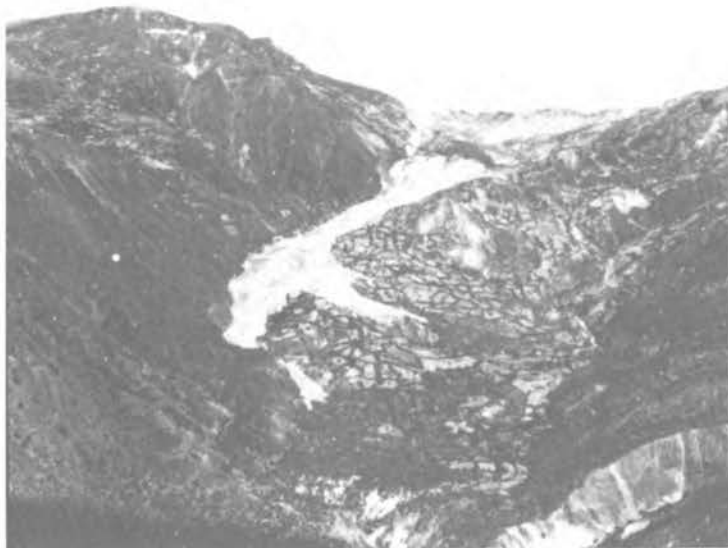
FIGURE 10. View of a typical side valley dipping into the main Mantaro river valley, and located near the Ccochacay ravine. No information is available concerning the slide shown here.

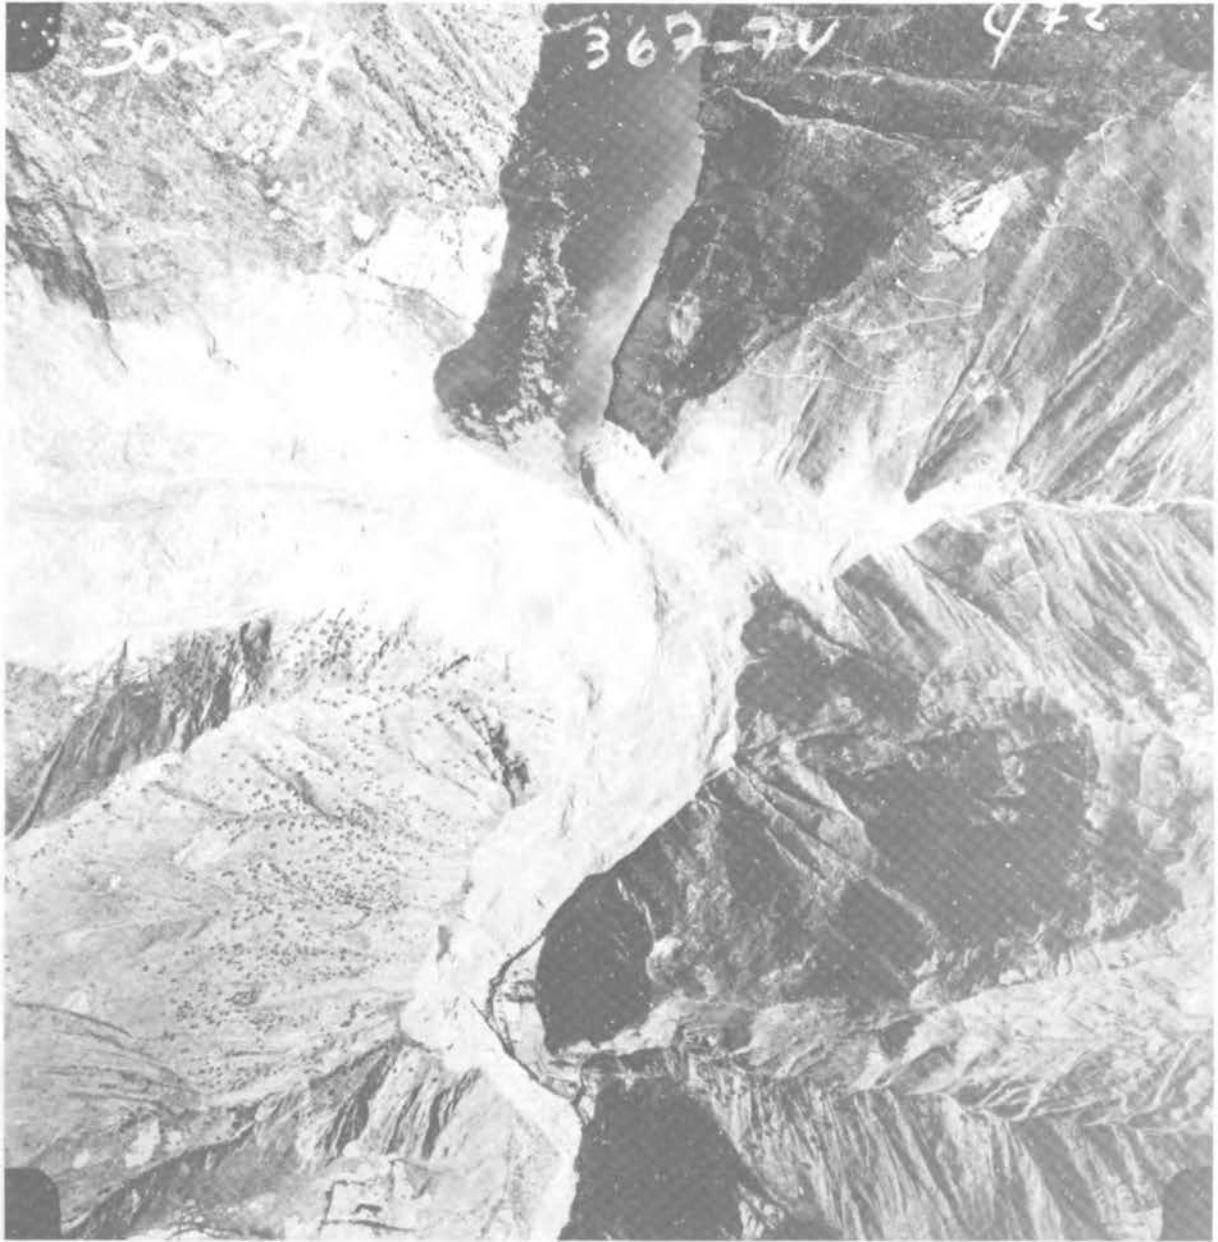
A vertical air photograph of the slide debris at the toe is shown in Figure 14. This photograph was taken May 30, 1974, just six days before the lake level reached the crest of the dam. An oblique air photo showing the entire slide area is shown in Figure 15. This photograph was taken June 9th, 1974, the day following the dam breach. This photograph conveys something of the size and extent of the slide which as mentioned, extended over a total horizontal distance of over 7 km and a vertical elevation difference of almost 2 km. Another slightly lower angle oblique air photo of the slide area taken July 7, 1974 is shown in Figure 16. A view of the lower lake area, taken July 7th, one month after the breach, is shown in Figure 17. An indication of the extent of upstream flooding and secondary sliding on the reservoir slopes can be seen in the photograph. The foreground portion of the photograph shows the Quebrada Tinte side of the Mantaro river valley where the fluidized slide material ran up and then fell back down the slopes. Also visible is the zone of mud splatter which is the dark area above the lighter shaded run up zone.

FIGURE 14. Vertical air photograph of the debris dam taken May 30, 1974 some nine days prior to the dam being overtopped. (Defensa Civil Photograph)

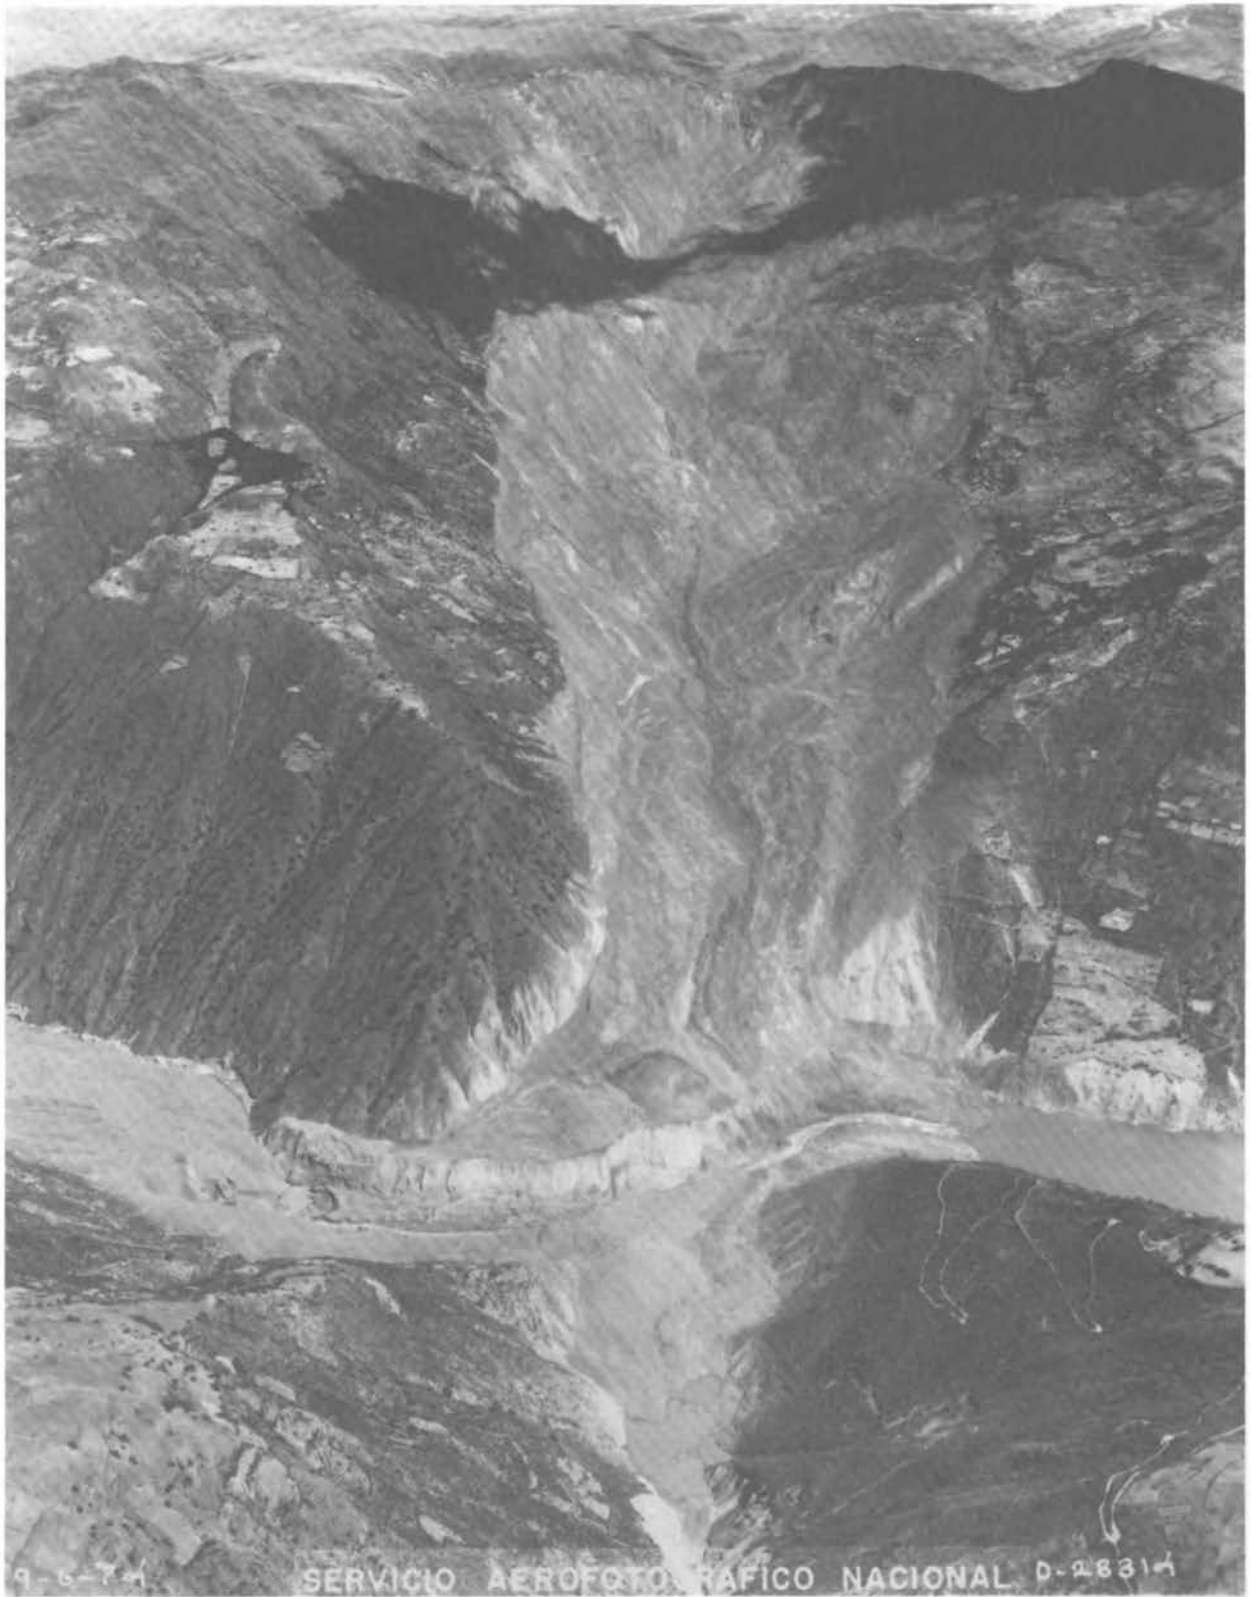
FIGURE 15. Oblique air photo taken June 9, 1974, the day following the major flooding from overtopping. (Servicio Aerofotografico Nacional, Peru)

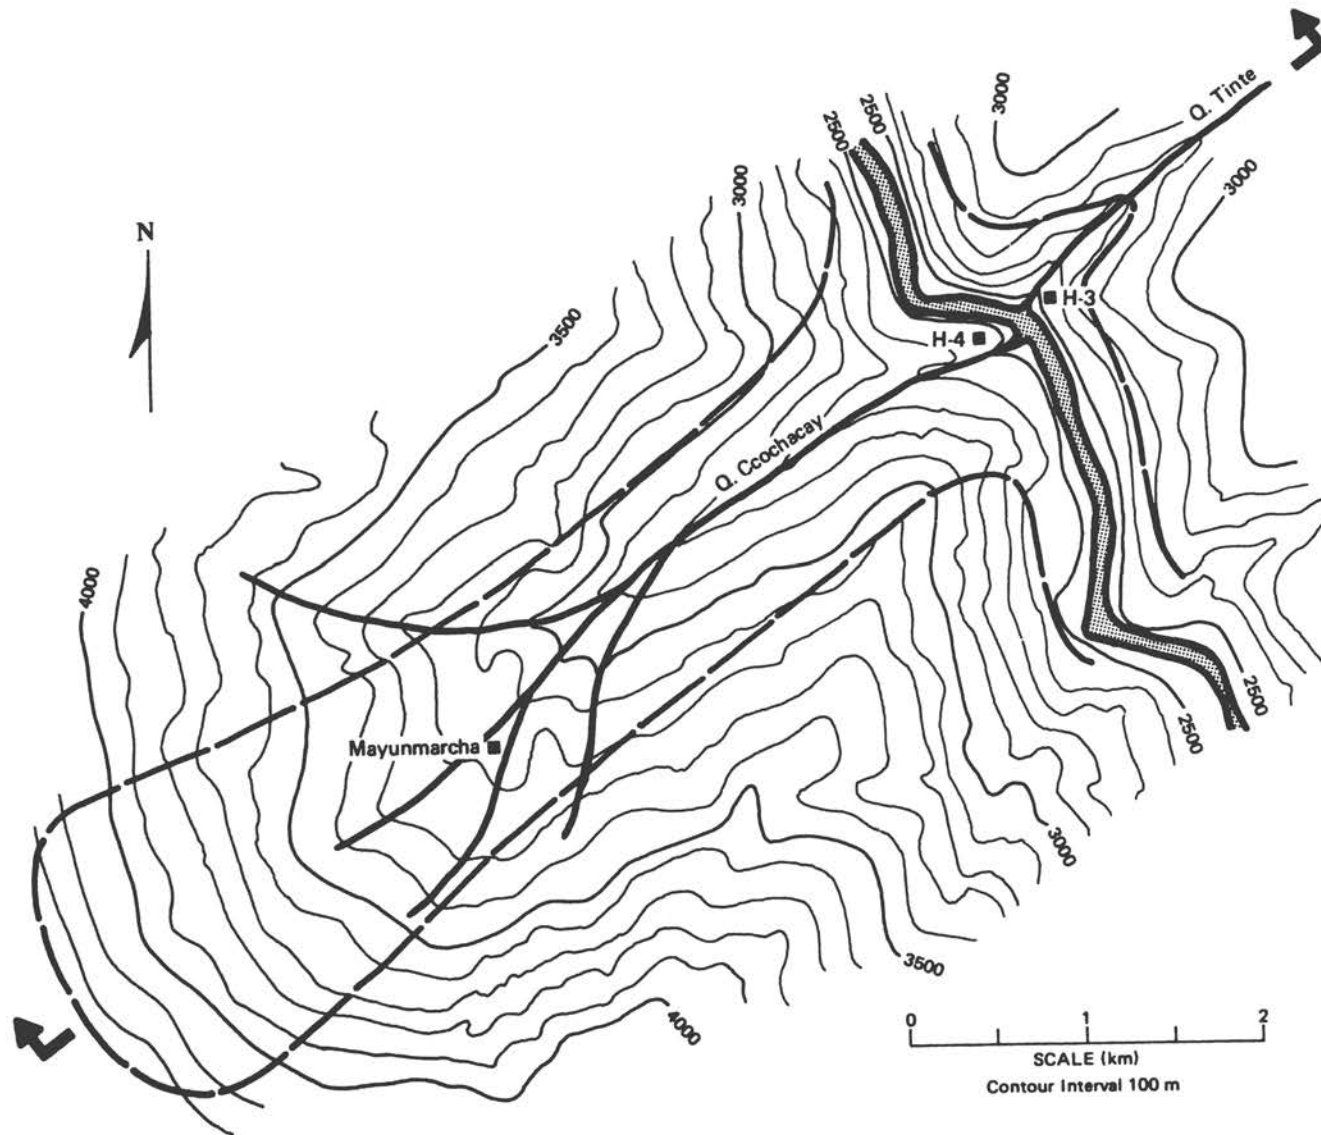
Plan views of the slide area taken from air photos made before and after the event are shown in Figures 18 and 19 respectively. A cross section along the length of the slide scarp area is shown in Figure 20. Note that this drawing is made with the horizontal scale shortened by half in comparison to the vertical scale, giving a distorted concept of the slope. From this drawing and from the other information gathered while on the inspection trip it appeared that the depth of sliding may have reached up to 150 meters below the original ground surface, and that the depth of slide debris deposited at the toe and in the Mantaro river valley may have been about the same.

FIGURE 18. Plan of area before landslide of 4/25/74.

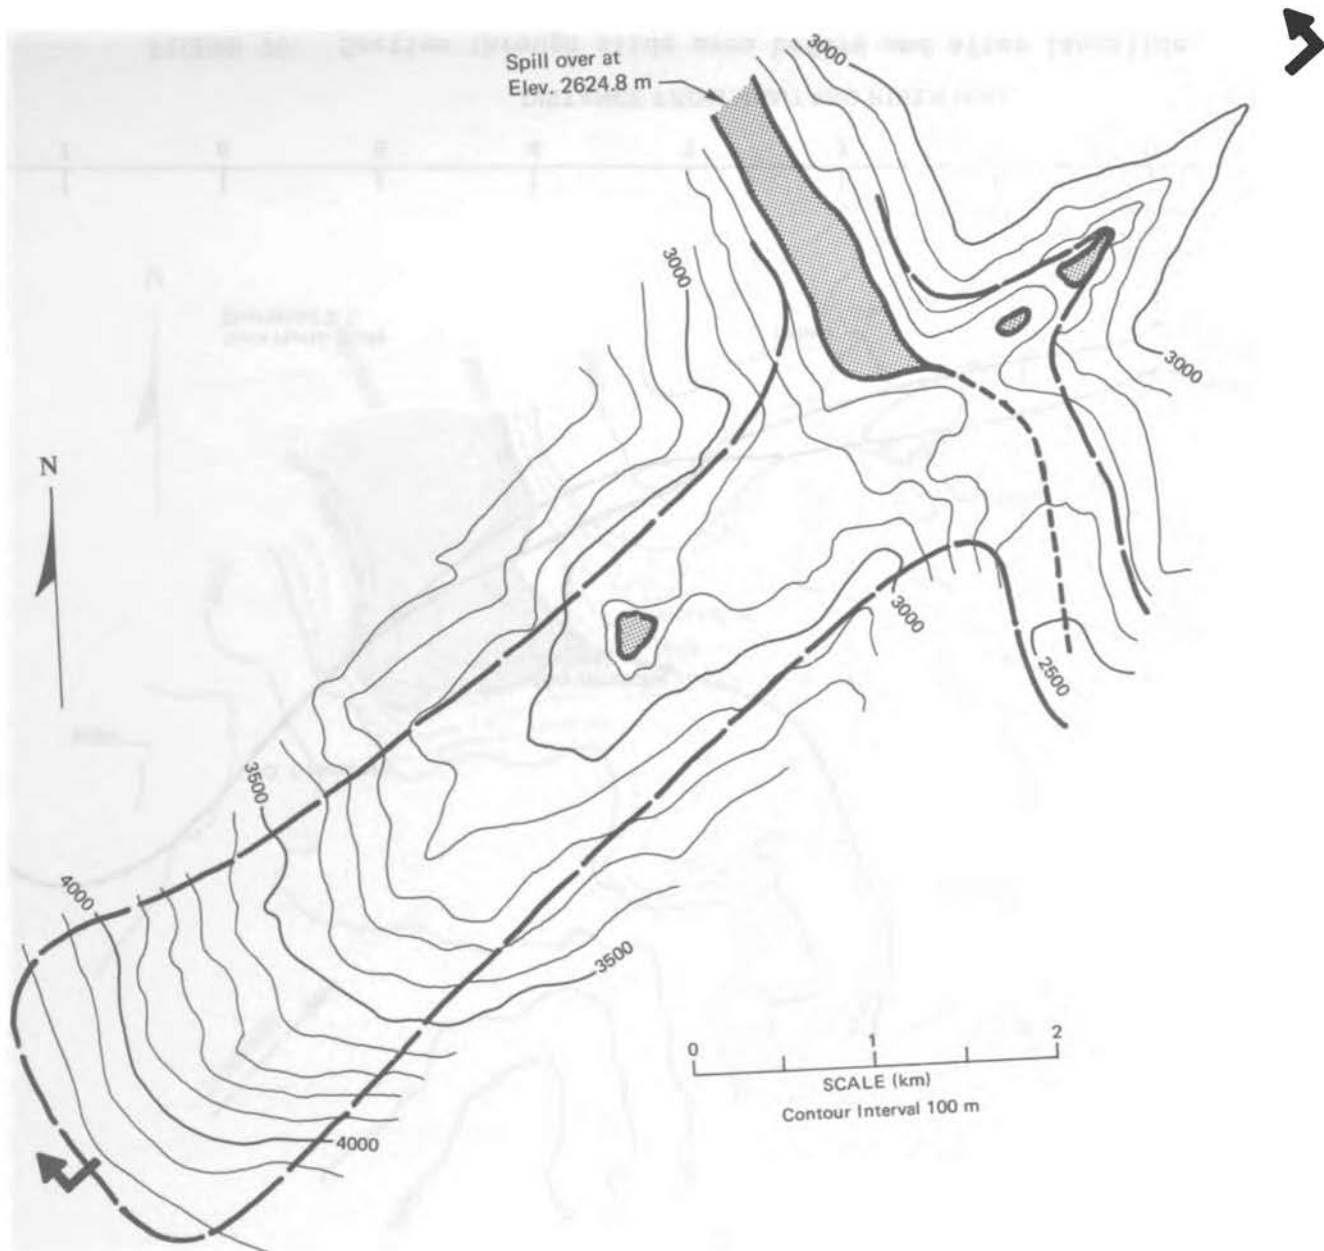
FIGURE 19. Plan of area after landslide of 4/25/74.

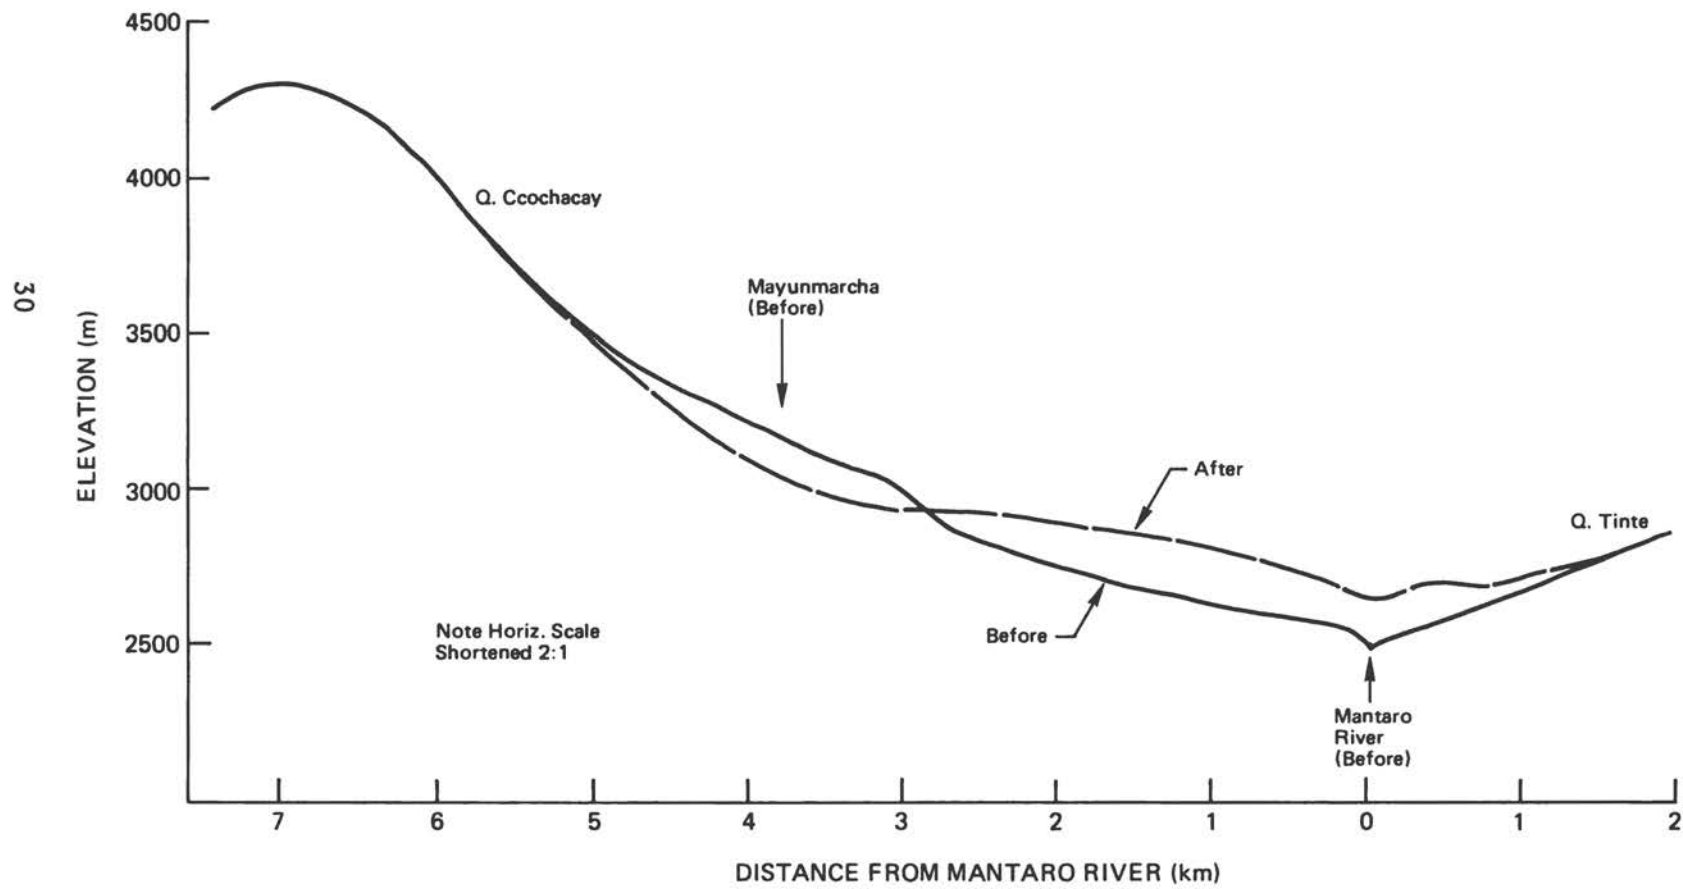
FIGURE 20. Section through slide area before and after landslide.

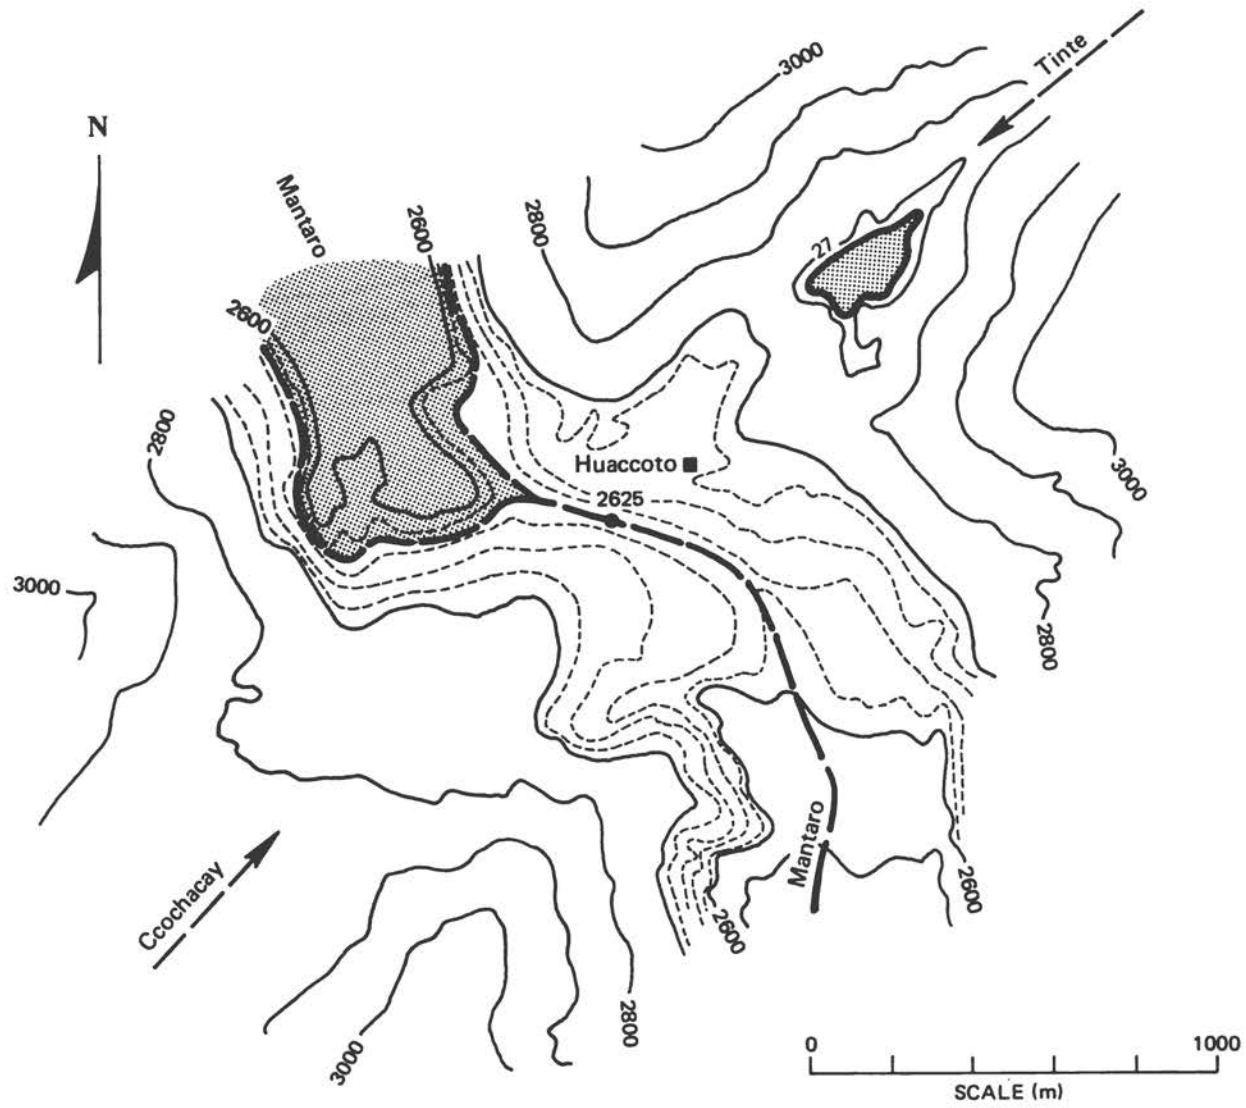
An enlarged plan view of the area at the toe after the slide is shown in Figure 21. The first exit path for the overflowing lake is indicated. An enlarged true scale sectional view of this enlarged area is shown in

FIGURE 21. Enlarged contour plan of area at Mantaro River after landslide.

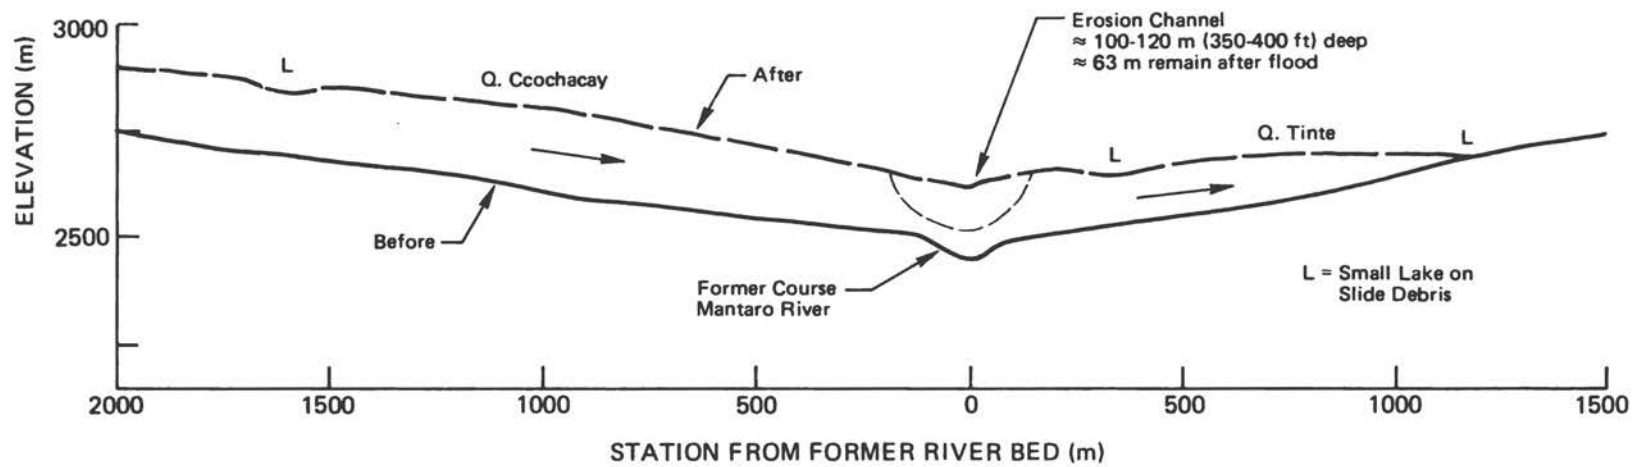
Figure 22 indicating the depth of the slide debris above the ground level before the debris dam was breached. While the old river canyon is a small feature in comparison with the surrounding topography, nevertheless it was sufficiently significant to leave a valley feature at the surface of the slide. This depression provided the exit for the subsequent overtopping.

For reference, the extent of down cutting in the erosion channel through the debris dam during the overtopping on June 6-8, 1974 is shown in Figures 22 and 23. Note that after the initial flood had subsided, a substantial dam some 63 m high still remained, creating a sizeable lake upstream. No doubt this will continue to erode slowly until the old regime slope of the river has again been established. At the time of our visit, about one month after the initial overtopping, there was still a sizeable lake behind this debris dam. However the water in the river downstream was very muddy indicating that erosion was continuing.

FIGURE 22. Enlarged longitudinal section along slide debris.

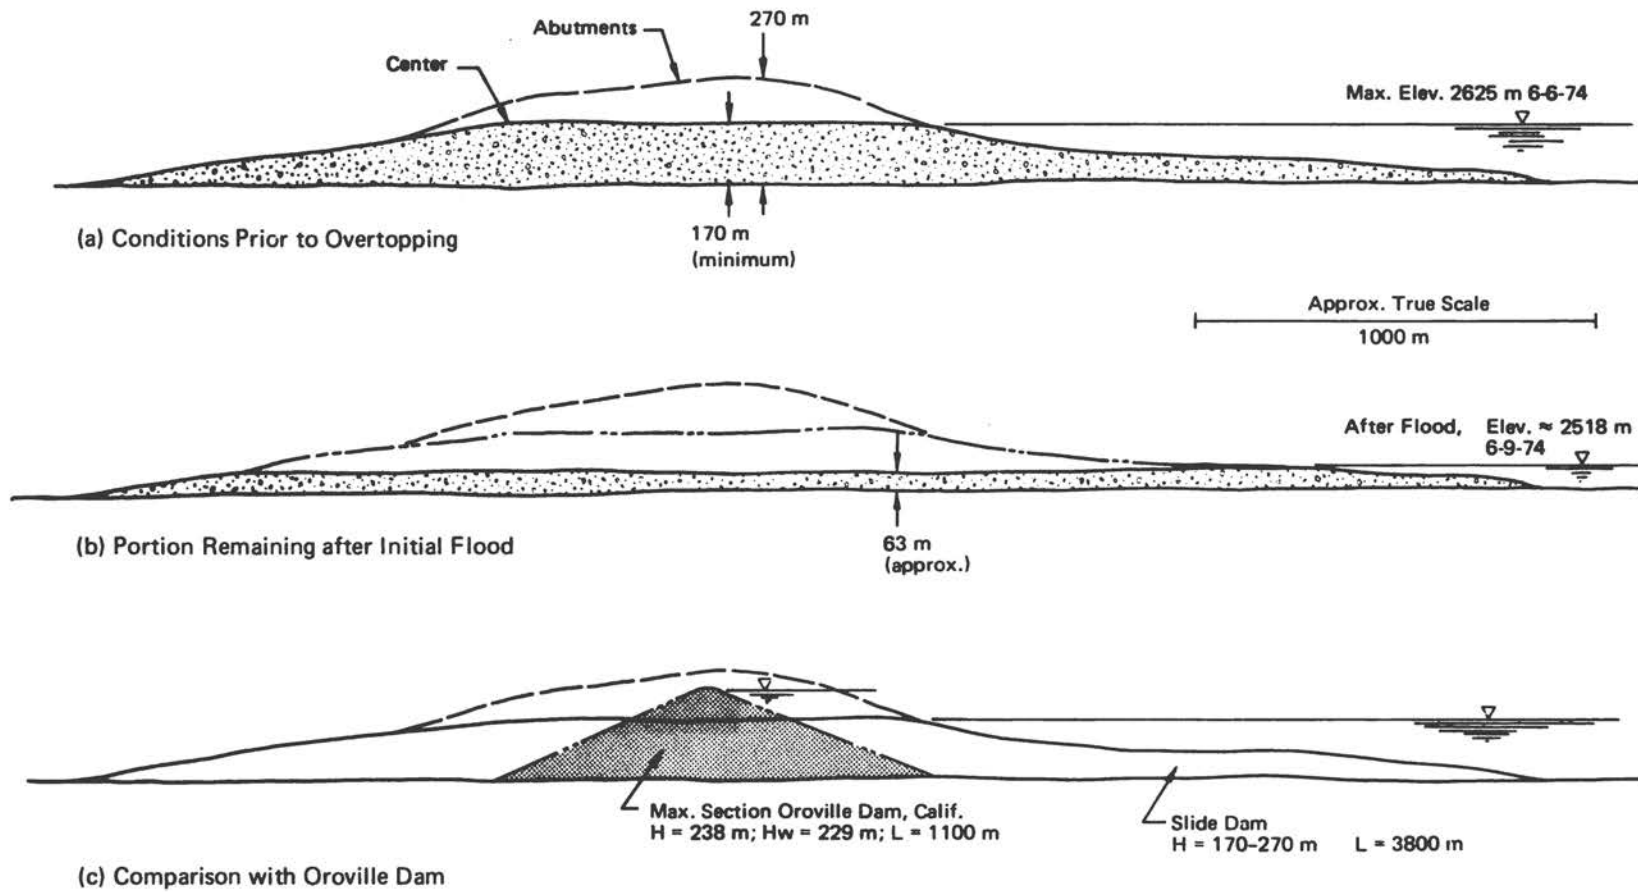
A true scale transverse section across the slide debris at the river level, which is really a cross section of the debris dam is shown in Figure 23a. Note that the elevation of the debris is considerably lower in the old river valley than over the old banks or abutments to this debris dam.

In order to illustrate the enormity of this landslide and resulting debris dam, a comparison has been made with two other subjects which may be familiar to many readers. On Figure 23c an outline of the maximum section of the Oroville dam in California has been superimposed on the cross section of the debris dam from the Mantaro river landslide. At the time of its construction about ten years ago the Oroville dam was the tallest earth dam in the world, being some 230 m high at the maximum section. Note that although it is higher than the slide debris in the river channel, it is not as high as the level of the debris on the abutments. Furthermore, the steep side slopes of the Oroville dam lead to a considerably smaller structure than this landslide debris dam. The Oroville dam is only about 1/20th the volume of this debris dam.

FIGURE 23. Transverse section of slide dam for various comparisons.

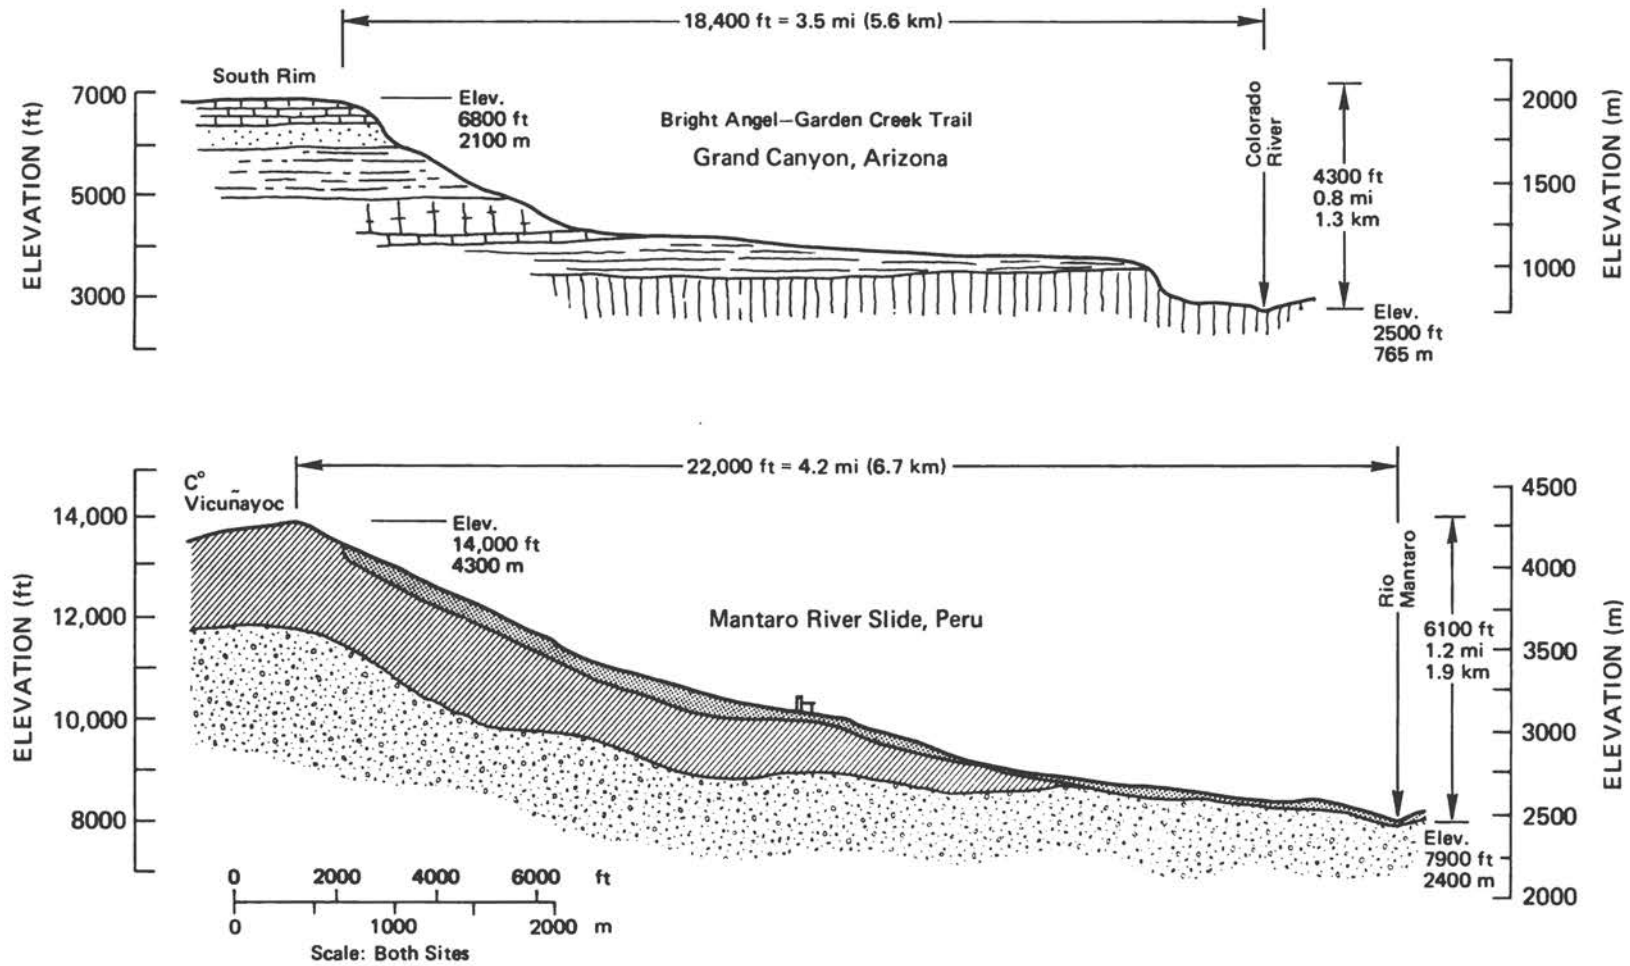
On Figure 24 a comparison is made of the slide area along the Quebrada Ccochacay from the mountain peak to the Mantaro river, with the south side of the Grand Canyon along the Bright Angel - Garden Creek Trail from the south rim to the Colorado river. The vertical and

FIGURE 24. Comparison of cross sections: Grand Canyon, Arizona and Mantaro River slide.

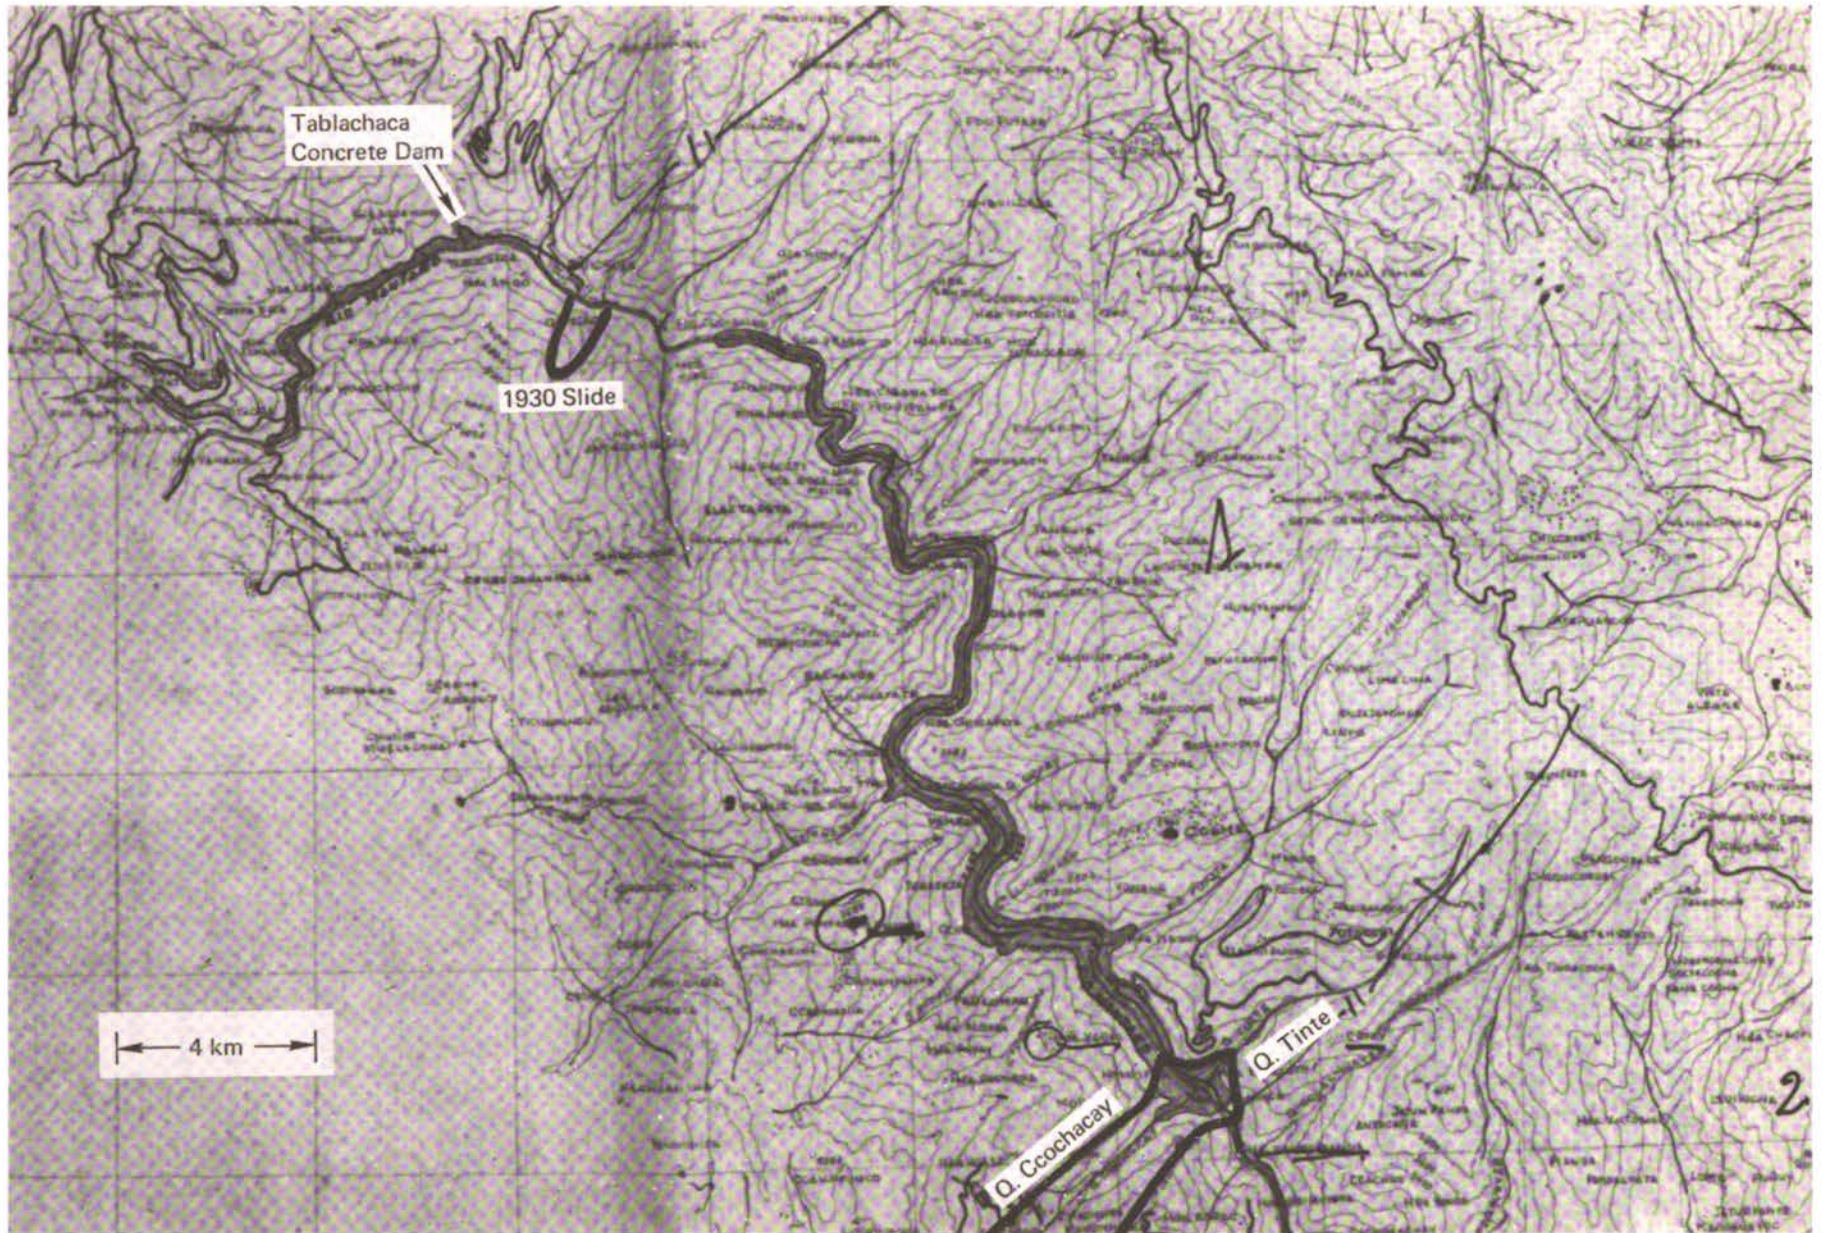
A plan view of the slide dam and the lake formed thereby is shown in Figure 26. This lake was only a few hundred meters wide, but stretched

FIGURE 26. Map showing extent of lake which formed behind the slide dam.

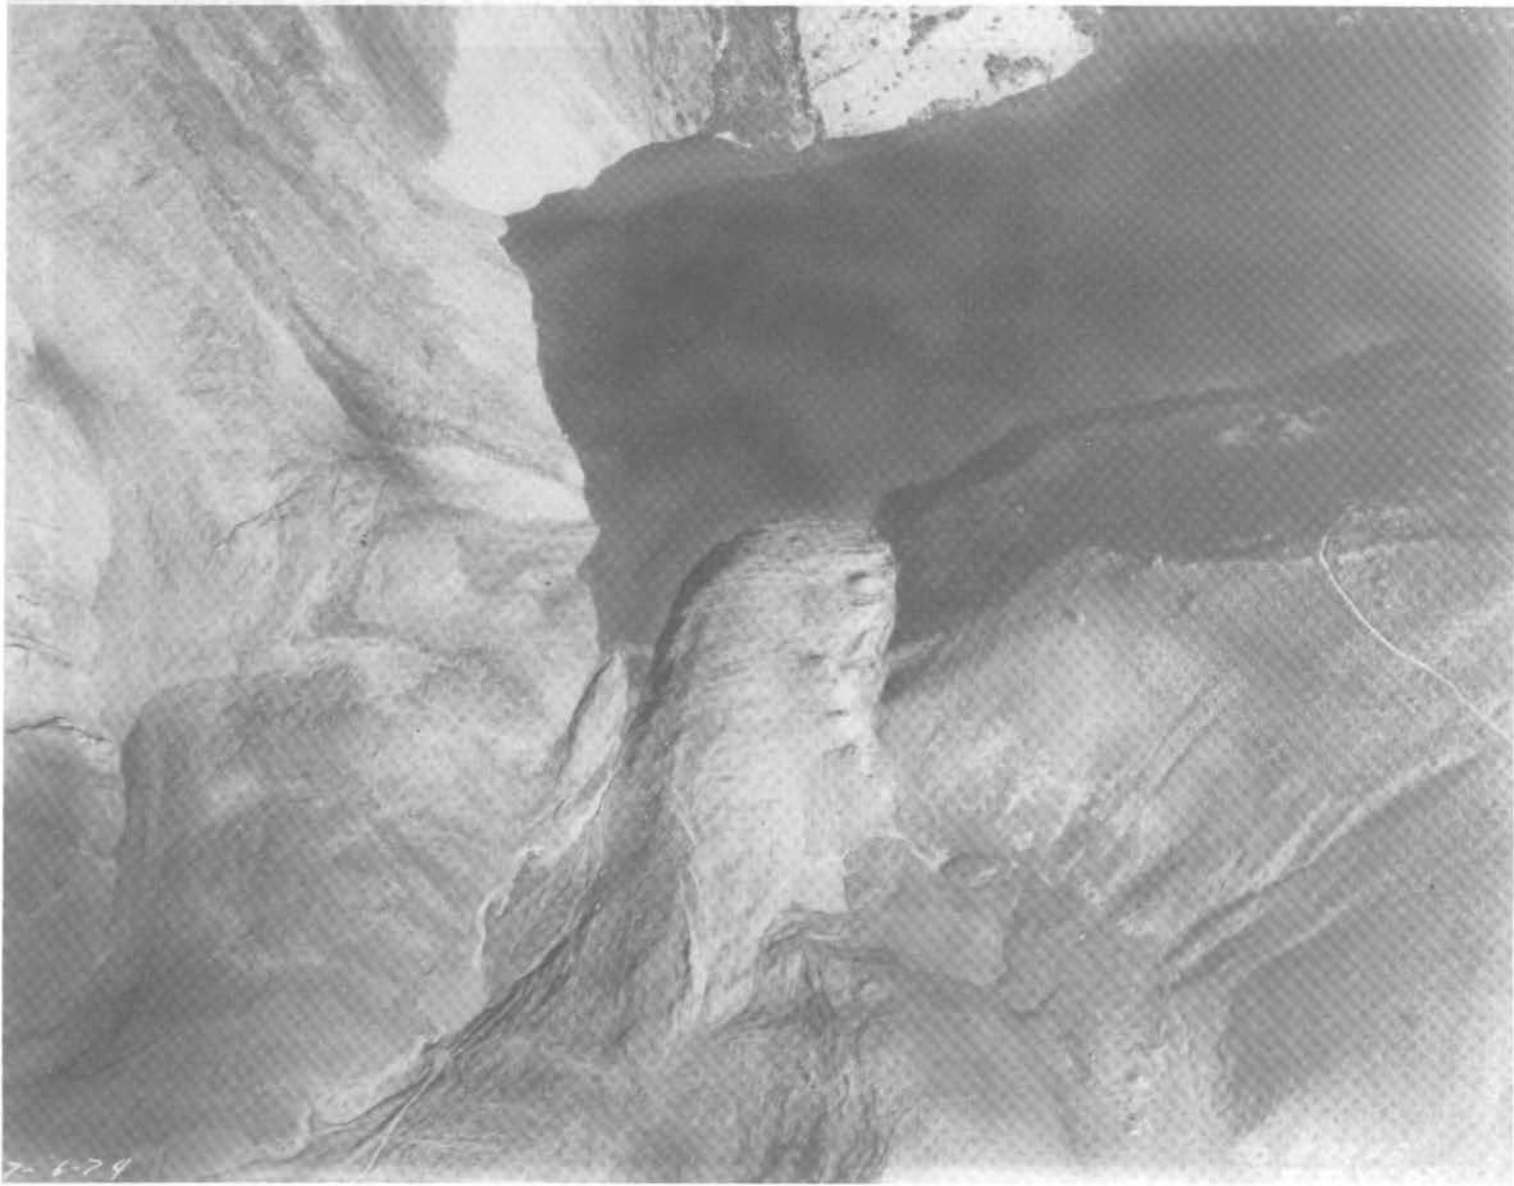
FIGURE 31. Air photo taken June 7, 1974, just as the water began to trickle over the debris dam.
(Defensa Civil Photograph)

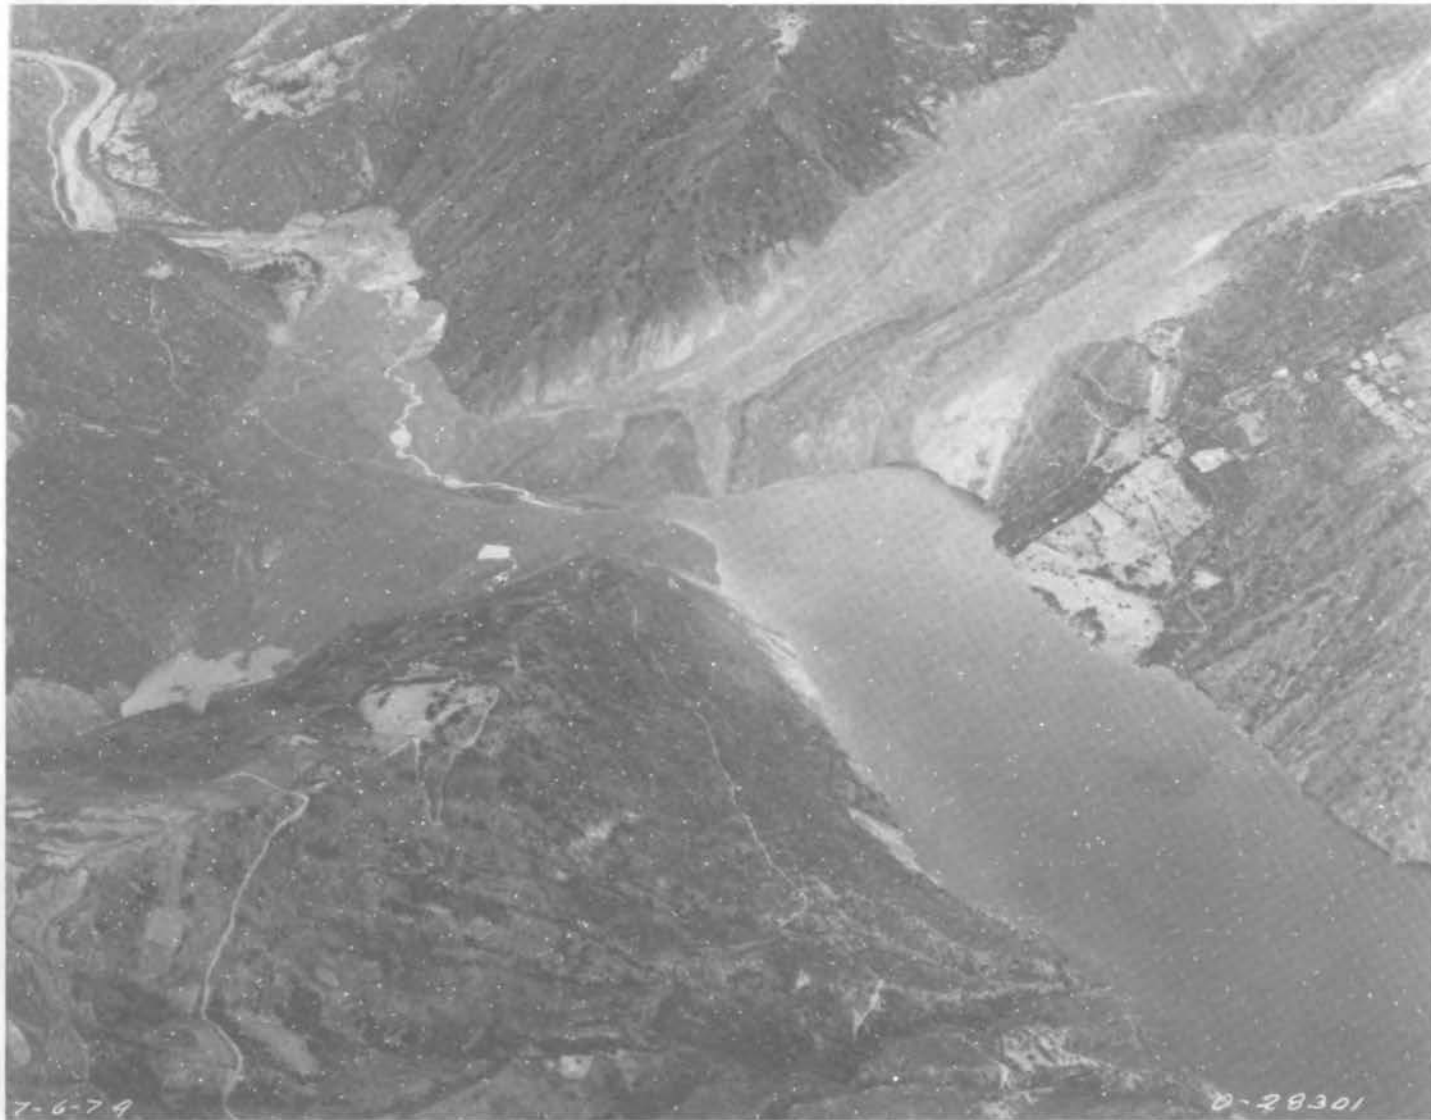
FIGURE 32. Oblique air photo taken June 6, 1974, showing water as it begins slowly to flow over the debris dam. (Defensa Civil Photograph)

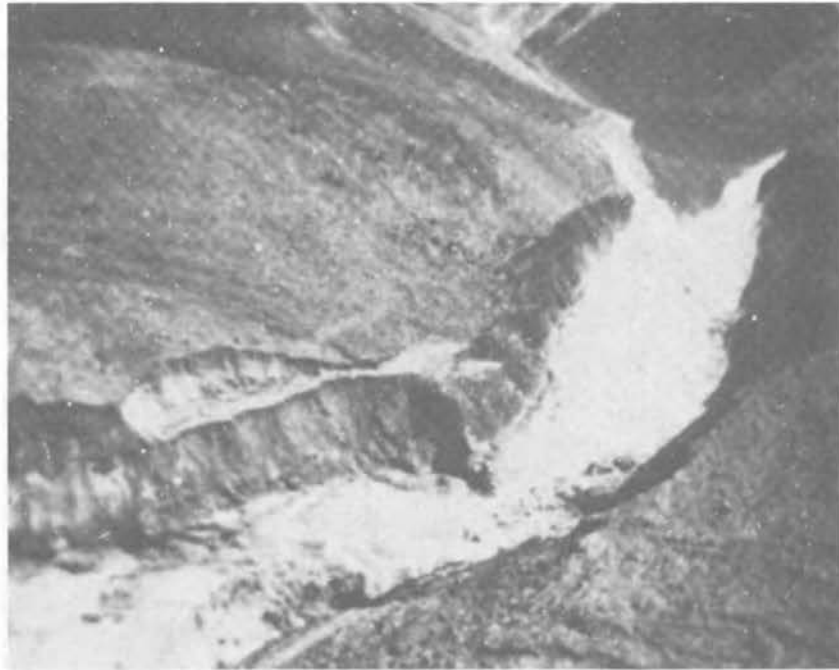
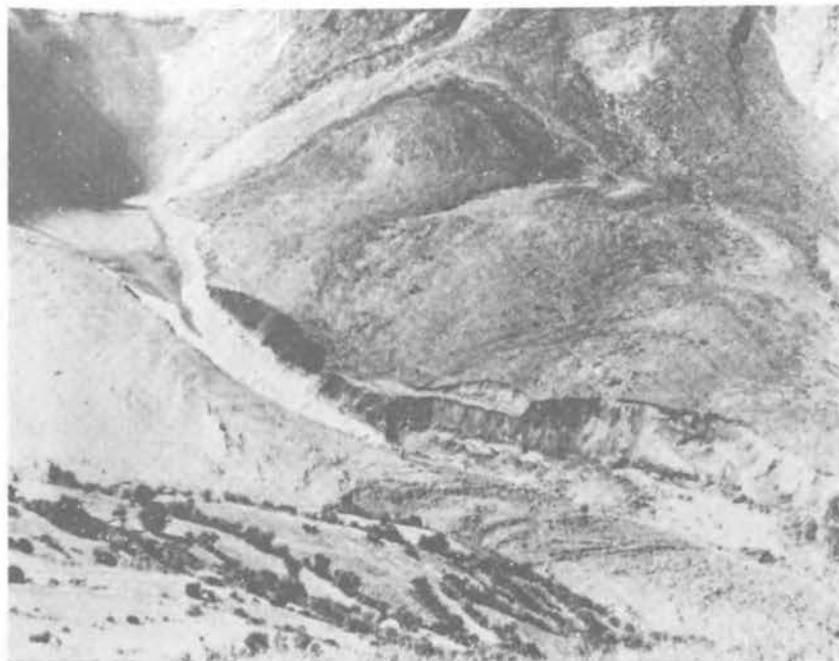
FIGURE 33. Two views of the Mantaro River flood over the debris dam during periods of high flow rate.
