LANDSLIDE OF APRIL 25, 1974 ON THE MANTARO RIVER, PERU

report of inspection

Kenneth L. Lee
University of California, Los Angeles

J. M. Duncan
University of California, Berkeley

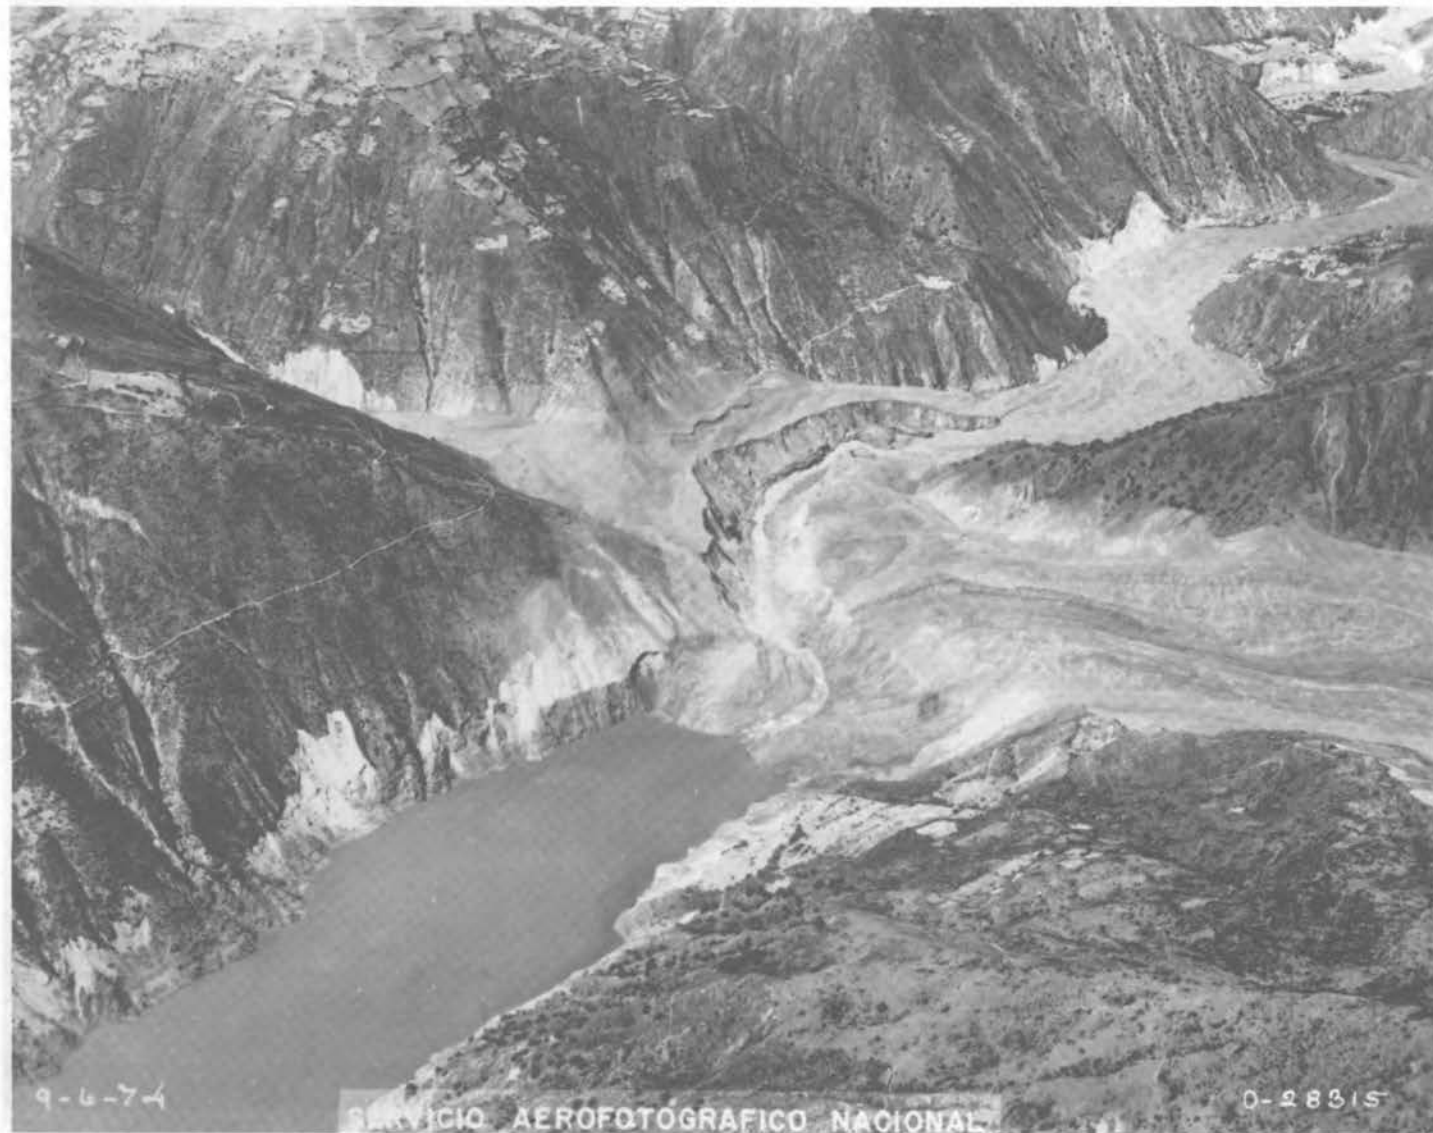
FIGURE 34. Oblique air photo looking downstream across the debris dam, taken June 9, 1974, the day after the flood. (Defensa Civil Photograph)

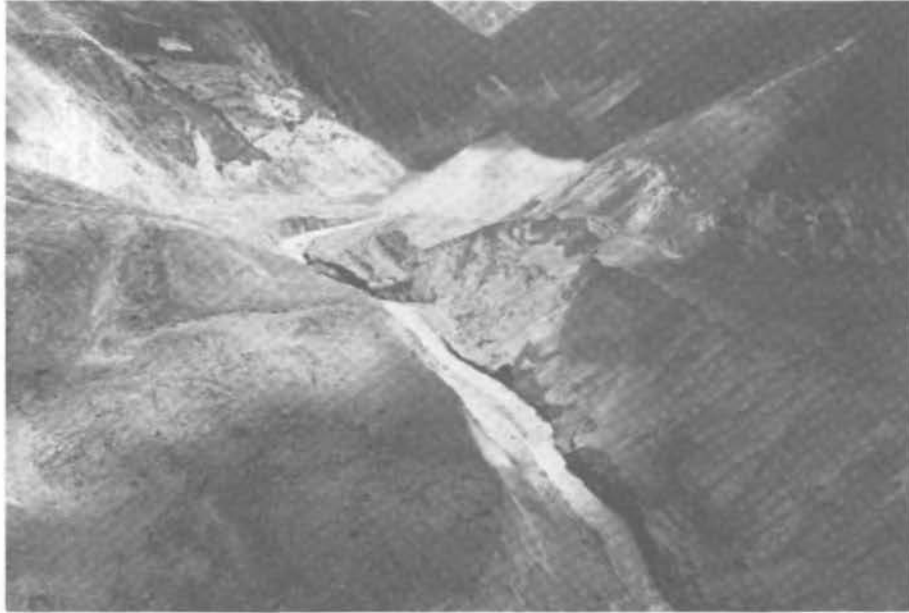
FIGURE 35. Air photo looking upstream across the debris dam, taken one month after the flood.

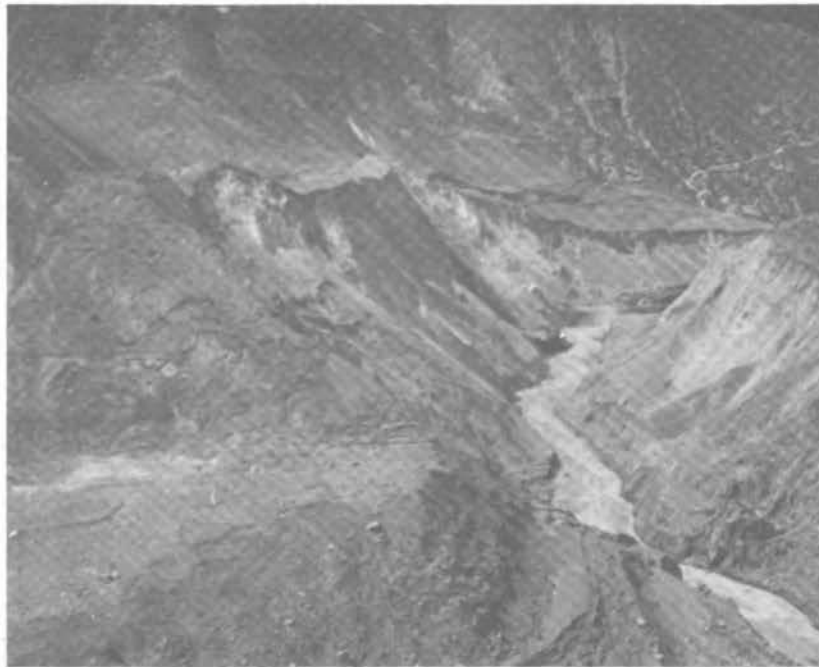
FIGURE 36. Air photo looking downstream along the erosion channel, taken one one month after the flood.

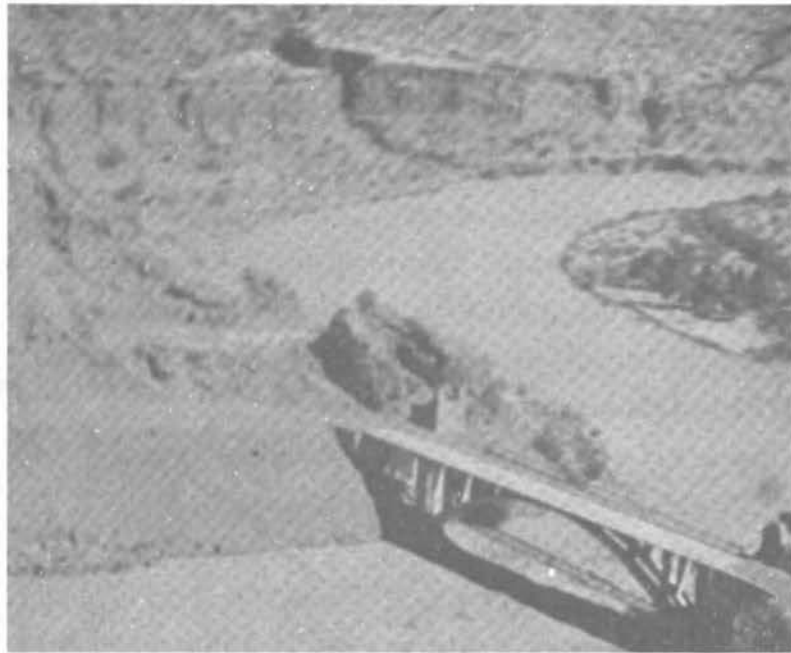
FIGURE 38. Mayoc bridge across the Mantaro River taken as the flood waters were rising. (Photograph courtesy of General Rodolfo Acevedo del Campo)
