EARTHQUAKE IN ROMANIA

MARCH 4, 1977: Δ

An Engineering Report

NATIONAL ACADEMY PRESS
Washington, D.C. 1980

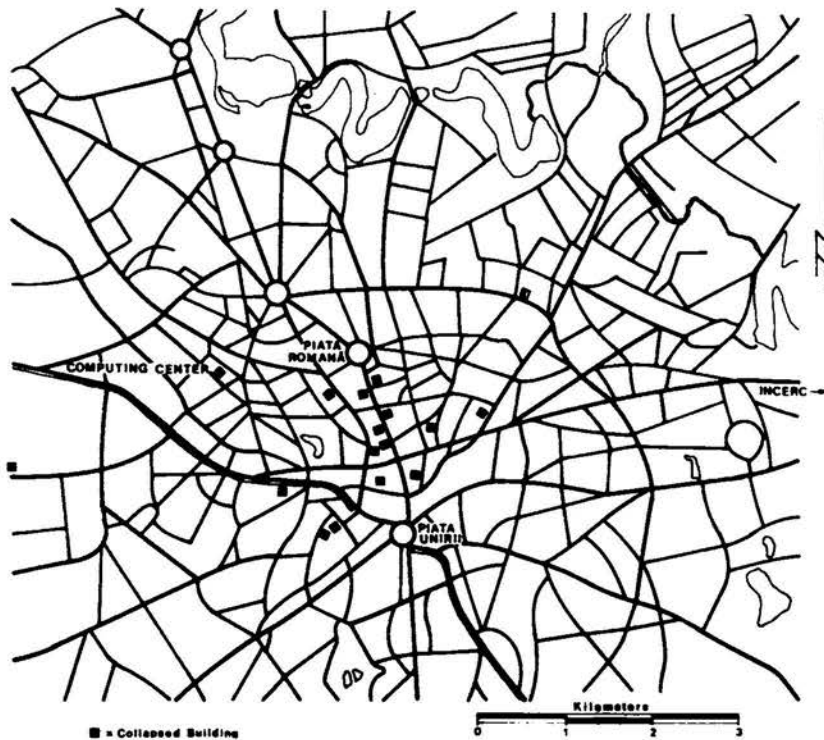
Figure 6 Street map of Bucharest showing collapse locations.

Most of the earthquake damage was concentrated in the city of Bucharest. Thirty-five buildings collapsed, most of them near the heart of the city. Figure 16 shows one collapsed structure, and the street map of Figure 6 locates many of them. All but three of the

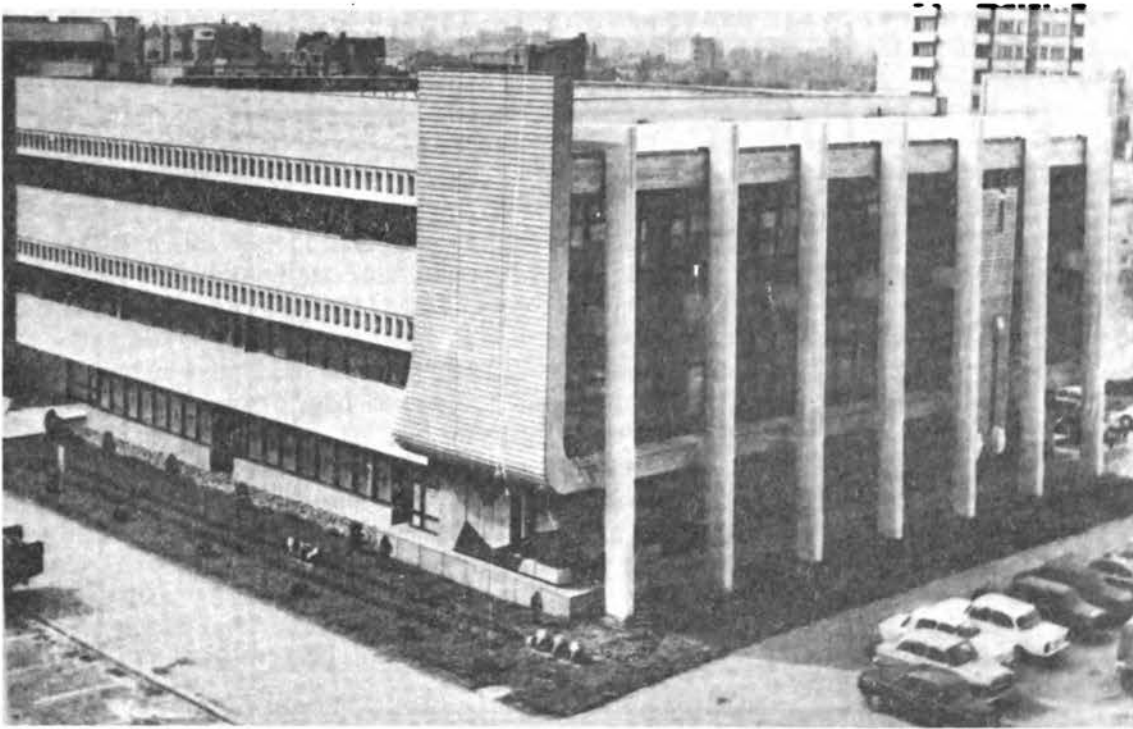
The most instructive building collapse in Bucharest was the new computing center, built in 1967, shown in the pre-earthquake photo, Figure 23. This was a three-story building comprising a central structure 30 m square with service towers at both ends structurally separated from the central building. It was designed according to the Romanian seismic code; the design base shear was 6 percent of the weight of the building. The central part of the building collapsed; the service towers did not. Figure 24 shows the collapse.

Figure 23 Computing center before the earthquake.

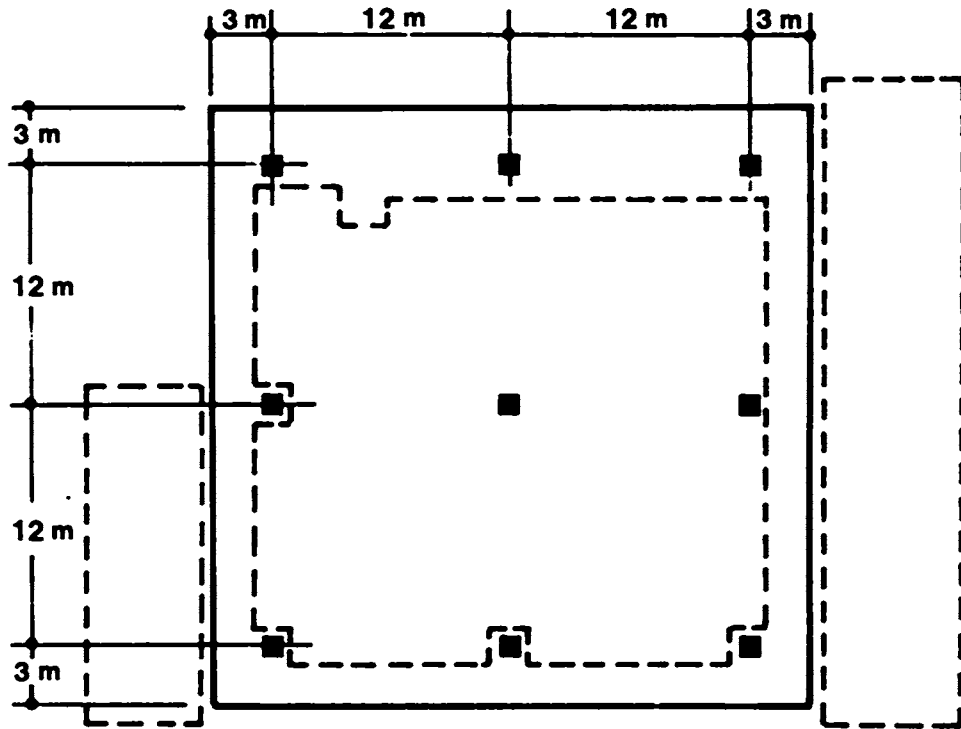
The central building was cast-in-place reinforced-concrete construction with precast concrete exterior walls above the ground story. No shear walls were in the central building. The upper stories had continuous bands of windows separating the precast wall units. The ground story was enclosed by walls set in from the exterior building lines and capped with a continuous band of sash. Figure 25 shows the ground-floor layout. The building above was supported entirely on nine columns spaced 12 m center to center in both directions, with the slabs cantilevered 3 m beyond the outside columns on all sides. Note in Figure 25 that the nonstructural exterior walls run around the columns; no column in the ground story had lateral restraint of any kind.

Figure 25 Computing center, ground-floor layout.

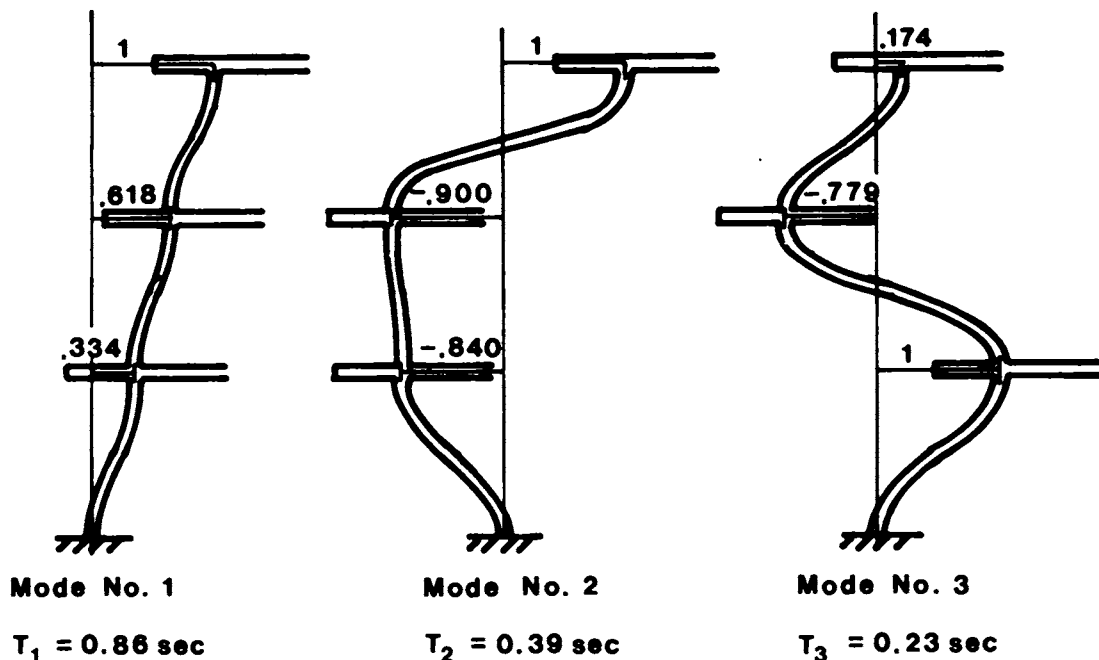
The main building was structurally separated from the service towers, and nearly all of the lateral stiffness of the main building derived from the columns. If only column stiffness is considered, the column bases are treated as fixed, and the floors are taken to be rigid, then the three modes of vibration and their periods are as shown in Figure 28. Thus the fundamental mode period for this idealization is in the range of very strong spectral acceleration for both horizontal components of the ground motion recorded in Bucharest. Any flexibility of the floor system or column footings, or any structural damage, would lengthen the period and put it in the range of even greater spectral acceleration. The exterior walls were of virtually no benefit because they were isolated from the ground-story columns and contained a band of steel window sash in each story, which separated them structurally from the story above.

Figure 28 Computing center, mode shapes and periods.

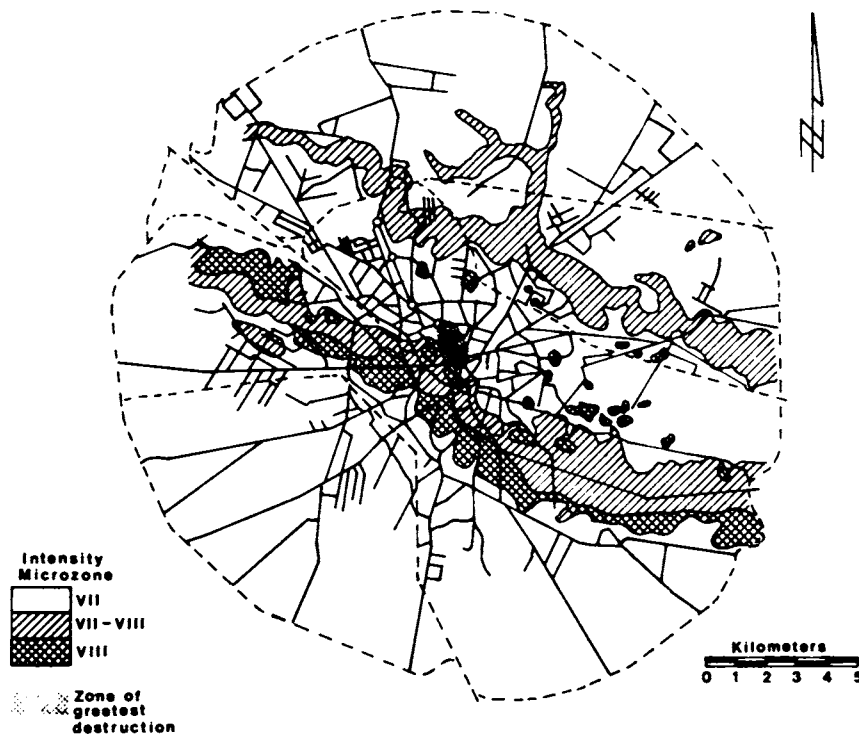
Figure 31 Microzone map of Bucharest.

The city of Bucharest was microzoned for seismic risk in 1973 as part of a UNESCO project, "Survey of Seismicity of the Balkan Region" (Ref 12), more commonly known as the Balkan Project. The microzone map is shown as Figure 31. Three levels of risk are identified for the city, corresponding to intensities VII, VII-VIII, and VIII. Generally the microzones indicating the greatest risk follow the course of the Dimbovita river southeastward through the city and are also found in isolated pockets away from the river. The intermediate risk zones form a broader band along the Dimbovita and also along a chain of lakes extending roughly parallel to the Dimbovita farther to the north. The region of greatest destruction, shown in Figure 31, lies mainly in the microzone designated as least vulnerable.
