**EARTHQUAKE IN CAMPANIA-BASILICATA, ITALY**

**NOVEMBER 23, 1980**

**A RECONNAISSANCE REPORT**

**James L. Stratta, Consulting Structural Engineer, Menlo Park, California**  
**Luis E. Escalante, Los Angeles Department of Water and Power, California**  
**Ellis L. Krinitzsky, Waterways Experiment Station, Vicksburg, Mississippi**  
**Ugo Morelli, Federal Emergency Management Agency, Washington, D.C.**

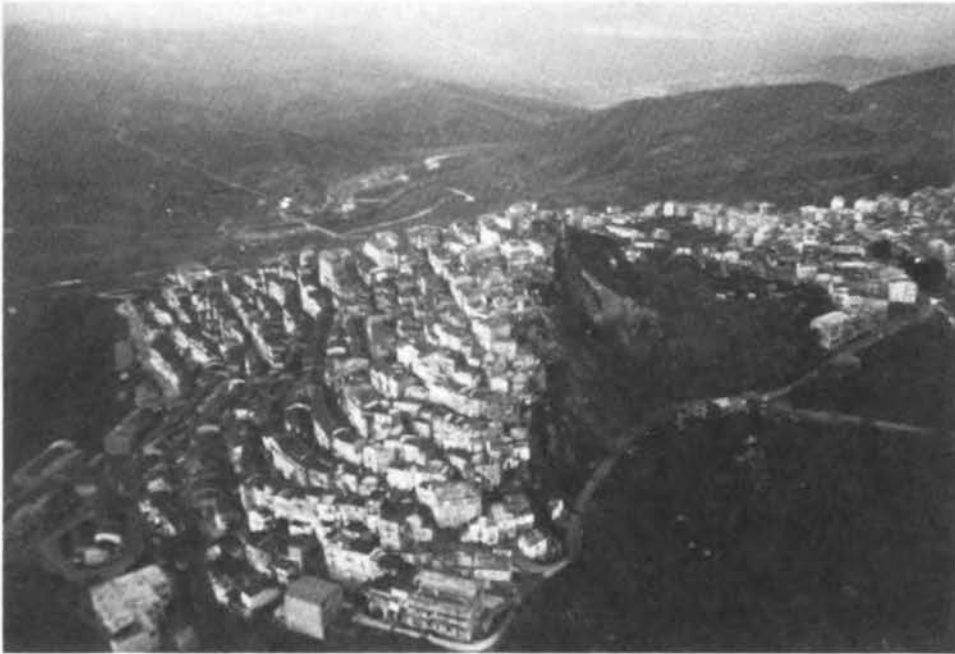
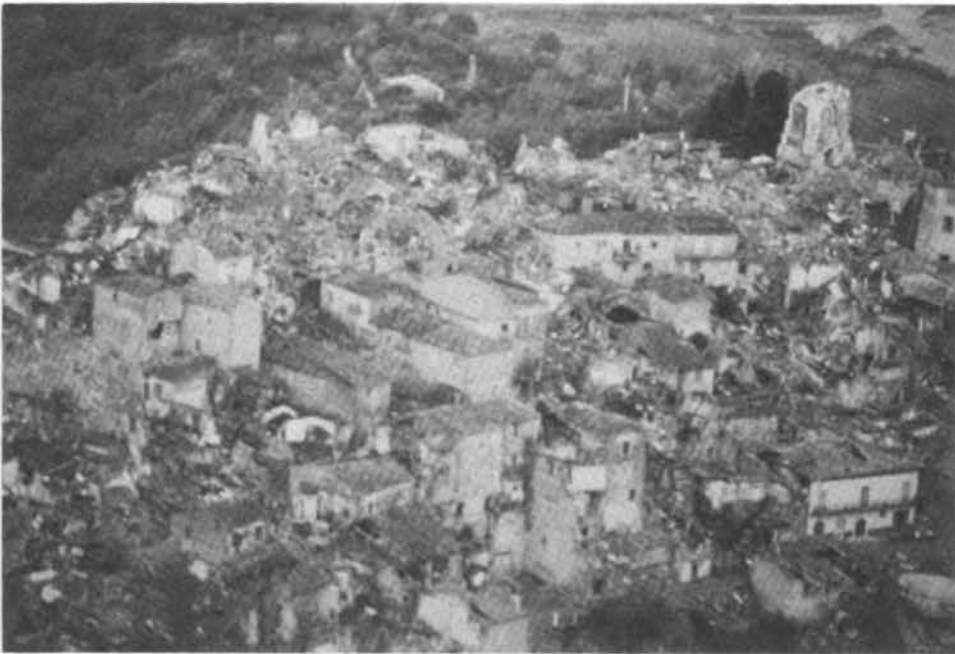
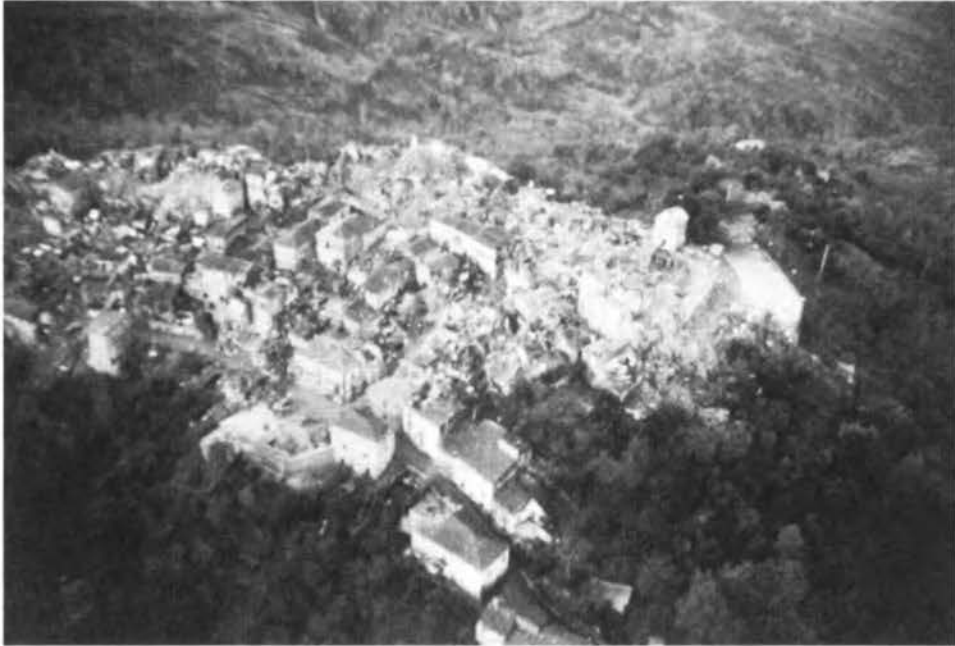
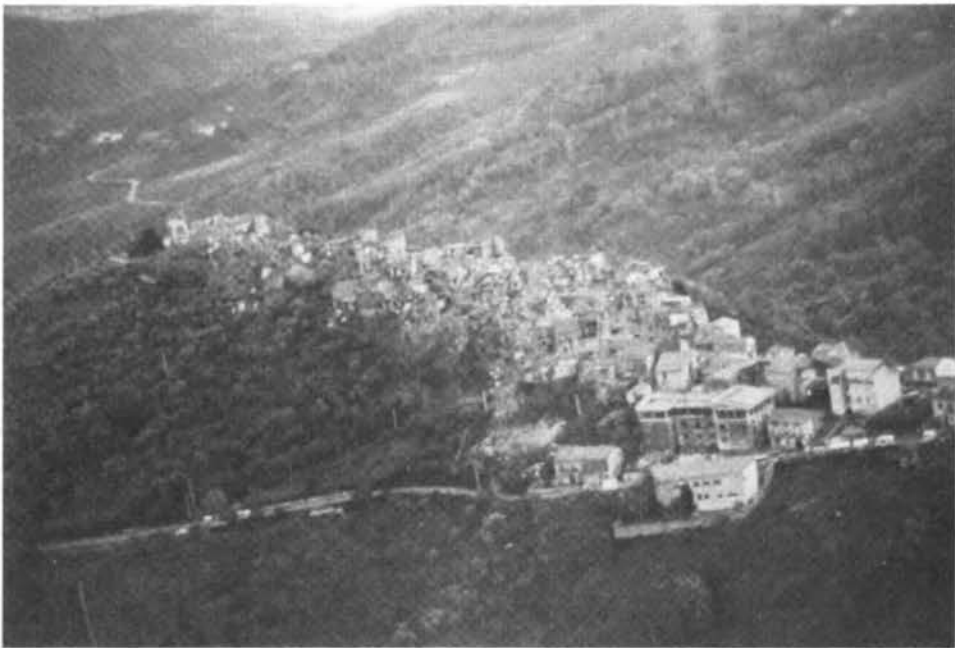
Another contribution to the damage could well have been a ground acceleration amplification introduced by the topography of some of the damaged areas. The aerial views in Figure 14 show some of the damaged towns. The towns were on top of mountain ridges, a situation that could easily create a condition for amplification.

**Figure 14. Typical towns on mountain ridges.**

**Figure 14 (cont'd). Typical towns on mountain ridges.**

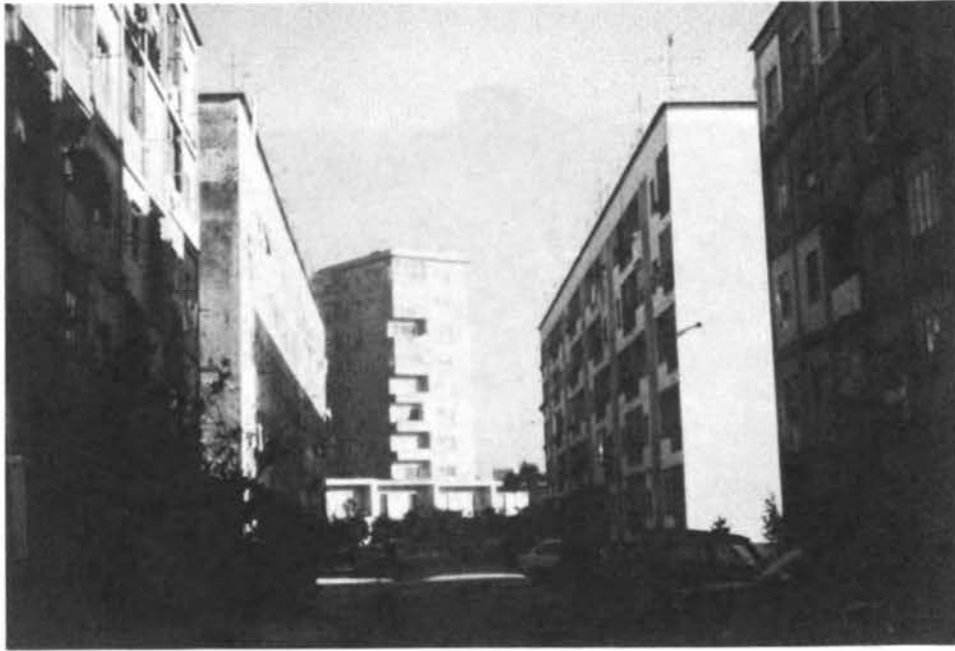
Naples was the largest city (population 1,225,000 in 1978) within the affected area. Visual inspection suggested a rather low intensity of shaking here. Most of the damage was to older types of construction (Figure 15a). However, two recent structures (about 30 years old) showed severe damage. A 10-story housing unit identical to the one shown in Figure 15b collapsed, killing all 52 occupants. The remaining basement of the collapsed structure is shown in Figure 15c. Close observation of the remaining two structures indicates repairs had been made in the past at floor construction joints (Figure 15d). The cause of the previous problem was not known. What appears to be an exterior shear wall is a concrete frame with infill masonry wall.

**Figure 15. Damage to concrete structures with infill walls.**  
(a) A large housing project of 5-story and 10-story units, all constructed of concrete frames with infill walls.  
(b) Shows a 10-story surviving unit, similar to the one that collapsed.

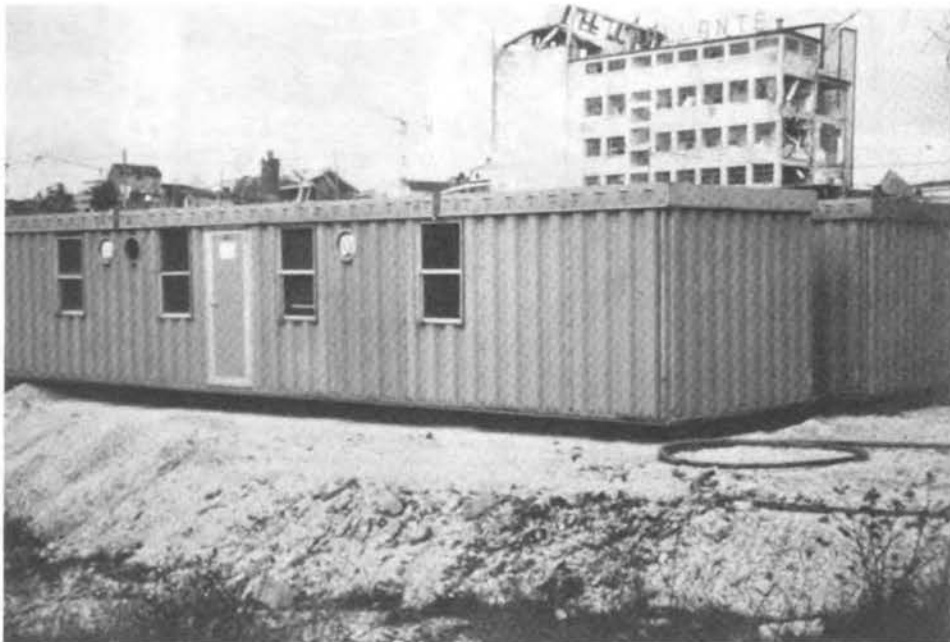
**c**

Figure 22 (cont'd). Damage in the town of Lioni.  
(b) Residential building with heavy damage to the first floor. Total collapse is imminent. (c) Prefabricated houses being installed in Lioni. The Pallante factory is in the background.

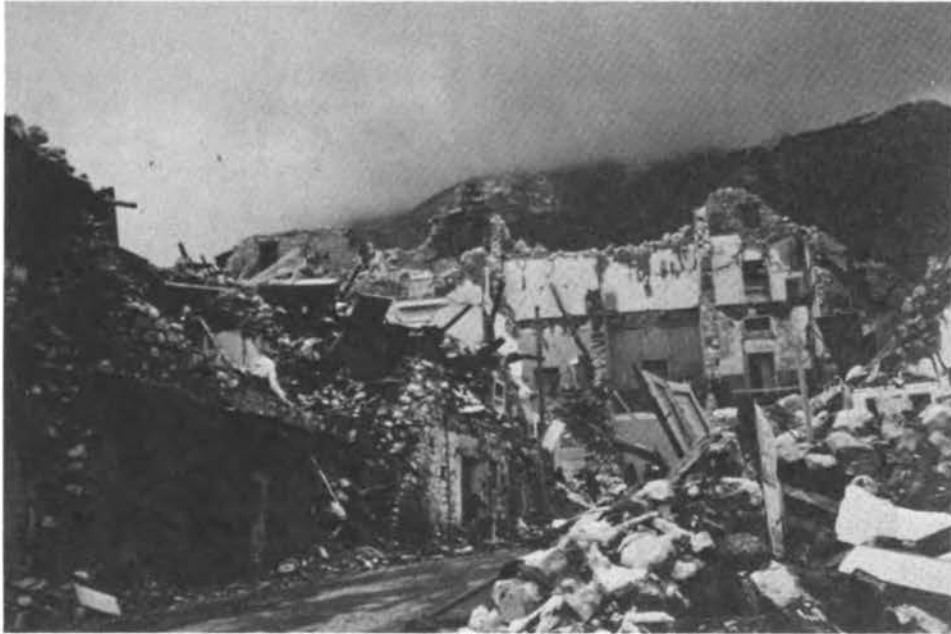
c

Figure 25 (cont'd). Damage in Laviano. (c) A view from the top of the town, showing the city hall in the background.

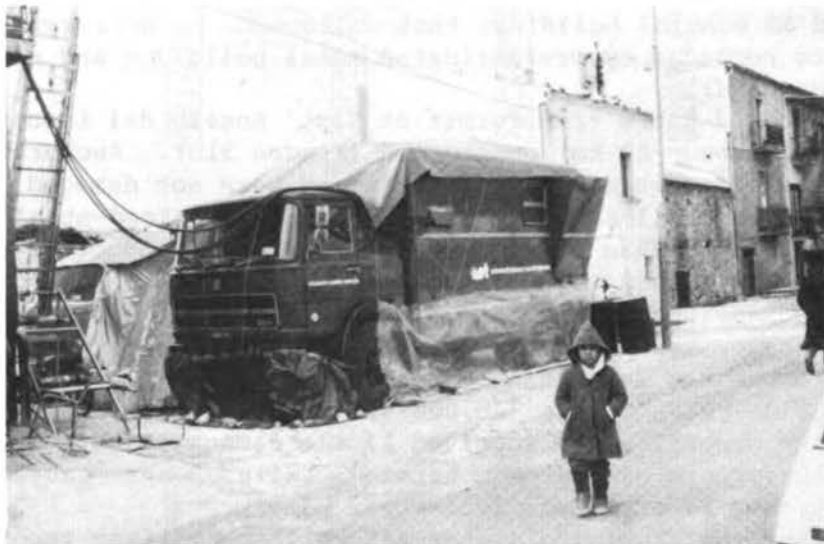
c) The substation in Balvano (epicentral distance--22 km) was without power for 3 days. At the time of the team's visit, mobile generators (Figure 29) from Bologna in northern Italy were supplying 450 amperes at 220 volts to emergency operations, tent cities, and surviving residences.

Figure 29. Mobile generator unit supplying approximately 10 kilowatts of electrical energy to communications and other equipment in Balvano.

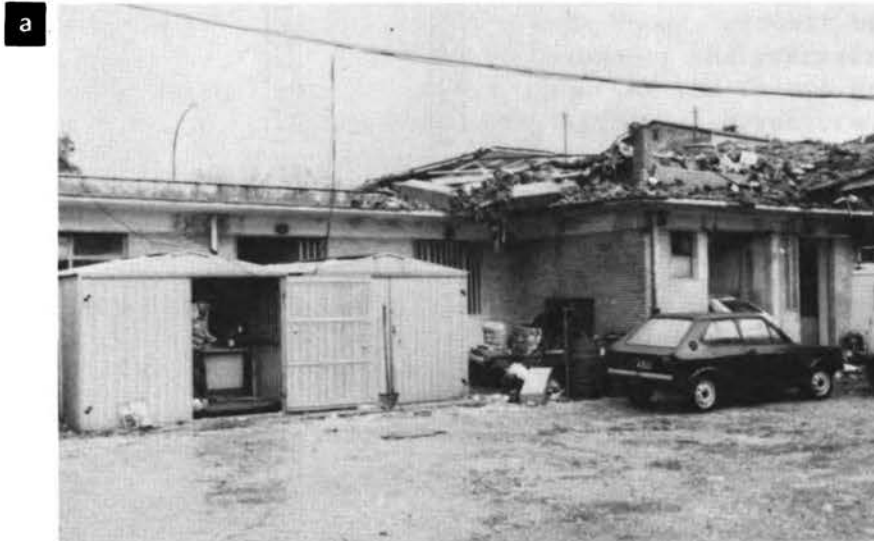
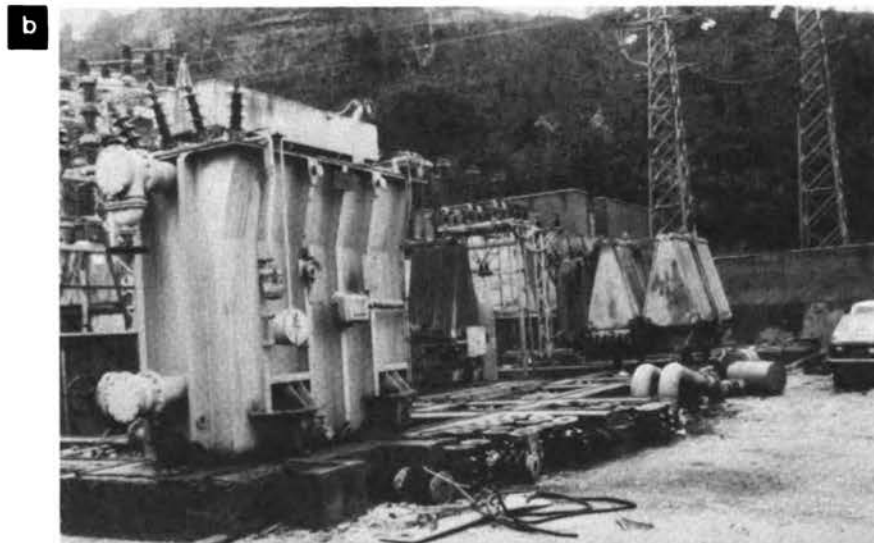
A 60,000/20,000-volt transformer at Sant' Angelo dei Lombardi suffered broken ceramic bushings (terminals). There was significant damage to the 20,000-volt distribution system. Numerous substations were damaged, and 20 control buildings that collapsed, or were severely damaged, were replaced by prefabricated metal buildings and new control boards (Figure 31a).

One unanchored spare transformer at Sant' Angelo dei Lombardi (epicentral distance--20 km) overturned (Figure 31b). Anchored in-service transformers did not overturn and were not damaged. In fact, one substation controller reported that several latticed-steel power-line towers fell there because of foundation failures. Conductors in low-voltage (220 and 380 volt) lines were reported to have broken as a result of the swaying of steel and precast concrete poles. When these lines became taut, because of insufficient slack, the conductors either ruptured or broke the supporting insulators.

**Figure 31. Electrical power in Sant' Angelo dei Lombardi.**  
**(a) Prefabricated metal building houses the control equipment of an electrical power distributing station.**  
**(b) Electric power transformer (left) in the distributing station. A spare transformer, unanchored, was overturned here.**

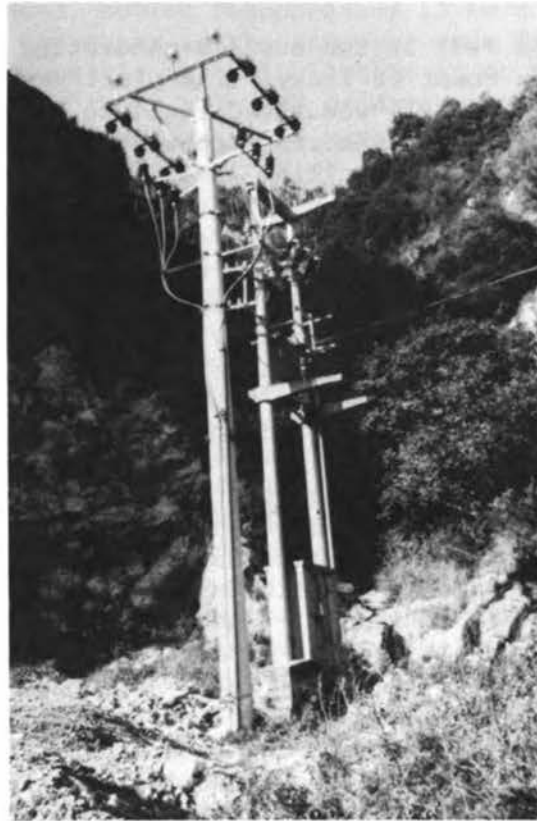
Distribution transformers (20,000/380 and 220 volts) were mostly located on the ground. They received little damage (Figure 32). Several pole-top transformers had ceramic terminal failures that caused power outages, but they did not fall from their platforms.

Figure 32. Electric power near Salerno.  
Small distributing station.

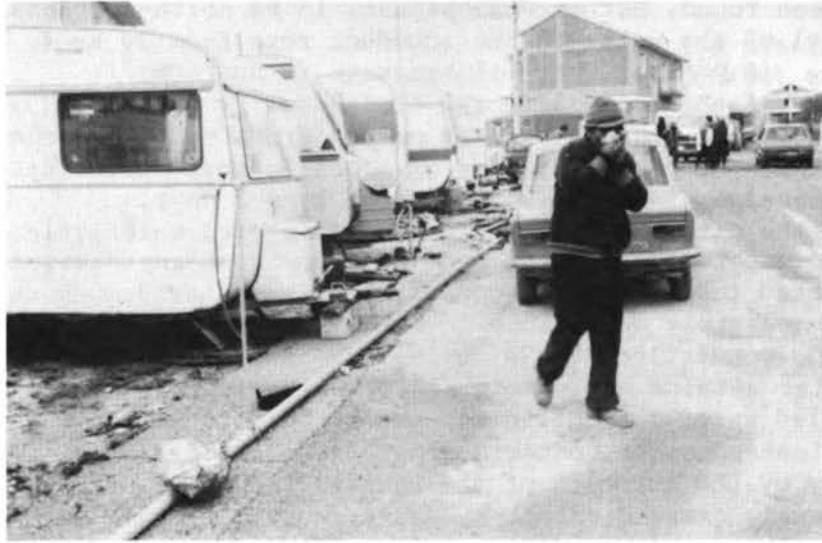
In the severely damaged towns, the water supply systems were deliberately shut down because of fear of contamination from possibly ruptured sewer and water underground lines. Temporary hookups were made to the water supply lines outside the towns, and aboveground pipelines constructed to the surviving residential areas, tent and trailer camps, field hospitals, and other essential facilities. Water spigots were located at many locations along these pipelines (Figure 33).

**Figure 33. Aboveground water line with hookup for trailer in the town of Lioni.**
