Hurricane Iwa, Hawaii, November 23, 1982 (1983)

Hurricane Iwa, Hawaii, November 23, 1982

Committee on Natural Disasters
Commission on Engineering and Technical Systems
National Research Council

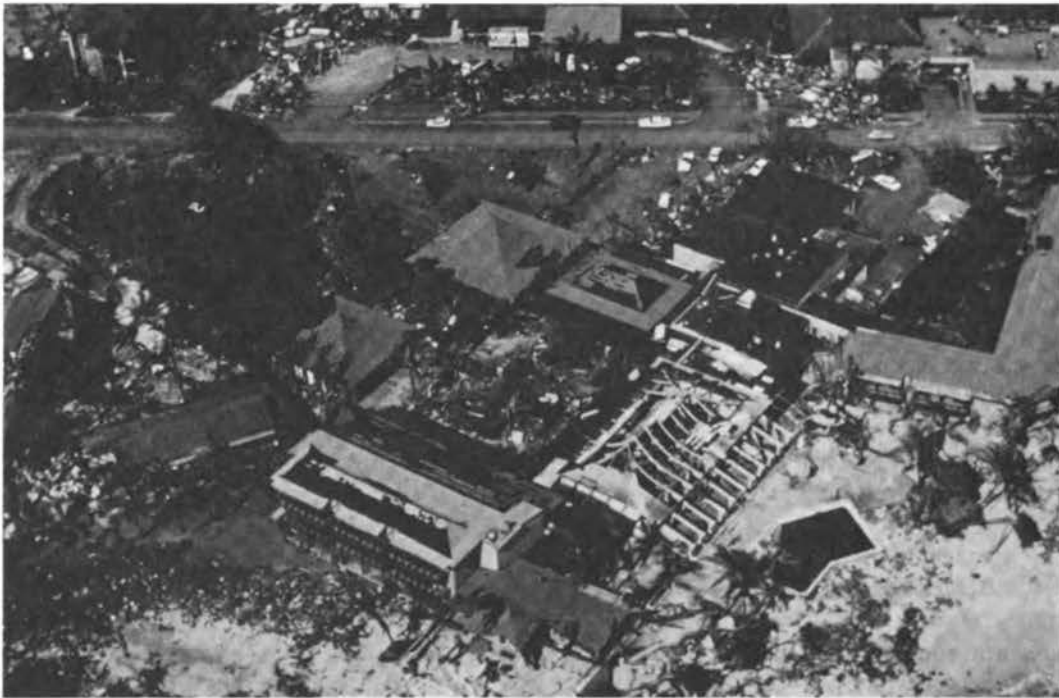
FIGURE 3.2 Damage at Sheraton-Kauai on Poipu Beach.

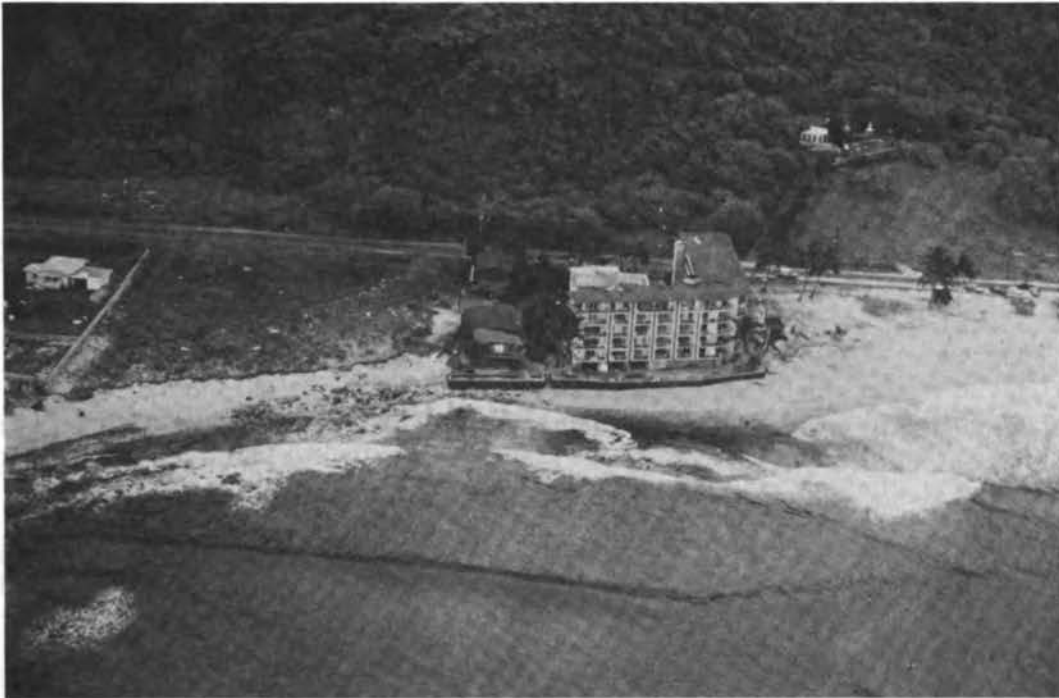
FIGURE 3.3 Makaha Shores Condominium, Oahu.

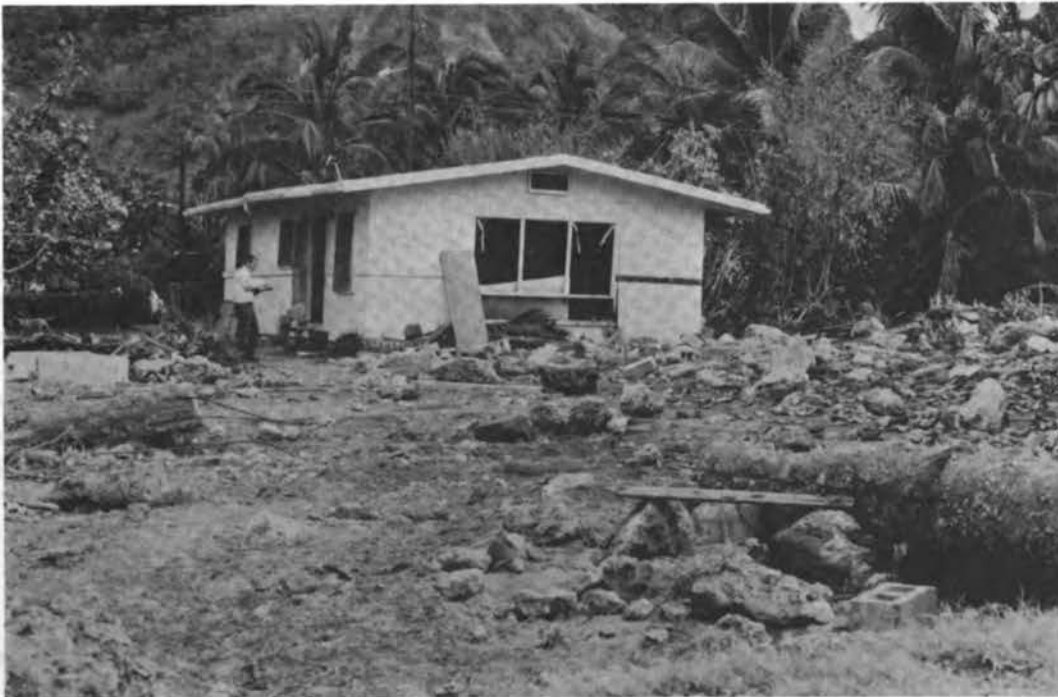
FIGURE 3.4 Damaged beachfront residence at Makaha, Oahu (note that home was transported off concrete slab foundation 100 yds inland by storm surge and wave action).

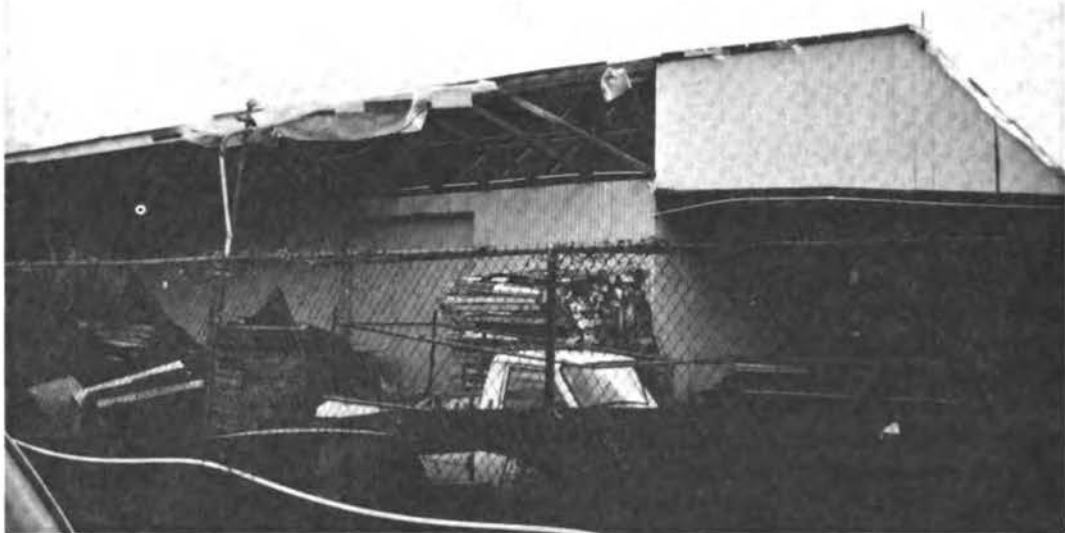
FIGURE 3.7 Damage to warehouse building, Kauai.

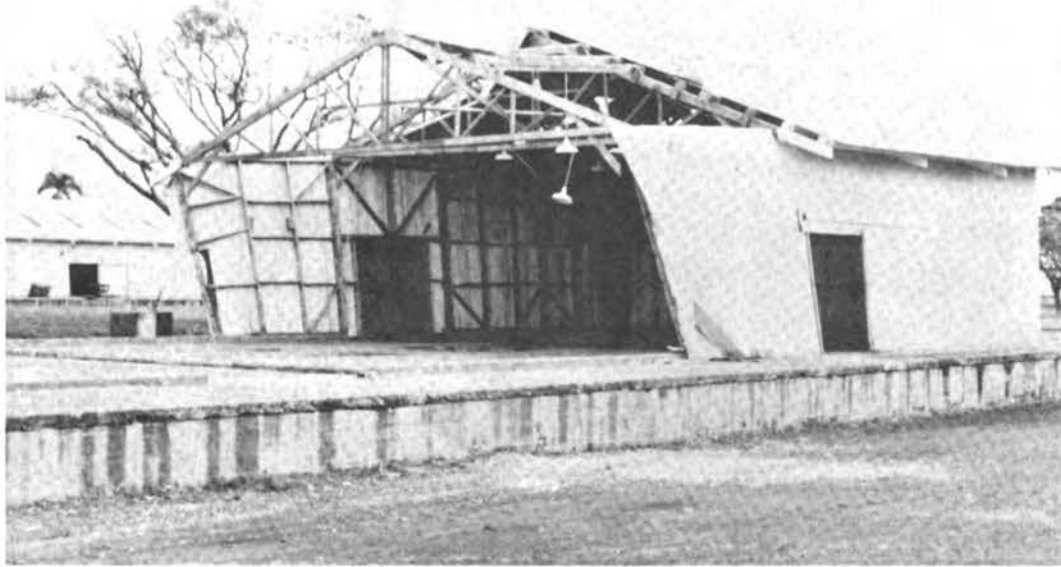
FIGURE 3.9 Damage to timber-framed building clad with light-gage metal sheeting (note that most of the damaged building had been removed at the time the photograph was taken).

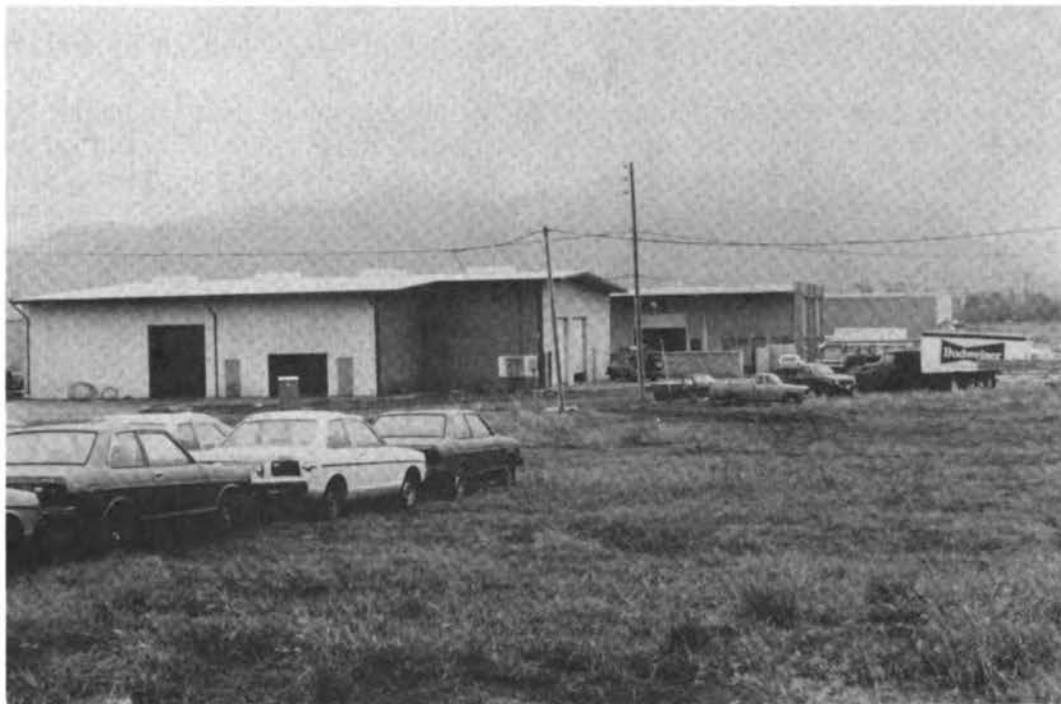
FIGURE 3.10 Preengineered metal buildings at Kauai (no observed damage).

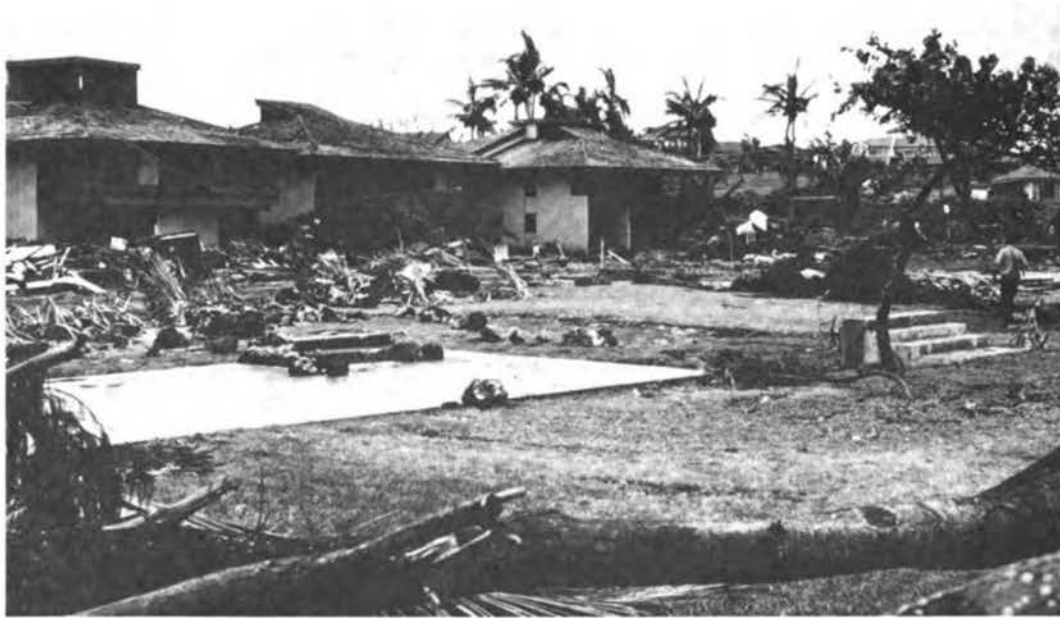
FIGURE 3.13 Damage to beachfront single-family dwellings on Kauai.

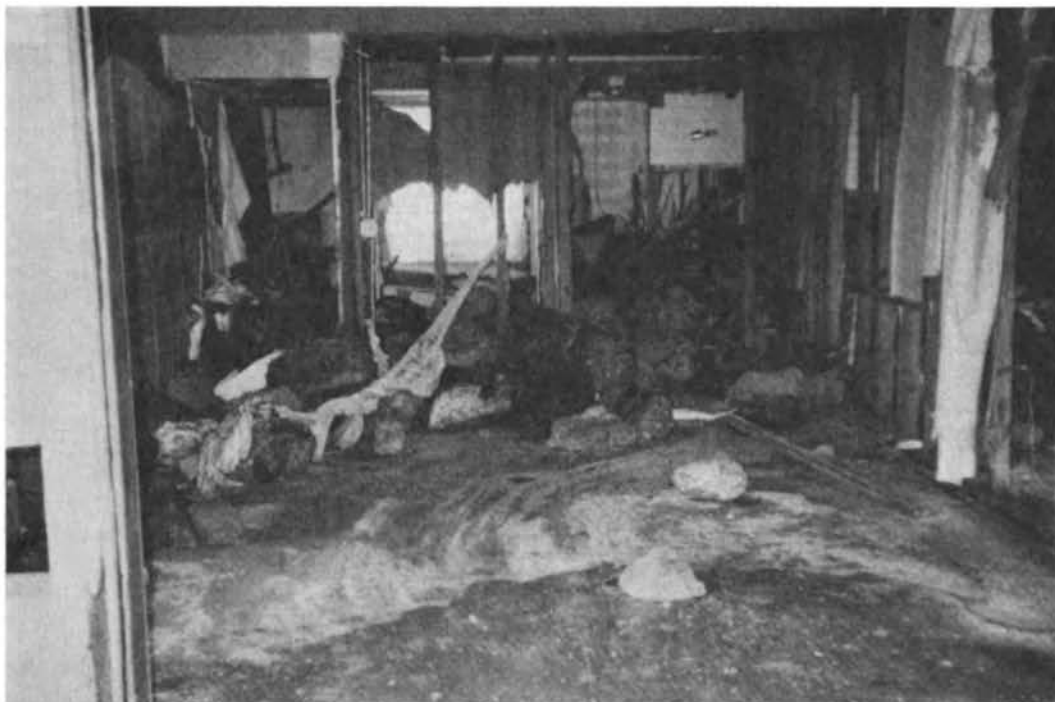
FIGURE 3.29 Storm surge, wave, and flooding damage to interior of unit at Sheraton-Rauai.

although flooding of the ground-level portion of these structures occurred as far as 150 yd from the beach area.

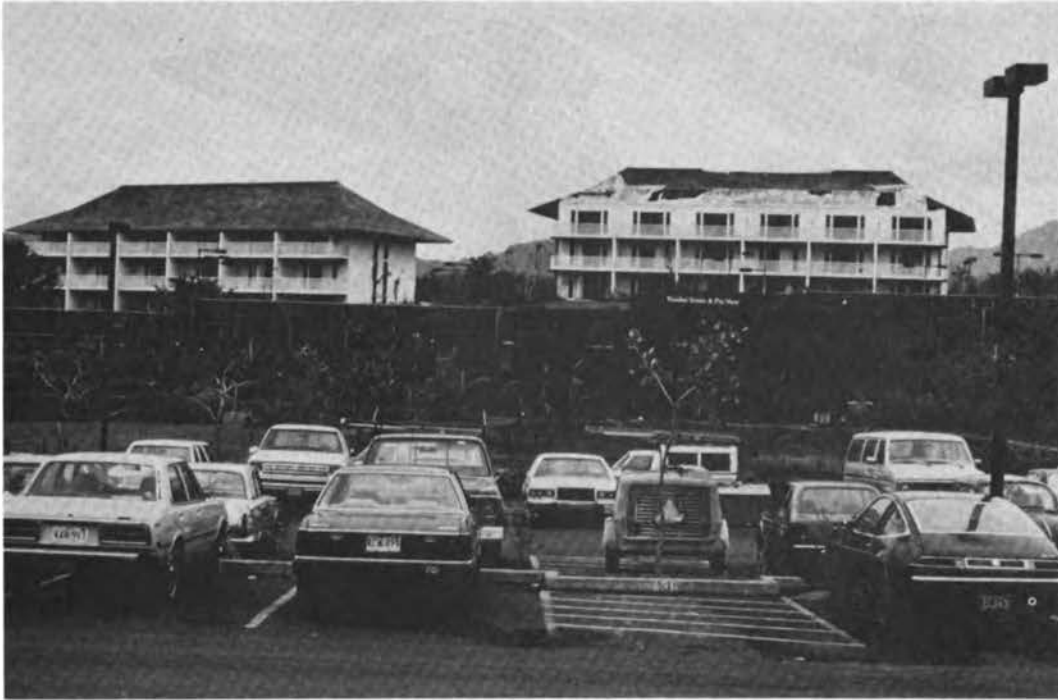
FIGURE 3.34 Roof damage to building inland from Poipu Beach, Kauai.

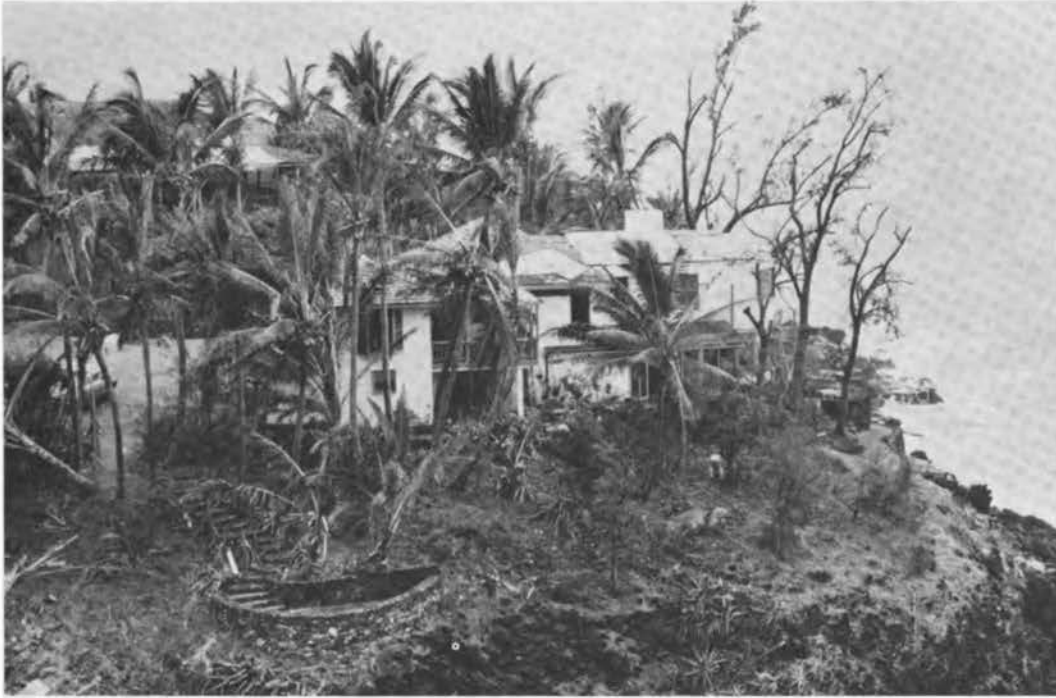
FIGURE 3.37 Wind damage to single-family dwelling on bluff at Makahuena Point, Kauai.

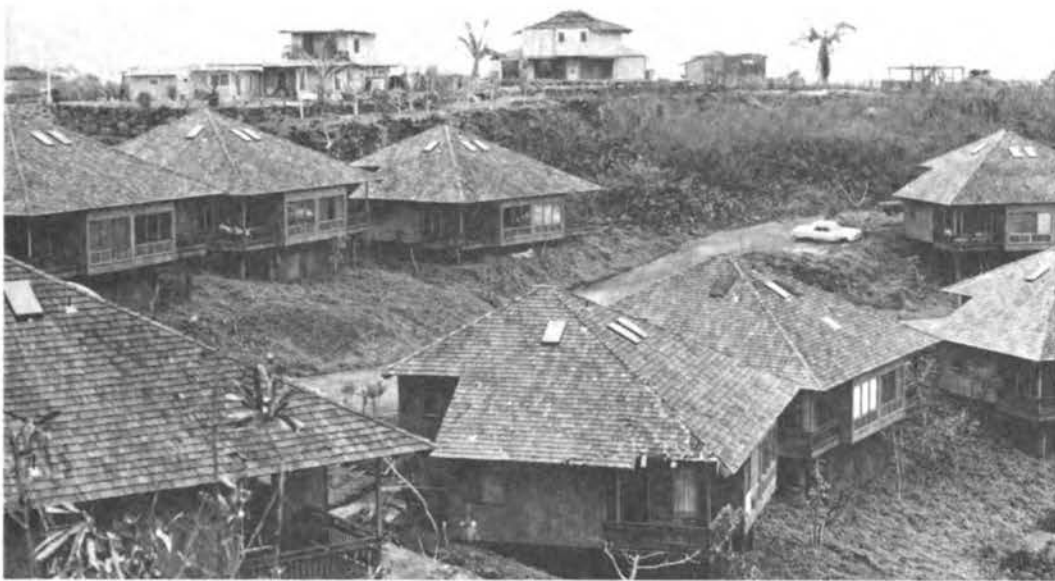
The terrain along the coastline changes abruptly from a narrow beach at Brennecke to cliffs rising nearly vertically from the water to elevations of 100 to 150 ft above mean sea level at Makahuena Point (Figure 2.1). This region provides a beautiful scenic setting for a large number of relatively new condominium developments and single-family dwellings. Unfortunately, the extent of damage observed by the team and the peak wind gust of 126 mph (71 mph sustained) recorded at this location (Table 2.1) indicate that winds striking the coastline from the south to southeast were sharply amplified. Major damage occurred to condominiums and homes located near the bluffs (Figures 3.37 and 3.38). Those well-designed buildings that apparently were capable of resisting the wind loadings were nevertheless inflicted with heavy damage by windborne shingles and other debris. The Poipu Shores Condominiums, a reinforced concrete shear wall structure having prestressed floor slabs (shown at the bottom and center of Figure 3.39), lost 45 percent of the glass windows in its 36 units due to impact by handsplit shakes that had been blown off the roofs of other buildings or homes upstream. Major water damage subsequently occurred to the contents of most of the units from rainfall. Damage decreased rapidly with increasing distance inland from the coastline and was soon limited to minor losses of shingles or roof tiles (Figures 3.40 and 3.41).

FIGURE 3.41 Minor cladding damage to sheltered condominiums sited in Poipu Crater at Makahuena Point, Kauai.

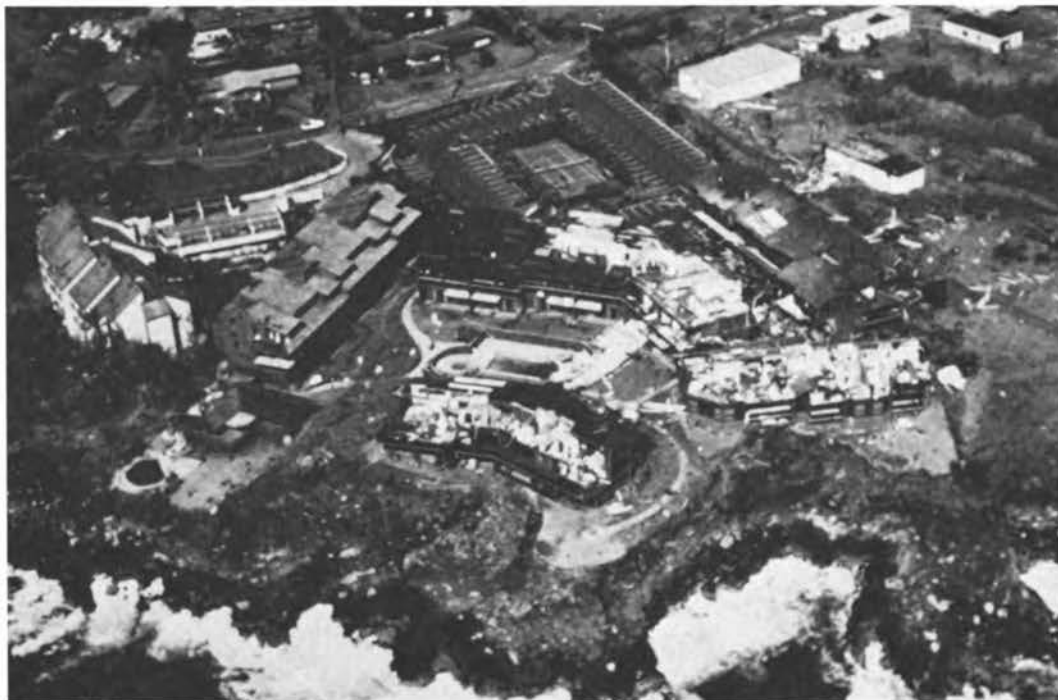
The Makahuena Condominium was constructed in 1980 immediately adjacent to the bluffs, as shown in the aerial photograph of Figure 3.42. Many of the units sustained major damage (Figure 3.43). These three-story timber-framed structures used a roof framing system consisting of multiple tongue-and-groove roof decking spanning between exposed interior beams; the maximum span noted was 15 ft. The unique roof decking consisted of five 1 x 8 planks (actual dimensions were 3/4 in. x 7-1/4 in.) laminated together, as shown in Figure 3.44. Attachment of the decking to the supporting beams and walls was with two 60d spikes having a penetration of approximately 2.0 in. and randomly spaced approximately 12 in. on center. Roof overhangs, end rakes, and a high percentage of glazed areas in the walls fronting on the ocean were used in the design. Failure was most probably initiated by loss of glass on the windward side, which created a high internal pressure that combined with the exterior suction on the roof surface to produce failure of large portions of many of the units' roof systems. For one of the units, a section of the roof decking approximately 30 ft x 80 ft was blown off as a unit into the wind. This struck another condominium upwind and inflicted extensive damage, clearly suggesting inadequate anchorage of the decking to the supporting structure.

FIGURE 3.42 Makahuena Point Condominiums sited immediately adjacent to bluff.

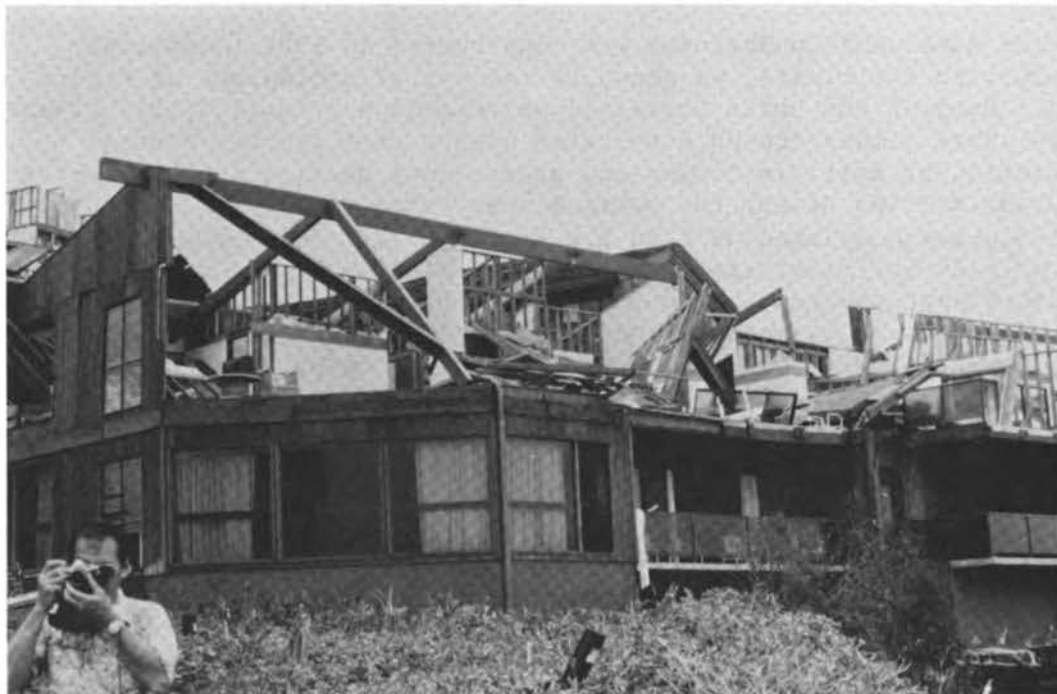
In reviewing the damage to these units and others in the immediate vicinity, the team made the following observations. First, wind speeds in excess of 60 mph (the minimum prescribed value in the code) should have been anticipated for structures on the high bluffs overlooking the

FIGURE 3.43 Wind damage to Makahuena Point Condominiums, Kauai.

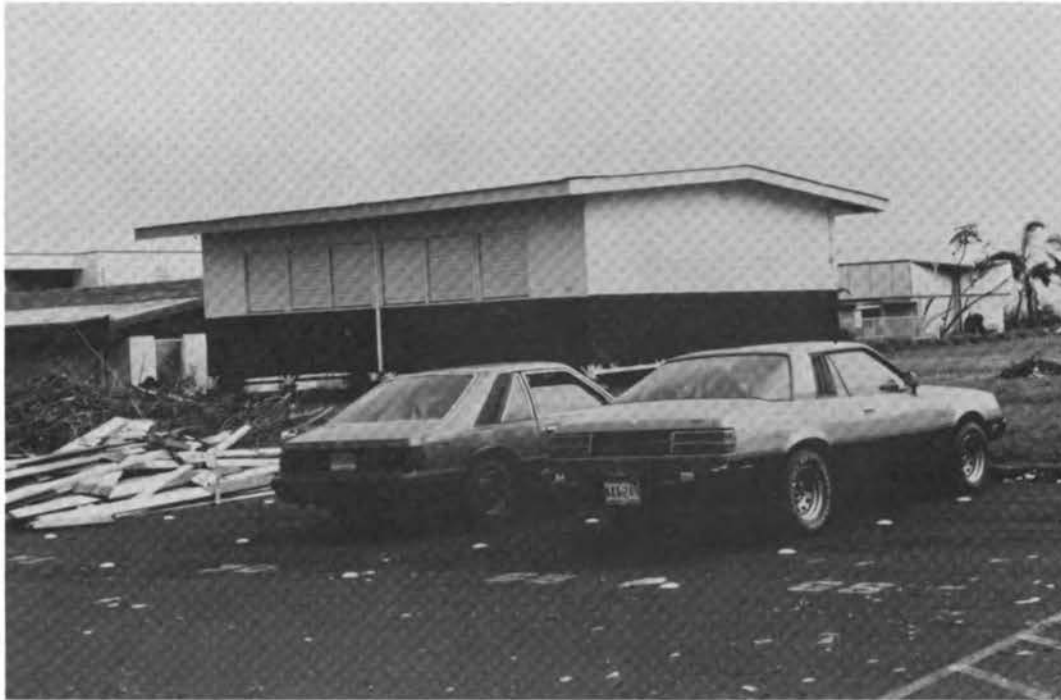
FIGURE 3.49 Undamaged bungalow unit at Kauai High School.

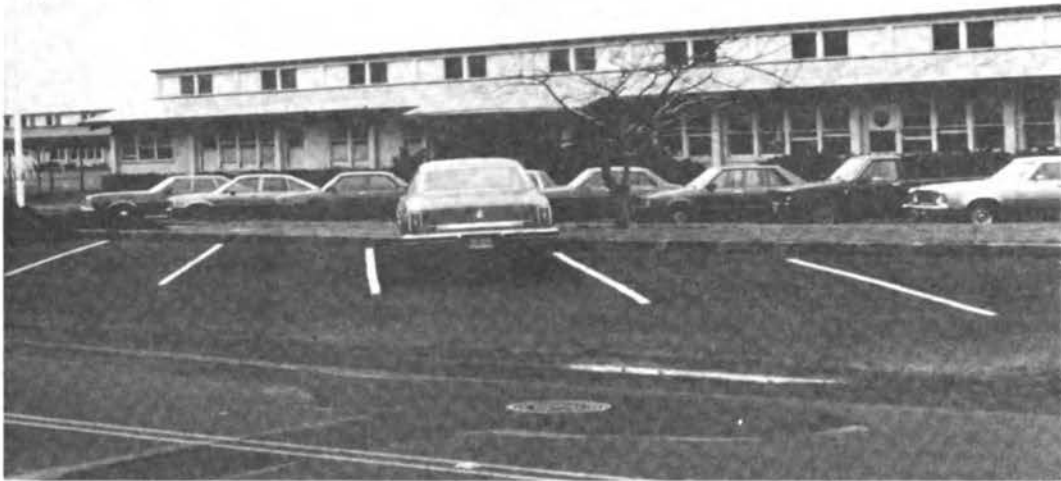
FIGURE 3.53 Undamaged Wilcox Elementary School at Lihue, Kauai.

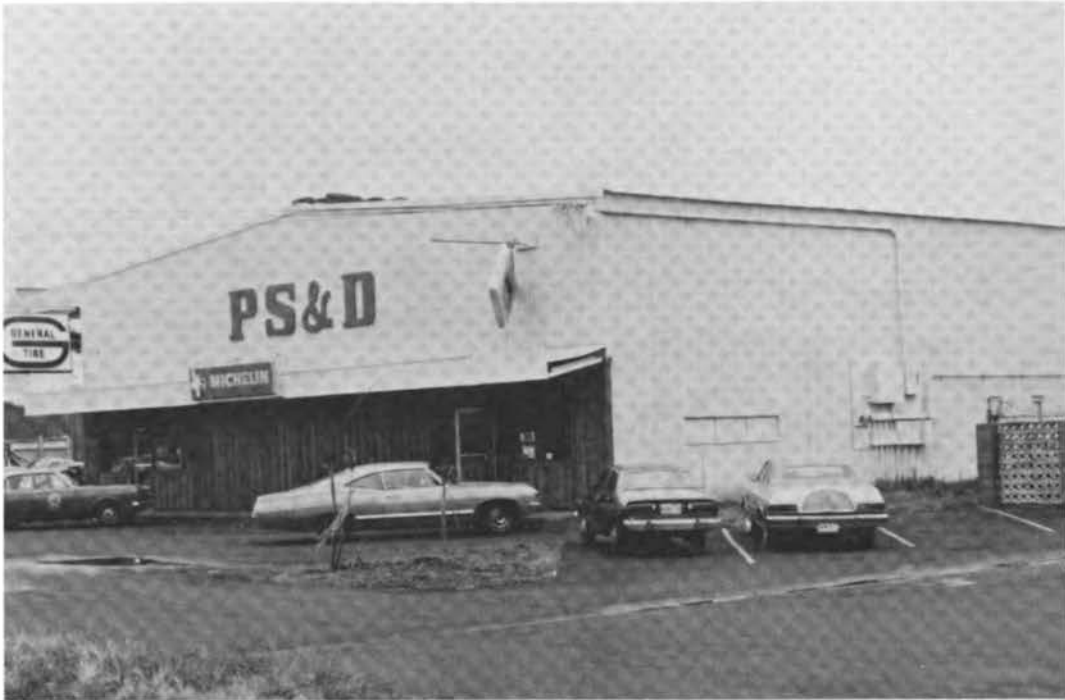
FIGURE 3.55 Undamaged preengineered metal building at Lihue, Kauai.

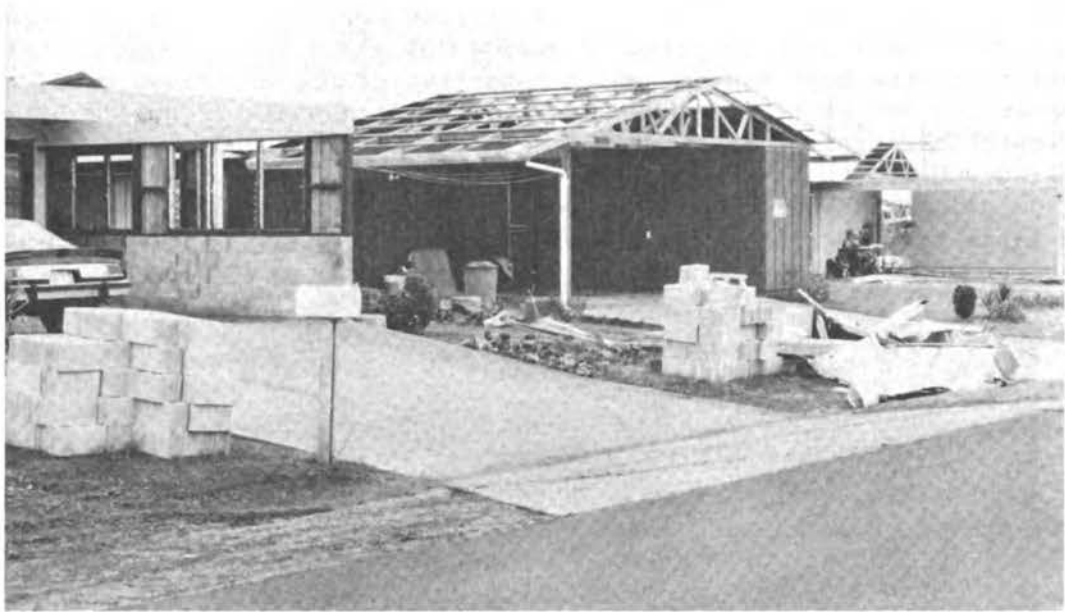
FIGURE 3.57 Damage to roof covering of single-family dwelling at Kapaa Meadows, Kauai.

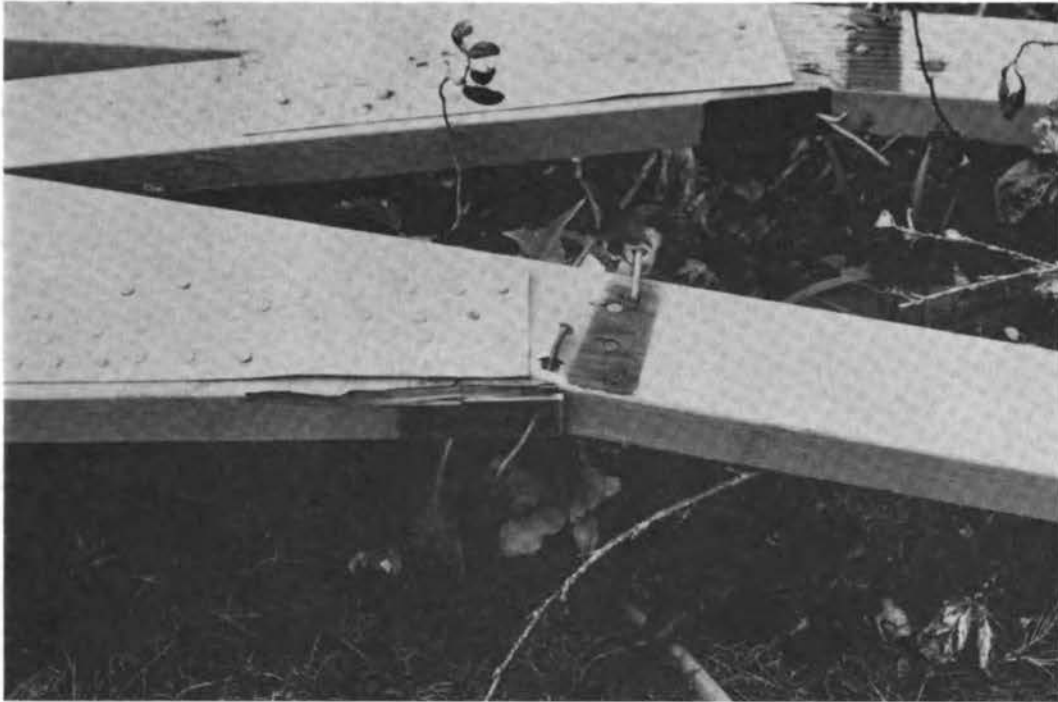
FIGURE 3.59 Toe nailing of prefabricated roof trusses to stud walls (note a single fastener is used for anchorage).

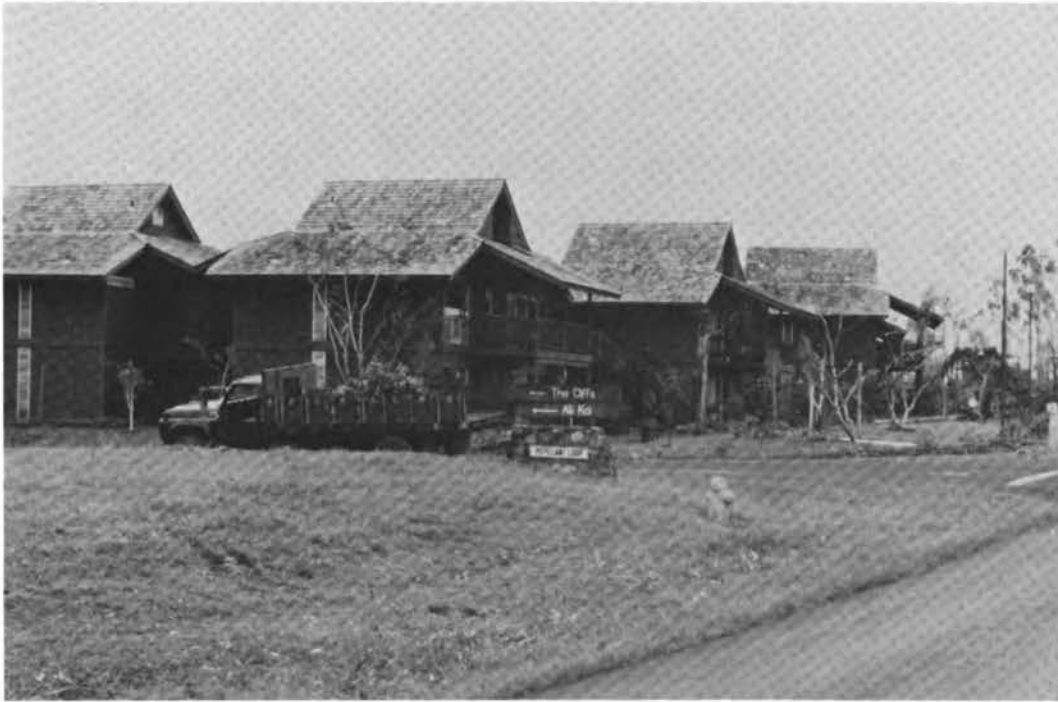
The general performance of six distinct units, of which Figure 3.60 depicts five, was investigated by the team. The units at Pali Ke Kua, the Hanalei Bay Villas, the condominiums at the Hanalei Bay Resort, and the Bali Hai Restaurant (located adjacent to the Hanalei Bay Resort units) all sustained wind damage ranging from superficial cladding damage to their roofs and sliding glass doors to the loss of major portions of their roofs and walls. The townhouses at Pu'u Po'a and Hale Moi, on the other hand, experienced no visible damage other than an occasional missing shingle or roof tile. The Sandpiper Village units (Figure 3.61) located east of the other developments and on flat open country terrain had no visible damage.

FIGURE 3.61 Undamaged Sandpiper Village units, Kauai.

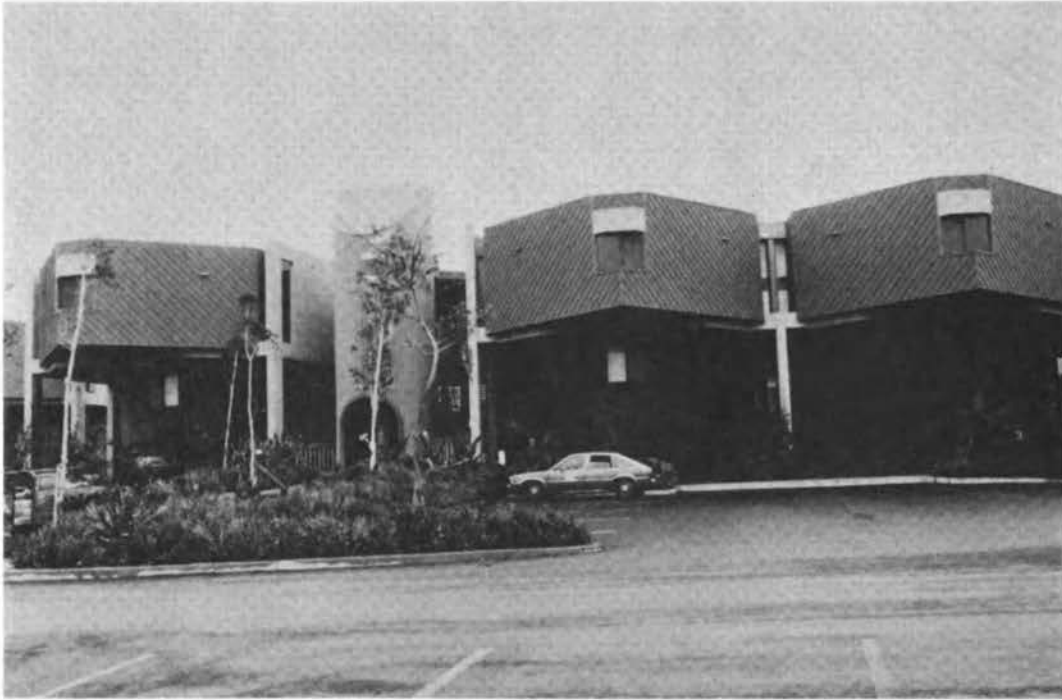
The conventional timber-framed Hale Moi units sustained only very minor cladding damage to the roof coverings. The Pu'u Po'a condominiums (Figures 3.63) are of reinforced concrete shear wall construction, and no damage to these units was observed. However, the other two housing developments, Pali Ke Kua and Hanalei Bay Villas, sustained major damage to many of their units. In each case the location of the units appeared to be a factor.

FIGURE 3.63 Undamaged Pu'u Po'a units, Princeville, Kauai.

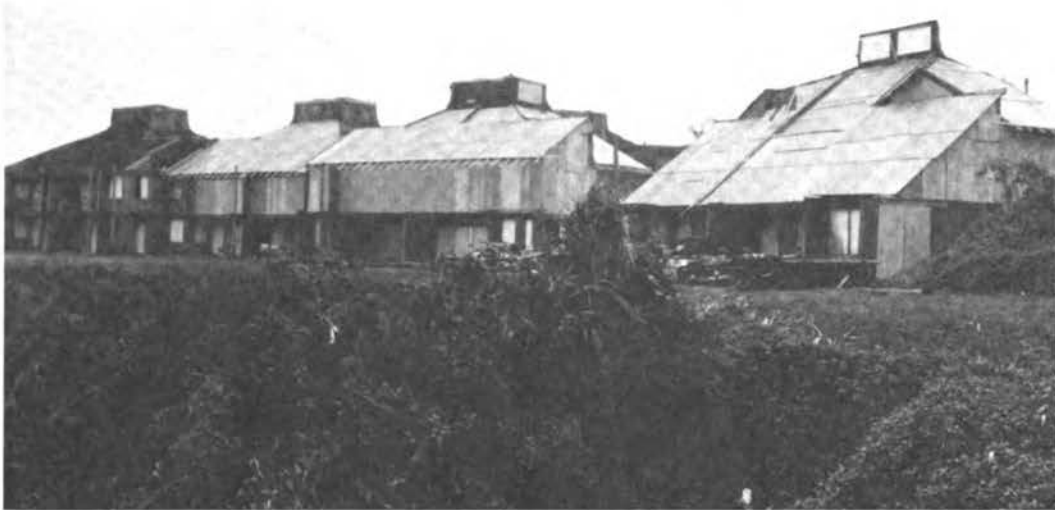
The aerial photograph of Figure 3.64 provides a panoramic view of the damage sustained at Pali Ke Kua and the lack of damage to the Hale Moi units in the upper right-hand corner (see also Figures 3.60 and 3.62). The influence of terrain exposure is clearly seen, as those units near the cliffs along the oceanfront (Figure 3.65) were subjected to amplified speeds for winds flowing over the top of the bluffs from the southwest or west. The units at Pali Ke Kua were two-story multiple-family dwellings of conventional timber-framed construction. Note the high percentage of glazed areas on the windward faces.

Failures of the sliding glass doors or windows and the subsequent increase in internal pressure together with the external suction undoubtedly contributed to the losses of major portions of the roofs of these units.

FIGURE 3.65 Damage to townhouses at Pali Ke Kua, Princeville, Kauai (note high percentage of glazed areas in damaged walls).

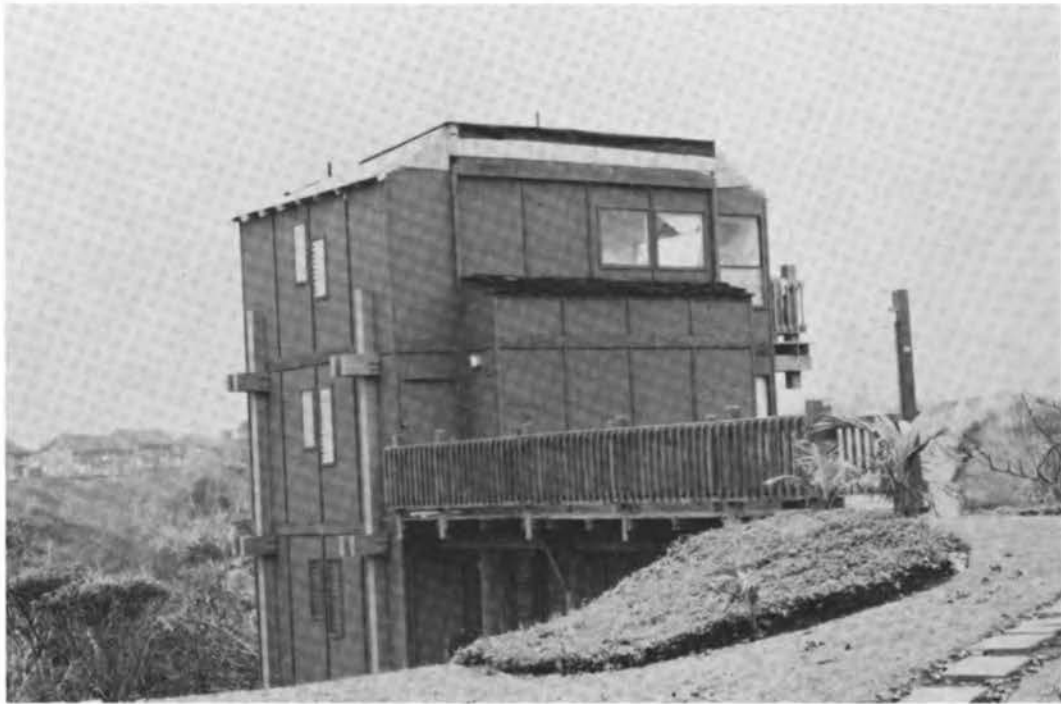
The Hanalei Bay Villas are two- and three-story single-family dwellings that use the pole house design concept (Figures 3.66, 3.67, and 3.68); the floors and walls are of conventional wood joist and stud wall construction, respectively. Walls overlooking the golf course to the south were provided with a high percentage of glazed areas. Extensive wall damage was limited for the most part to these areas (Figure 3.68). The roof framing consists of four hip beams extending from the corners of the stud walls (which are arranged in a square floor plan) and converging at the center of the roof. The hip beams were toe nailed to each other at the apex of the roof, but apparently they were not fastened to the stud walls at the corners of the structure (Figure 3.69). Valley rafters at 90 degrees to the stud walls were toe nailed to the hip rafters and toe nailed (and blocked) to the top plate of the walls at the overhand.

FIGURE 3.67 Pole house type construction of Hanalei Bay Villas at Princeville, Kauai.

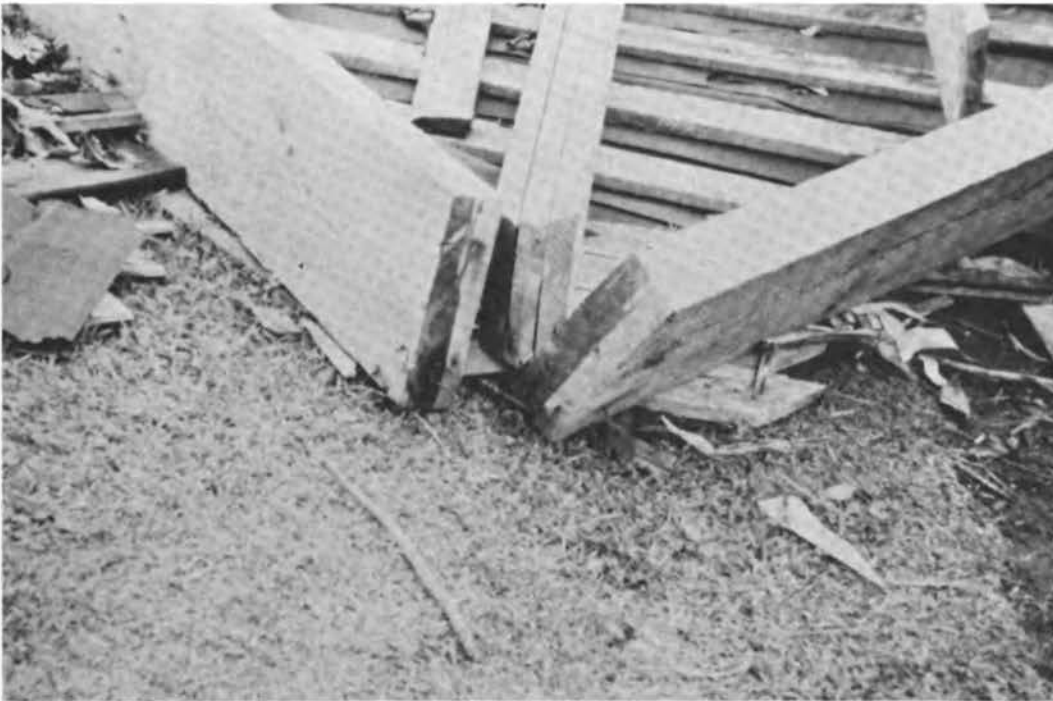
FIGURE 3.69 Fastener details of hip roof.

Almost all of these units sustained major damage to large portions of their roofs. This damage could have been eliminated or at least mitigated through the use of proper connections. At the very least, metal framing angles should have been provided to connect the hip beams to each other at the apex of the roof and to the top plate of the stud walls. Furthermore, experience has shown that the use of toe nailing for rafters that have large overhangs should be avoided where possible.

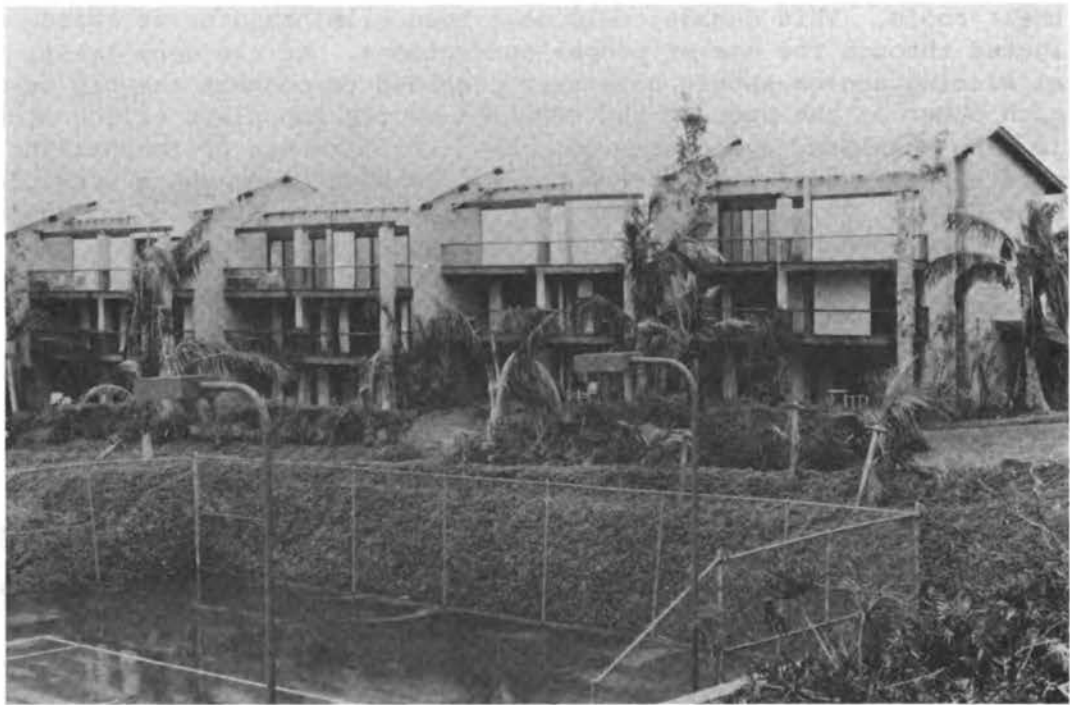
The Hanalei Bay Resort, shown in Figure 3.60, consists of clusters of two-story townhouse units, tennis courts, swimming pools, and the Bali Hai Restaurant. The development is located at the end of a ridge overlooking the ocean with deep ravines on either side. The general topography can be seen in Figure 3.70. The units are constructed of reinforced masonry load-bearing walls, reinforced concrete floor slabs, and lightweight timber-framed roofs. Most of the units sustained extensive roof damage (Figures 3.70 and 3.71). Because of time limitations, the team did not closely inspect these units, and the reader is referred to the report by the Structural Engineers Association of Hawaii (1983). This document attributes much of the observed damage to inadequate nailing of the tongue-and-groove wood decking to the timber supporting beams. Figure 3.70 shows that roof surfaces exposed to the winds from the south to west directions sustained the most damage. Again, the influence of topographic features on the wind environment appears to be a major contributing factor.

FIGURE 3.71 Hanalei Bay Resort townhouses (viewed from northeasterly direction).

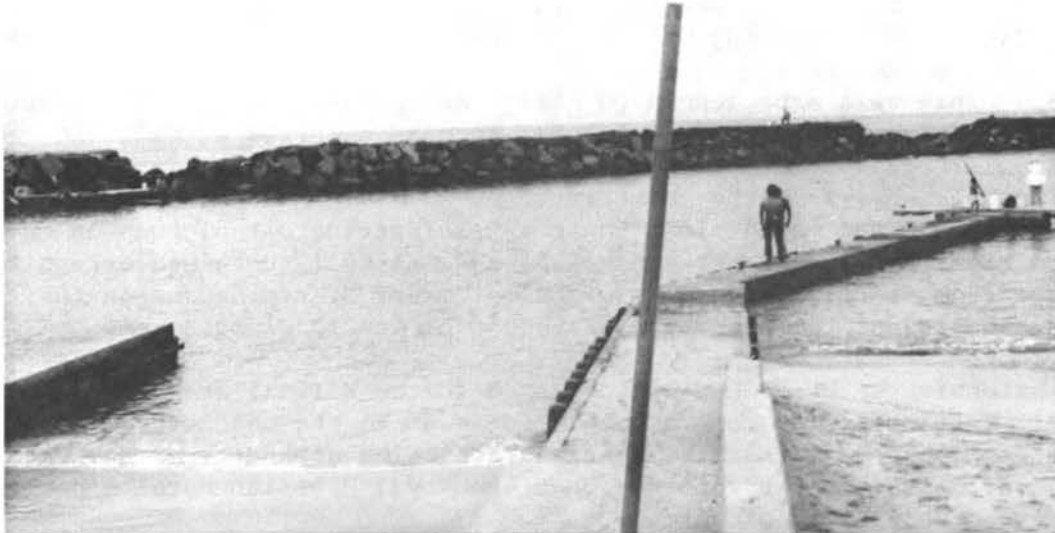
This section describes damage in a general geographical order beginning at Haleiwa and continuing around the coastline in a counterclockwise direction. At Haleiwa an offshore breakwater built with federal funds for beach protection was severely damaged. Continuing down the coast, the Waianae small-boat harbor breakwater designed by the Corps of Engineers sustained very minor damage and appeared to have protected the boats in the harbor quite well. However, the Pokai Bay breakwater, a state-operated small-craft harbor of refuge less than two miles away, was breached in three places and rendered inadequate for boat protection (Figure 3.73). Large oil pipelines extending from a point 1.5 miles offshore to the two refineries at Barbers Point were damaged by wave- and wind-generated currents, although no major oil spillages occurred.

FIGURE 3.73 Storm surge and wave damage to Pokai Bay breakwater, Oahu.

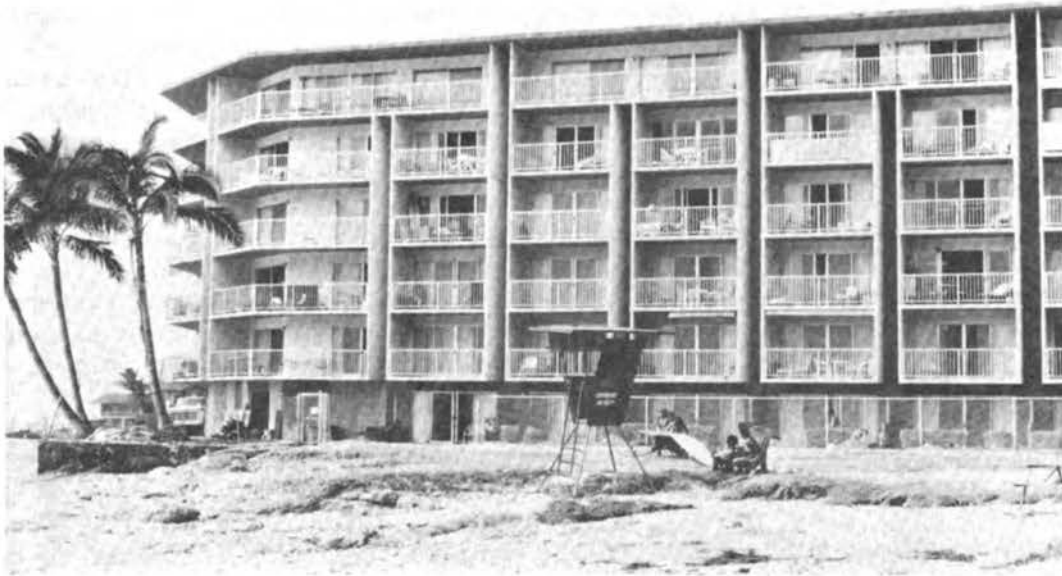
A large portion of the ground-level floor of the Makaha Shores Condominium was gutted, with one resident reporting waveborne debris striking and breaking a glass door on the second floor of the building (Figure 3.75). A careful inspection of this reinforced concrete load-bearing-wall building indicated that it had sustained no apparent structural damage. The bearing wall in this case also functions as a shear wall. The building was constructed very near the water but was partially protected by a grouted unreinforced lava rock seawall (Figure 3.76). This wall experienced no damage and prevented extensive erosion around the footings of the structure, such as occurred at Kuhio Shores on Kauai (Figure 3.19). Note that the bearing walls of this building are roughly normal to the coastline.

FIGURE 3.75 Water and wave damage to Makaha Shores Condominium, Oahu.

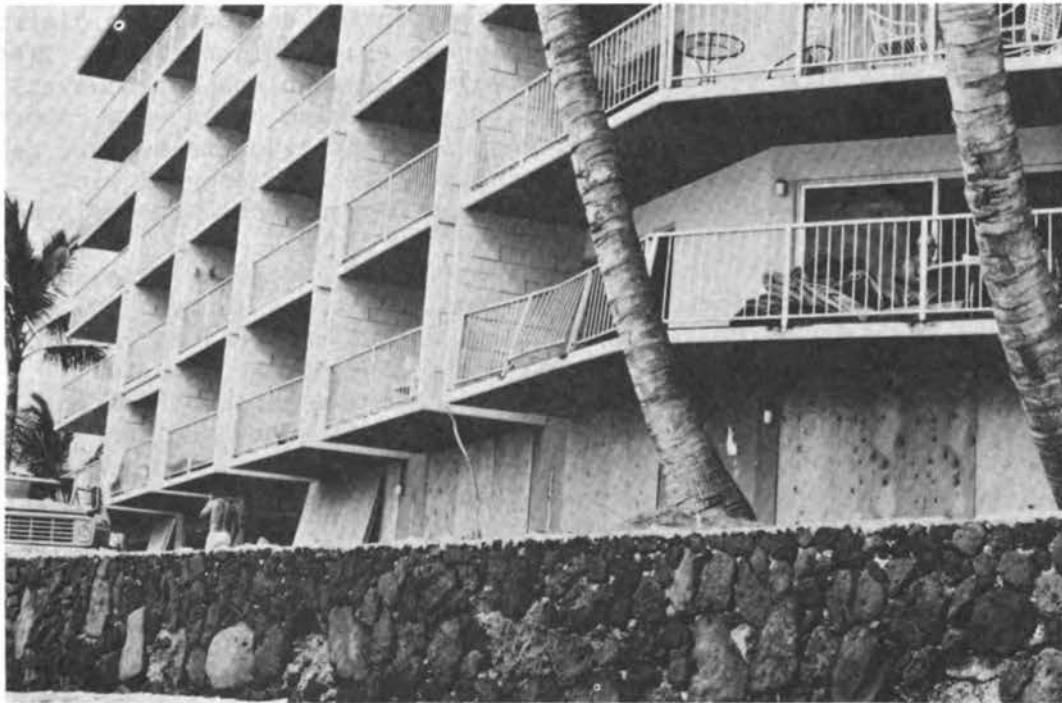
FIGURE 3.76 Seawall protecting Makaha Shores Condominium.

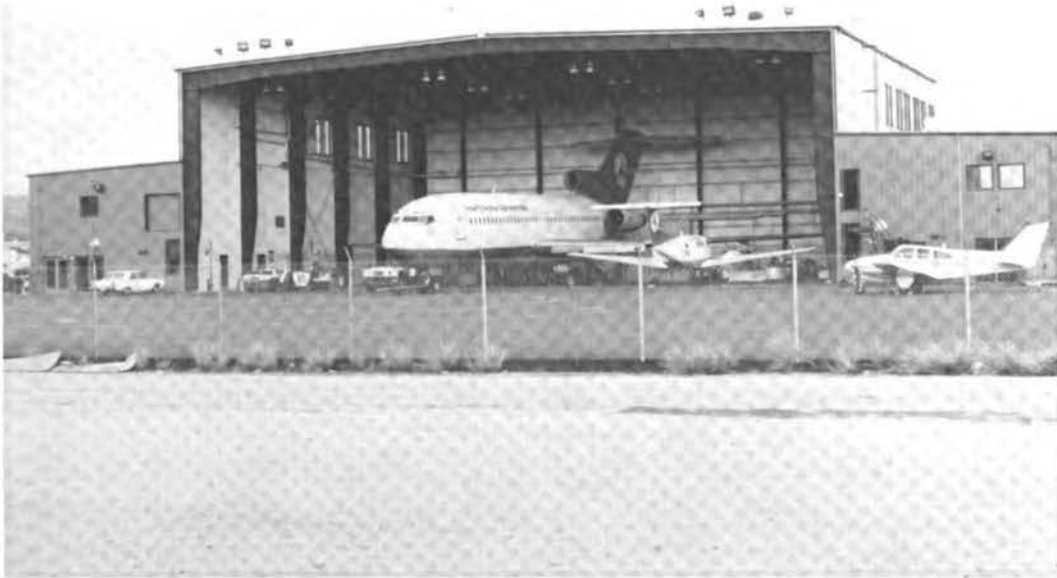
minor cladding damage (to roof coverings, glass windows, etc.) caused by windborne debris. A variety of modern preengineered metal buildings were located in the airport area. A number of these buildings were designed as hangars and were open on the side facing the storm (Figure 3.77). Other hangars for small aircraft were enclosed by large folding doors on the windward side (Figure 3.78). The team observed no indication of structural distress for any of the buildings. The team did note a bothersome item, however; the existence of a large number of old, metal- and timber-framed structures clad with light-gage corrugated metal sheeting (Figure 3.79). These structures, located in close proximity to newer buildings, posed a high hazard to life and property during the passage of the hurricane. A number of these buildings lost large portions of their roof and wall panels that were inadequately fastened to the purlins or had rusted through at the sites of fasteners.

FIGURE 3.77 Undamaged preengineered metal hangar building at Honolulu International Airport (note building was open on windward face for Iwa).
