Hurricane Iwa, Hawaii, November 23, 1982 (1983)

Hurricane Iwa, Hawaii, November 23, 1982

Committee on Natural Disasters
Commission on Engineering and Technical Systems
National Research Council

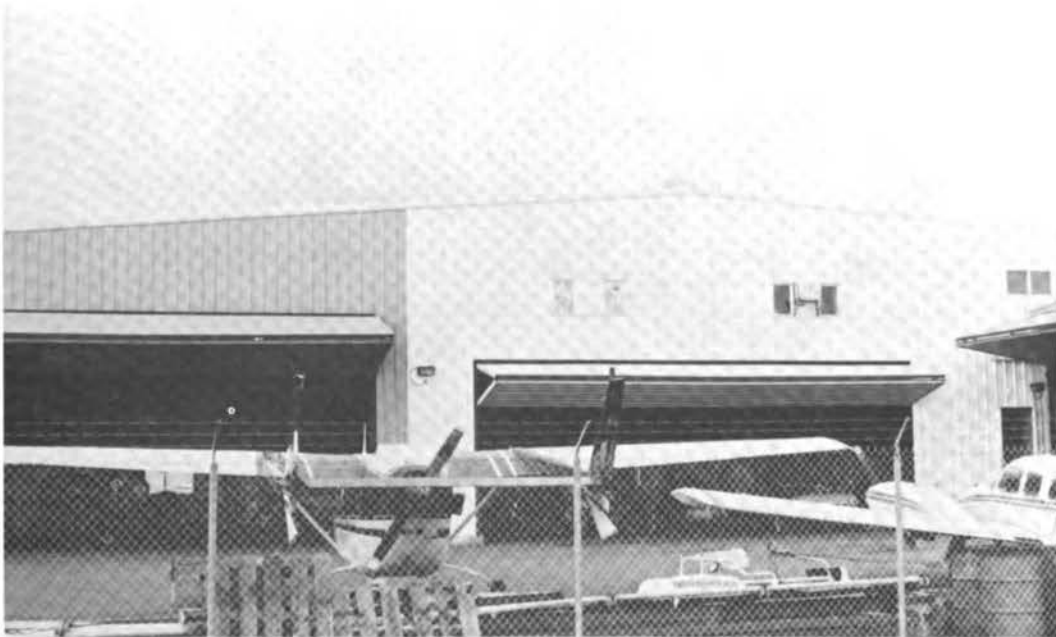
FIGURE 3.78 Undamaged preengineered metal hangar building at Honolulu International Airport (note large fold-up doors that escaped damage).

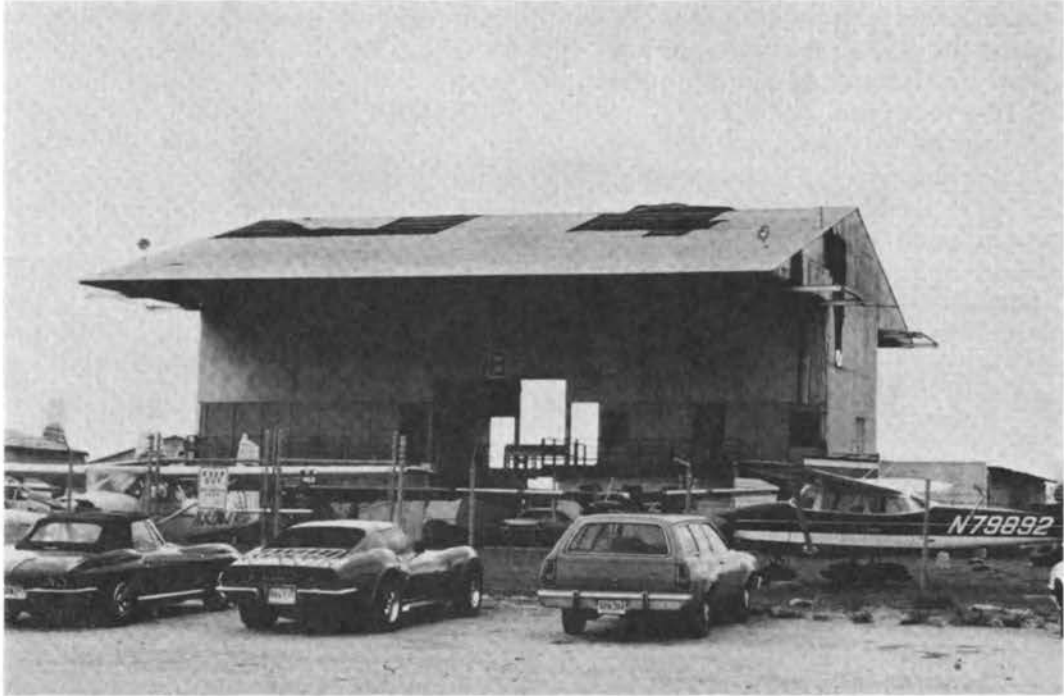
minor cladding damage (to roof coverings, glass windows, etc.) caused by windborne debris. A variety of modern preengineered metal buildings were located in the airport area. A number of these buildings were designed as hangars and were open on the side facing the storm (Figure 3.77). Other hangars for small aircraft were enclosed by large folding doors on the windward side (Figure 3.78). The team observed no indication of structural distress for any of the buildings. The team did note a bothersome item, however; the existence of a large number of old, metal- and timber-framed structures clad with light-gage corrugated metal sheeting (Figure 3.79). These structures, located in close proximity to newer buildings, posed a high hazard to life and property during the passage of the hurricane. A number of these buildings lost large portions of their roof and wall panels that were inadequately fastened to the purlins or had rusted through at the sites of fasteners.

FIGURE 3.79 Old metal hangar building at Honolulu International Airport (note large portions of missing roof cladding).

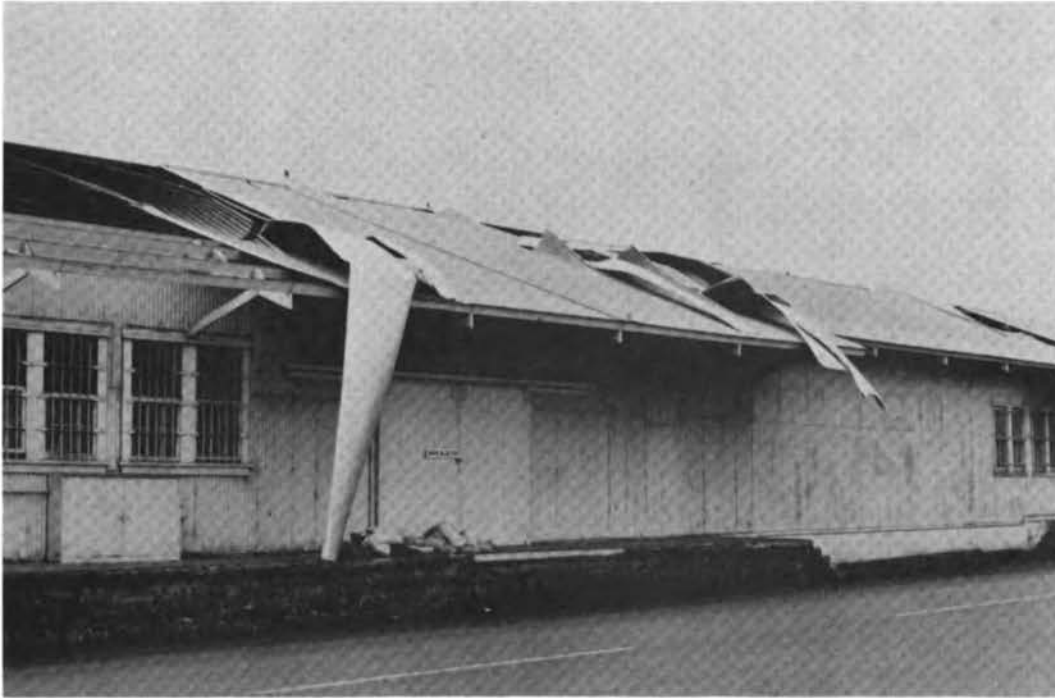
The bulk of the estimate made by the Federal Emergency Management Agency (1982) for wind-induced damage from Iwa at U.S. Army installations is based on the severe damage that occurred to the old timber-framed warehouse buildings and their contents at Schofield Barracks (Figures 3.8, 3.9, and 3.81). Damage was extensive, with a large number of structures being completely destroyed. Failure of these buildings can be attributed to the loss of the light-gage corrugated metal sheeting panels nailed to timber purlins. The sheeting-purlin roof system was necessary to provide the roof diaphragm action, and loss of this system caused collapse of the buildings. Figure 3.82 shows the nailing schedule for most of these buildings. Failure occurred due to failure of the nail heads, withdrawal of the nails, or in some cases pulling of the panels through the nail heads.

FIGURE 3.81 Cladding damage to warehouse buildings at Schofield Barracks, Oahu.

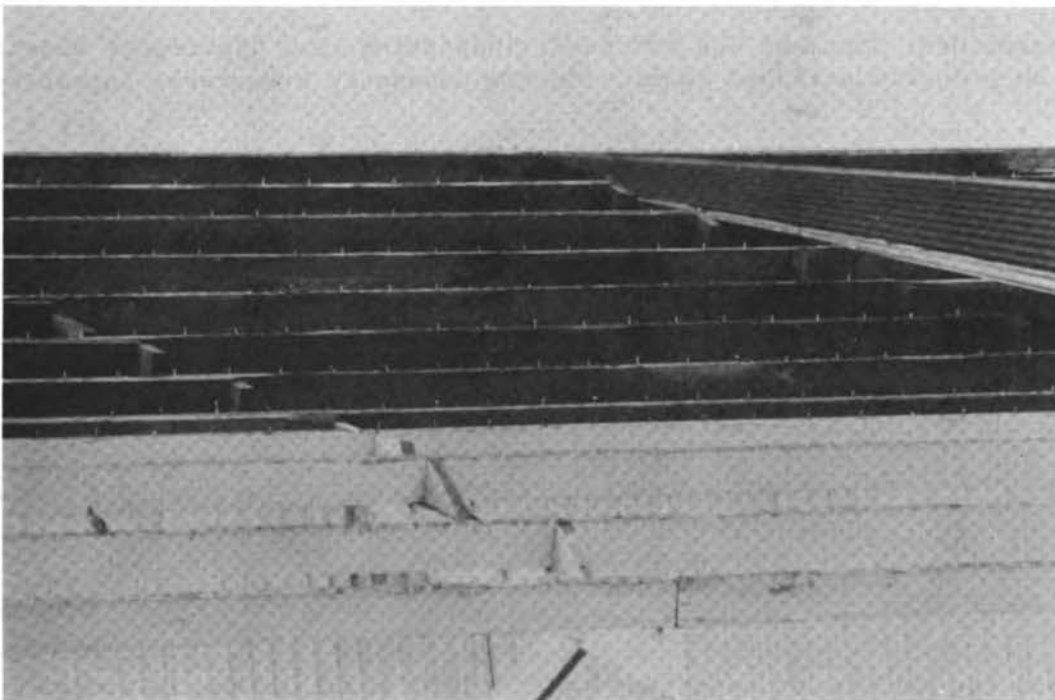
FIGURE 3.82 Nailing schedule for attachment of light-gage metal cladding to timber purlins.

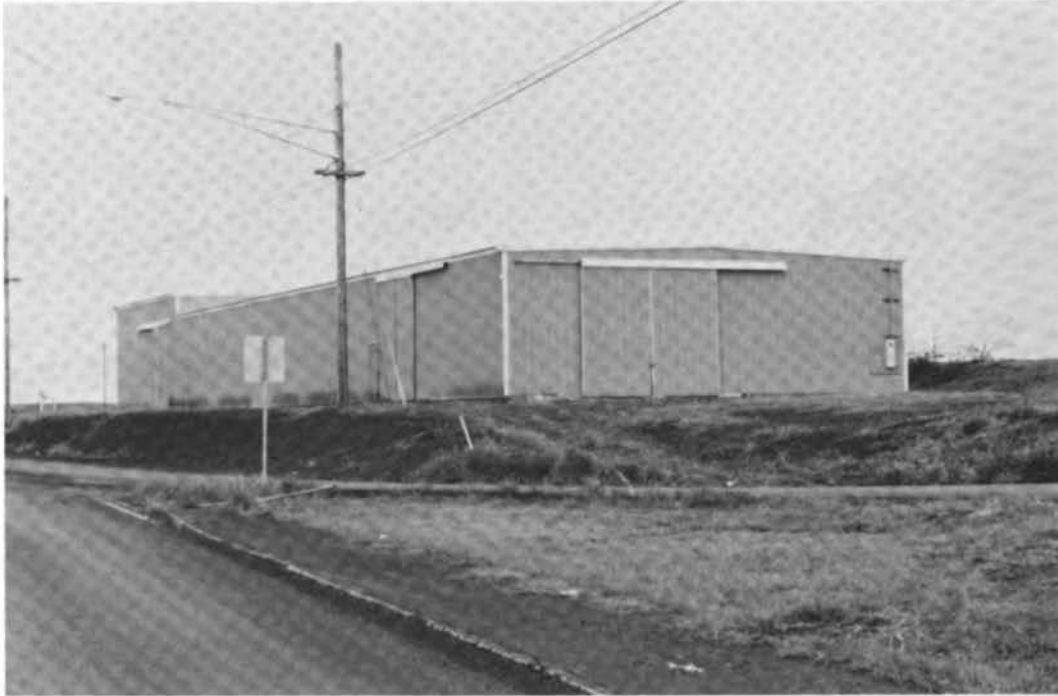
One interesting structure is a modern preengineered building located in this general area on Kam Highway that endured maximum exposure to the wind (Figure 3.83). The structure is clad with light-gage sheeting, but

FIGURE 3.83 Undamaged preengineered metal building located on Kamehameha Highway near Wahiawa, Oahu.

no structural distress was observed, indicating that light-gage sheeting can be properly attached to provide the necessary structural integrity.

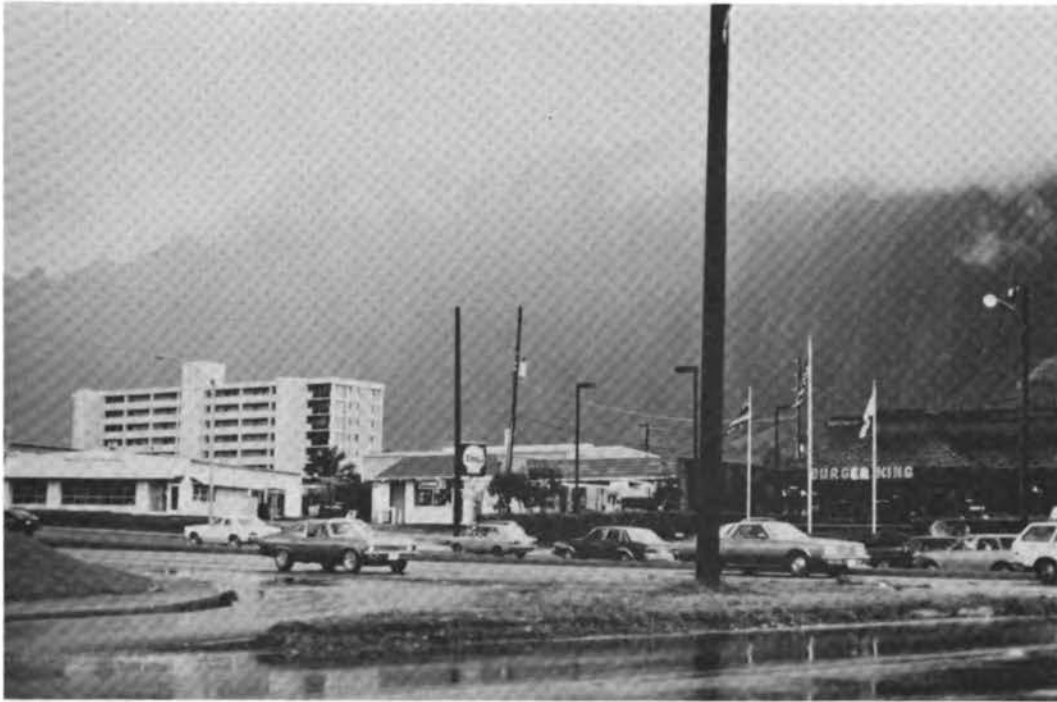
Sustained wind speeds in the Kaneohe area were estimated to be from 65 to 70 mph due to amplification of winds to the lee of the Koolau Range (Figure 3.84). Damage to residential construction and small-business buildings was widespread (Figures 3.85 and 3.86), but it was confined, for the most part, to minor losses of roof coverings and glass damage due to windborne debris (such as shingles and foliage). The team observed that, in general, the quality of construction of single- and multiple-family dwellings in Kaneohe was better than that noted on Kauai. This undoubtedly contributed to there being less damage observed in this area than in a comparable wind environment on Kauai.

FIGURE 3.84 Lee of Koolau Range, Kaneohe, Oahu.

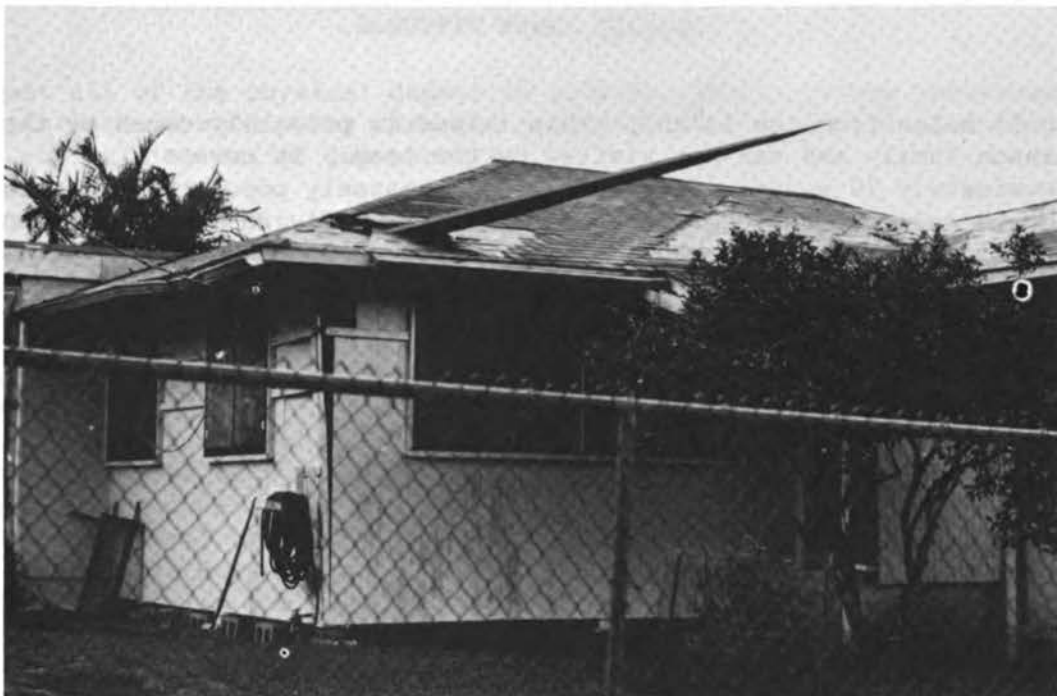
FIGURE 3.85 Missile damage to roof of residence at Kaneohe, Oahu.

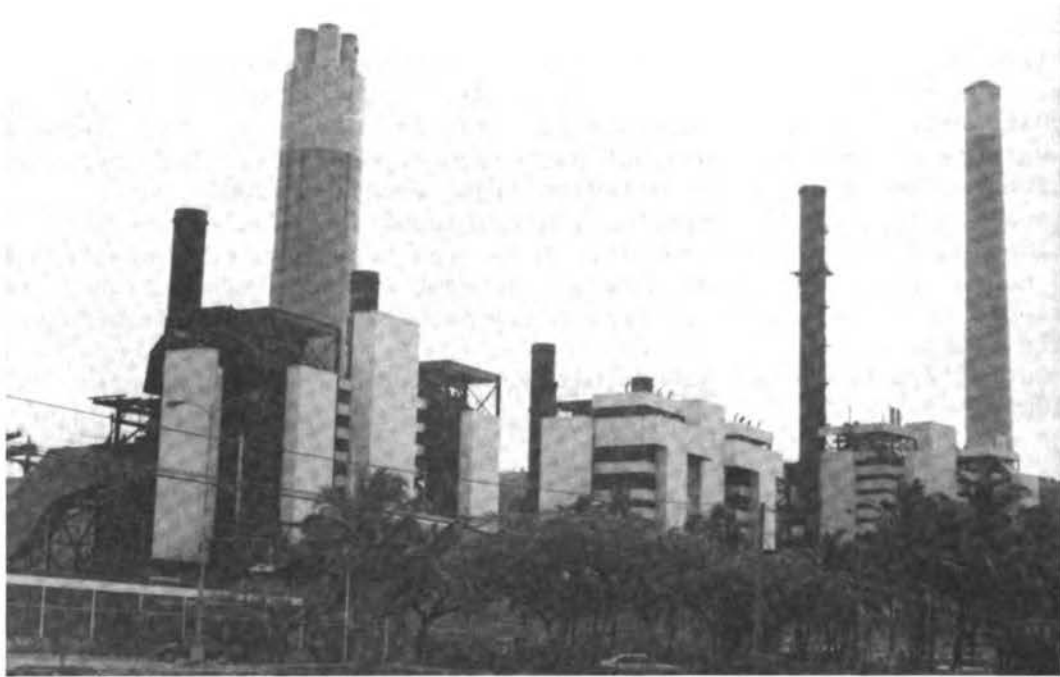
There was no damage to transmission or distribution substations or their equipment. Generating stations (power plants) were not damaged. There was a report that the Kahe power plant (Figure 4.2) condenser cooling seawater intake system had ingested large quantities of sand. This phenomenon occasionally occurs during storms that stir up the sea bottom around the intake structures of power plants on exposed coastlines.

FIGURE 4.2 Undamaged Kahe power plant on the coast of Oahu 4-1/4 miles north of Barbers Point.

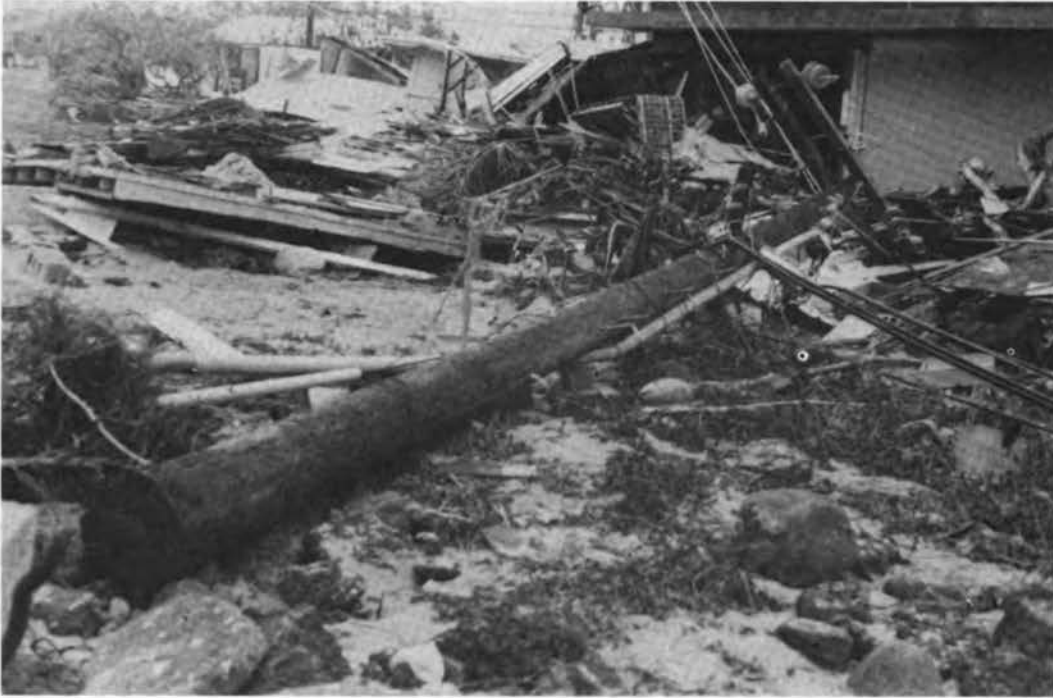
It was observed that many poles carrying power transmission and distribution lines fell over due to soil rupture caused by soft saturated soils, insufficient embedment of the pole, or both (Figure 4.3). Many poles failed by bending and shear failure at ground level (Figure 4.4); fewer failed at various heights above ground level (Figure 4.5). Several citizens stated that they had seen failures of poles weakened by termite infestation.

FIGURE 4.3 Power and telephone pole at Poipu, Kauai, that toppled due to soil embedment failure.

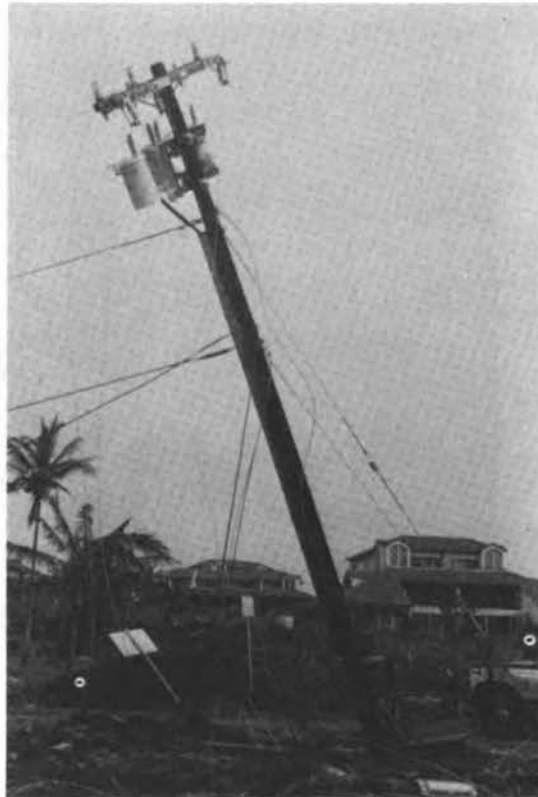
FIGURE 4.4 Power pole at Poipu, Kauai, that failed due to pole rupture at ground level.

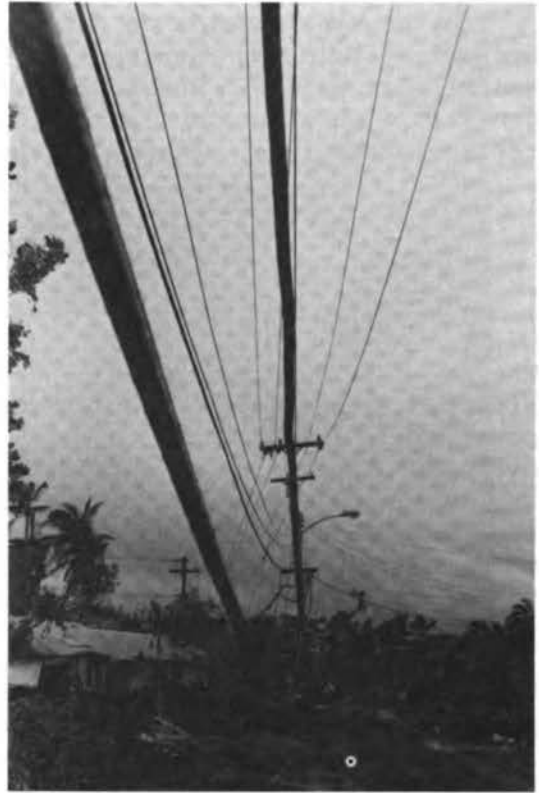
The Hawaiian Telephone Company systems on both Kauai and Oahu were affected by the loss of cables supported on poles owned jointly with the power companies (Figure 4.7). On Kauai, damage to cables mounted on overhead poles was severe (Figure 4.8).

FIGURE 4.7 Damaged power transmission lines and telephone cables on jointly owned wood pole at Poipu, Kauai.

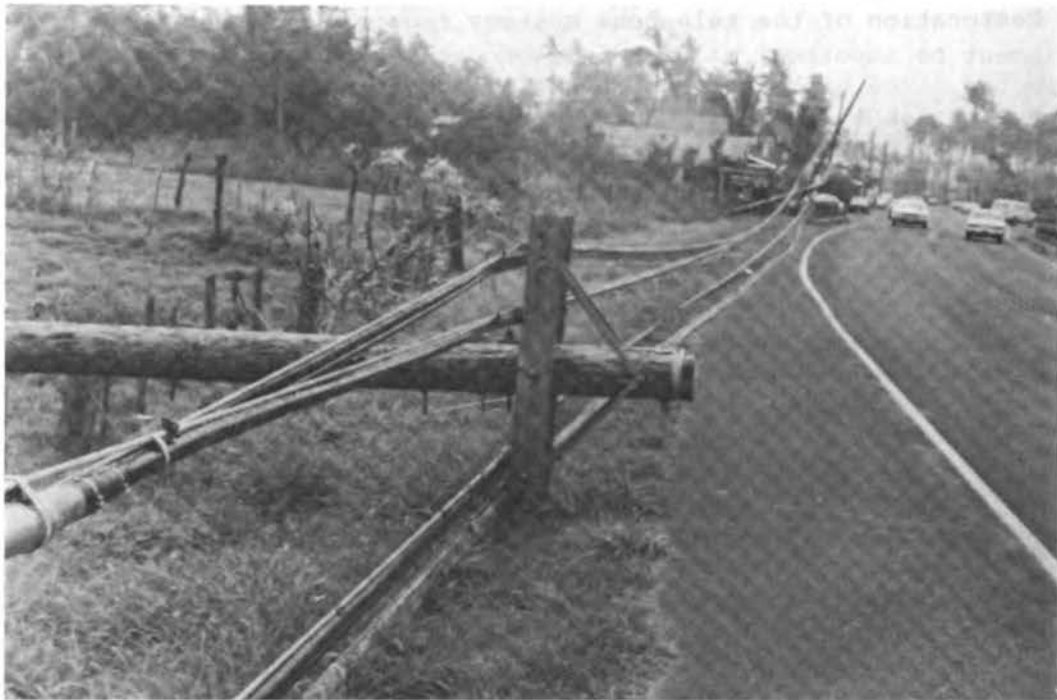
FIGURE 4.8 Telephone cables that toppled due to failure of supporting wood poles south of Kapaa, Kauai.

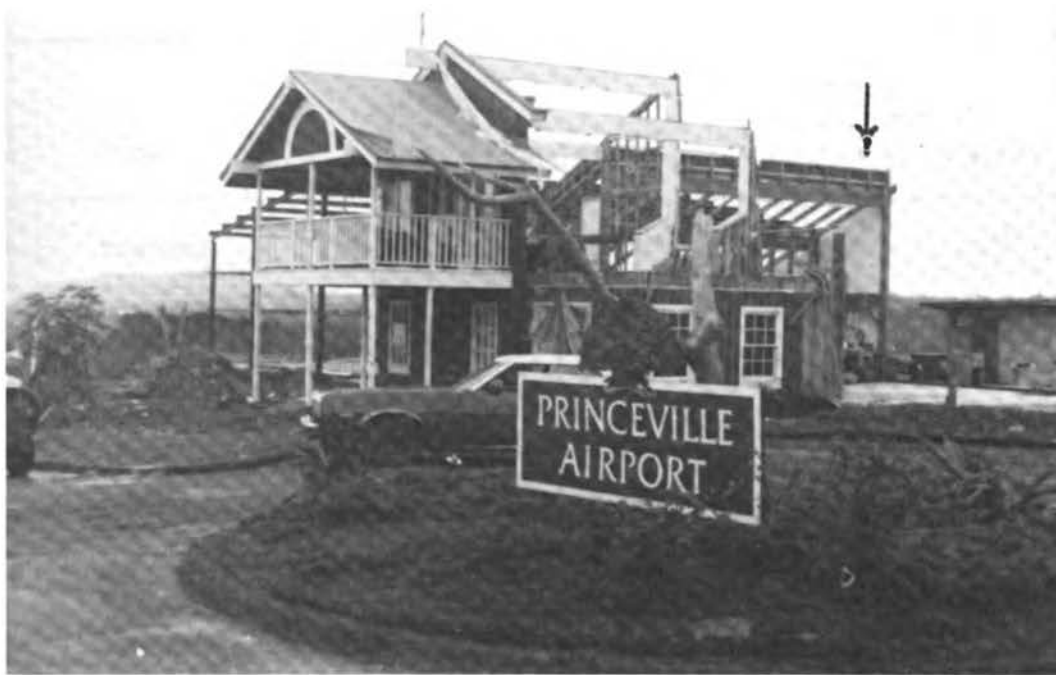
Princeville Airport on Kauai suffered roof damage to buildings due to high winds. A collapsed hangar roof damaged two helicopters, one severely (Figure 4.10).

FIGURE 4.10 Partially destroyed aircraft hangar at Princeville Airport at Hanalei, Kauai.
