Hurricane Alicia, Galveston and Houston, Texas, August 17-18, 1983 (1984)

Hurricane Alicia Galveston and Houston, Texas August 17-18, 1983

Committee on Natural Disasters
Commission on Engineering and Technical Systems
National Research Council

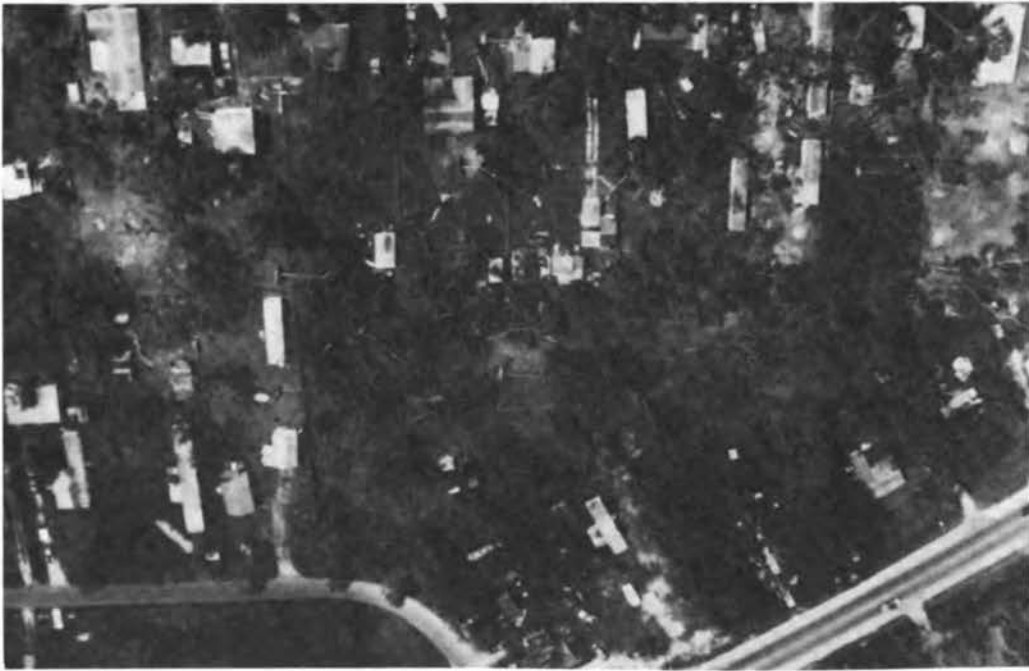
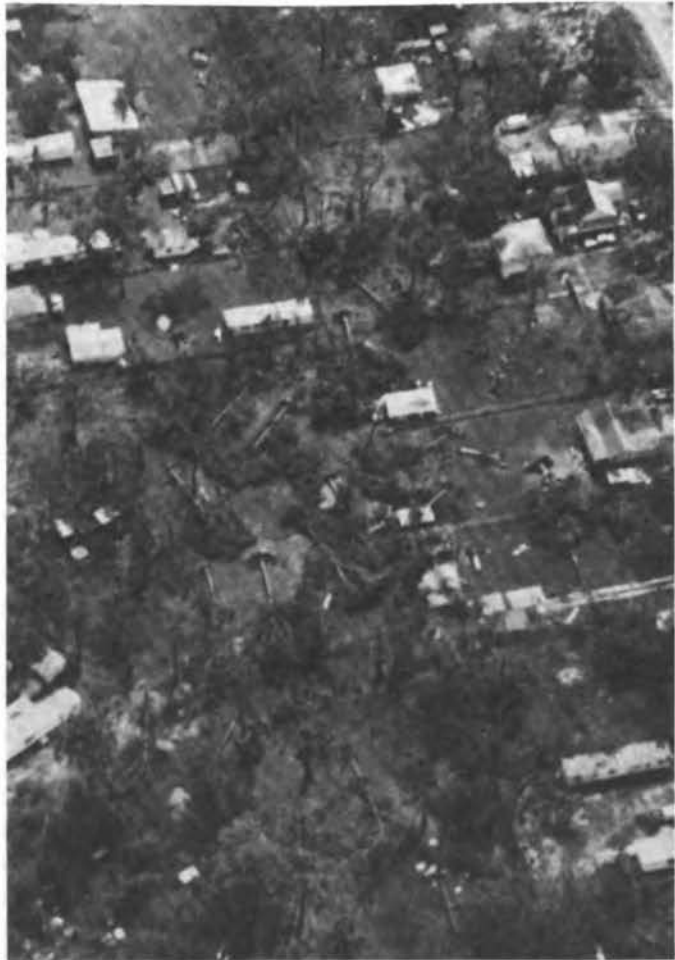
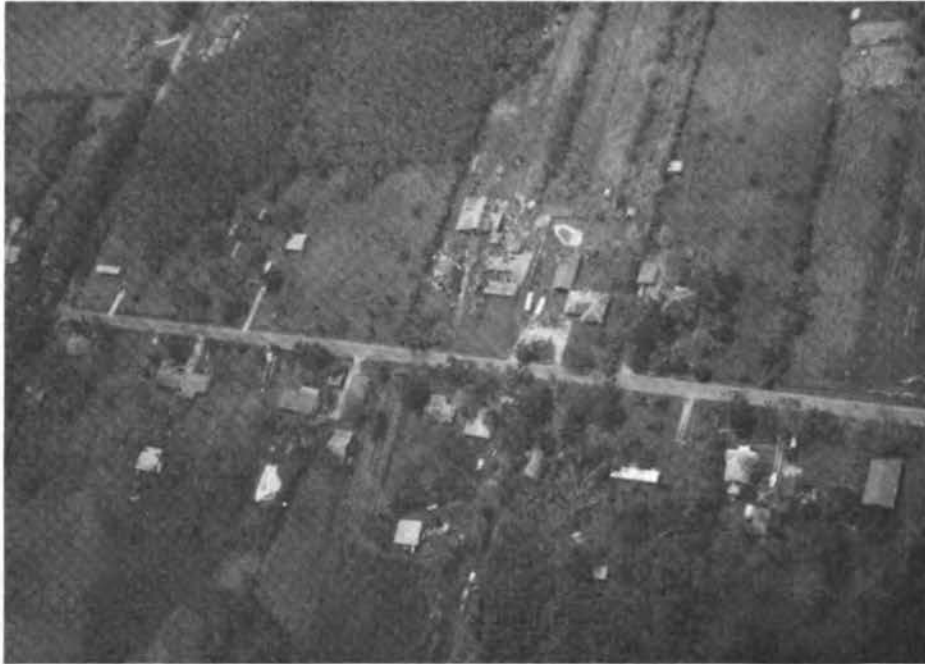
FIGURES 2.11A-2.11B Aerial damage photographs taken from a NOAA helicopter at 1,000 ft on August 25, 1983.

FIGURE 2.11C Aerial damage photograph taken from a NOAA helicopter at 1,000 ft on August 25, 1983.

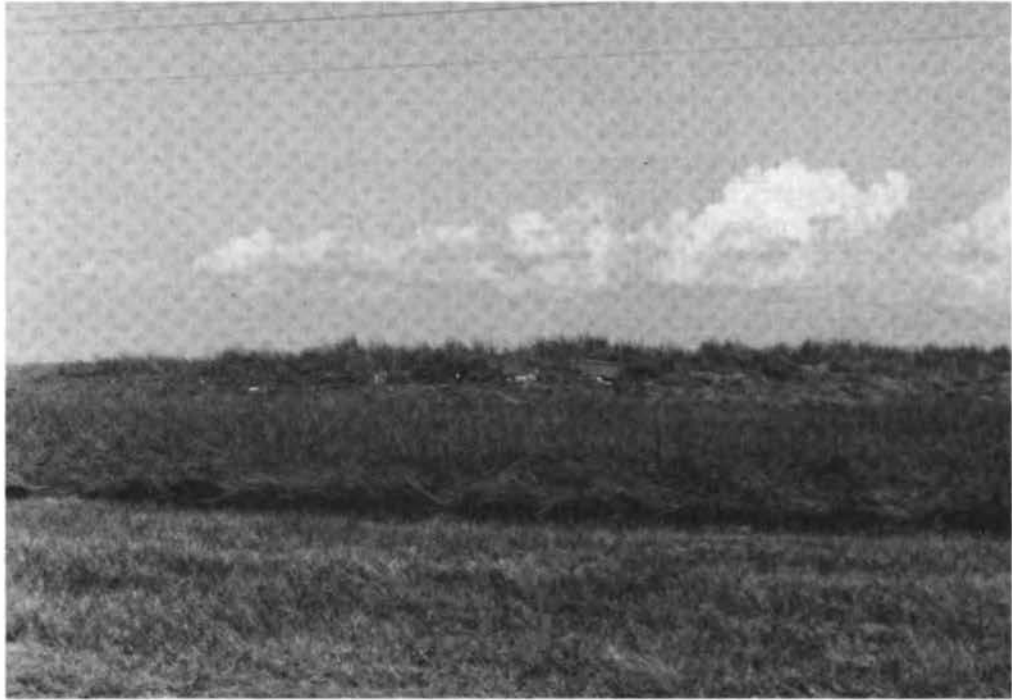
FIGURE 3.1 Debris line on bay (north) side of the foredune on Follets Island about 1-1/2 miles east of San Luis Pass.

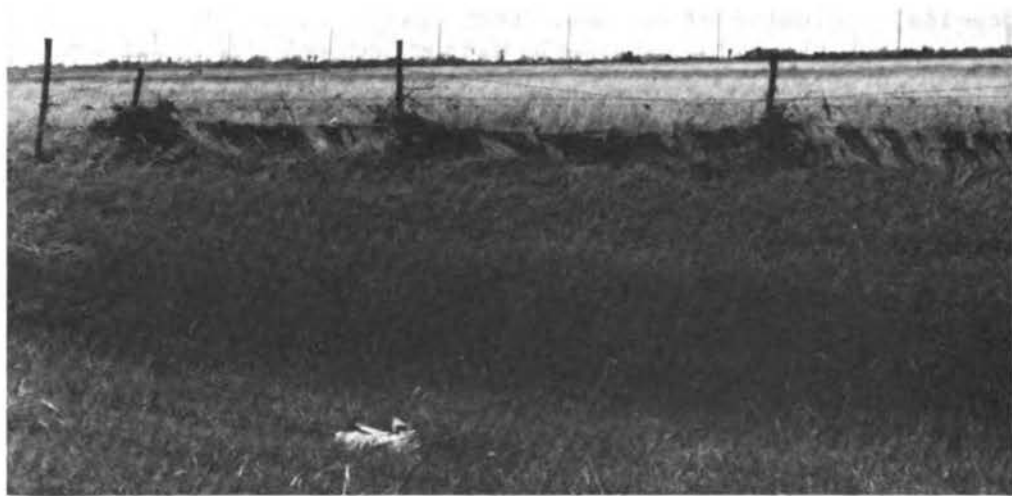
Water marks in closed buildings are good indicators of maximum water levels that do not include the effects of wave action. However, during the Hurricane Alicia investigation, water marks were difficult to distinguish, probably because the flood waters contained little or no suspended sediment. No water marks were observed on the outside of buildings, and water marks inside buildings were composed of bits of vegetation, including seeds. Debris lines, usually composed of loose vegetation, were common (Figure 3.1) and were usually a clear, though not precise, indicator of maximum water level, including the effects of wind waves and run-up. Where their height spanned the flood level range, fences were also good indicators of maximum water level because bits of floating vegetation were caught by the individual fence strands. Thus the line between bare and "clothesline" strands clearly indicated the maximum water level (Figure 3.2).

FIGURE 3.2 Debris on barbed wire fence about 1/2 mile west of Eight Mile Road on western Galveston Island.

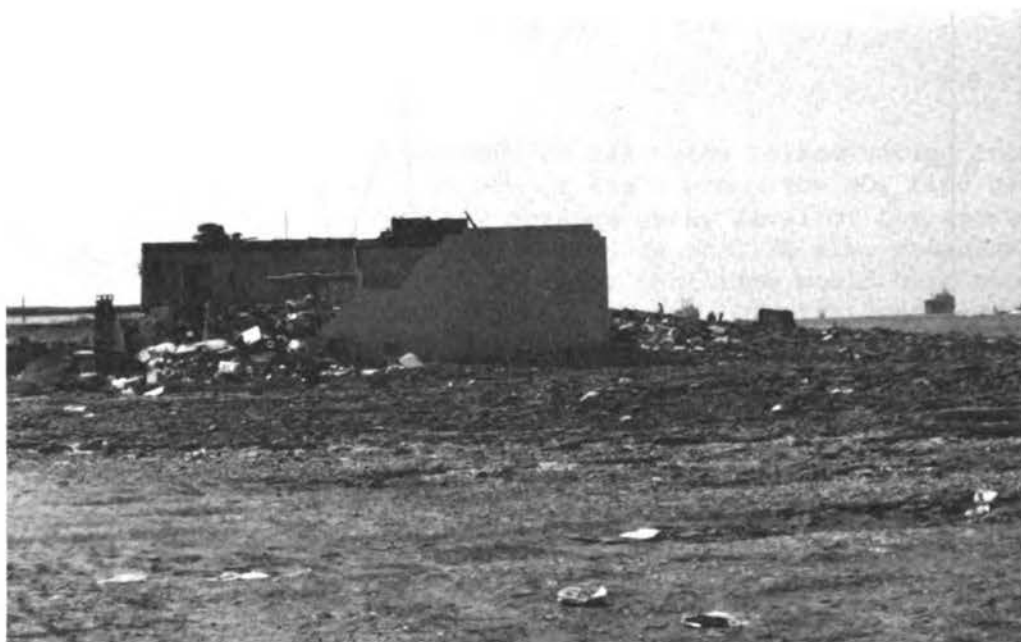
Along the front of East Beach the beach and lower dunes were overtopped by 2 to 4 ft of water, which then flowed landward toward the seawall. When the seawall stopped the northward movement of the overtopping water, it turned eastward and ran over the shoreward section of the north jetty into Galveston Inlet. Scour near the junction of the north jetty and the seawall was intense (Figure 3.4). The land and jetty level in this area is about 3 ft above NGVD, and thus the depth of the flowing water was between 4 and 6 ft.

FIGURE 3.4 Scour and building damage near the intersection of the Galveston seawall and the west jetty of Galveston Inlet.

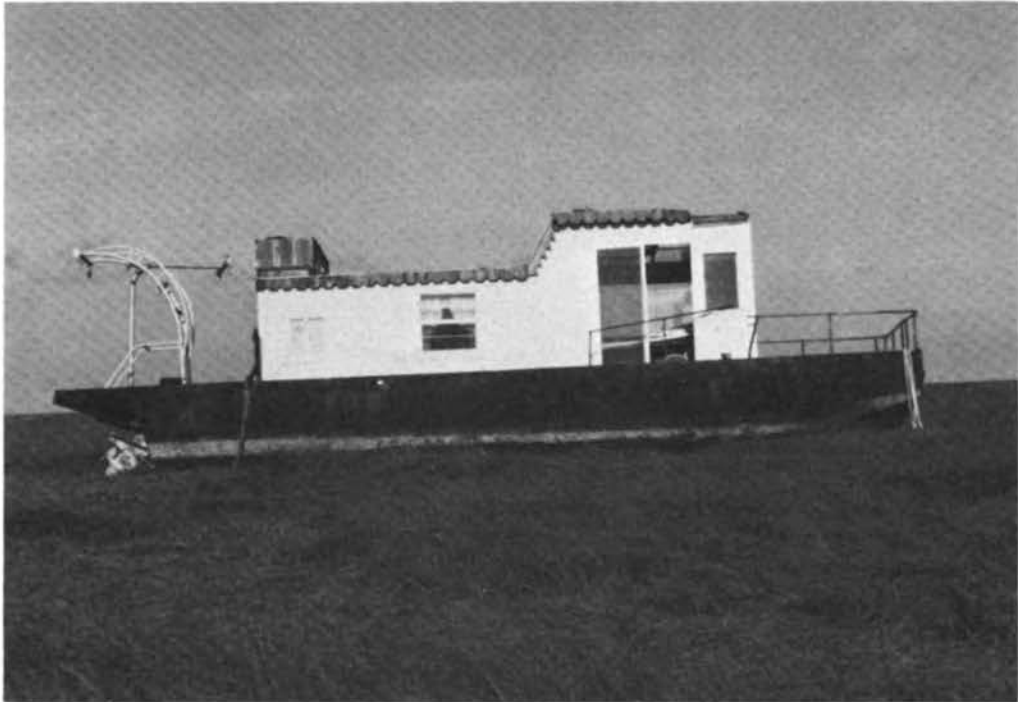
elevations in the bays were about 10 ft. Evidence of water levels consisted of debris lines on the bay side of the dunes at distances of 1.5, 2.0, 4.5, 7.5, and 8.5 miles from the east end of the island, as well as a stranded houseboat between the highway and the dunes fronting the Gulf at the 4.5-mile point (see Figure 3.7). Highway elevations were estimated from USGS quadrangle sheets.

FIGURE 3.7 Houseboat grounded between the highway and the Gulf about 4-1/2 miles west of San Luis Pass on Follets Island. Note fresh barnacles on the bottom of the boat.

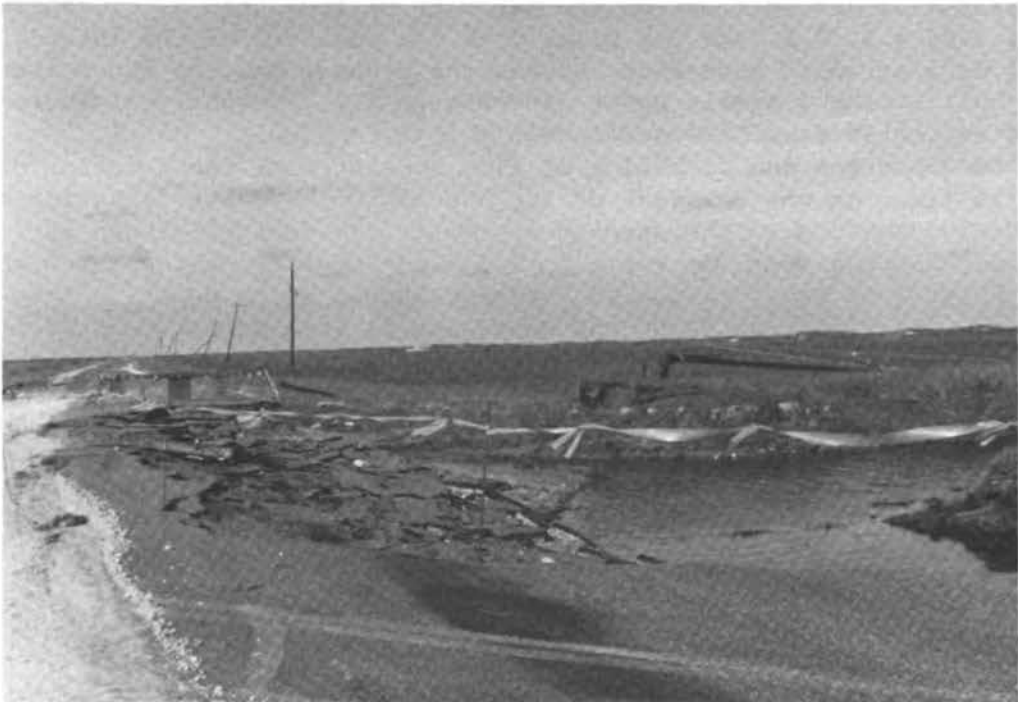
Evidence for the direction of flow consisted of the location of debris lines on the bay side of the dunes and the characteristics of several cuts through the dunes and body of the island between the highway and the Gulf. These cuts appeared to start at the beach when the water from the bays poured seaward through a low point in the dunes. Sand from the beach and dunes was flushed seaward and carried away by the currents and turbulence in the surf zone. As this process continued, the channel was cut further and further inland. Most of the cuts ended seaward of or at the highway. However, one cut extended completely through the highway, and other cuts ended in the highway pavement (see Figures 5.1-5.3). Figure 3.8 shows the landward end of one cut, and Figure 3.9 shows the extent of the breach made through the backbeach dunes.

FIGURE 3.8 Washout channel looking south toward the Gulf about 7 miles west of San Luis Pass on Follets Island.

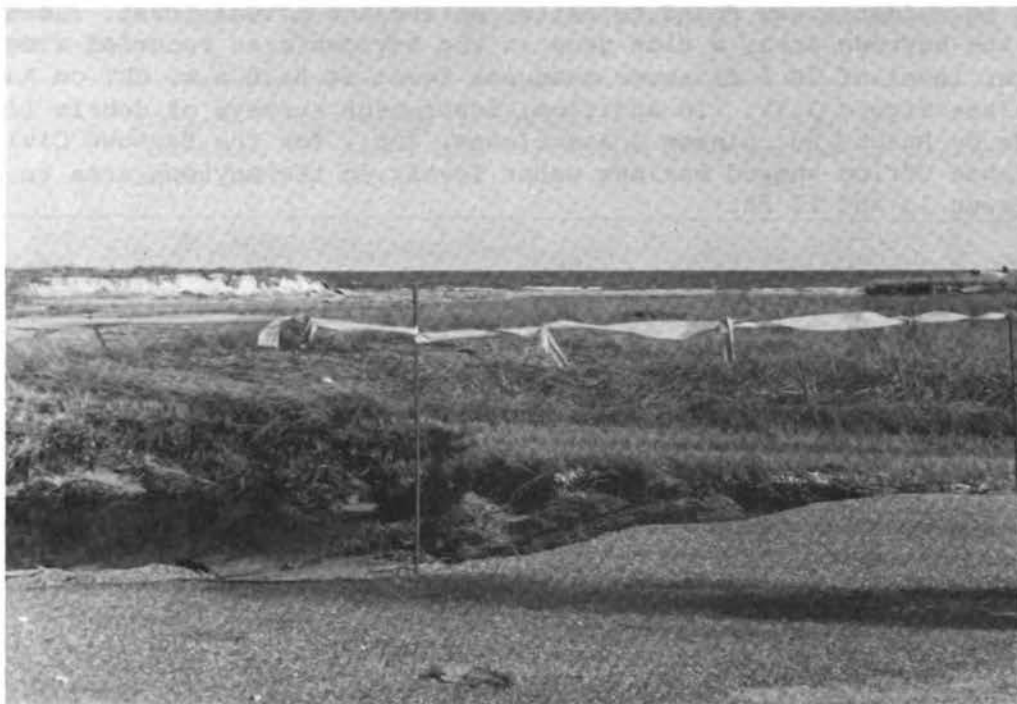
FIGURE 3.9 Portion of the channel shown in Figure 3.8 looking toward the Gulf. Note dune erosion in the vicinity of the beach.

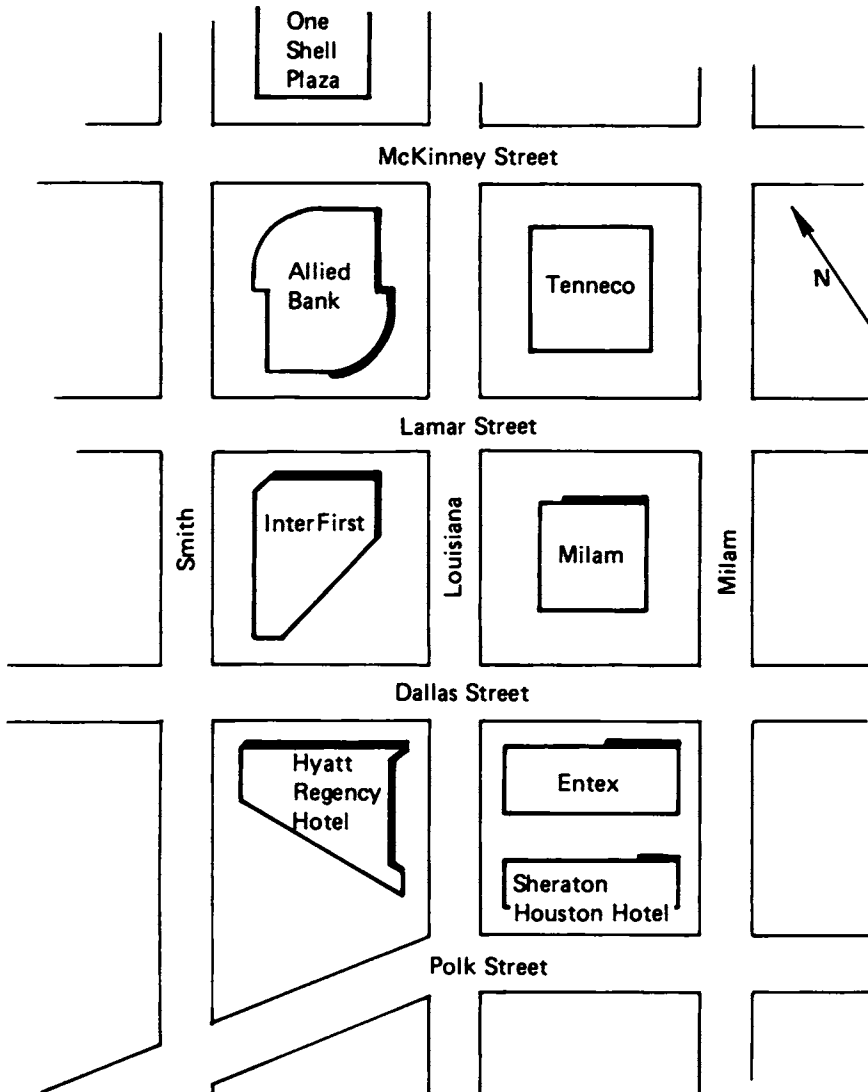
The area of the Houston central business district in which substantial windowpane and glass cladding breakage occurred is bounded by McKinney Street on the northeast, Polk Street on the southwest, and Smith and Milam streets on the northwest and southeast respectively (Figure 4.1). The high-rise buildings in this area are the Allied Bank Plaza, the InterFirst Plaza, the Hyatt Regency Hotel, the Tenneco, Milam, and Entex

FIGURE 4.1 Areas of extensive glass breakage, indicated by bold lines, in the Houston central business district.

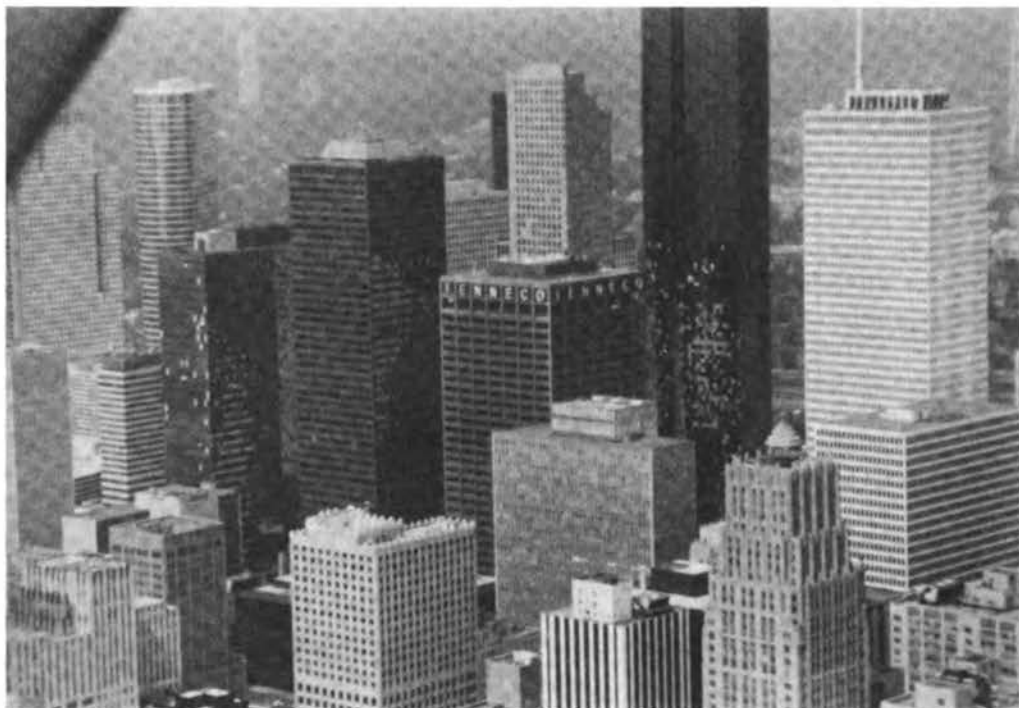
buildings, and the Sheraton-Houston Hotel. All are fully engineered buildings. Figure 4.2 is an aerial photograph of this block. There was substantial glass breakage on at least one face of all these buildings except the Tenneco Building. Faces with regions of intense glass breakage are identified in Figure 4.1 by bold lines. Damage to these buildings is described in the following sections.

FIGURE 4.2 General view of the Houston central business district toward the west.

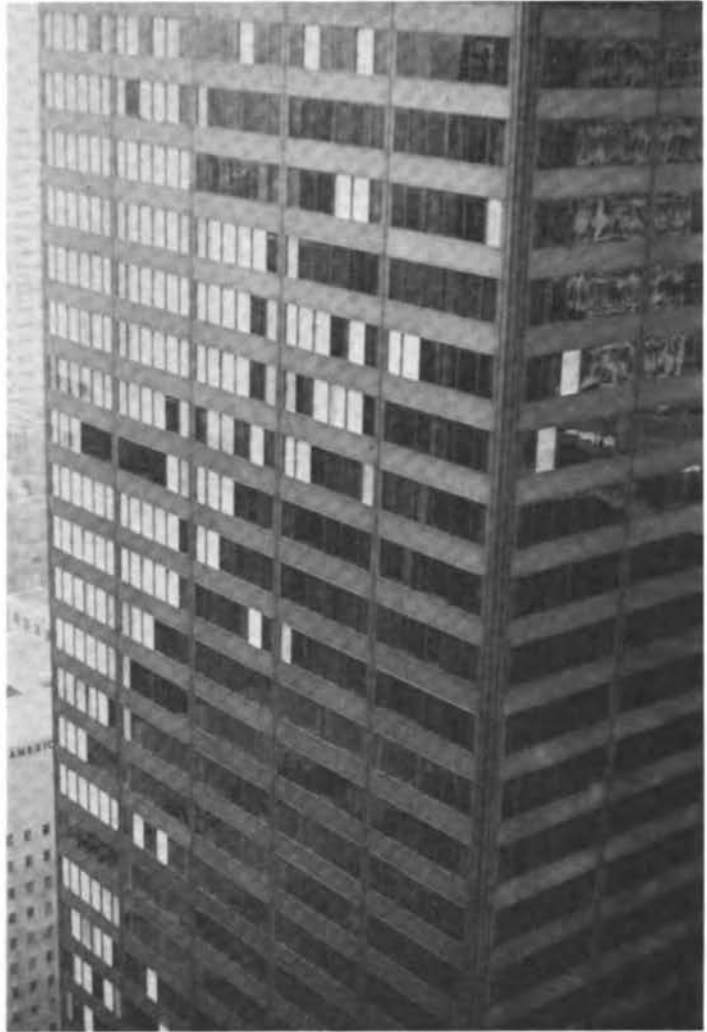
Breakage on the Milam building was concentrated on the northeast face around the level of the top of the Tenneco Building. Figure 4.8 shows

FIGURE 4.8 Closeup of glass damage to the Milam Building.

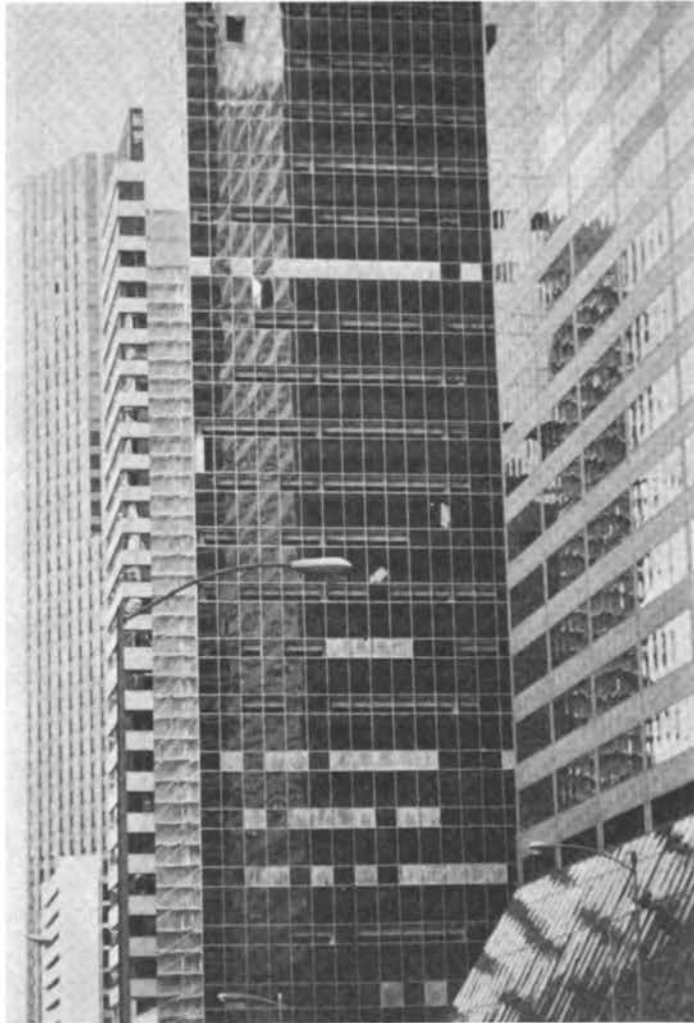
There was general glass breakage on the Entex Building, but damage was concentrated along the east corner of the northeast face (Figure 4.9). The breakage was more prevalent in the tempered spandrel glass. It should be noted that this building has a history of occasionally losing a glass panel.

FIGURE 4.9 Glass damage to the northeast face of the Entex Building.

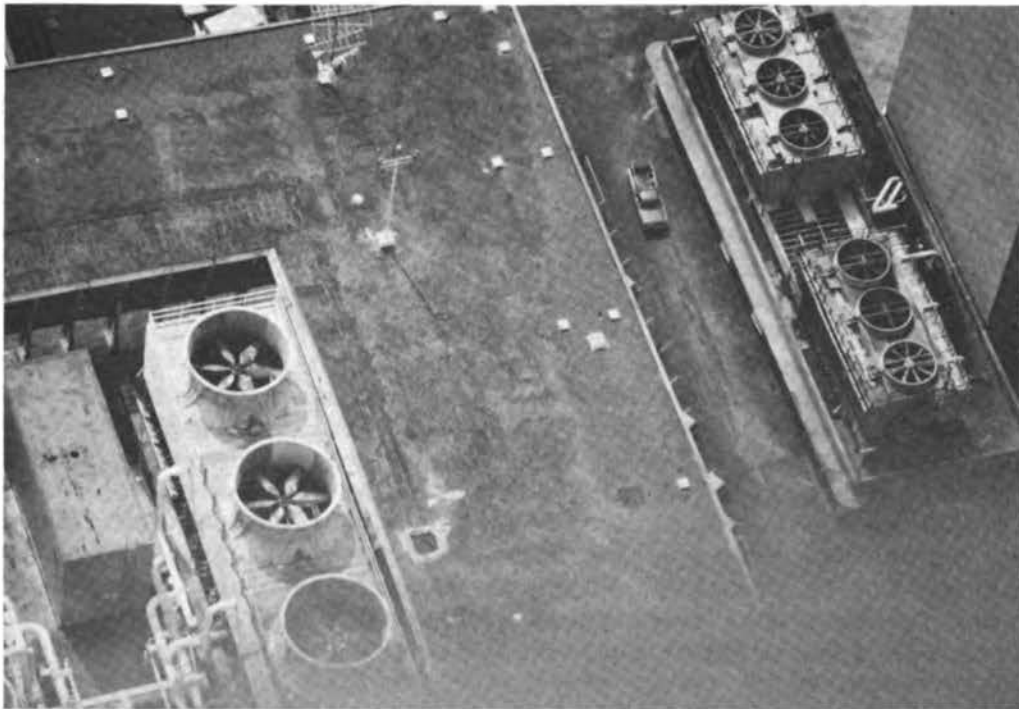
In view of the above-mentioned regions and their vulnerability to missile damage, there is substantial evidence that missile impact had a significant role in the glass breakage in the central business district. Both the InterFirst and Allied towers had no glass damage above the height of the Tenneco Building, except a few panels. This reaffirms that the windowpanes in the top zone, designed on the basis of extreme design winds and wind tunnel pressure measurements, performed satisfactorily. Most of the glass breakage on the Allied and InterFirst towers was in the lower and middle zones. The Tenneco and Entex buildings have built-up roofs with mechanical penthouses that might have been major sources of missiles, including roof gravel, ripped sections of sheet metal, chunks of tar, and other materials. On these roofs, gravel is mixed with asphalt for several reasons; it is also a cheap and efficient ballast for roofing insulation. The potential hazard of significant quantities of loose gravel on roofs during strong winds should not be overlooked (Minor et al., 1978), regardless of recent advances in roof design methods. Figures 4.11 and 4.12 show a general view of the roofs of the Tenneco and Entex buildings. The scour pattern on the Tenneco roof indicates southerly winds, which were prevalent during the latter part of the morning as the eye of the storm passed to the west of the central business district.

FIGURE 4.11 General view of the roof of the Tenneco Building.

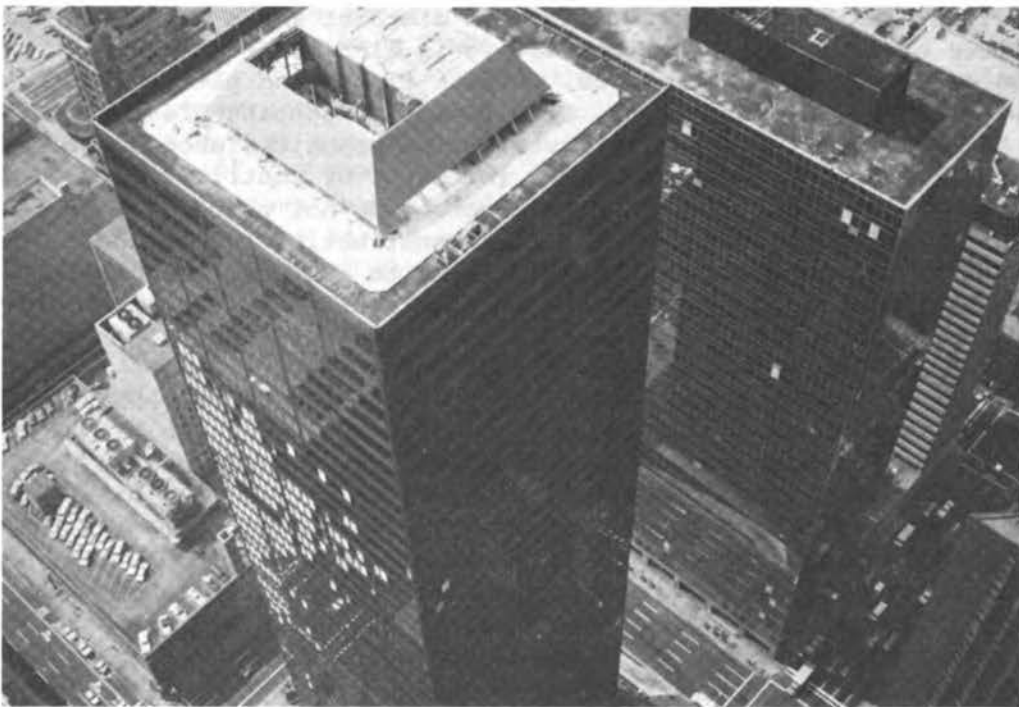
FIGURE 4.12 General view of the roofs of the Milam and Entex buildings.

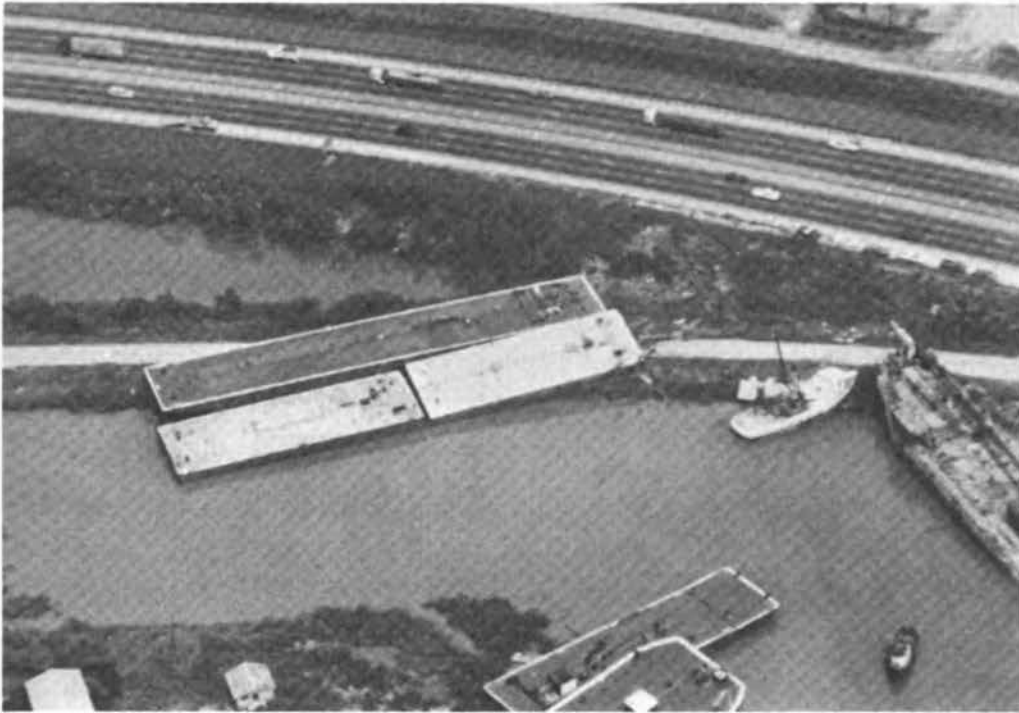
Destruction of boats in the Houston Yacht Club marina was almost total as Hurricane Alicia ripped through the area and piled boats on top of each other. Boats moored in individual docking bays were picked up and hurled about by winds and surge. Some large barges in the Houston ship channel got loose as well during the storm, resulting in damage to dock facilities (Figure 4.17). Some of the oil storage tanks near the Houston ship channel were floated from their original locations by high water (Figure 4.18).

FIGURE 4.17 Barges and a tanker in the Houston ship channel area.

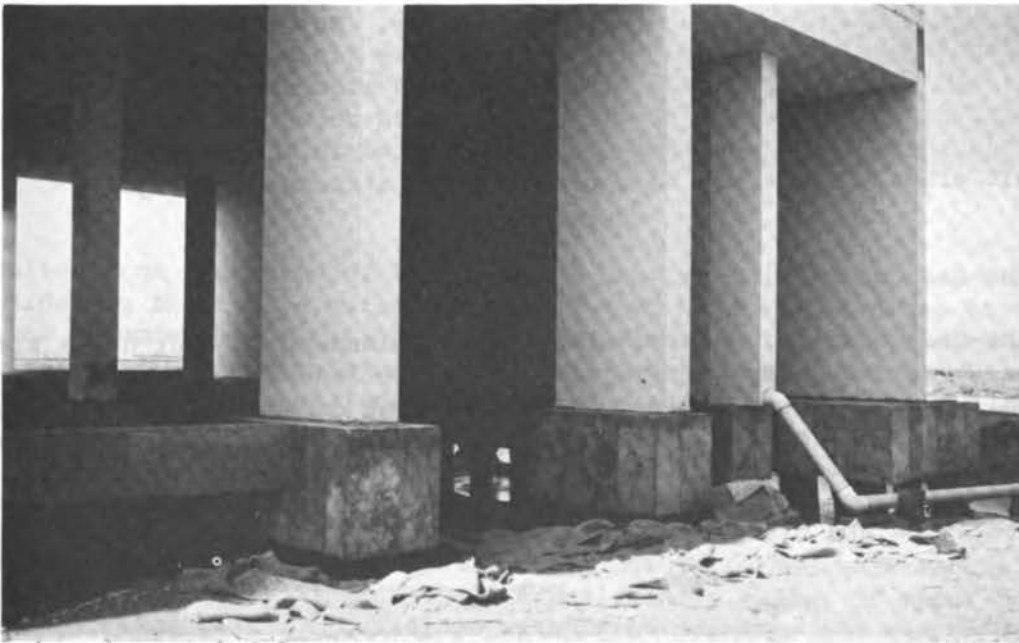
The Galvestonian is a very large high-rise condominium, crescent-shaped in plan, under construction next to the Islanders Inn on East Beach (Figure 4.19). It bore the brunt of winds, waves, and flooding directly from the Gulf. The facade of the building experienced minor damage, and extensive erosion occurred around its foundation. However, the structural integrity of the foundation was not affected (Figure 4.20). The reinforced concrete structural system performed satisfactorily.

FIGURE 4.20 Erosion around the foundation of the Galvestonian.

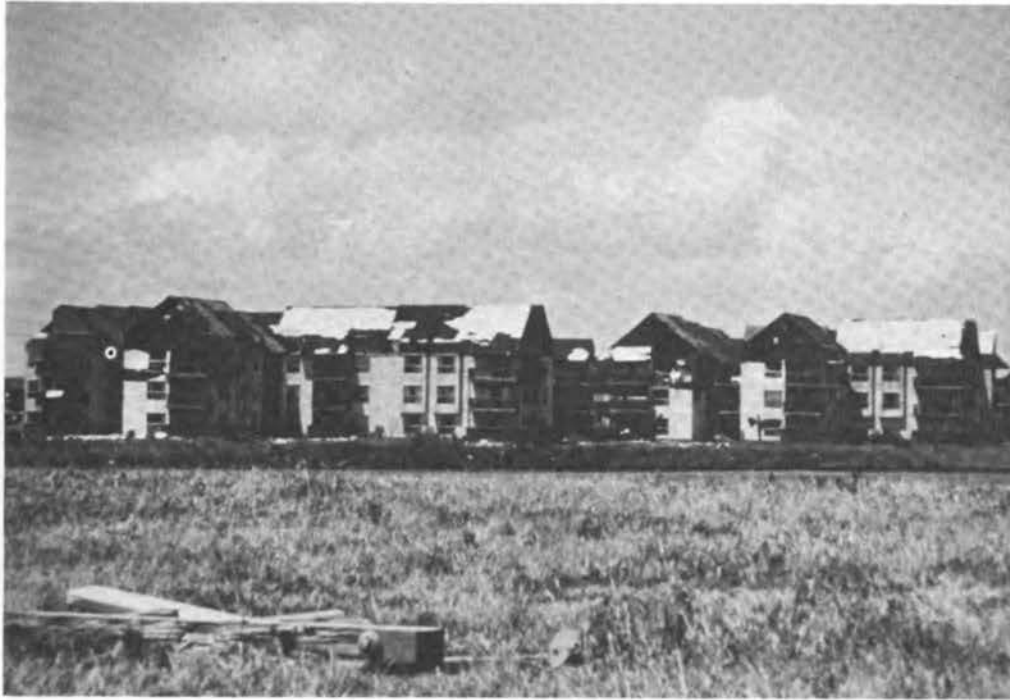
Single- and multiple-family dwellings and small commercial units such as convenience stores, which generally receive no engineering attention, usually experience the heaviest overall damage during wind storms. Alicia was no exception. The hurricane ripped off the roofs and top floors of some buildings while merely taking a few shingles from others. Heavy rains contributed to water damage as homes left with gaping holes and collapsed walls were drenched by the downpour. Single-family dwellings near the water were extensively damaged along

FIGURE 4.32 Roof damage to apartments near the seawall.

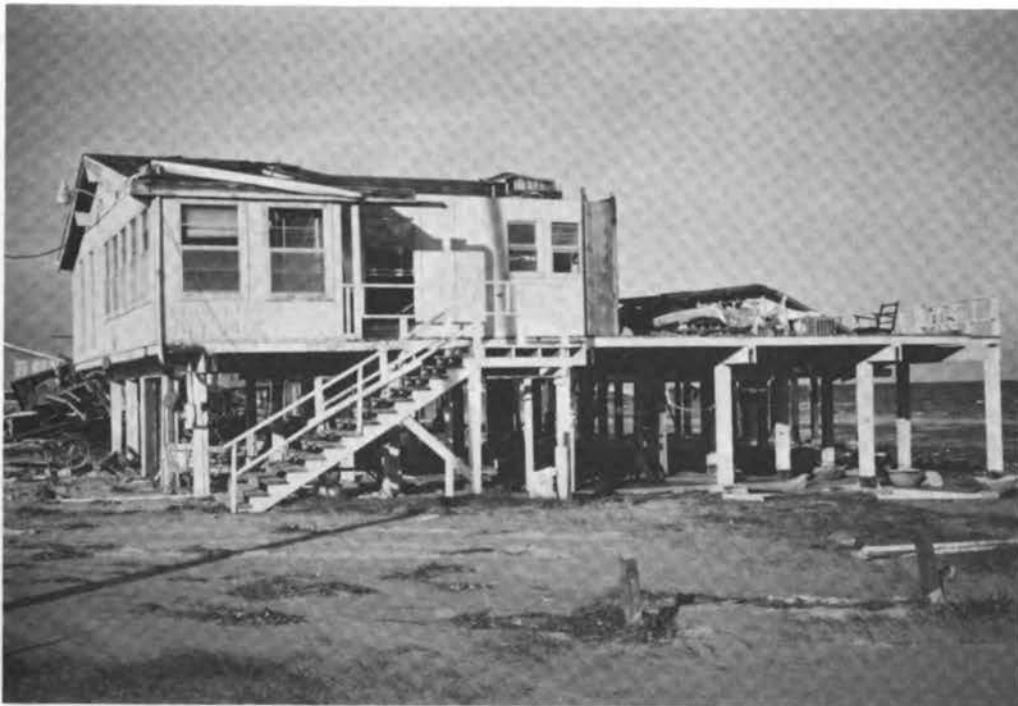
The seafront side of the house in Figure 4.42 was totally destroyed due to wind. The partial survival of the landward portion was perhaps a result of the large size of the house and its number of interior walls. These could have stiffened the structure and kept the leeward portion from blowing away. The house next door was a complete disaster. The foundation slab was partially washed away, and the rest of the foundation was exposed due to erosion and wave action. This did not have any bearing on the overall catastrophic failure of the house (Figure 4.43). The connections of the studs to the base and top plates and the roof to the top plate were poor, with no hurricane anchors. Figure 4.44 shows the details of some of the connections and corroded nails in studs.

FIGURE 4.42 Typical example of partial collapse of a large house in Terramar Beach.

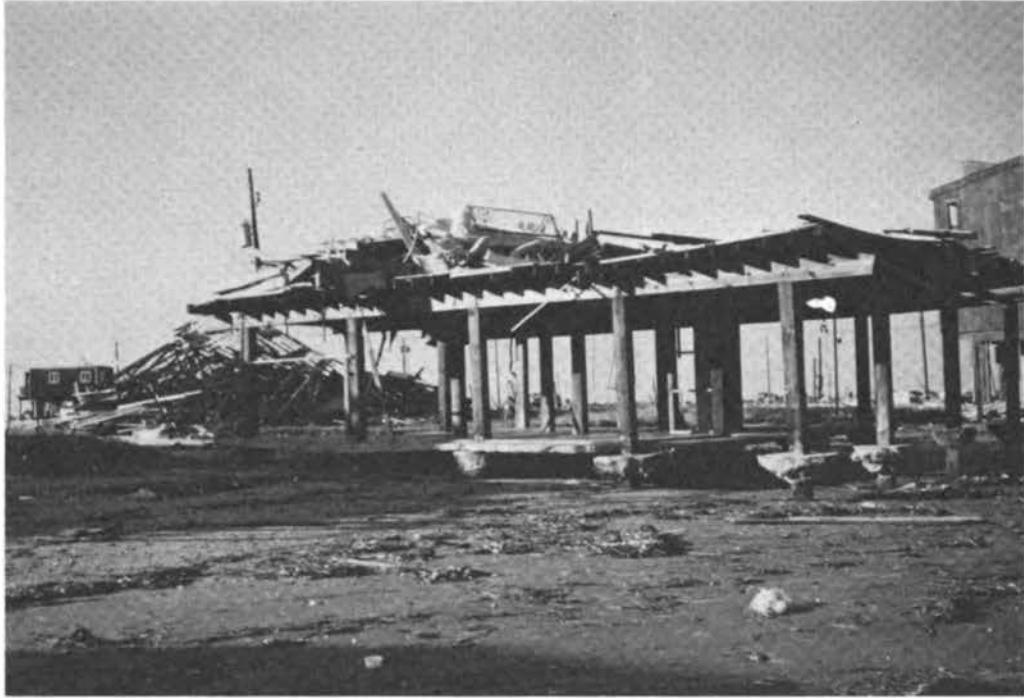
FIGURE 4.43 Example of a superstructure blown away by the wind. A mound of lumber, furniture, and appliances is in the backyard of the house.

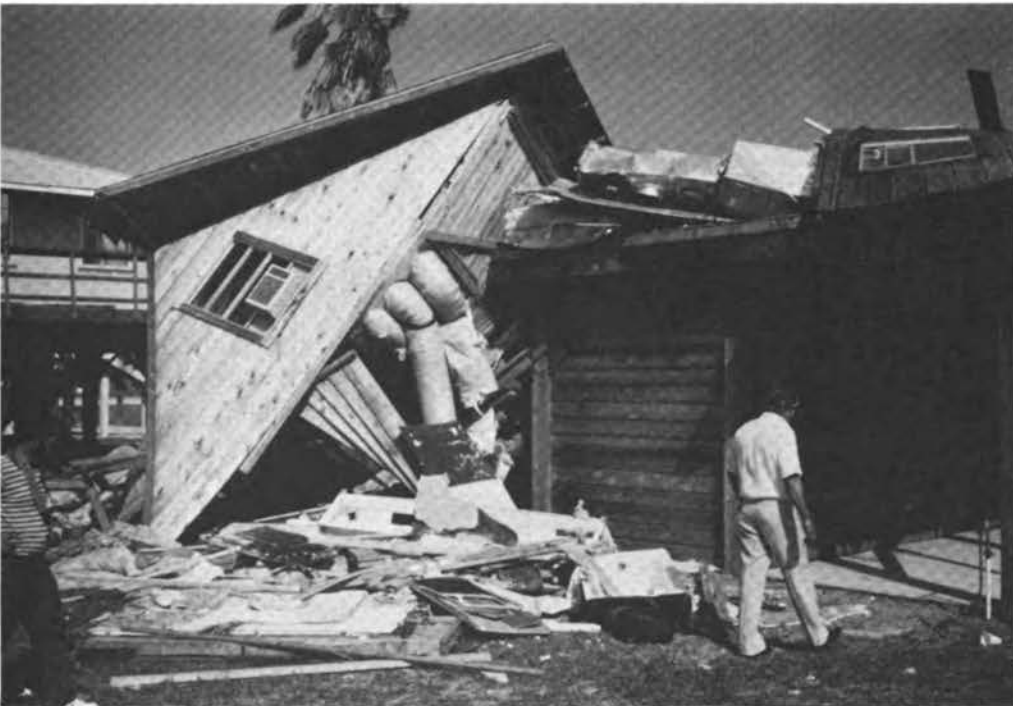
Figures 4.45 to 4.48 exemplify some of the damage in Sea Isle. Figure 4.45 shows an oceanfront house that lost a good portion of its superstructure to wind forces. The extent of damage decreased for houses inside the subdivision (Figure 4.46), which experienced lesser wind speeds because of being sheltered. Figure 4.47 shows part of a roof lying on the ground. There were hurricane clips, but they did not extend to the wall studs and the end plate was dislodged from the wall system. On the bay side of the subdivision, a house had lost its second story completely (Figure 4.48) due to poor linkage between subsystems.

FIGURE 4.48 Typical example of poor connections between sub-systems.

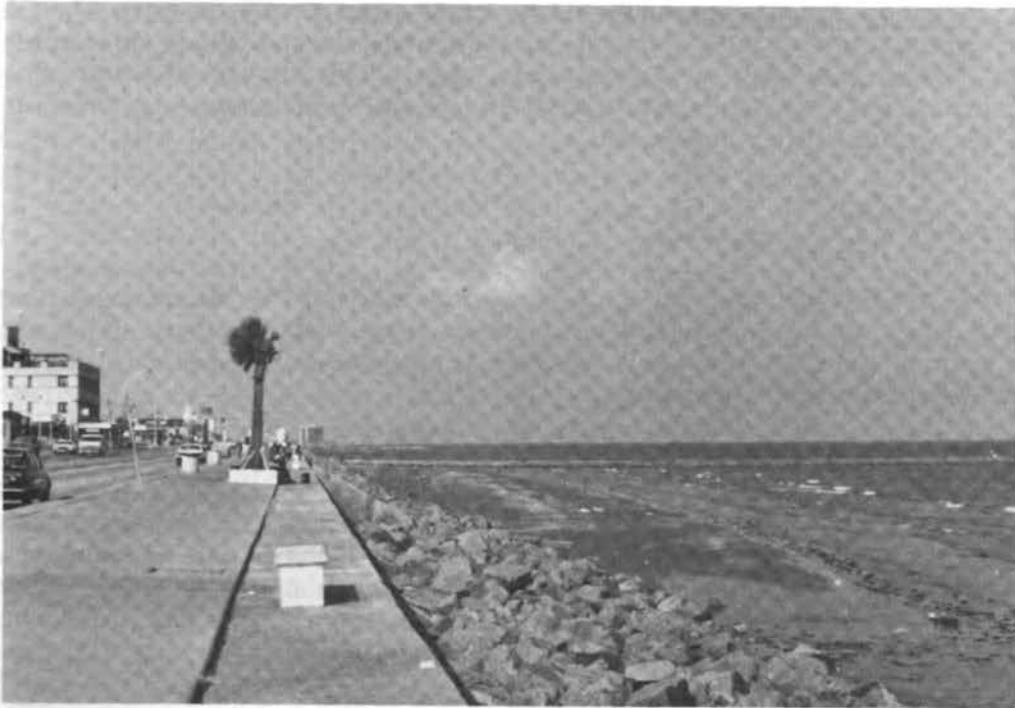
Visual inspection of all of the major coastal structures in the area showed only minor damage to any structure, except in the case of one or two groins in front of the seawall (Figure 4.55). These groins were built using chunks of concrete pavement apparently salvaged from the breakup of unwanted paved areas. Groin damage occurred in the immediate vicinity of the beach and did not affect the functional capacity of the structures. The seawall and other groins (Figure 4.56) sustained no damage visible from the seawall. No damage was observed at the Texas City hurricane protection project, and no damage was reported at either the Texas City or the Freeport hurricane protection projects. The study team observed minor damage to a concrete slab revetment at Seabrook during its ground survey. There were also reports of damage to other small private structures around Galveston Bay and along the front of Galveston Island west of the seawall.

FIGURE 4.56 Galveston seawall and groin.

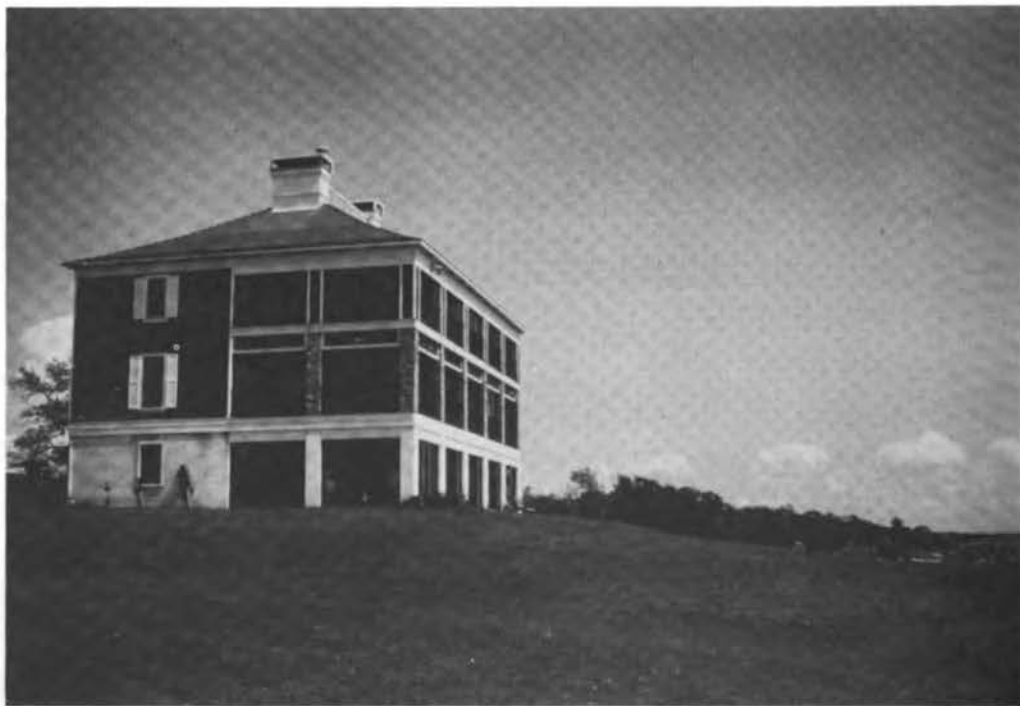
A number of houses in Seabrook lost part or all of their walls or roofs. The damage pattern again suggested that failure was initiated by the storm surge. In Figure 4.58 a house fronting the bay lost its wall system due to wave action, which led to the collapse of the roof system. The three-story structure in Figure 4.59, perhaps marginally engineered, lost a brick veneer wall that was not properly anchored, and a combination of storm surge and wind action caused heavy damage. Figure 4.60 shows a closeup of a slab with anchor bolts. Obviously the house was uplifted due to poor connections. A view of the ground-level enclosure of a bayfront house shows damage due to storm surge (Figure 4.61). Once the enclosure lost one side, winds tore apart the interior of the house. The house on top did receive minor damage from high winds. A mansion in Seabrook, on top of a hill, survived the fury of Alicia (Figure 4.62). The mansion did not experience any storm surge effects and there was no evidence of wind damage.

FIGURE 4.62 This mansion survived the storm very well.

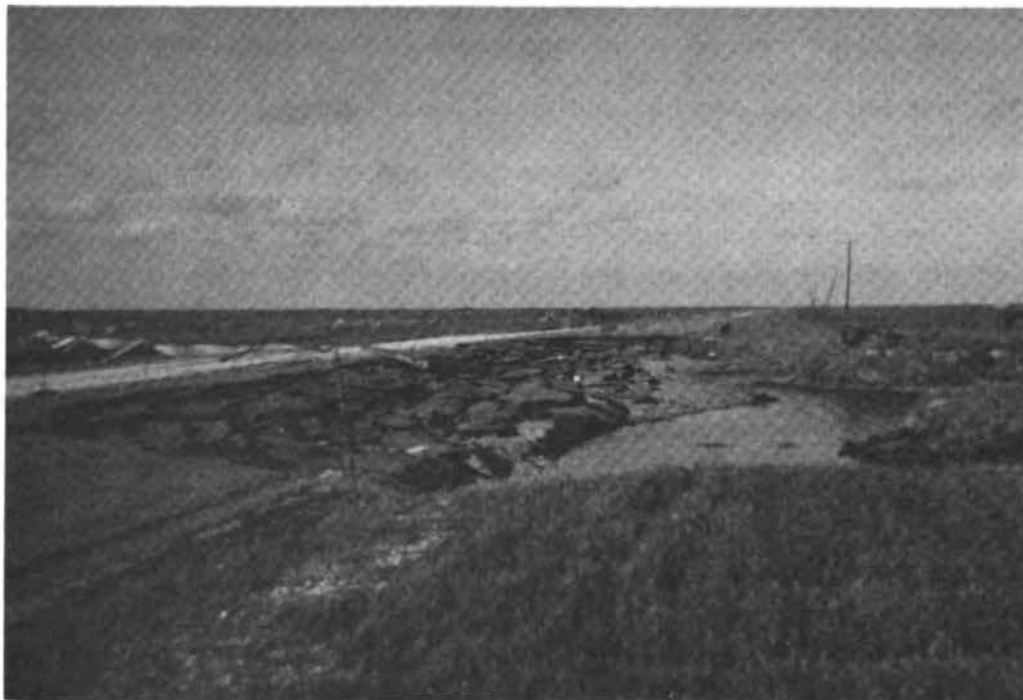
The storm did not cut any highways, but some roadbeds were undercut on the main highway on Follets Island (see Figures 5.1-5.3). This undercutting occurred when the high water that ponded behind the island flowed into the Gulf. In one case, the undercutting extended through

FIGURE 5.2 Typical undercut of roadbed on San Luis Pass Road, Follets Island.

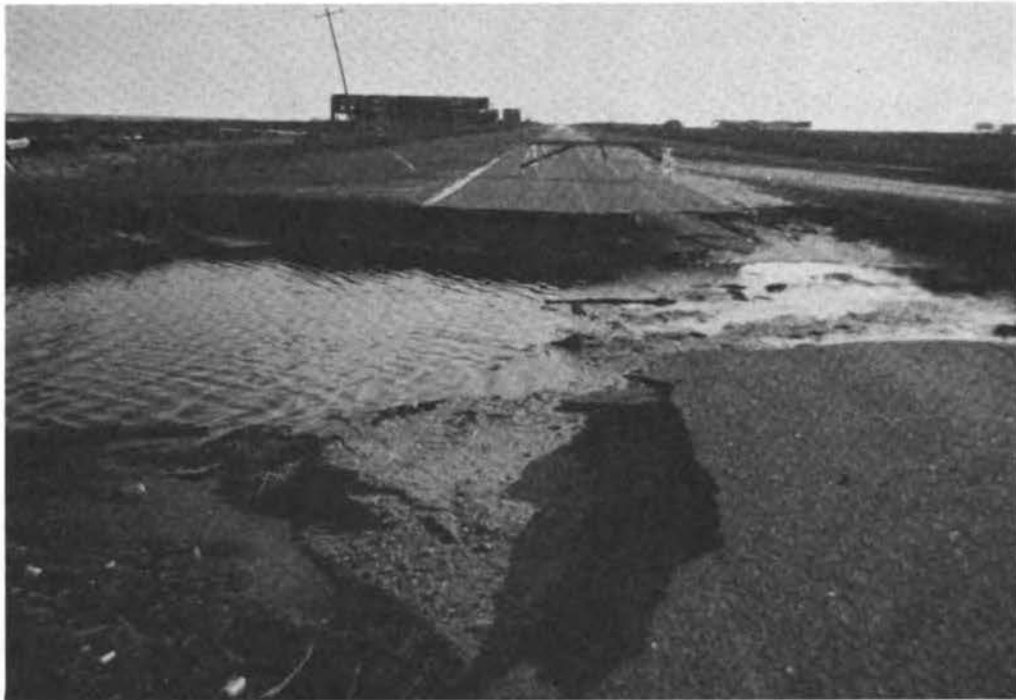
FIGURE 5.3 Total washout of shoulder and road on San Luis Pass Road, Follets Island.

the highway pavement but not through the road shoulder. This allowed traffic to bypass the cut on the shoulder. Trees and debris also blocked some highways temporarily.
