Heat-Straightening Repair of Damaged Steel Bridge Girders: Fatigue and Fracture Performance

NCHRP REPORT 604

**Heat-Straightening Repair of
Damaged Steel Bridge Girders:
Fatigue and Fracture Performance**

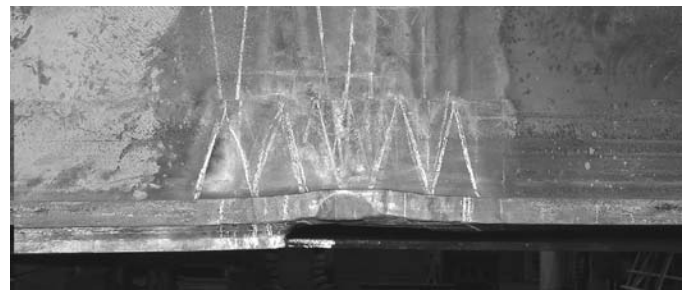
Figure 2.4. Induced camber due to heat straightening on Specimen 1D/R-1.

During the heat-straightening process, clamps were used to ensure stability of the beam in the fixture so it could not roll over as the repair progressed. Due to the lack of dead load restricting the upward movement and the restraint of the clamps, the beam developed camber, resulting in minor localized bending of the bottom flange in addition to that caused by the impact, as shown in Figure 2.4. Full-depth vee heats on the flange to remove the sweep from the damage caused member shortening, also contributing to the camber. No further repairs were made, and this bending was considered to be damage that was not fully repaired. The repaired damage was within the tolerance limits listed in the FHWA manual. As verified through FE analysis and instrumentation installed on the specimen, this global camber had no effect on the fatigue stress range at the details of interest. To mitigate this problem on subsequent repairs, new supports were made to allow the specimen to be free to move, yet remain stable in the heat-straightening fixture.

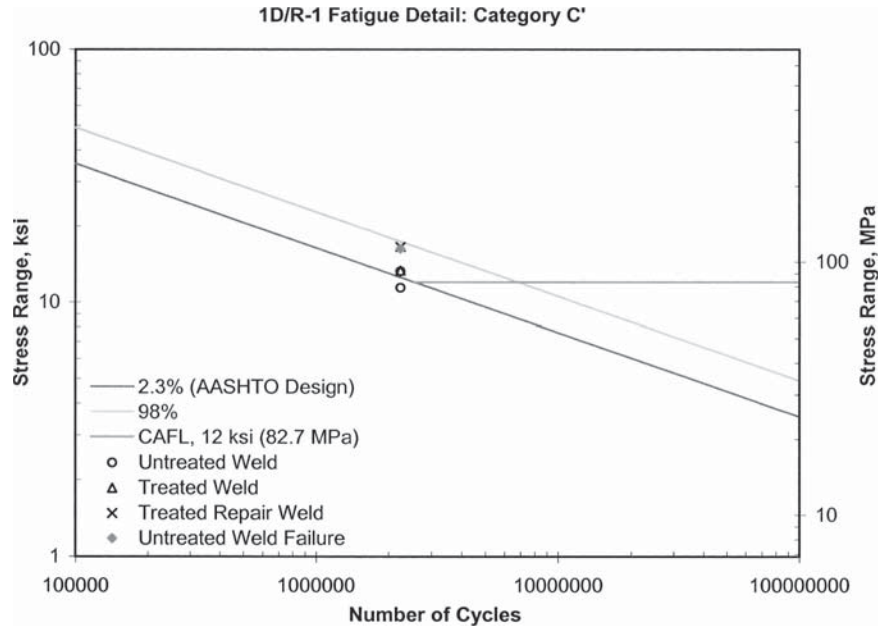
Figure 2.5. Specimen 1D/R-2 fatigue test results—Category C'.

After repairs were complete, the specimen was cyclically loaded at a constant amplitude for 2.242 million cycles. The test ended when a crack formed at Stiffener 2, severing 90% of the flange and extending up 6 in. (152 mm) into the web. The failure occurred at roughly 183,233 cycles past the mean value of fatigue life at a stress range of 16.3 ksi (112.4 MPa). This data point, shown as a solid diamond in Figure 2.5, along with the remaining data that did not crack are presented on a

stress-cycle (SN) curve for the particular detail category along with the CAFL, the 2.3% probability of failure AASHTO design curve, and the 98% probability of failure curve. Note that because of the cracking that occurred on the specimen prior to fatigue testing, some of the data include “treated” weld toes. (In this case, treated means the welds were either ground to remove small cracks at the weld toe or repaired.) The tabulated results of the fatigue tests can be found in Appendix B. Simi-

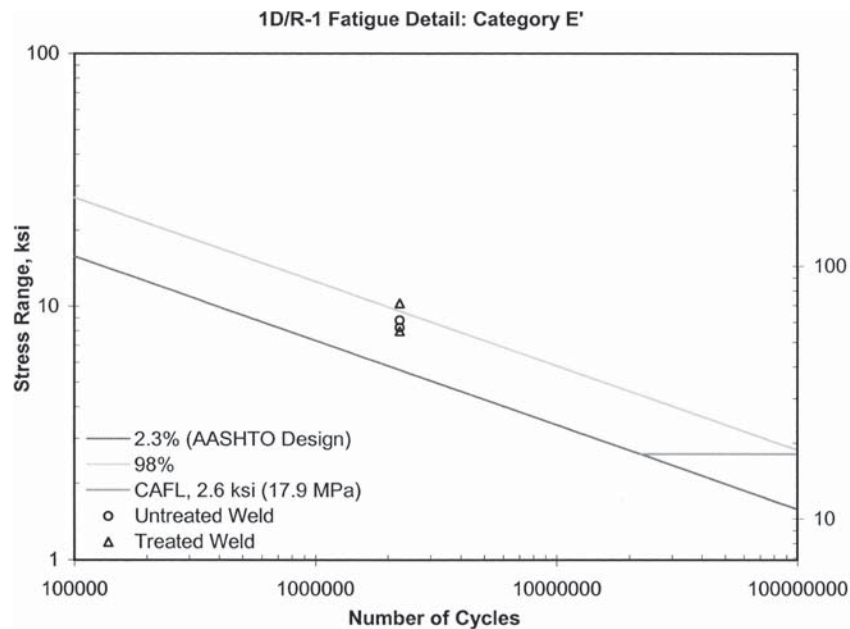
Figure 2.6. Specimen 1D/R-1 fatigue test results—Category E'.

larly, the data, none of which represent a failure, for the Category E' details is shown in Figure 2.6.

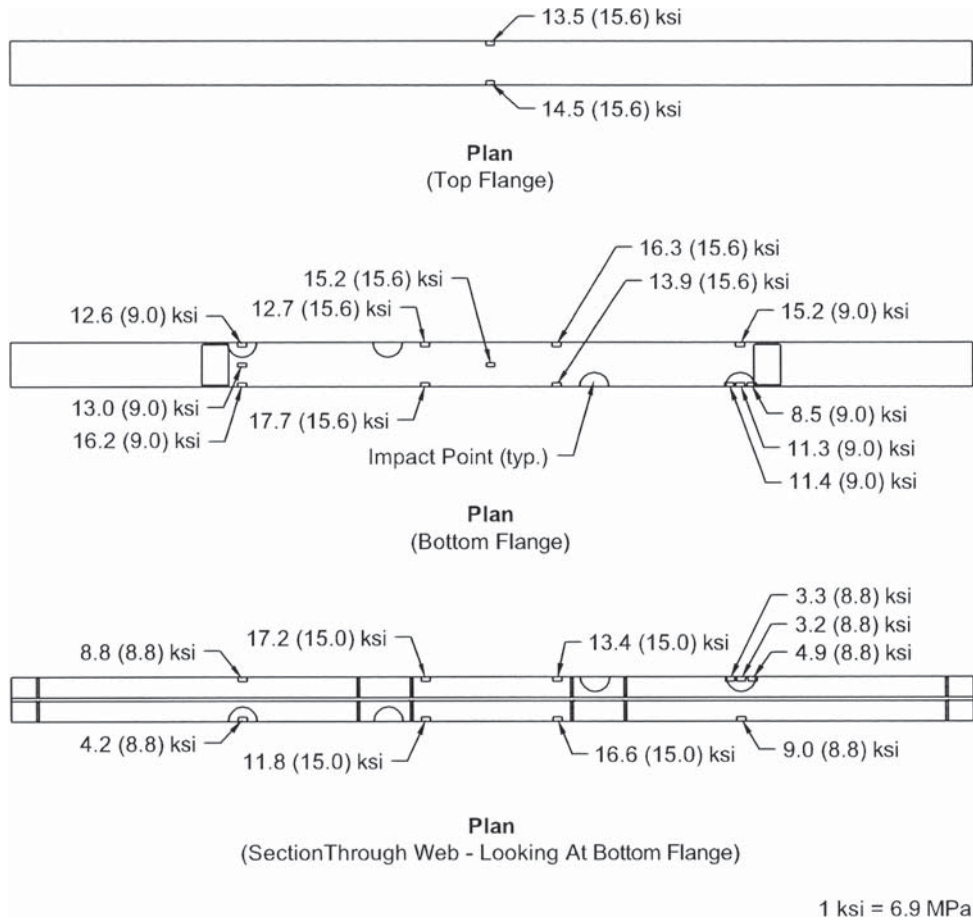
Figure 2.7. Stresses at detail locations under static load, Specimen 1D/R-2.

The distribution of measured stresses in the beam is presented in Figure 2.7. Also shown in parenthesis are the theo-

To compensate for the increase in stress at the flange attachments, a decision was made to divide the test into two separate phases, evaluating each of the details separately. The first fatigue test was used to test the flange attachments, Category E, at a stress range of 9 ksi (62.1 MPa). The stress range produced at the stiffeners, Category C' , was only 10.5 ksi (72.4 MPa), which is below the CAFL of 12 ksi (82.7 MPa) for these details. At this stress range, the C' details are considered to have infinite fatigue life and the cycles applied during the first half of the test should not produce any fatigue damage. This first test ran for 2.822 million cycles. At the end of the test, there was a noticeable crack, roughly 5 in. (127 mm) long, along the toe of the weld on flange attachment Detail 1. However this was not considered failure by traditional testing criteria developed in early fatigue testing conducted by Fisher, et al. (6). Failure is defined as a through thickness (of the flange) fracture that has severed about 75% of the flange area or has resulted in excessive deflection. There was also a small crack at the toe of the weld on flange attachment Detail 2 but again, nothing that constituted failure since the test exceeded the lower bound design curve. Nevertheless, these cracks would likely grow very quickly from this point forward. The data are shown in Figure 2.8.

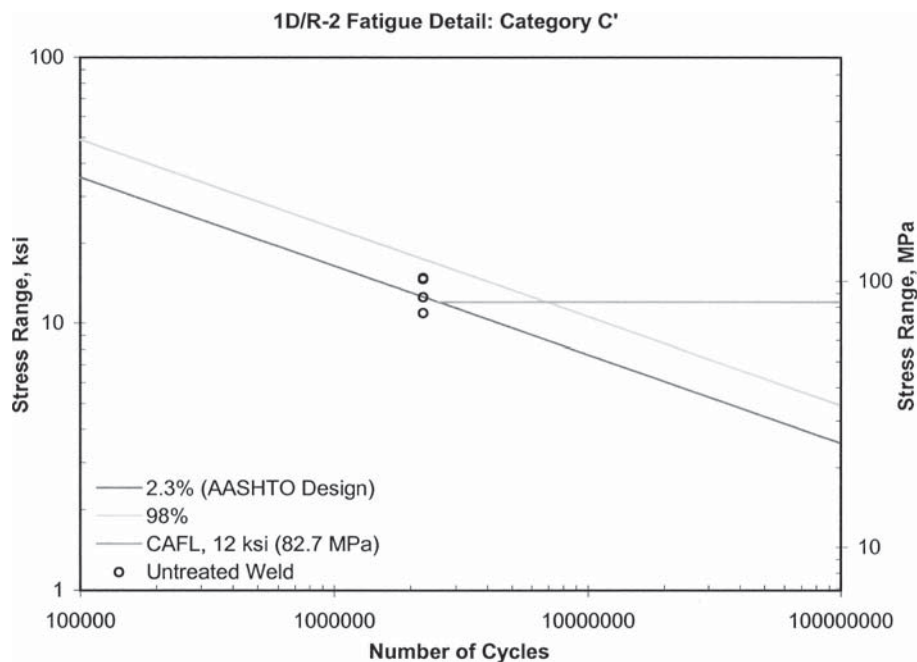
Figure 2.9. Specimen 1D/R-2 fatigue test results—Category C'.

that a crack formed at the toe of the weld at Stiffener 1 at a stress range of 14.8 ksi. This extended through the thickness of the flange but only severed about 15% of the flange area and was not considered a failure based on the criteria cited. Data are shown in Figure 2.9. The tabulated results for both fatigue tests can be found in Appendix B.

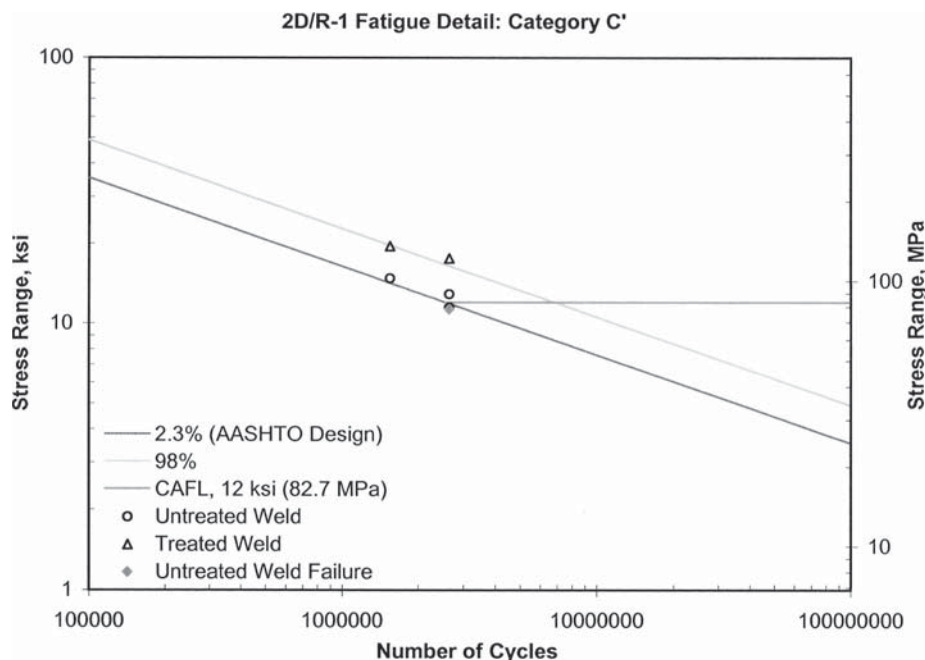
Figure 2.12. Specimen 2D/R-1 fatigue test results—Category C'.

The fatigue testing of this specimen ended prematurely due to a crack that formed at the repair weld near Stiffener 1 severing 100% of the flange. This occurred after 1.542 million cycles. Note that this crack was not at the weld toe of the stiffener, the fatigue detail that was a focus of the test. In order to test the other details, the lower portions of Stiffener 1 on both sides of the web were removed and splice plates were attached to continue fatigue testing. This procedure is often used in fatigue testing. Once the beam was repaired, the testing resumed. Testing was terminated after a total of 2.644 million cycles were applied and transverse Stiffener 2 failed due to a crack severing 100% of the flange and extending up three-quarters of the web. This occurred at a stress range of 11.3 ksi (77.9 MPa), below the CAFL of this detail, but considered to be within normal scatter of the available database for this detail. This, along with the other Category C' data, are shown on the SN curve in Figure 2.12. Figure 2.13 presents the results for the Category E' details that were tested.

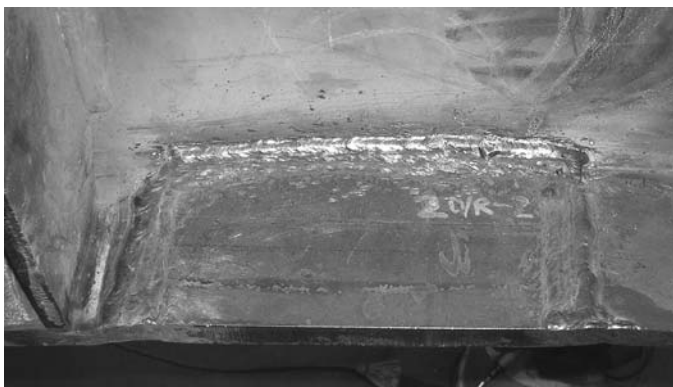
Figure 2.15. Repair of brittle fracture near Stiffener 1, Specimen 2D/R-2.

As a result of this brittle fracture (the crack that formed at the flange attachments and the hairline fractures on this specimen), an evaluation of the restraining forces was made prior to completing the repair. Instrumentation of a localized damage area and an FE analysis of this specimen were conducted to determine the cause of the cracking. It was determined that the hairline fractures discovered on Specimens 1D/R-1, 1D/R-2, and 2D/R-1 were due to unanticipated high tensile stresses in the area of the localized damage caused by the hor-

izontal restraining forces used to remove the induced sweep from the specimen.

Figure 2.14 shows fractures that consisted of a crack on the underside of the flange at the center of the localized damage as well as on the top of the flange around the localized damage perimeter. Holes were drilled to prevent further propagation of the cracks and the area was successfully heat-straightened. A 5 in. (127 mm) by 10 in. (254 mm) portion of the flange was removed and extra plate material that was supplied by the fabricator was used to replace this area with a welded repair, as shown in Figure 2.15. Although this repair would not be recommended in the field, the original remaining stiffener welds still provided data for this detail.

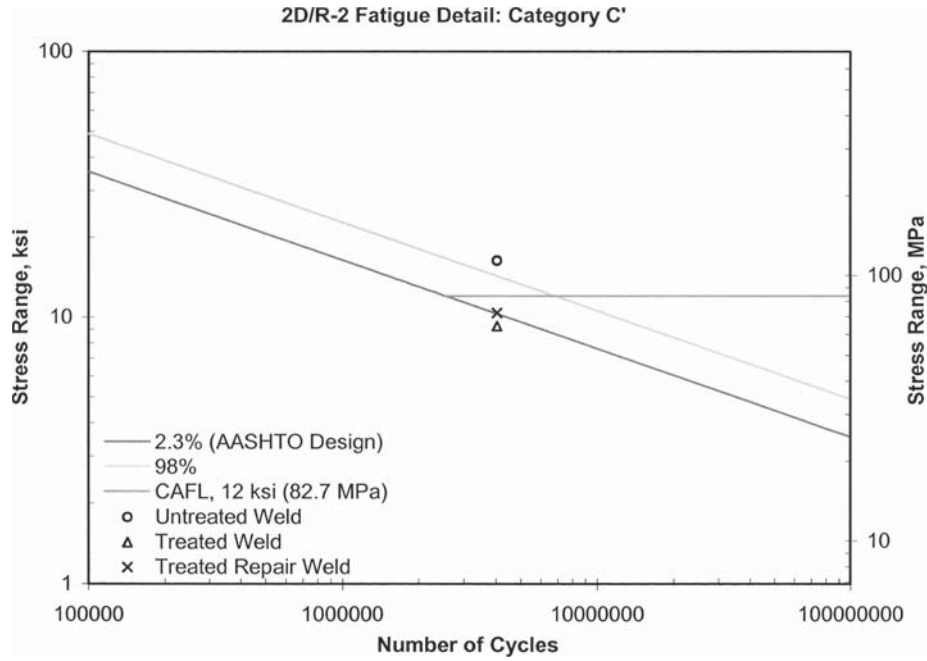
Figure 2.16. Specimen 2D/R-2 fatigue test results—Category C'.

The fatigue test ran for 4.049 million cycles and was terminated due to a crack at a repair weld made near Stiffener 1 that severed 100% of the flange and extended up 12 in. (305 mm) into the web. This failure was not at a detail that was being investigated, and because the testing of the details was roughly at or past the mean fatigue life, the testing was stopped. The results of the Category C' details are shown in Figure 2.16. In addition, the results of the Category E details are shown in Figure 2.17.

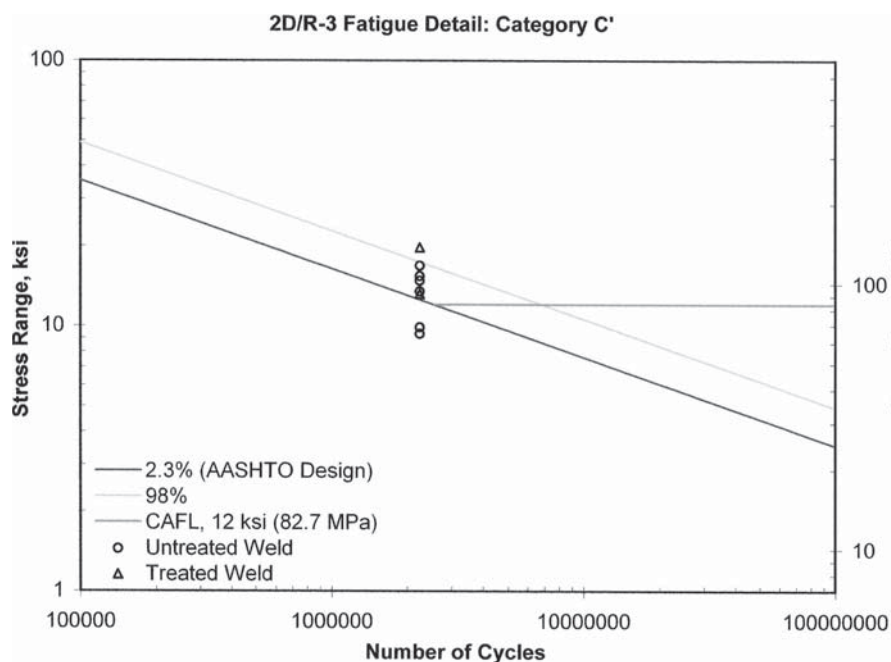
Figure 2.18. Specimen 2D/R-3 fatigue test results—Category C'.

The fatigue testing was terminated after a total of 2.241 million. No failures were experienced on this specimen and the testing was stopped just past the mean life before cracking was observed, ensuring material was available from the critical locations for subsequent impacts and material property testing. Results of the testing are shown in Figure 2.18 and Figure 2.19 for the Category C' and Category E' details, respectively.

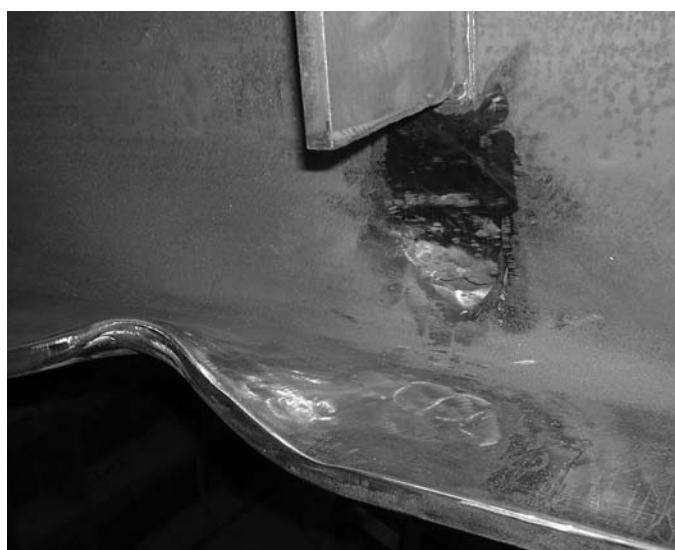
Figure 2.22. Portion of stiffener removed prior to heat-straightening repair.

formance of rolled beams. The fatigue details on this specimen were transverse stiffeners welded to the tension flange (Category C'). However, the test regime included removing a portion of the stiffener following each impact, completing the heat-straightening repair and replacing the removed portion of the stiffener with a welded replacement. This process was repeated three times with the portion being removed each D/R cycle. The summary of the damage imposed on this specimen is listed in Table 2.7.

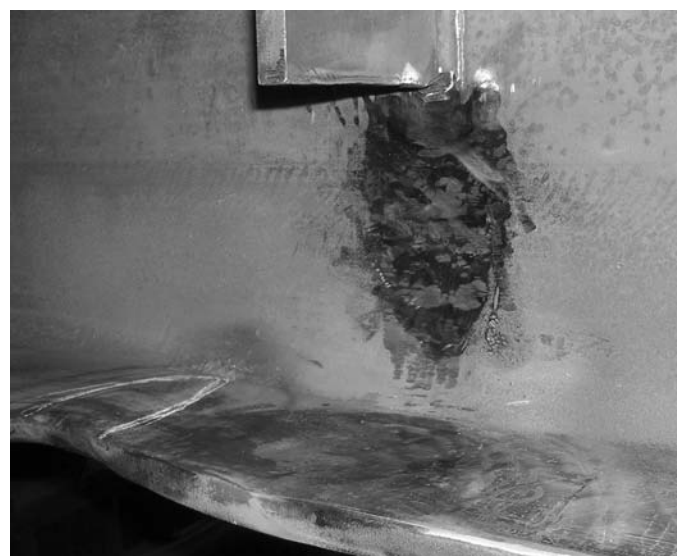
Figure 2.23. Completed heat-straightening repair at stiffener detail.

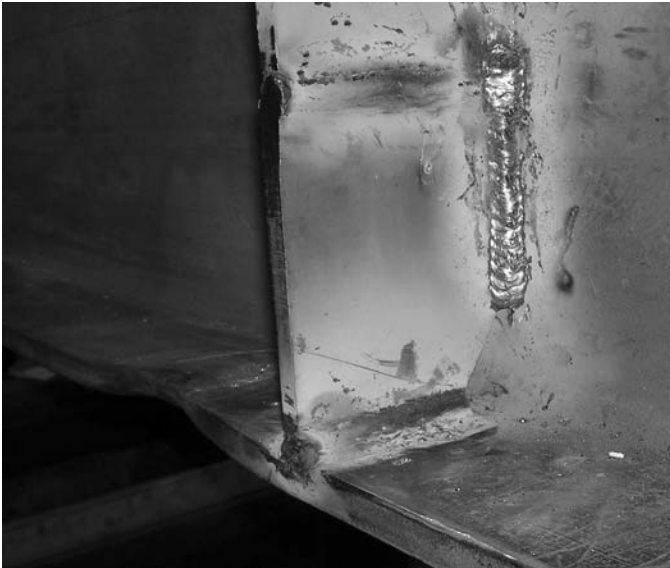
Figure 2.24. Portion of stiffener replaced using a welded repair following the heat-straightening repair.

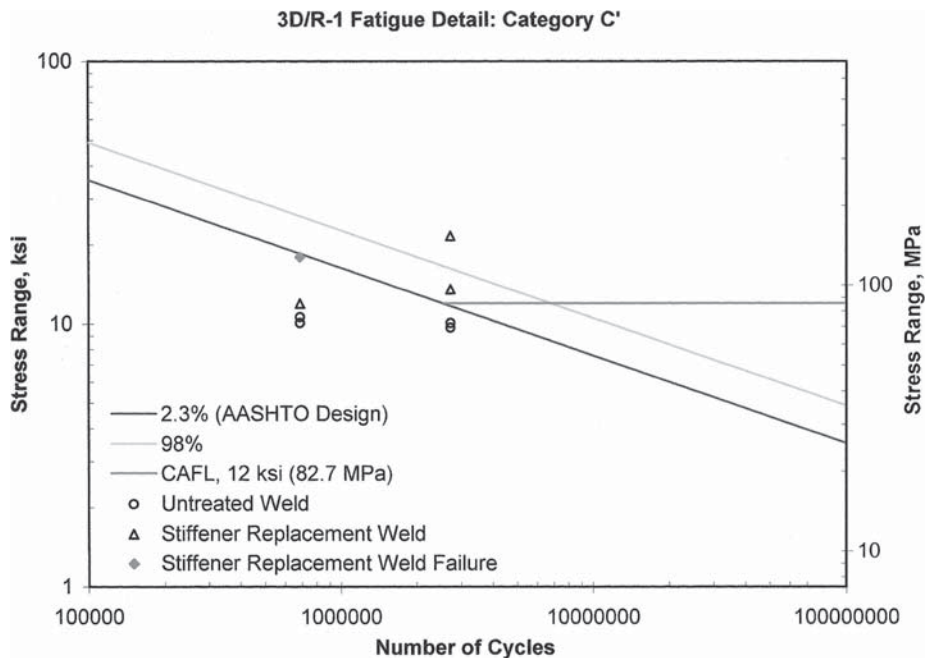
Figure 2.25. Specimen 3D/R-1 fatigue test results—Category C'.

The fatigue testing ran for 689,500 cycles until a crack formed at the flange weld toe adjacent to the impact point at Stiffener 2. The crack severed 90% of the flange and extended half way up the web. The low number of cycles would have terminated testing of Stiffener 1, so splice plates were added to complete the testing, similar to previous specimens that also formed cracks. The test ran for an additional 2.793 million cycles for a total of 3.429 million cycles at Stiffener 1

without the formation of a crack. These results are shown in Figure 2.25.

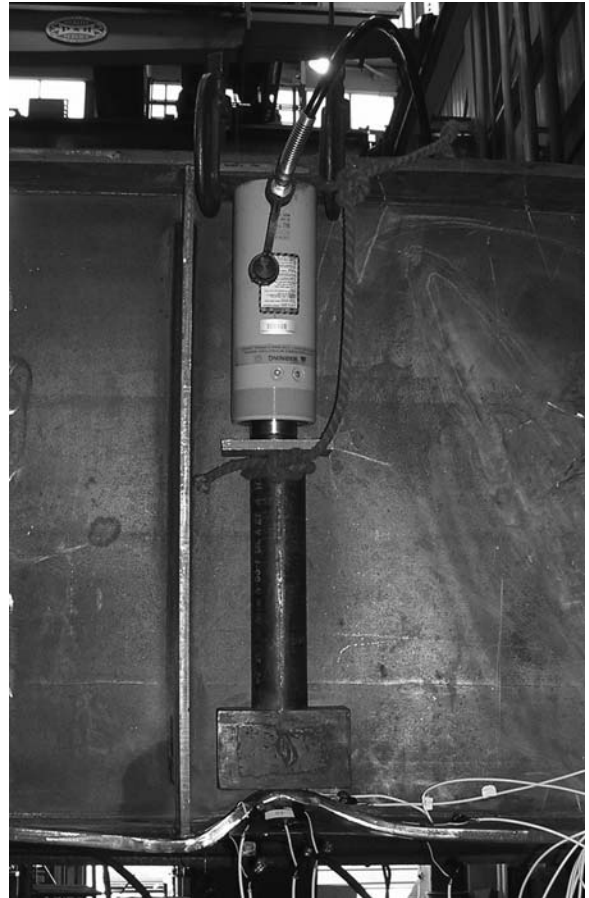
Figure 2.30. Vertical restraining force.

10.5 tons (3005 kN), and stress was recorded at each gage location for the increments. A maximum tensile stress of 12.6 ksi (86.9 MPa), 35% of the nominal yield stress, was measured on the underside of the flange at strain gage B4 with the 10.5 ton (3005 kN) load. Note that the instrumentation could not measure locked-in stresses, such as residual stresses present in the

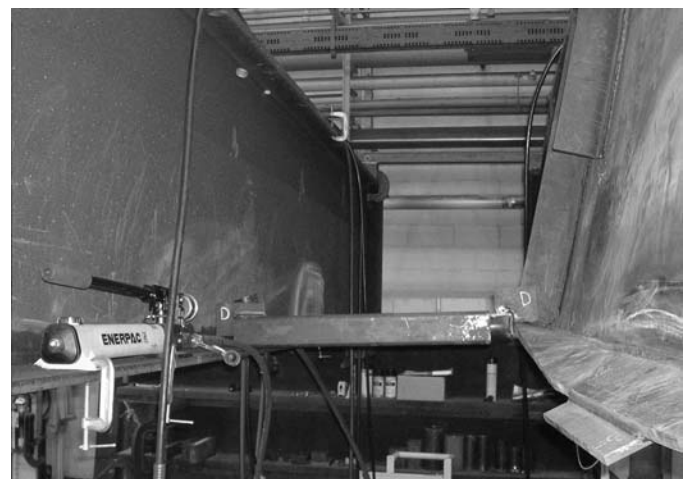
Figure 2.31. Horizontal restraining force.

Next, the horizontal load was applied separately in several increments while stresses were recorded at each increment. Surprisingly, at a restraining force of only 3 tons (859 kN), a stress of about 19.6 ksi (135.1 MPa) was measured at the weld toe of the stiffener (strain gage T1) and 18.2 ksi (125.5 MPa) on the underside of the flange (strain gage B4). This was a little more than 50% of the nominal yield stress for these two locations, but the load was only 60% of that previously applied during the repair process. The horizontal load of 5 tons (1431 kN), which was applied during the previous repairs, was found acceptable by the methods provided in the FHWA manual. Obviously, this load would have produced local stresses approaching the nominal yield point at these two locations. Although the vertical restraining force was initially thought to have been the primary factor contributing to the hairline fractures, the data showed that the horizontal restraining force produced levels of stress high enough to produce cracking.

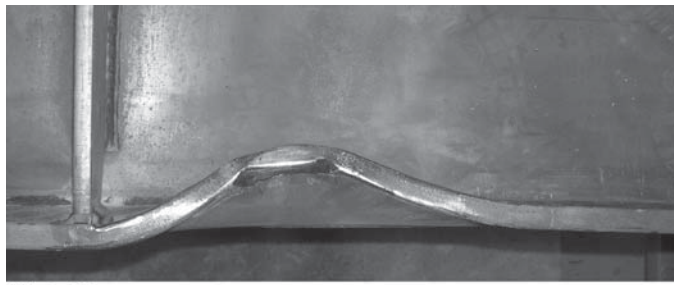
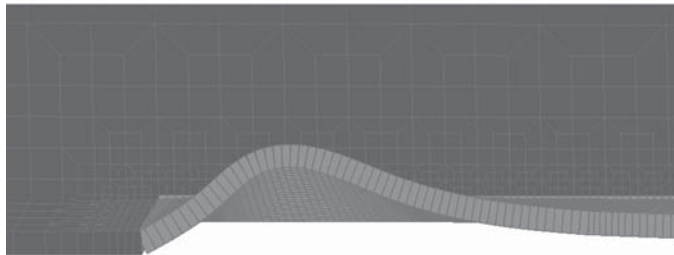
Figure 2.40. Comparison of modeled damage to a typical localized impact.

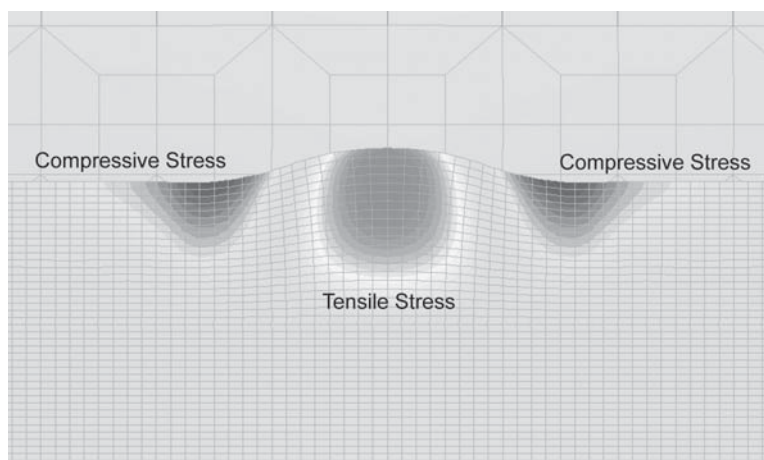
of the models and can be considered typical. As seen in the figure, large tensile stresses are present on the concave side of the localized damage. This is the area on the residual damage (for all geometries) that experiences the most tensile stress. The increase in stress is limited to that of the damaged area and the opposite side of the flange where the edge of the flange experiences some minor compression.

Figure 2.41. Stress contour of localized damage.

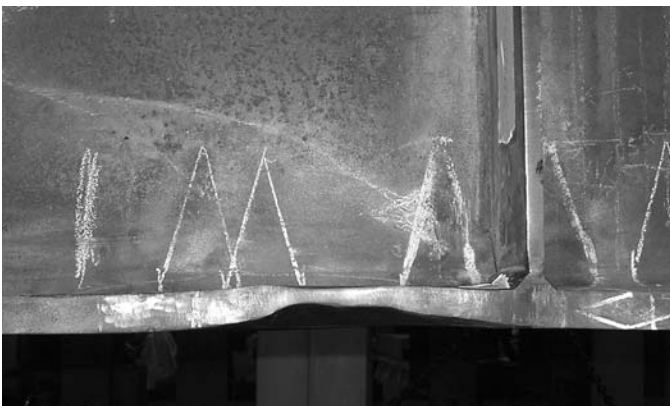
(Note that if the engineer feels that this reduction does not warrant a repair weld or the addition of splice plates to increase the cross section, the area will remain as is.) In Figure 2.43, one of the repaired impacts where this has occurred is shown. It should be noted that this thinning only occurs at the edge of the flange and extends inward about one-eighth to one-quarter of the flange width. As shown in Figure 2.43, the geometry only resulted in a reduction of less than 5% of the cross-sectional area.

Figure 2.43. Detail of repaired localized damage showing thinning of the flange.

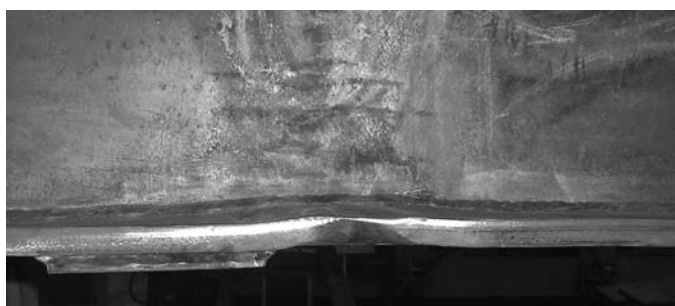
Figure 2.50. Residual damage on Specimen 1D/R-2.

One of the five instrumented locations had a flange thickness of 0.75 in. (19 mm) and width of 10 in. (254 mm), and measured residual damage height of 0.25 in. (6 mm) and length of 5 in. (127 mm) as shown in Figure 2.50. The stress amplification determined from the instrumentation yielded roughly 1.8 [refer to Figure 2.7, measured stress of 16.2 ksi (111.7 MPa) at a location where the theoretical stress would be 9 ksi (62.1 MPa)] while the result from the FE model also was approximately 1.8. Using the member and residual damage geometry, the SAF equation generated a result of 2.0. These values are considered comparable, and the residual damage was within the general trend of the curves. It did not

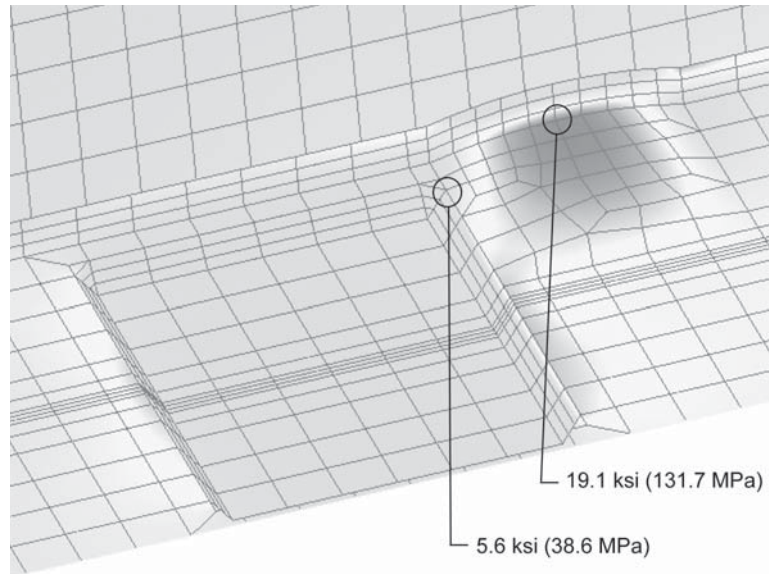
Figure 2.57. Stress contour of residual damage near flange attachment (convex side up).

As shown in Figure 2.57, stress at the concave side of the residual damage was 19.1 ksi (131.7 MPa) while at this same location on the control model, it was 11.5 ksi (79.3 MPa); thus SAF is equal to 1.7. The stress at the corner of the weld toe also was compared to the control model and was reduced 40% from 14.8 ksi (102.0 MPa) to 5.6 ksi (38.6 MPa). Stresses along the length of the weld toe on the opposite side of the flange also were compared and found to have a negligible change. When comparing these results (maximum of 1.7) to the SAF equation (2.0), the SAF equation over-predicted the SAF by about 20%. This verified that if the residual damage is oriented in this direction, the SAF equation will over-predict the modeled results. Next, these results were compared to the model containing the residual damage with the convex side facing down. This would determine if Equation 2.3 over-predicted SAF for residual damage near flange attachment details.

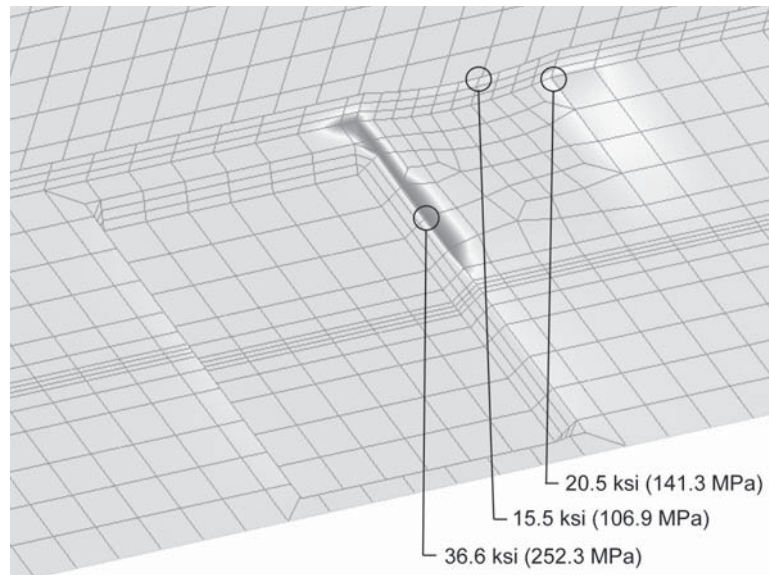
Figure 2.58. Stress contour of residual damage near flange attachment (convex side down).

Figure 2.58 shows that the maximum stress occurs along the weld toe with a maximum of 36.6 ksi (252.3 MPa) at 2 in. (51 mm) from the edge of the flange attachment. Considering the moment gradient, stress on the control model at this same location was 15.2 ksi (104.8 MPa), resulting in a SAF of 2.4. Stresses at two other locations were not as significant, but did yield a SAF of 1.9 for both locations. From the results of the flange attachment analysis, the orientation of the residual damage does determine the stress present at the flange attach-

ment weld toe. As stated earlier, a significant comparison cannot be made between these results and Equation 2.3 because the orientation of the residual damage was not investigated. However, the equation does provide a reasonable estimate of SAF for these two specific cases.

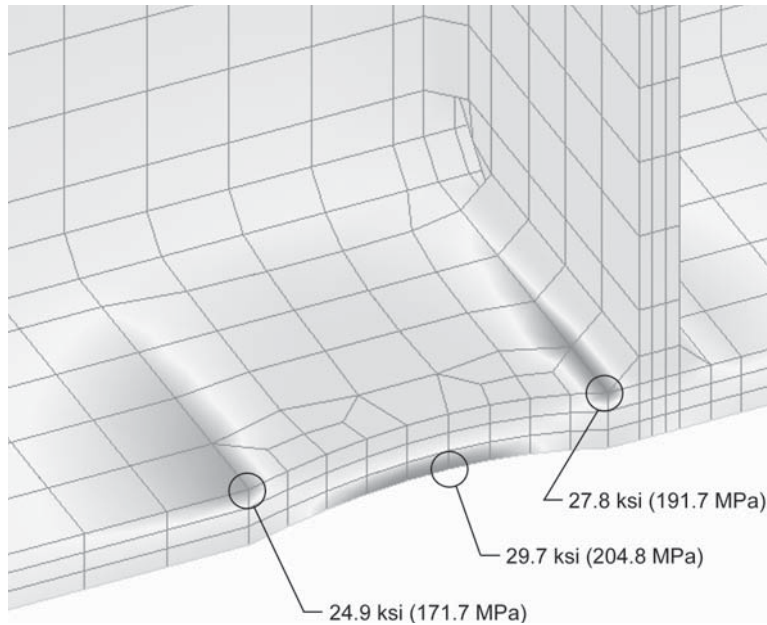
Figure 2.59. Stress contour of residual damage near stiffener.

Figure 2.59 shows the three locations that were investigated for the stiffener detail. The first was at the edge of the underside of the bottom flange, where the largest stress was 29.7 ksi (204.8 MPa). At the same location on the control model, the stress was 15.4 ksi (106.2 MPa), resulting in a SAF of 1.9. At

the second location, 27.8 ksi (191.7 MPa) was present at the weld toe while stress from the control model at that location was 14.0 ksi (96.5 MPa), resulting in a SAF of 2.0. The last location was at the point where the residual damage begins to flatten. This had a stress of 24.9 ksi (171.7 MPa) on the damaged model and 15.3 ksi (105.5 MPa) on the control model, resulting in a SAF of 1.6. As described earlier, the largest stress taken from the shell models was located on the concave side of the residual damage. However, because of the presence of the stiffener, the larger SAF was located at the weld toe. In

comparison, both are relatively the same, so SAF due to this residual damage would be roughly 2.0. These values now can be compared to the SAF calculated by Equation 2.3, which yielded a value of 2.0, essentially the same. Thus for this specific case, the SAF equation does give accurate SAF predictions for the transverse stiffener welded to the bottom flange.

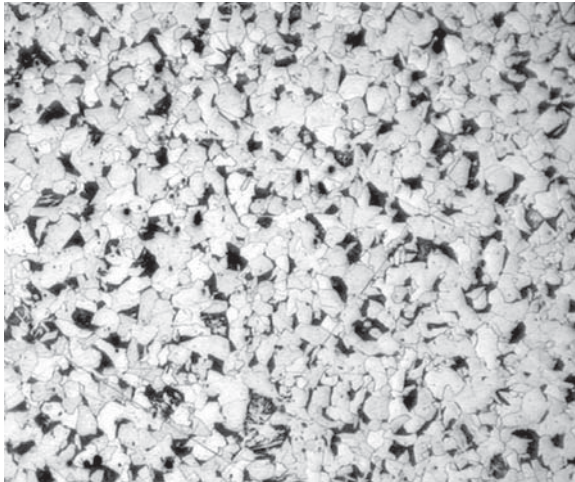
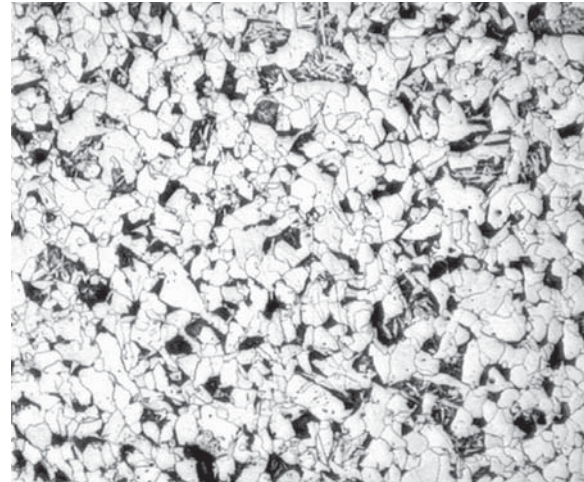
a) Original material (1000X)

b) One D/R cycle (1000X)

Figure C-1. Microstructure before and after one D/R cycle, specimen 1D/R-1.

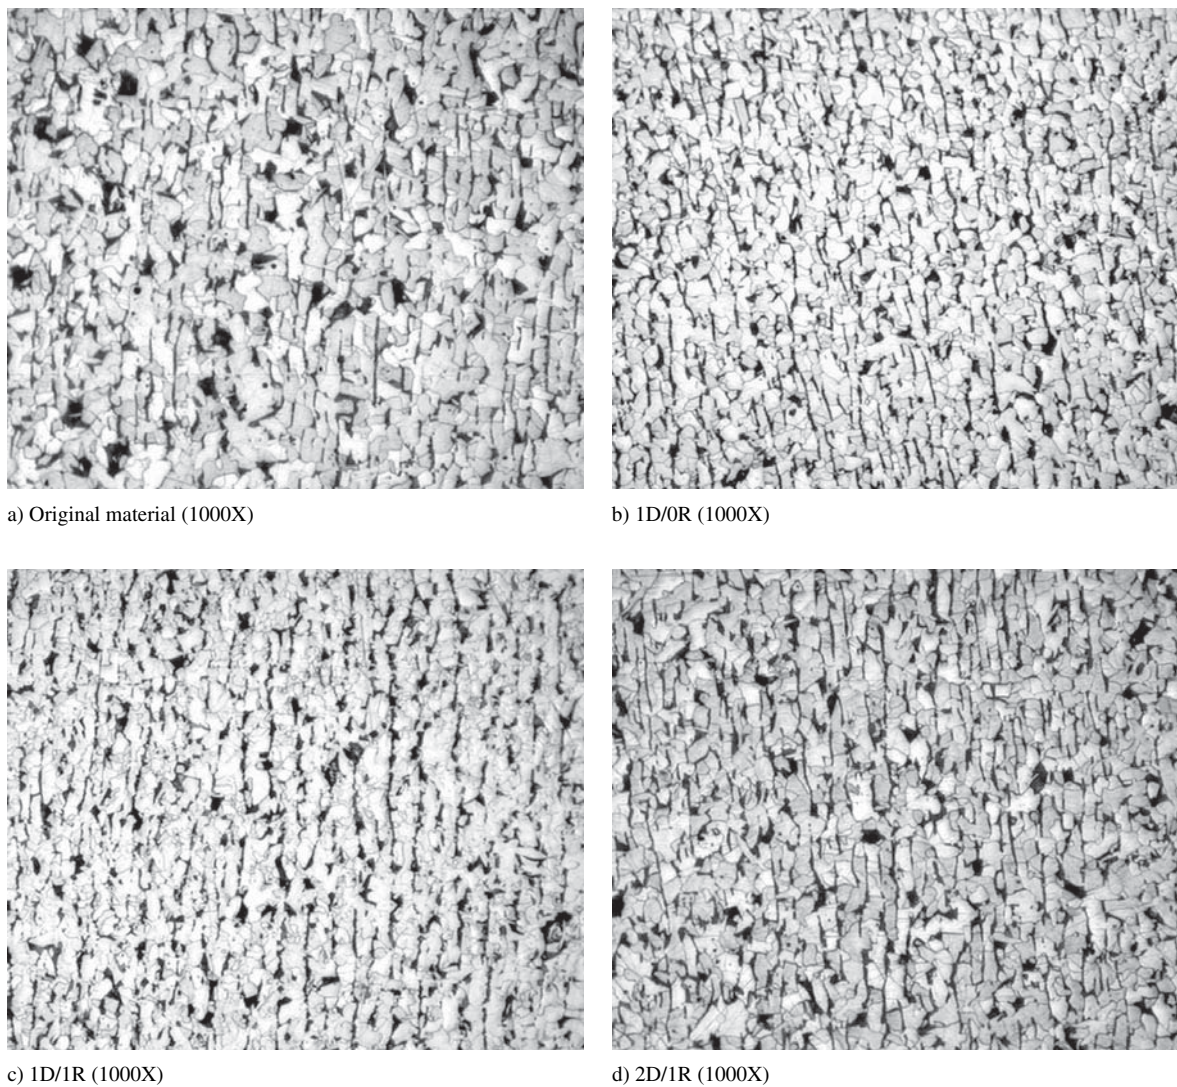
Figure C-2. Microstructure before and after one D/R cycle, specimen 1D/R-2.

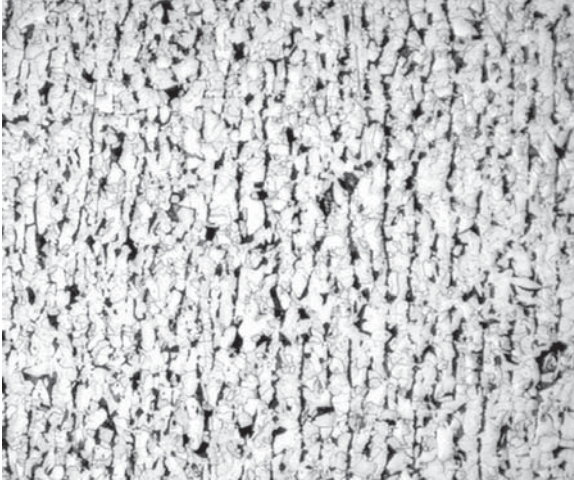
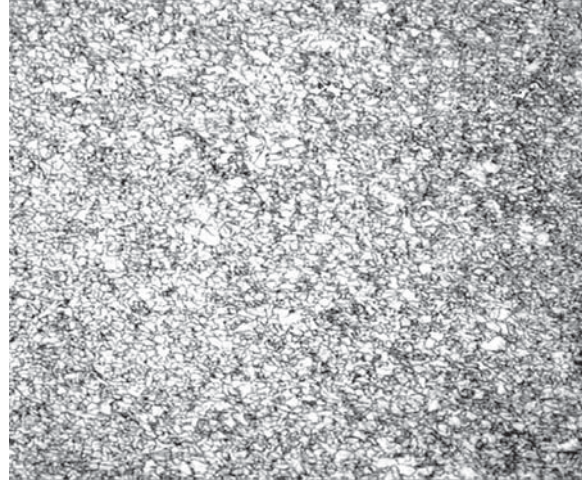
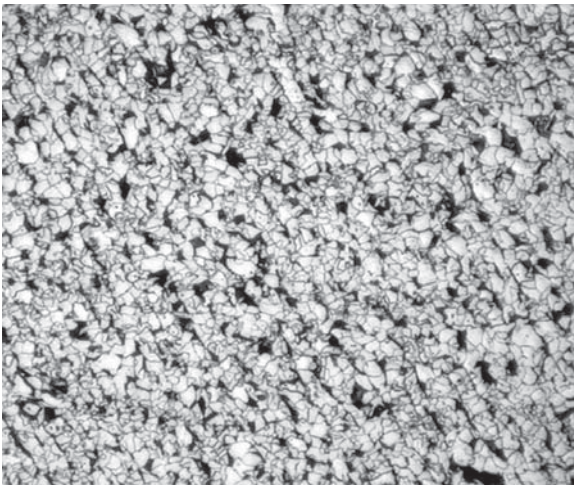
a) Original material (1000X)

b) 2D/2R (1000X) - Overheated

c) 2D/2R (1000X)
