NCHRP REPORT 656

**Criteria for Restoration
of Longitudinal Barriers**

**Hampton C. Gabler
Douglas J. Gabauer
Carolyn E. Hampton**

VIRGINIA POLYTECHNIC INSTITUTE AND STATE UNIVERSITY
Blacksburg, VA

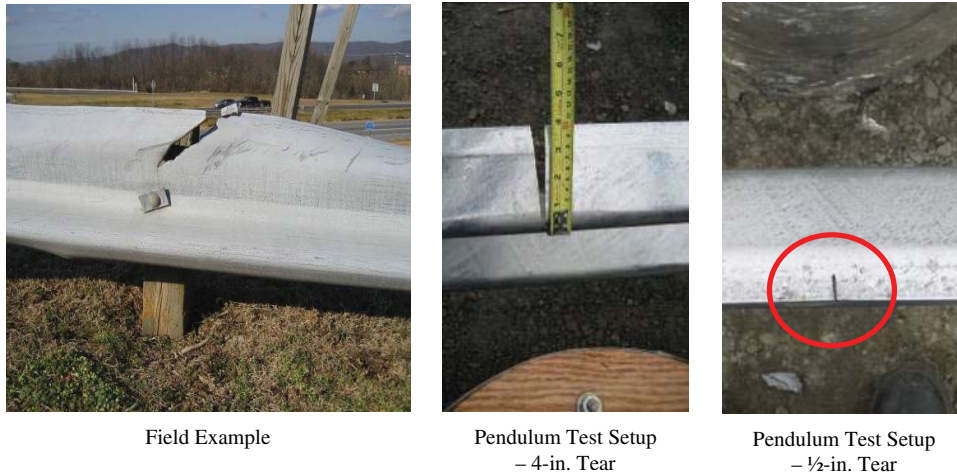
The objective of this evaluation was to determine the effect of a vertical tear on barrier crash performance (Figure 14). The approach was to subject a barrier test section with an artificially introduced vertical tear to a pendulum test. The performance of the barrier section with the flaw was compared to the performance of a similar barrier section with no flaw. This chapter presents the pendulum test results of both the baseline undamaged section and the section with the vertical tear. The pendulum test setup was described in an earlier chapter on the research approach.

Figure 14. Vertical tear evaluated in pendulum tests.

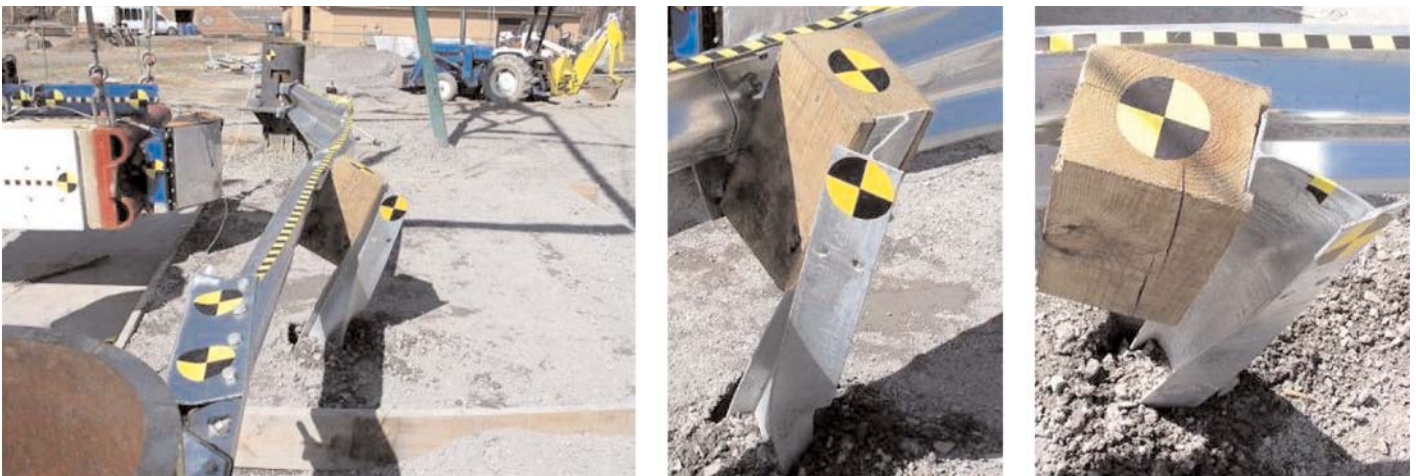
Pendulum tests were conducted at two impact speeds: 32.2 km/hr (20 mph) and 28.2 km/hr (17.5 mph). In Test 03-2, the undamaged barrier contained the pendulum mass impacting at 30.9 km/hr (19.2 mph). The impact speed was calculated using the data from the pendulum-mounted accelerometers. The maximum dynamic deflection of the test section was 739 mm (29.1 inches) at 140 ms after the initial impact, computed from the pendulum acceleration data. The maximum static crush at the center of the w-beam was 356 mm (14 inches). The overall damage and individual post damage is shown in Figures 15 and 16. The post at the splice location (center in Figure 15) experienced more torsion than the non-splice post and had some minor cracking at the flange. The post at the splice location also remained connected to the rail while the post bolt at the non-splice location pulled through the slot in the rail. There were no failures in the anchor cables in this test, and there was no visible separation of the cable from the swaged portion of the anchor cable assembly. At the splice location, there was approximately 19 mm (0.75 inches) of relative movement between the two w-beam rail sections. No tears were evident in the guardrail and no bolt failure was observed. The left portion of Figure 17 shows

Figure 15. Test 03-2: overall damage (right) and post damage at splice (center) and non-splice location (right).

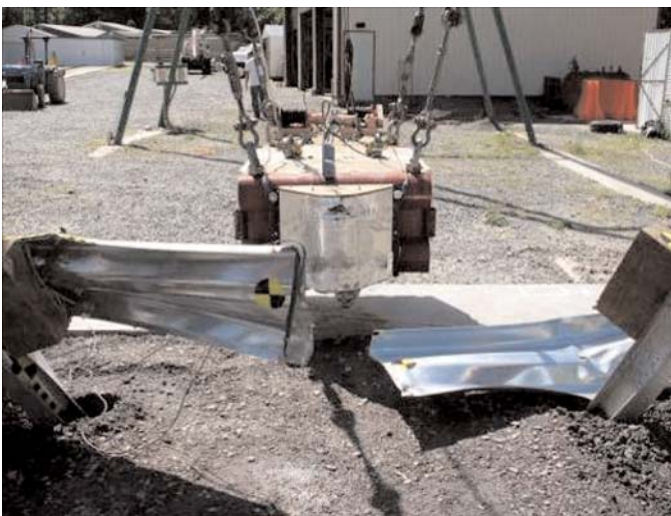
Figure 16. Test 03-5: overall damage.

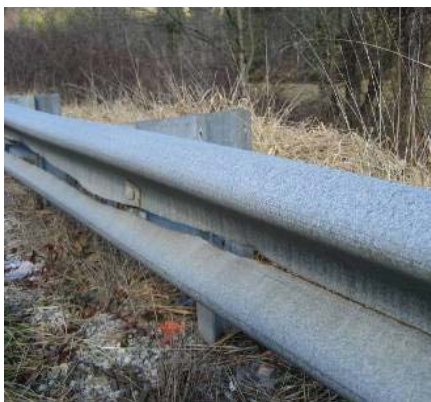
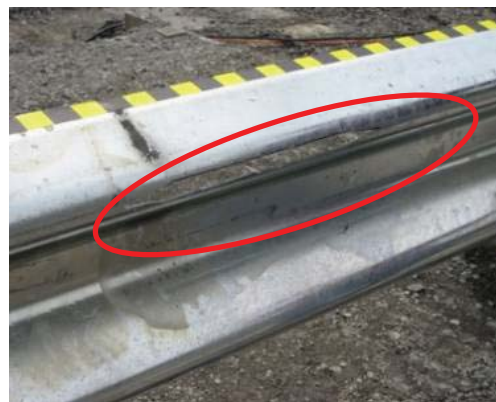
The horizontal tear damaged barrier in Test 07-3 contained the pendulum mass impacting at 29.3 km/hr (18.2 mph), which was calculated using the data from the high speed video footage. The maximum dynamic deflection of the test section was 579 mm (22.8 inches) at 130 ms after the initial impact, computed from the pendulum acceleration data. The maximum static crush at the center of the w-beam was 406 mm (16.0 inches). The damage at the impact location and individual post damages are shown in Figure 20. Both post-rail connections remained intact and there was 16 mm (0.63 inches) of relative movement between the two w-beams at the splice location. Figure 21 shows time sequential snapshots of Test 07-3 obtained from the high speed camera positioned overhead.

In Test 02-1, the horizontal tear damaged barrier (overhead sequence not shown) was unable to contain the pendulum mass impacting at 31.2 km/hr (19.4 mph), which was calculated using the data from the high speed overhead video. The deflection of the rail was 699 mm (27.5 inches) at 128 ms after the initial impact, which was just prior to penetration of the w-beam section. The barrier section failed at the splice due to

Figure 19. Horizontal tear evaluated in pendulum tests.

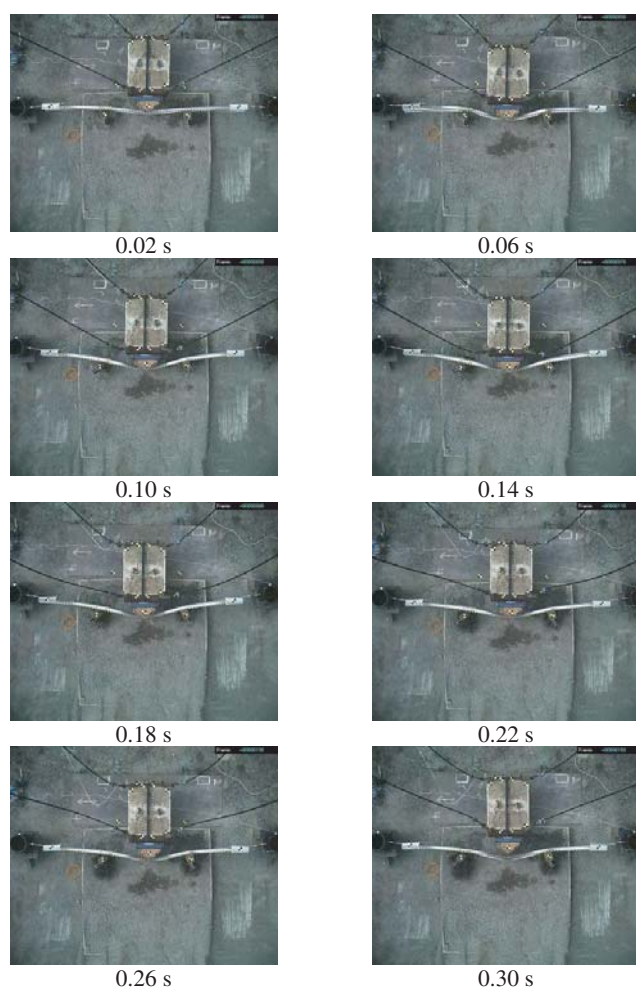
Figure 21. Sequential overhead photographs for 29.3 km/hr pendulum impact of barrier with horizontal tear damage (Test 07-3).

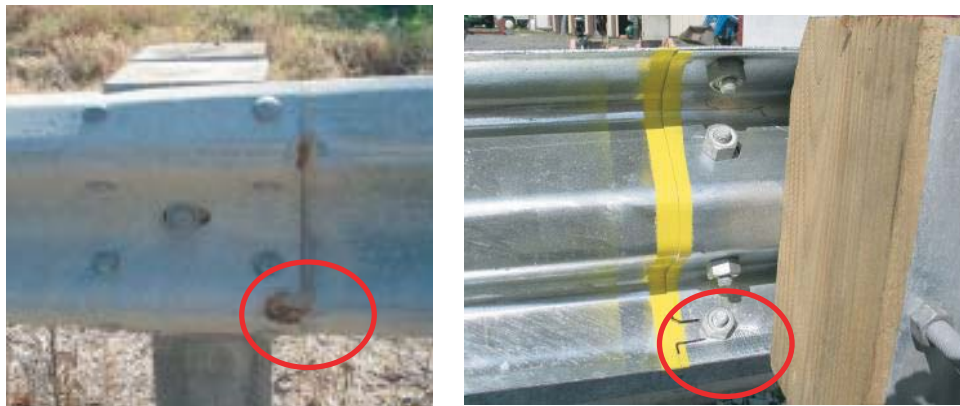
The objective of this evaluation was to determine the effect of splice damage on barrier crash performance by pendulum testing (Figure 23). The performance of the barrier section with splice damage was compared to the performance of a similar barrier section with no flaw. The pendulum test setup is described in an earlier chapter on the research approach.

Figure 23. Splice damage evaluated in pendulum tests.

A pendulum test of a strong-post w-beam barrier with splice damage resulted in successful containment of the pendulum mass. The splice damage consisted of extending the hole for a single splice bolt to the end of the rail (e.g., no bearing capacity for that particular bolt). Under a pendulum impact at 29.3 km/hr (18.2 mph), this barrier was able to contain the impacting pendulum mass with performance indistinguishable from the undamaged barrier section. It is known however from full-scale crash testing as well as the splice failures observed in the pendulum tests that the splice is a weak point in the guardrail system. Balancing these two observations, the research team recommends a repair threshold of 2 or more splice bolts with any guardrail material missing around the bolts with high priority. In the case of damage to a single splice bolt, the research team assigned the repair a medium priority (rather than a low priority) based on the fact that the splice is the weak point in the rail element (Exhibit 3.0).

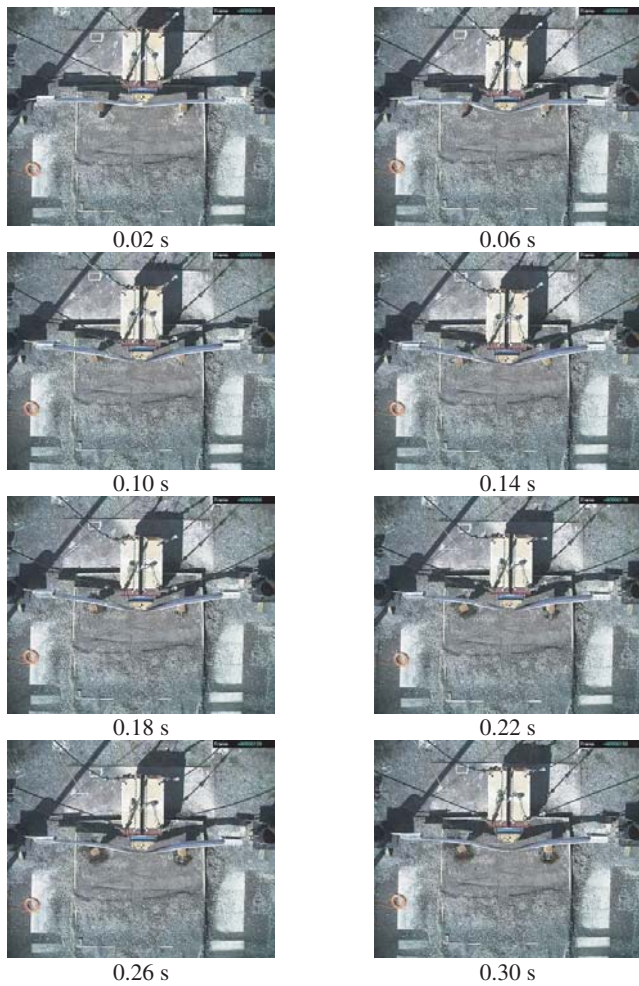
view of the splice damage and the individual post damage is shown in Figure 24. Figure 25 shows time sequence snapshots of the test obtained from the overhead camera.

Figure 25. Sequential overhead photographs for splice damage, Test 07-4 (29.3 km/hr).

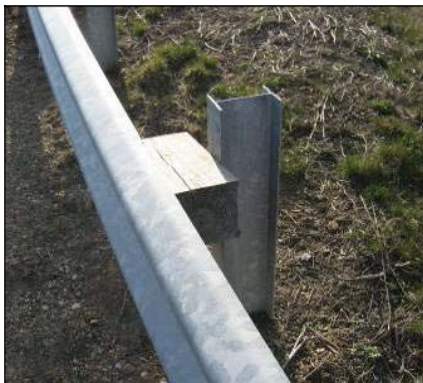
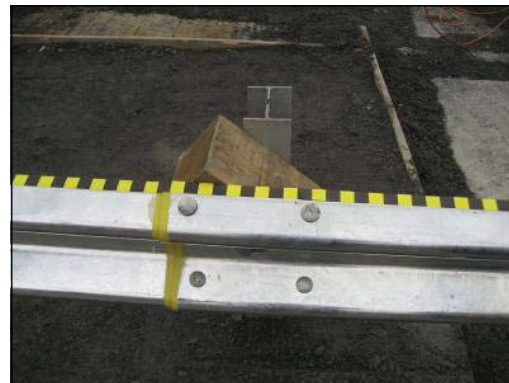
The objective of this evaluation was to determine the effect of twisted blockouts on barrier crash performance by pendulum testing (Figure 26). The performance of the barrier section with twisted blockouts was compared to the performance of a similar barrier section without this flaw. The pendulum test setup is described in an earlier chapter on the research approach. In this case, the routed wooden blockout at the splice was installed rotated about the post-rail bolt. The blockout was rotated approximately 45 degrees with respect to the vertical in all tests.

Figure 26. Twisted blockout evaluated in pendulum tests.

The performance of the barrier section with this damage was indistinguishable from that of the undamaged barrier section

in two higher speed tests conducted. This suggests that this damage mode has little effect on the structural adequacy of the barrier. A pendulum test of a strong-post w-beam barrier section with a twisted blockout (~45 degrees relative to the vertical position) at the splice location successfully contained the pendulum mass.

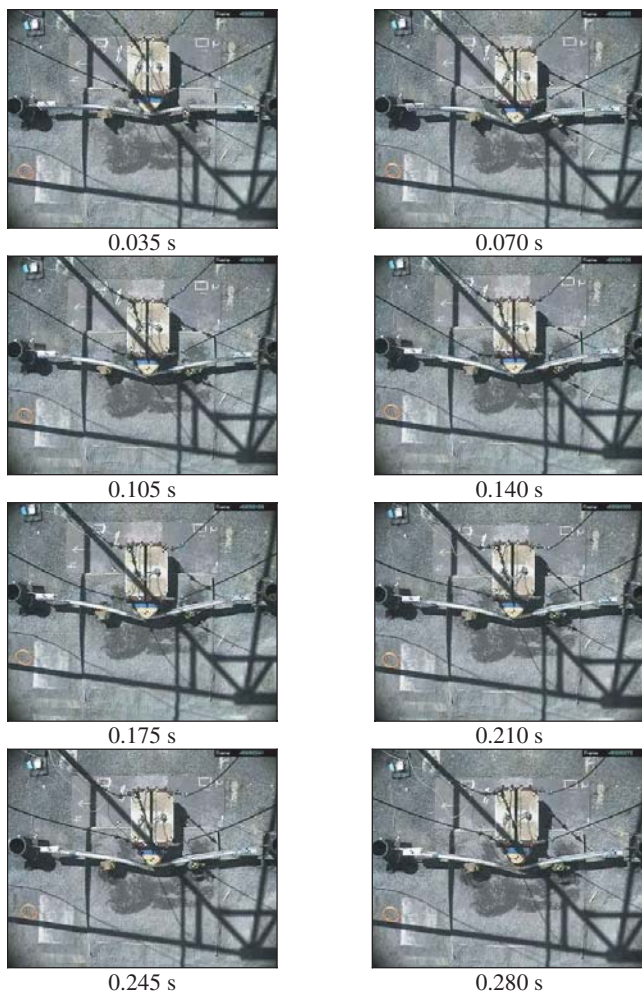
In Test 03-8, the twisted blockout damaged barrier contained the pendulum mass impacting at 31.2 km/hr (19.4 mph). The impact velocity was calculated using the data from the pendulum-mounted accelerometers. Based on the analysis of the high-speed overhead video, the maximum dynamic deflection was 691 mm (27.2 inches) at 131 ms after the initial impact. The maximum static crush at the center of the w-beam was 356 mm (14 inches). The overall damage and the post damage due to impact are shown in Figure 27. Figure 28

Figure 28. Sequential overhead photographs for barrier with a twisted blockout, Test 03-8 (31.2 km/hr).

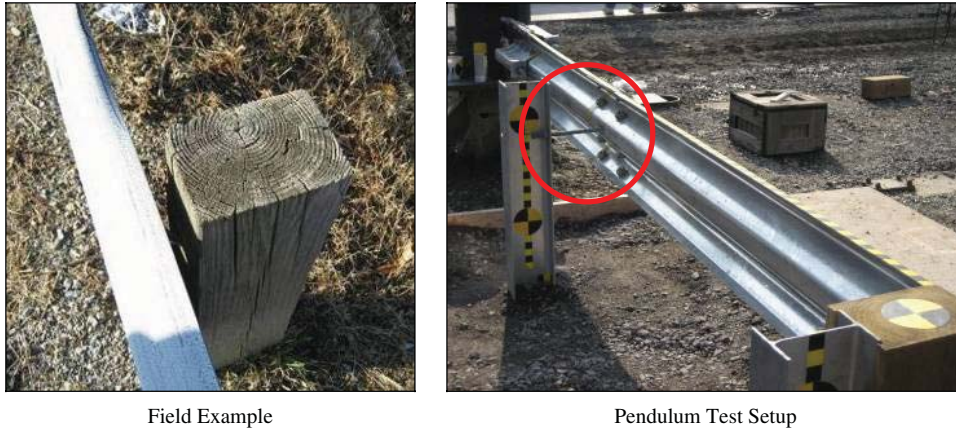
The objective of this evaluation was to determine the effect of a missing blockout on barrier crash performance through pendulum testing (Figure 29). The performance of the barrier section with a missing blockout was compared to the performance of a similar barrier section with a blockout in place. The pendulum test setup is described in an earlier chapter on the research approach.

Figure 29. Missing blockout damage evaluated in pendulum tests.

A pendulum test conducted at 20 mph of a strong-post w-beam barrier section with a missing blockout at the splice location resulted in successful containment of the pendulum mass (Test 01-4). There was strong evidence, however, that this damage mode could result in tearing of the w-beam. During the test, the absence of the blockout allowed the rail to be

driven into the steel post resulting in a 9-inch tear in the rail. It is possible that there may have been less of a propensity for tearing for wood posts. Another pendulum test was conducted at an impact speed of 17.5 mph to better represent the kinetic energy loading to a single section of barrier during a full-scale *NCHRP Report 350* test. In this test, the barrier successfully contained the pendulum mass with no evidence of w-beam tearing. To be cautious, the research team has proposed a threshold of one or more missing blockouts. This damage has been assigned a medium priority based on the potential for rail tearing that has been observed in the pendulum test.

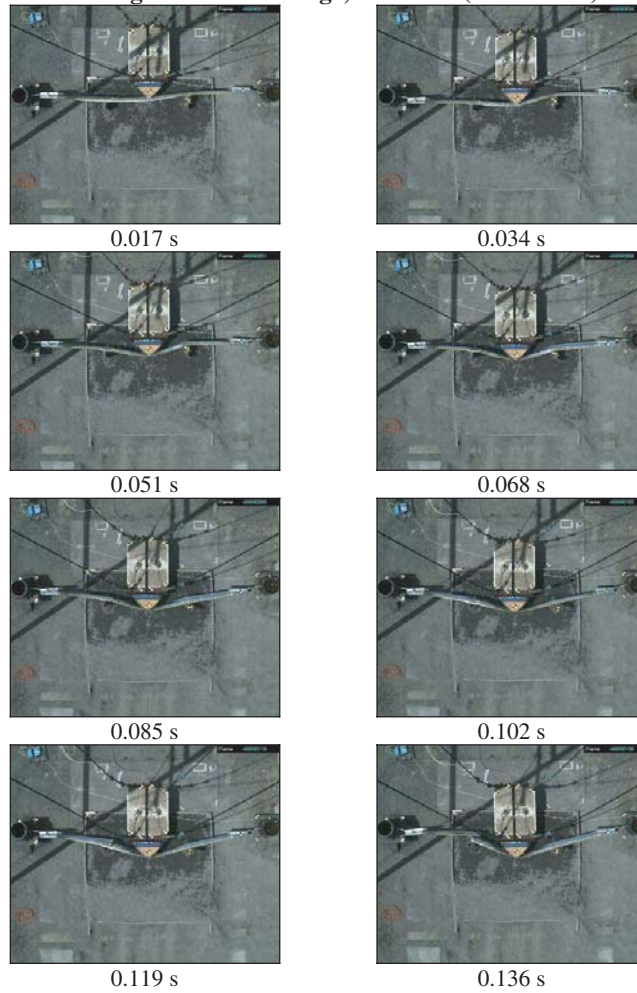
Missing Blockout Damage, Test 03-7 (30.6 km/hr)

Figure 31. Sequential overhead photographs for missing blockout damage.

Exhibit 5.0. Recommendation for missing blackout damage repair.

Damage Mode	Repair Threshold	Relative Priority
Missing Blockout	Any blockouts that have the following issues: <ul style="list-style-type: none"> • Missing, • Cracked across the grain, • Cracked from top or bottom of blockout through post-bolt hole, and • Rotted. 	Medium

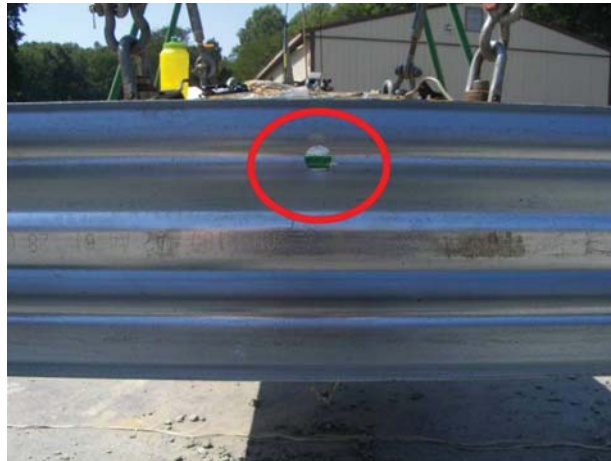
Pendulum Test Setup

cessful containment of the pendulum mass. To represent worst case conditions, the hole was aligned with the impact location and in the upper fold of the w-beam section. Based on the results of the test, the performance of the hole-damaged rail section was virtually identical to that of the undamaged strong post barrier section tested at the 17.5 mph impact speed. As a result, the research team has recommended that the repair be initiated if the hole exceeds 1 inch in height. Note that the limit on size of a non-manufactured hole has been specified in the vertical, rather than the horizontal, direction because the vertical direction is perpendicular to predominant (tension) loads, and is thus more likely to cause failures. A medium priority was assigned to smaller holes in the rail because of the possibility that holes may serve as the initiation point for horizontal tearing on impact. The only exception would be if this hole was located near the splice as described below.

Multiple holes in a rail section or holes with a diameter exceeding a height of 1 inch could lead to rail tearing as seen in the vertical tear pendulum tests. To avoid the possibility of catastrophic rail failure, these modes were assigned a high priority for repair. A special case was a hole of any size which intersects either the top or bottom edge of the rail. Because a hole which disrupts either the upper or lower surface of a rail has the characteristics of a vertical tear, this damage mode has the potential for the same catastrophic failure of the rail that was observed in the pendulum tests of vertical tears. This damage mode was given a high priority for repair (Exhibit 6.0).

Figure 34. Hole damage evaluated in pendulum tests.

Exhibit 6.0. Recommendations for hole in rail damage.

Damage Mode	Repair Threshold	Relative Priority
Non-Manufactured holes (such as crash-induced holes, lug-nut damage, or holes rusted-through the rail)	<ul style="list-style-type: none"> • More than 2 holes less than 1 in. in height in a 12.5-in. length of rail. • Any holes greater than 1in. in height. • Any hole which intersects either the top or bottom edge of the rail. 	High
	1 or 2 holes less than 1 in. in height in a 12.5-in length of rail.	Medium

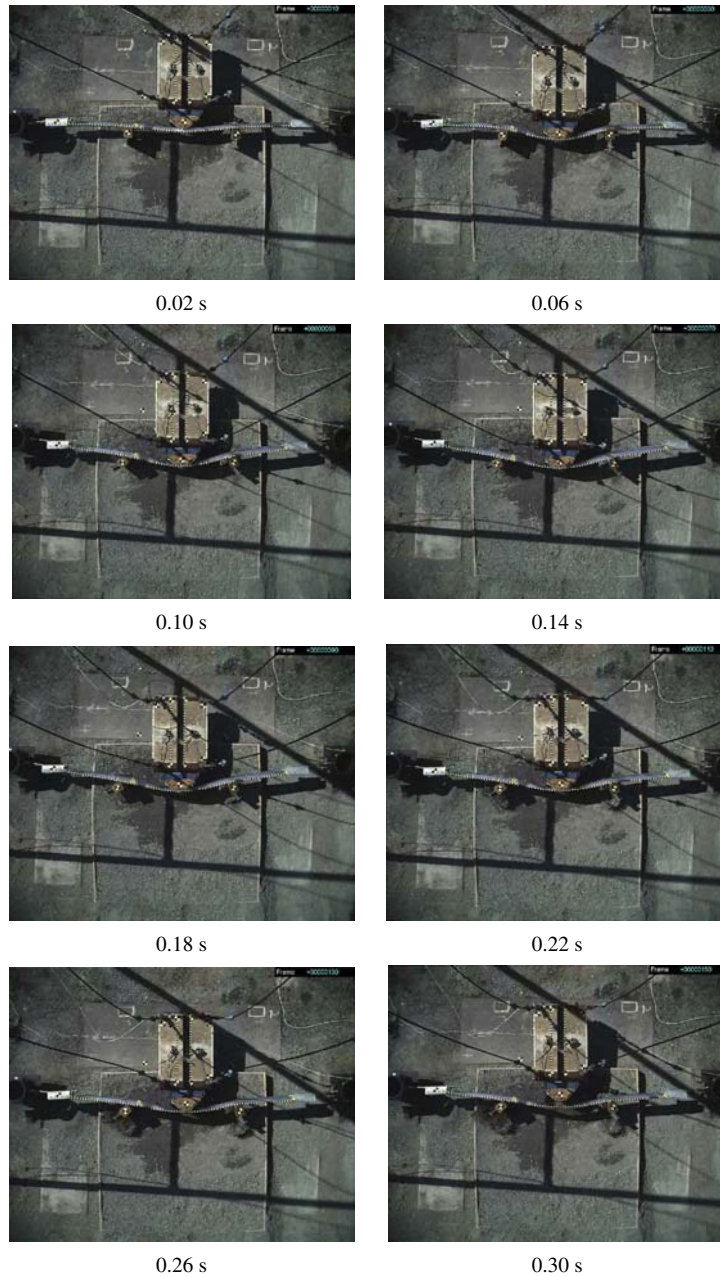
Figure 36. Sequential photographs for 1.25-inch hole damage (Test 07-2): overhead view.

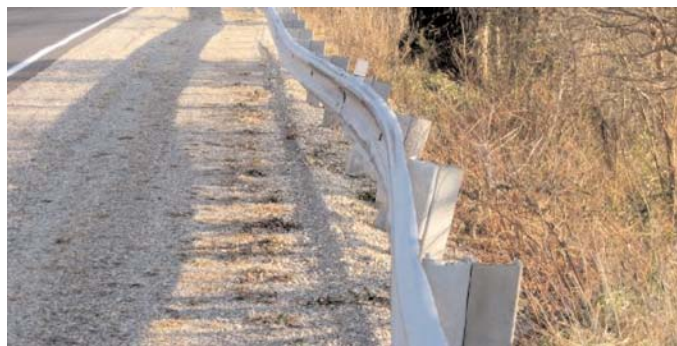
Rail and post deflection is one of the most prevalent types of damage in guardrail, most often caused by a lower severity crash. An example of this damage mode is shown in Figure 37. Impacts where the vehicle speed is lower may result in localized minor damage. Depending on the impact angle, the damage may be incurred only to the rail element, with minimal or no damage to the supporting posts and soil. Impacts with a higher speed but shallower angle can also result in more distributed rail and post deflection.

The amount of deflection that can be sustained by a guardrail before its safety is compromised is a major concern. Maintenance crews and highway agencies are often forced to balance the expense of continual repairs against the potential liability if the damaged guardrail is struck again. The survey of U.S. states and Canadian provinces presented earlier in this report revealed that very few agencies have quantitative criteria underlying the decision of when to replace a deflected guardrail. Among those agencies that have quantitative guidelines, the threshold deflection was most commonly set at 6 inches (152 mm) of deflection. This is also the recommended limit for minor damage specified by the Federal Highway Administration (FHWA, 2008). Individual agencies had limits as low as 3 inches (76 mm) or as high as 12 inches (305 mm). This study is intended to test the performance of guardrail with rail and post deflection to support a unified deflection limit based on quantitative data.

Figure 37. Guardrail with rail and post deflection.

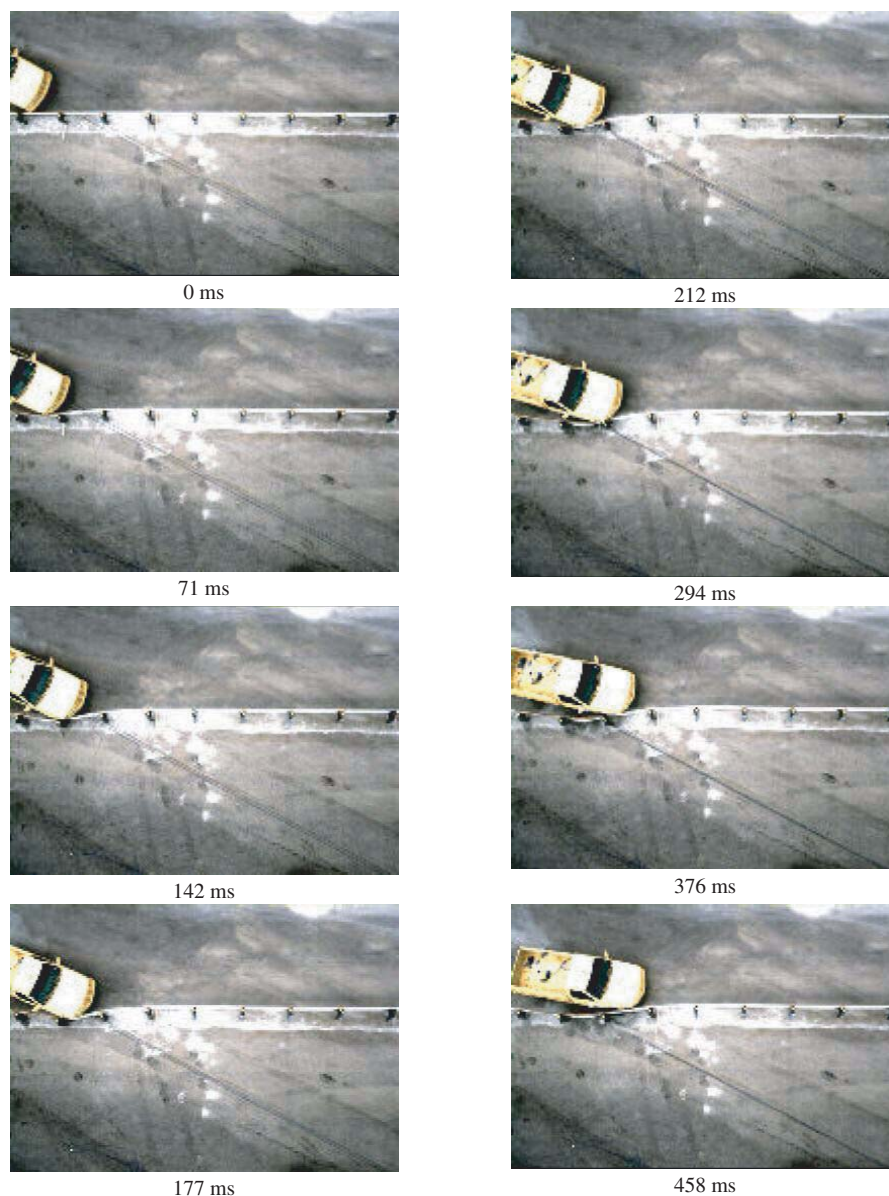
In the first impact, the impacting vehicle, a 1997 Chevrolet C2500 pickup weighing 4,632 lb (2101 kg), struck the guardrail at a speed of 30 mph (48.3 km/hr) at 26.0 degrees. This impact resulted in damage to 36 feet (11 meters) of barrier length of the total 162-foot (49.4 meters) length. The maximum permanent post and rail deflection was approximately 14.5 inches (368 mm). The barrier successfully contained the vehicle. The vehicle came to rest alongside the barrier due to the low initial speed of the vehicle. Figure 38 shows an overhead time series of the impact.

Figure 38. Time series for low-speed impact.

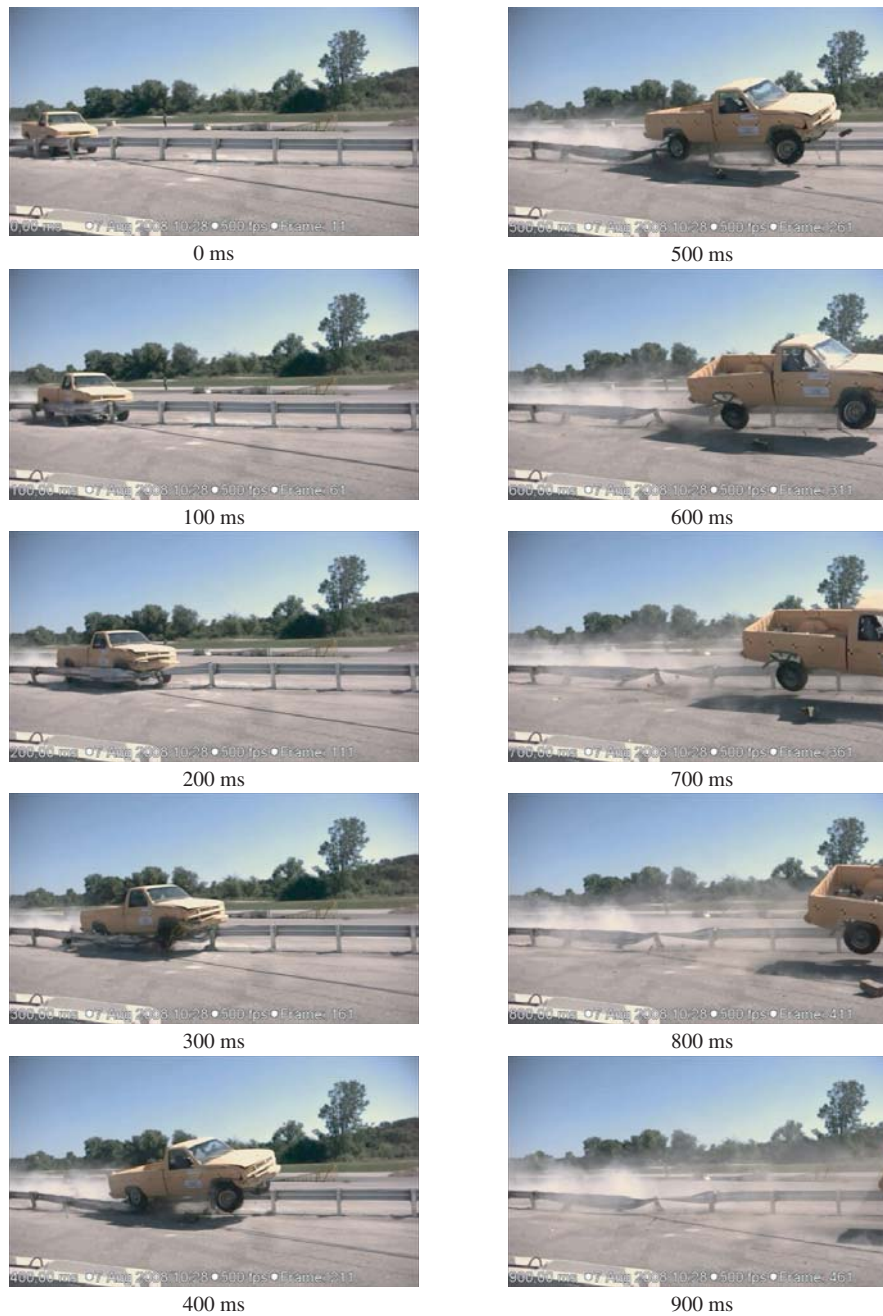
truck impacted the guardrail at the same initial impact point and area damaged by the previous vehicle. The impact conditions were 62.1 mph (99.9 km/hr) at 25.5 degrees (*NCHRP Report 350 Test 3-11* conditions). Due to the damage that had already incurred to the guardrail, the vehicle failed to redirect and override the guardrail. The vehicle returned to the ground on the opposite side of the guardrail and continued to travel at 43.2 mph (69.5 km/hr) and at an angle of 18.7 degrees from the guardrail. Post 13 failed to separate from the guardrail despite the significant amount of post and rail deflection during the test. A series of photographs showing the vehicle as it vaulted over the guardrail is shown in Figure 39. As shown in these photographs, the pickup truck vaulted over the barrier and came to rest upright behind the test installation.

Figure 39. Time series for second, high-speed impact into damaged guardrails.

The outcome of the crash tests demonstrated that there are limits to the amount of damage that can be sustained by guardrails while still maintaining its functional capacity. The test series showed that a guardrail with 14.5 inches (368.3 mm) of rail and post deflection in a guardrail represents an unacceptable condition that warrants high-priority repair. The performance of guardrail with lower amounts of deflection was evaluated with finite element models, as described in the following sections, to determine the limit of deflection that can be allowed.

The crash tests show that 14 inches of lateral post and rail deflection is a damage level which requires repair. The level of damage below 14 inches of post/rail deflection which may be acceptable was investigated by finite element simulation. A series of simulations was conducted to determine how much deflection could be permitted in a strong-post w-beam guardrail without compromising the safety of the system. All simulations were conducted with the LS-DYNA software as described earlier in this report. Simulations with combined rail and post deflection were conducted for 3, 6, 9, and

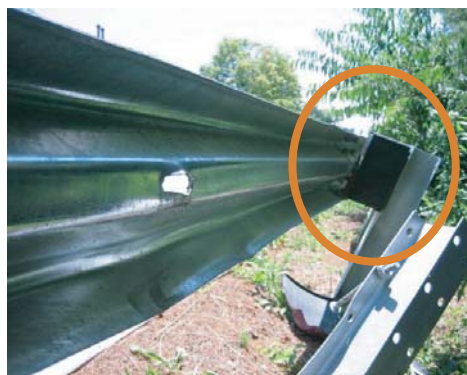
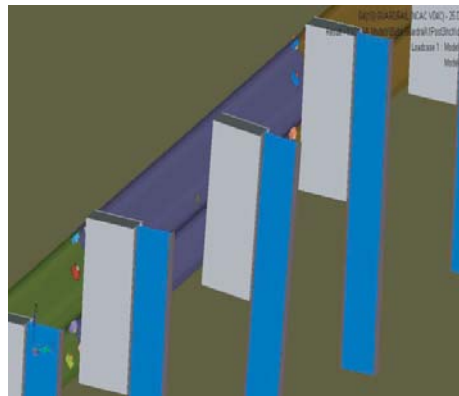
This chapter evaluates the effect of post and rail separation in strong-post w-beam guardrail systems. This type of damage commonly occurs in combination with minor rail deflection, but in this study it was considered in isolation. Figure 52 shows an example of post and rail separation in the field and a finite element model of this damage mode.

Finite element simulations were completed in which a 2000P vehicle impacted a barrier (at TL-3 conditions) with detached posts. Based on the field inspections of damaged barriers, the research team found that detached posts typically occur in tandem with some amount of post deflection away from the rail. For this study two simulations were conducted—the first for a single detached post and the second for two adjacent detached posts. To create a model of a rail with detached posts, the connection to the rail was severed and both posts were pushed out of line 3 inches with respect to their original position perpendicular to the barrier face. The procedure by which the post and rail separation was induced in the finite element model is described in the appendices. The resulting model is shown in Figure 52 for 3 inches of deflection of two adjacent posts. The vehicle was given the initial conditions specified by the *NCHRP Report 350* test criteria. The impact velocity was 100 kph at an impact angle of 25 degrees.

Figure 52. Post separation from guardrail.

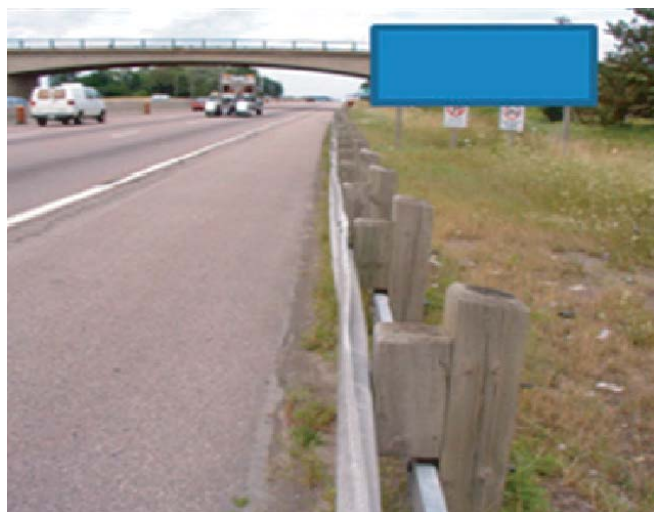
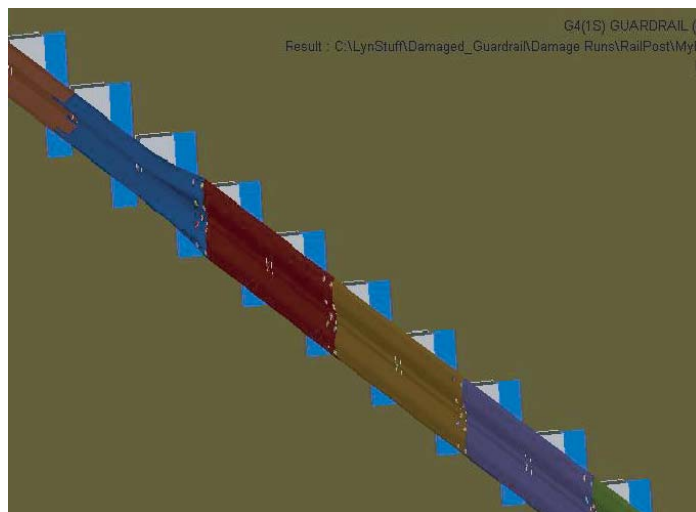
Field Example (courtesy of Ontario Ministry of Transportation)

Rail flattening in strong-post w-beam guardrail was a damage mode of concern to many state agencies, ranking just below rail and post deflection. In the field, rail deflection is often associated with collisions at shallow angles or caused by a snowplow rubbing against the rail. Rail flattening was characterized by loss of depth in the w-beam rail element, which was often accompanied by rail deflection and post deflection. Concurrent with the loss of depth was an increase in the height of the guardrail, i.e., the upper edge of the guardrail extended higher while the lower edge moved closer to the ground. Figure 55 shows an example of rail flattening caused by a snowplow, and a finite element model of this damage mode.

Figure 55. Rail flattening—field example vs. finite element model.
