Assessment of Remaining Fatigue Performance of High Mast Illumination Poles

Thesis

The University of Texas at Austin
May 2014

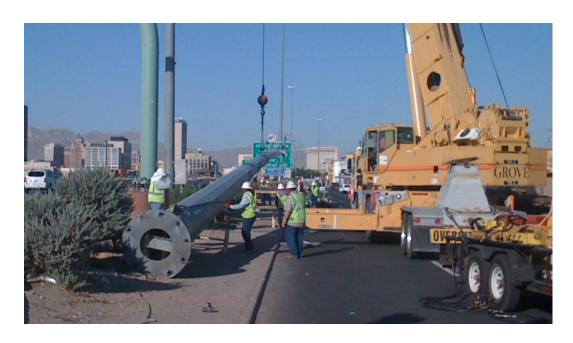
Figure 1.3: HMIP taken out of service

The research outlined in this thesis is focused on measuring the remaining fatigue performance of the shaft-to-baseplate connection used in an in-service high mast illumination pole. A severely damaged HMIP pole was removed in service (Figure 1.3) and subjected to laboratory testing to assess the remaining fatigue life. The remaining fatigue life was evaluated using the results of full scale experimental testing as developed in previous phases of this study at The University of Texas at Austin.

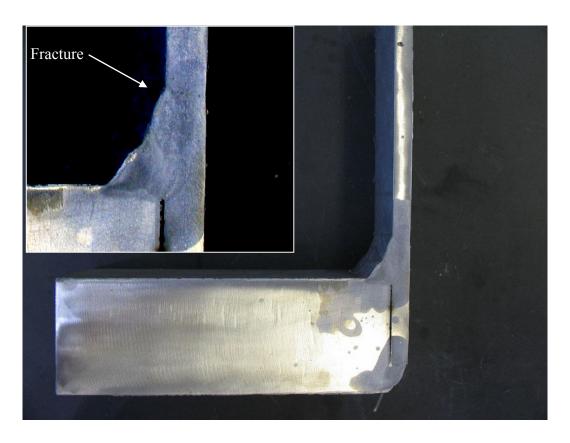
Figure 2.14: Etched cross section of fillet welded socket connection (Rios 2007)

The locations of the cracks are shown in Figure 2.13 and Figure 2.14Figure 2.13: Typical failure of fillet welded socket connection (Rios, 2007). The cracks initiated at the toe of the weld of the extreme tension fiber and propagated through the wall thickness and the connection cross-section.

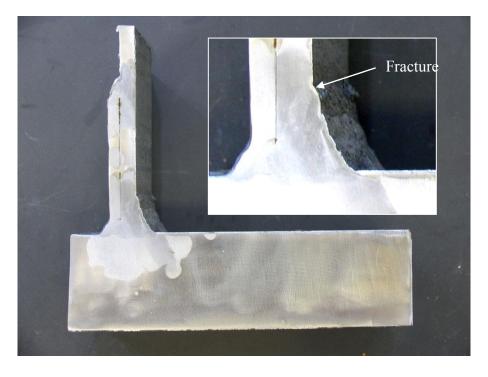
Figure 2.17: Etched cross section of Wyoming full penetration connection (Rios, 2007)

The location of the cracks is shown in Figure 2.16, Figure 2.17 and Figure 2.18. The cracks initiated at the toe of the weld of the extreme tension fiber and propagated through the wall thickness and the connection cross-section.

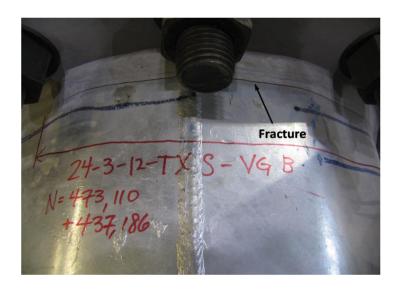
Figure 2.22: Shaft to base plate crack location (Stam, 2009)

The location of the cracks for the unstiffened sections was the toe of the weld of the shaft to the base plate. For specimens with external collars, the crack locations varied as showed in Figure 2.22 and Figure 2.23. For specimens with the stool base connection, the location of the cracks was the toe of the weld of the shaft to the stool plate as shown in Figure 2.24.

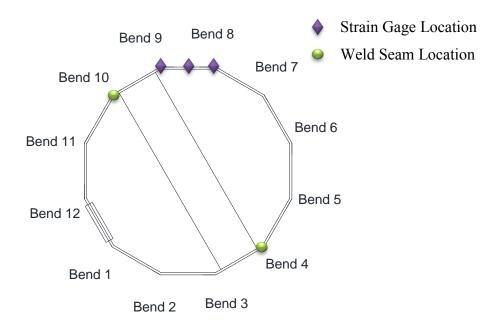
Figure 3.6: Orientation of in-service pole and location of strain gages during test #1

Figure 3.9 show the position of the strain gage pairs along the cross-sections of both test specimens for each test. The figures of the pole removed form service show a structural member that passes across the diagonal of the pole. The structural member consisted of steel channel that was welded between the channel and the wall of the high mast pole. The channel serves has an anchor for a winch system that is used to raise and lower the lighting ring when bulb replacement or other maintenance is necessary.

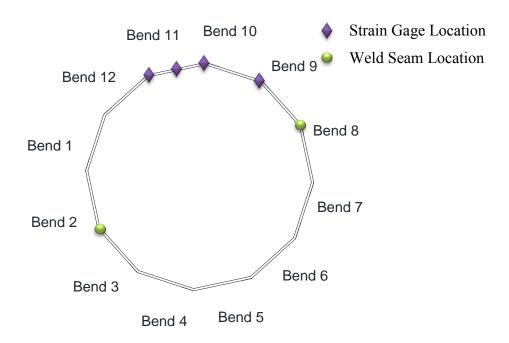
Figure 3.9: Orientation of "new" pole and location of strain gages during all tests

In the "new" pole that was fabricated as a companion for the pole removed for service, a large crack occurred that approached a critical size. The researchers worked with the sponsor to contract with a company that specializes in repairing high mast pole sections that have large cracks. Although the repair procedures and performance are discussed in more detail later in this thesis, no additional cracking was found in the pole after the repair. Since the gages were installed in the system after the cracking was observed and repaired in the "new" pole as shown in Figure 3.9, the position of the gages in the "new" pole remained unchanged as the pole didn't experience any failure of any kind after it was repaired.

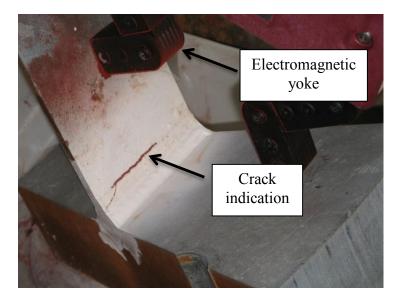
Figure 3.14: UT performed on a section cut of a HMIP (white powder is paint for making the iron particle more detectable)

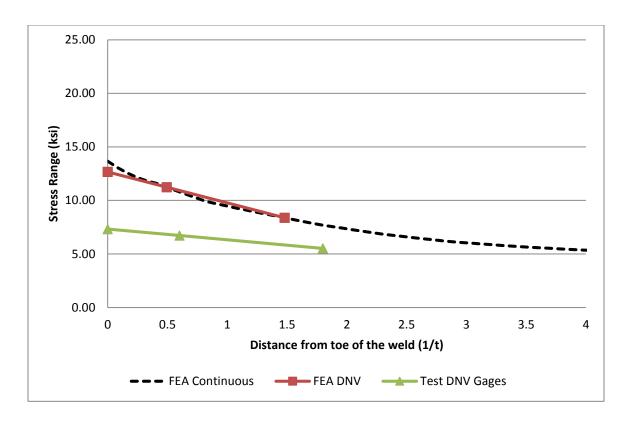
Figure 4.4: SCF - Test 1 - Bend 9

The fact that the pole was previously in-service and was experiencing crack growth at the bend locations justifies that results presented in Figure 4.4 and Figure 4.5 show a closer agreement of experimental results with FEA results at flats than at bends. This is due to the fact that when a crack initiates from a surface and propagates through the thickness of the material, the stress flow changes towards the portion of the material that is continuous. As a result, the stress drop at the strain gage location is observed which should not be misinterpreted with a lower stress range acting in the connection. On the contrary, when a crack is initiated or propagating the stress range is increasing in the remaining cross-section, accelerating the damage accumulation procedure.

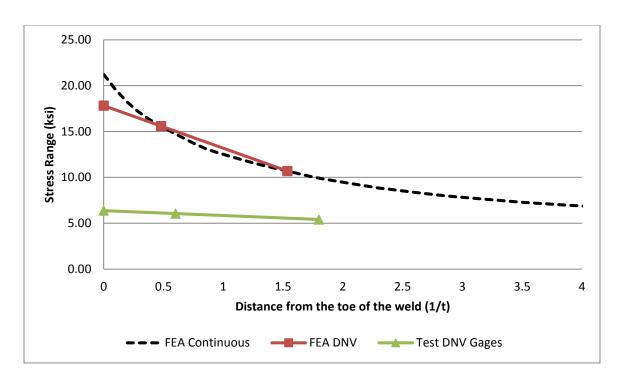
Figure 4.7: Stress profile close to the toe of the weld - Test 3 - Bend 12

Figure 4.7 and Figure 4.8 illustrate the experimental and analytical results for tests 2 & 3. The accuracy of the gage readings was again poorer at the location where the majority of the damage was occurring. This validates the hypothesis that the FEA can be a useful tool for analyzing undamaged poles, however non-destructive testing has to be conducted on a regular basis or field monitoring should be implemented in order to be able to evaluate the in-service condition of HMIPs.

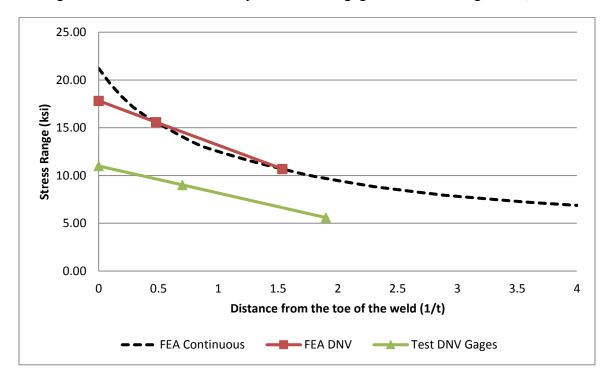
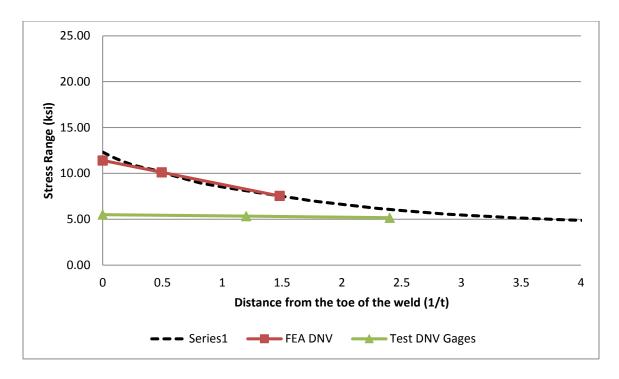
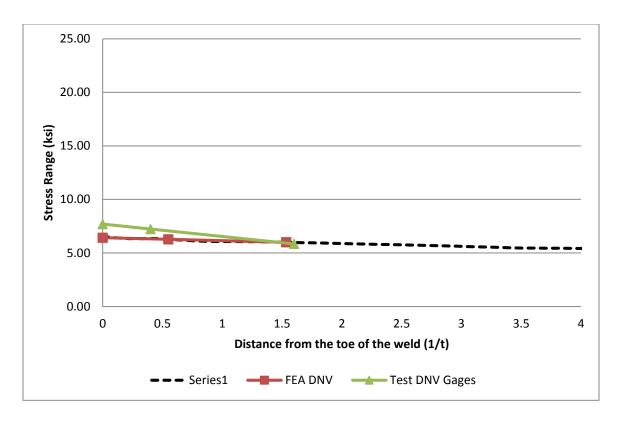
As can be seen from Figure 4.10, Figure 4.11, and Figure 4.12 while there is still a significant difference between the FEA and Test DNV results, the readings from strain gages in the case of the repaired pole are more closely related to the stresses predicted by the FEA than observed in the El Paso pole. A source that causes stress distortion close to the toe of the weld is the groove created by the UIT at the toe location, as can be seen in Figure 4.13. Another source of the inconsistencies can be the weld shape irregularity that was not modeled in the FEA studies.

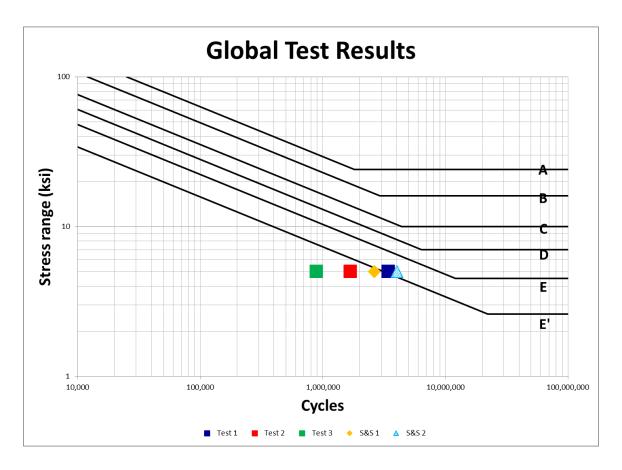
Figure 4.14: Global Test Results

Figure 4.14 presents the summary of all fatigue tests conducted throughout this phase of the HMIP study. In the figure, solid markers indicate terminated tests whereas the hollow marker indicates a non-failure test. Specifically, S&S 1 represents the first test which was terminated due to the failure of the companion specimen and S&S 2 the cycles which the repaired specimen experienced until the project was ended.

Considering the scatter of the fatigue tests, the results suggest that the pole experienced a relatively uniform damage in the field. Upon this assumption, valid predictions can be made with field instrumentation data.

Another outcome from this phase of the study is that the repaired and impact treated pole did not fail and that there were no evidence of cracks after the last test termination. This is encouraging repair as opposed to the replacement solution, especially when damage is observed.

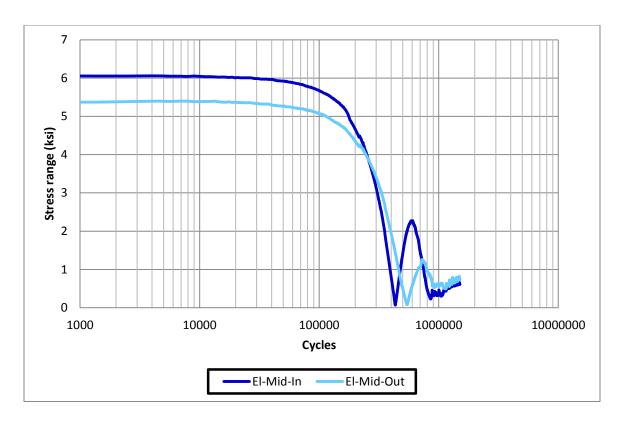
Figure 4.15: S-N curve (El Paso pole top shaft bend)- Test #3

Along with the monitoring of the number of cycles at which the HMIPs had lost 10% of their stiffness, the stress range at the gage locations was monitored as a result of the sinusoidal displacement that was imposed at the base of the pole. Figure 4.15 illustrates the rapid degradation of the stress range that was typically observed at locations were cracks were propagating once damage was accumulated. The "in" and "out" notation indicates the gage placed closer or further to the weld toe respectively.

As can be seen in the graph, after the stresses reached zero they increased and finally decreased to a level close to zero. This behavior can either be attributed to the crack interlock (destructive test pictures showed a non-plane crack surface) or to the potential redistribution of stresses while the crack was growing until the formation of a complete free edge.

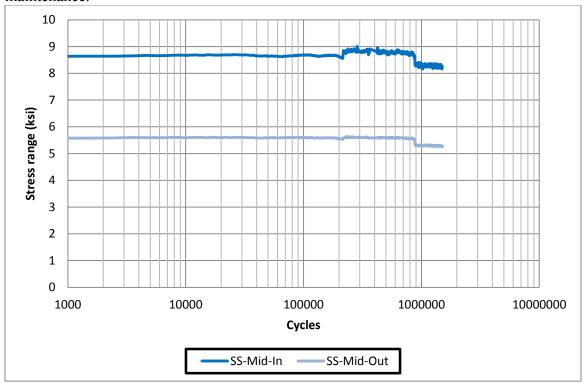
Figure 4.16: S-N curve (S&S Pole top shaft bend) - Test #3

Figure 4.16 illustrates the same data as Figure 4.15. The difference is that the data is acquired from gages close to the toe of the weld of a bend that had no initial cracking. As can be seen the stresses remained stable over the period of the testing and the minor fluctuations observed were due to the temperature change (affecting the oil pressure in the

hydraulics and the test setup) and required stops/restarts of the tests due to equipment maintenance.

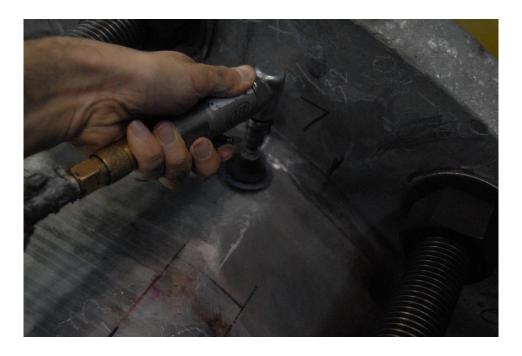
Figure 4.17: Galvanizing removal
