## Nondestructive Testing to Identify Delaminations Between HMA Layers, Volume 3 - Controlled Evaluation Reports

**SHRP 2 REPORT S2-R06D-RW-3**

# Nondestructive Testing to Identify Delaminations Between HMA Layers

## Volume 3

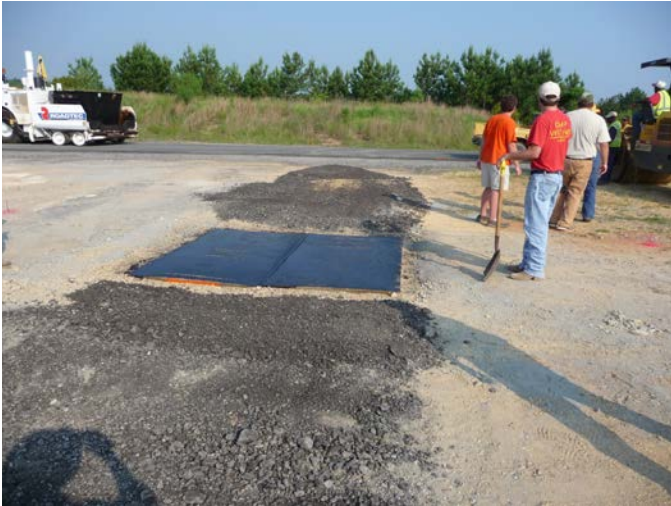
**Figure 1.2. Two plywood sheets for supporting test slabs.**

To facilitate construction and transportation, each of the two slabs was supported by four 4-ft by 8-ft laminated sheets of plywood. The plywood base was put on the ground, and hot asphalt tack was sprayed on the plywood surface (Figure 1.2) to ensure a good bond between the asphalt slabs and the plywood base. Then two layers of HMA with a total thickness of 4 to 6 in. were paved over the plywood sheets and carefully compacted.

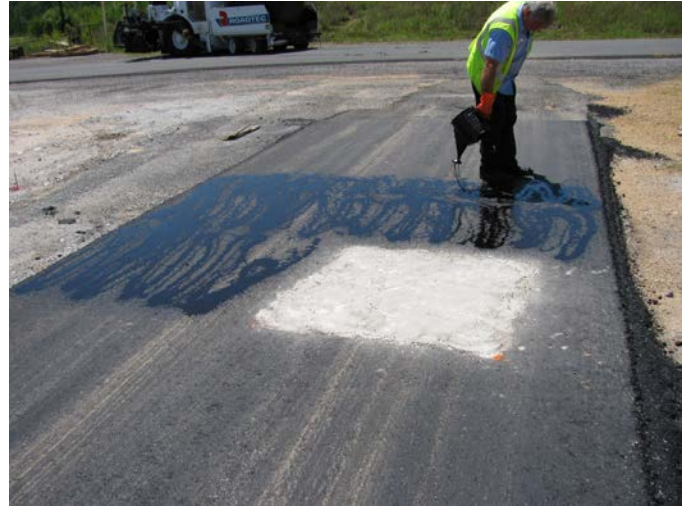
**Figure 1.4. One square covered with baghouse fines.**

After the third HMA layer was completed, the locations of two slabs were again surveyed and marked on the pavement. To create a debonded interface at a 2-in. depth for Slab A, a 4-ft by 4-ft square covered with baghouse fines was placed as shown in Figure 1.4. Hot asphalt tack was sprayed around the square to make good bond interfaces at a 2-in. depth for Slab B and the other half of Slab A. Then the last (surface) HMA layer was paved to a thickness of approximately 2 in. and carefully compacted.

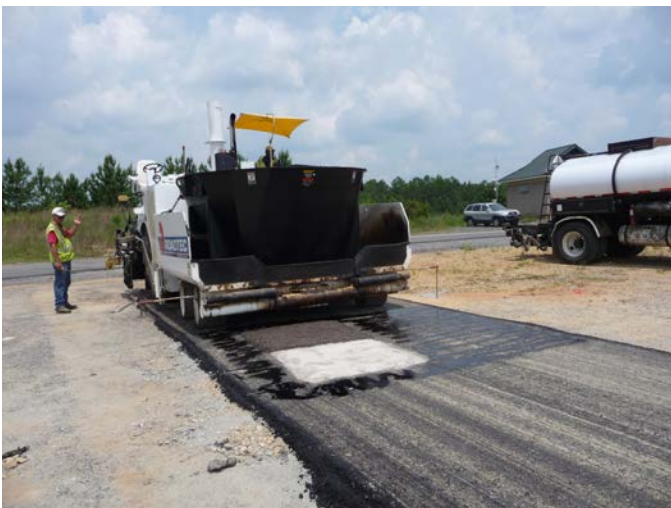
**Figure 1.3. Two squares covered with baghouse fines and RAP materials.**

Before the third asphalt layer was paved, the locations of two slabs were surveyed and marked on the pavement. Baghouse fines and RAP materials were placed on two 4-ft by 4-ft squares as shown in Figure 1.3 to simulate debonding and stripping interfaces at a 4-in. depth for Slab B. For Slab A, asphalt surface was tacked to make a good bond interface at a 4-in. depth. Then the third HMA layer that was approximately 2 in. thick was paved and carefully compacted.

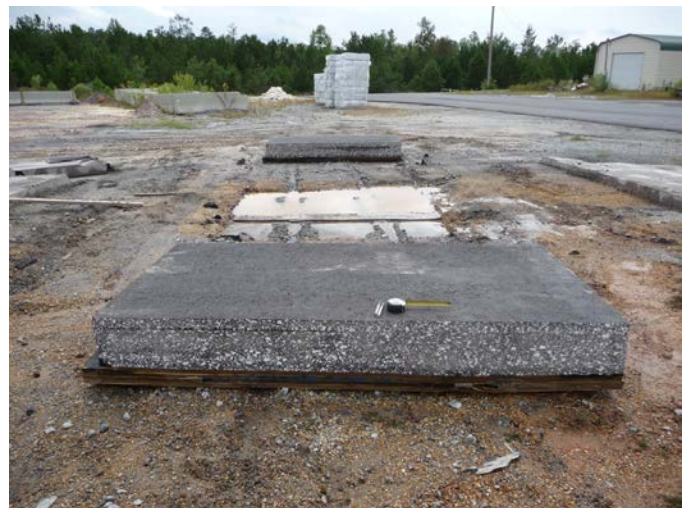
**Figure 1.5. Slab A (foreground) and Slab B (background).**

After the construction was completed, two slabs were cut out of the pavement section (Figure 1.5). The locations of stripped and debonded interfaces were examined. Figure 1.6 shows Slab A, which has one half of the slab with all good bond interfaces, and the other half of the slab with a debonded interface at a depth of 2 in. Slab B, as shown in Figure 1.7, has an approximately 1-in.-thick stripped layer at a depth of approximately

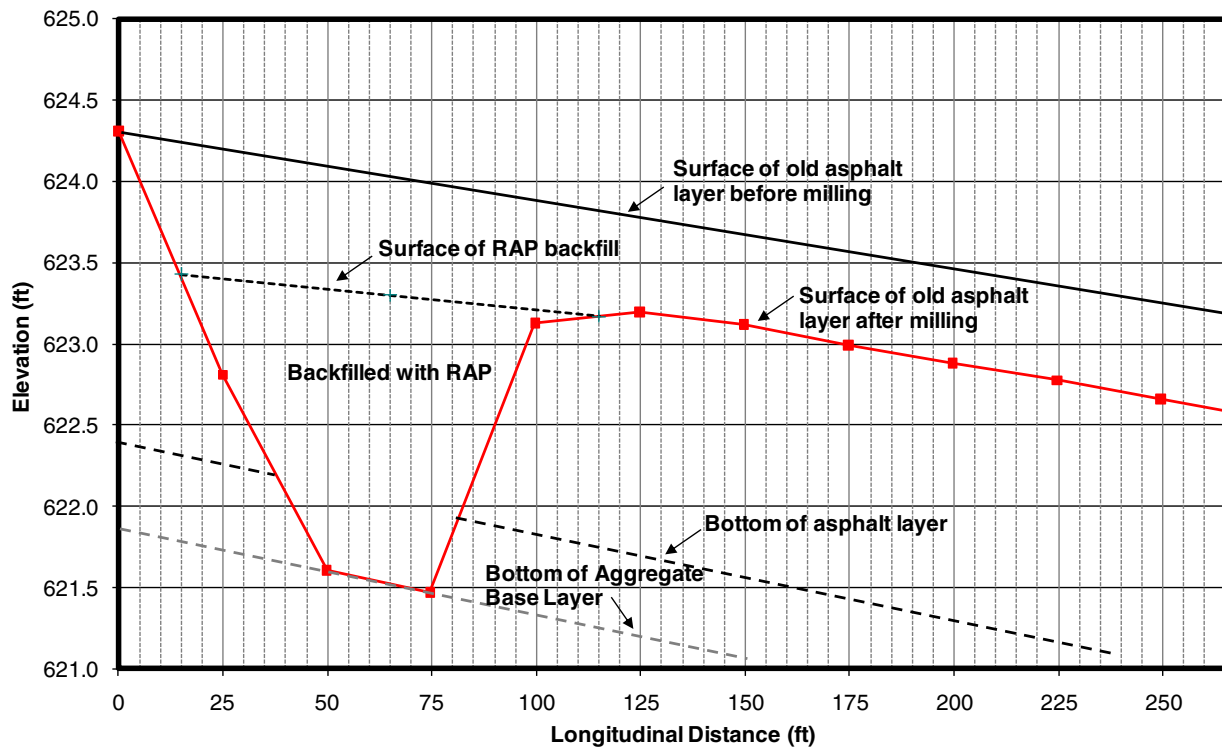
Figure 1.20. Milling and backfilling profile (Stations 0+00 to 2+65).

As previously described, the 10 pavement test sections were built in the inside lane adjacent to Section 5 between Stations 0+15 and 2+65. The old pavement section built between those stations was constructed in 2000 with a 24-in.-thick HMA layer on top of a 6-in.-thick aggregate base. Because there were deep cracks between Stations 50 and 75, repairs were done before construction of the delamination test sections. The asphalt and a portion of the aggregate base layers were milled at the beginning of the old pavement section (Figure 1.20). For the second half of the experimental section, the old asphalt layer was milled approximately 6 in. thick to accommodate the delamination test sections.

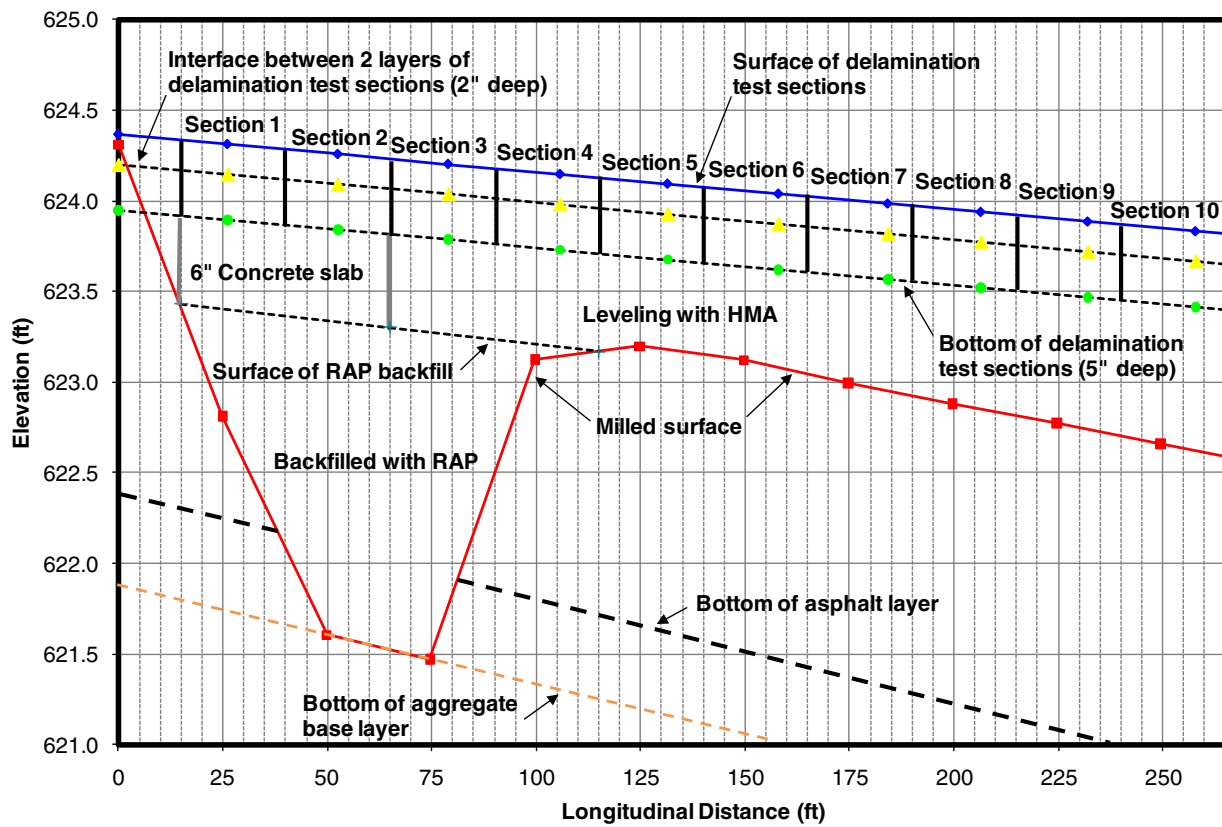
Figure 1.21. Pavement test section profile (Stations 0+00 to 2+65).

After the milling and backfilling work was completed, a 6-in.-thick concrete slab was constructed from Station 0+15 through Station 0+65, as shown in Figure 1.21. Layers of HMA were paved from Station 0+65 through Station 2+65 to *(text continues on page 9)*

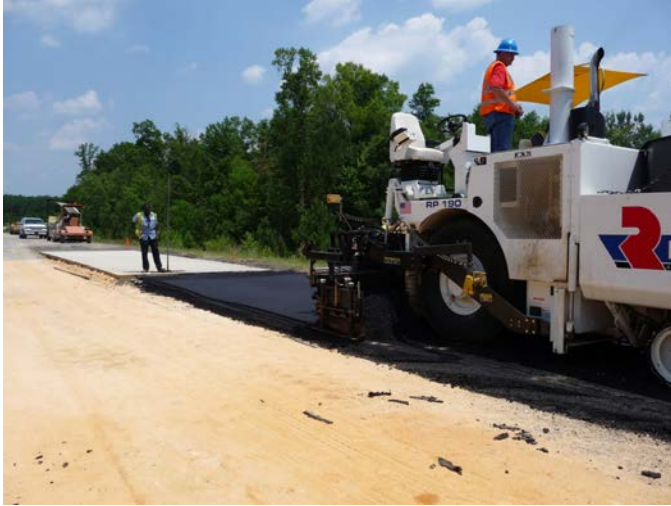
**Figure 1.22. Concrete slab (Stations 0+15 to 0+65) and leveling HMA (Stations 0+65 to 2+65).**

prepare the bottom surface for the delamination test sections. Figure 1.22 shows the concrete slab and the leveling layers of HMA being constructed between Stations 0+65 and 2+65.

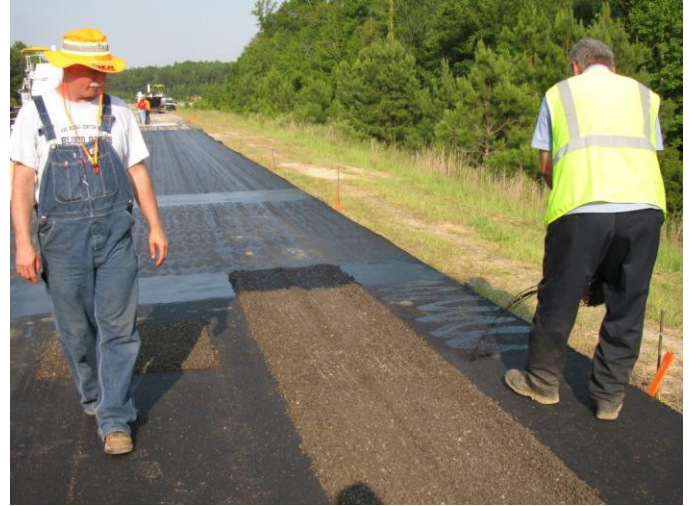
**Figure 1.24. Uncompacted RAP material approximately 1 in. thick placed in Section 8 at depth of 5 in.**

As previously illustrated in Figure 1.9, Sections 1, 8, 9, and 10 were designed to have delamination problems at 5 in. depth. As shown in Figure 1.23, two layers of brown paper were used as a bond breaker on the left, and baghouse fines material was used on the right in Section 1, as shown in Figure 1.10. As previously shown in Figure 1.17, a partial striping condition was designed at 5 in. depth. An approximately 1-in.-thick, uncompacted RAP layer was used to create the striping condition in the field (Figure 1.24). Following

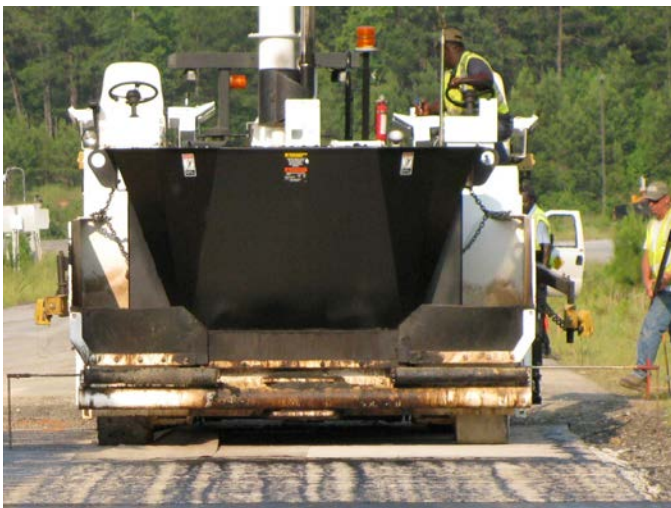
**Figure 1.23. Brown paper (left) and baghouse fines (right) used as bond breakers in Section 1 at depth of 5 in.**

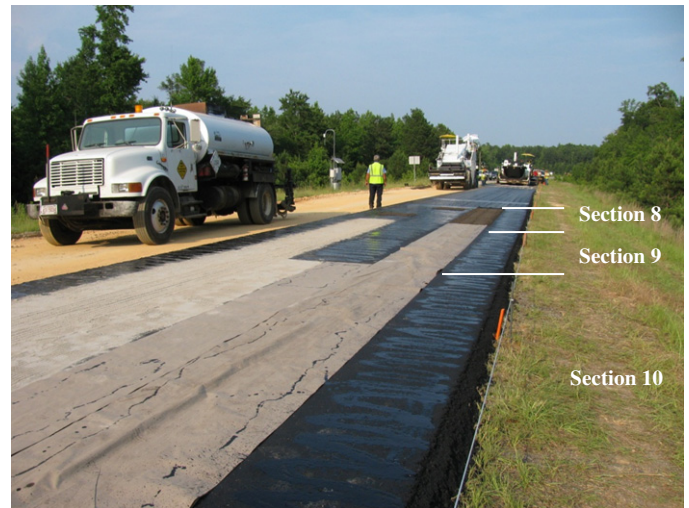
**Figure 1.25. Brown paper and baghouse fines used at depth of 5 in. in Sections 9 and 10, near Section 8 (Figure 1.24 above).**

the proposed designs for Sections 9 (Figure 1.18) and 10 (Figure 1.19), the research team used two layers of brown paper on the right and baghouse fines on the left as bond breakers in the field, as shown in Figure 1.25.

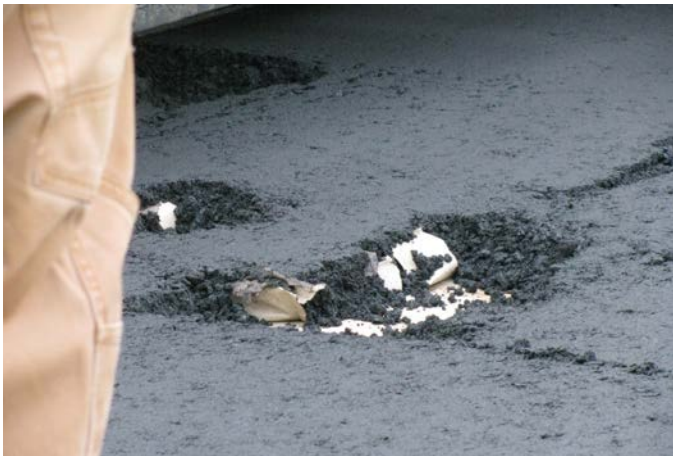
**Figure 1.26. Brown paper torn by paver at one location in Section 9.**

No traffic was permitted on the newly paved experimental sections. A hot spray-applied asphalt tack was placed between lifts, and no tack was placed on delaminated areas. Despite the presence of the delaminated conditions, the placement of the 3-in. bottom lift for the delamination test sections went smoothly, except for two problems: the paver tires picked up the paper, and the screed ripped the top layer of paper at one location in Section 9 (Figure 1.26). The HMA layer was repaired (filled), but the double paper condition was lost.

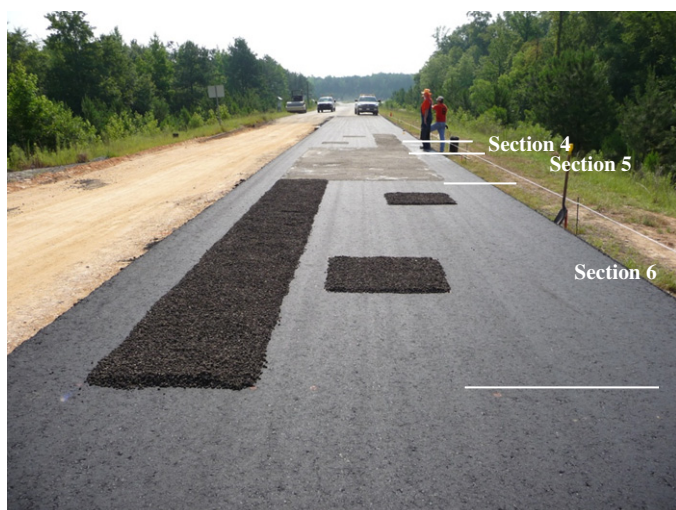
**Figure 1.27. Approximately 1-in.-thick, uncompacted RAP materials placed in Section 6 at depth of 2 in.**

After the bottom lift was placed and cooled down, the research team placed the delamination conditions at a depth of 2 in. Because of the problems with the paper as previously discussed, the paper was not used as a bond breaker at the 2-in. depth. Figure 1.27 shows an approximately 1-in.-thick, uncompacted RAP layer that was placed in the three locations in Section 6, as previously detailed in Figure 1.15. Baghouse fines material was used in Sections 4 and 5 as a bond breaker (Figure 1.28), and the dimensions of the delaminated areas in Sections 4 and 5 are shown in Figure 1.13 and Figure 1.14, respectively.

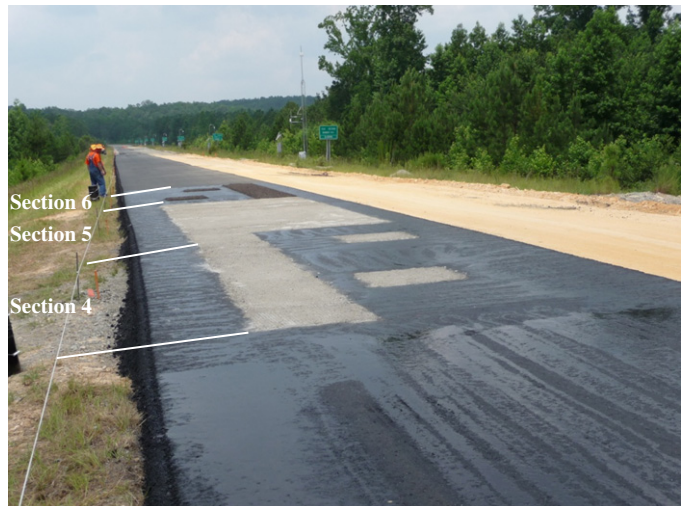
**Figure 1.28. Baghouse fines used as bond breaker in Sections 4 and 5 at depth of 2 in.**

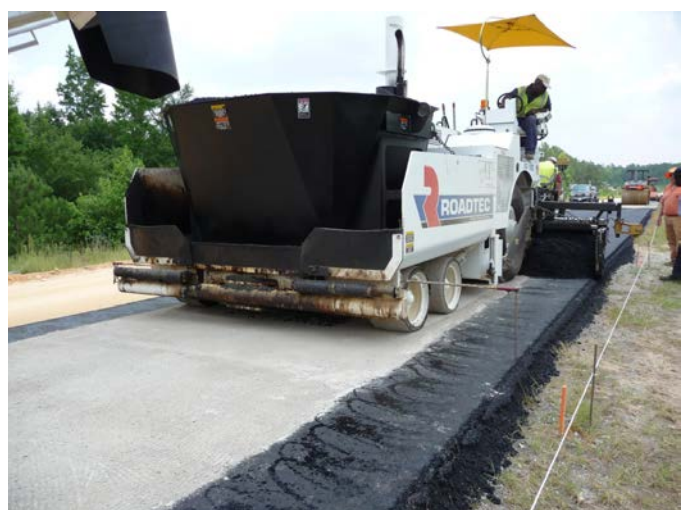
**Figure 1.29. Paver placing 2-in. surface lift over baghouse fines in delaminated area in Section 5.**

Figure 1.29 shows the paver placing HMA on the delaminated area of baghouse fines at a depth of 2 in. in Section 5. The placement of the 2-in.-thick HMA surface layer in Sections 4 and 5 went smoothly. As shown in Figure 1.30, the paver was moving to the delaminated areas and using uncompacted RAP materials in Section 6. The placement of the surface layer went

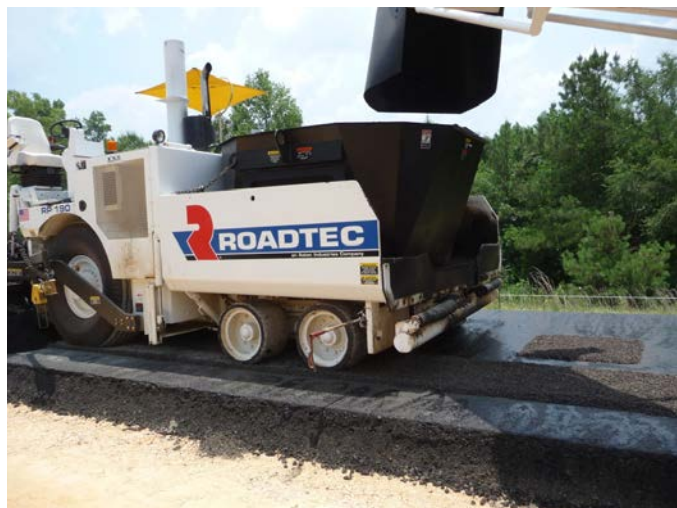
**Figure 1.30. Paver moving into delaminated areas and using RAP materials in Section 6.**

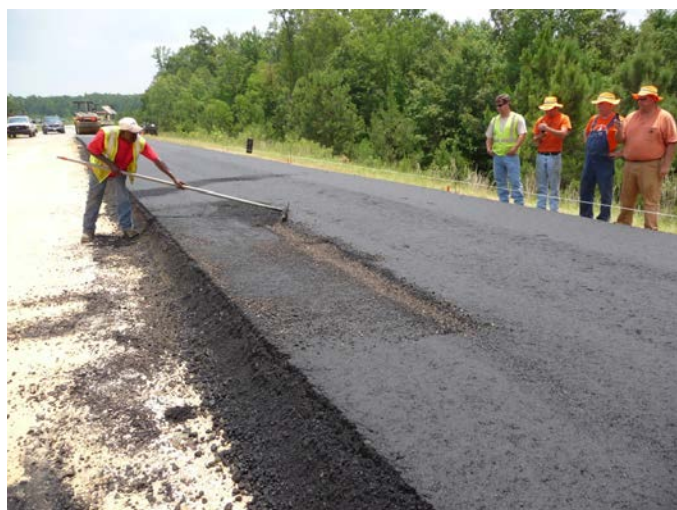
**Figure 1.31. Paver pushing RAP materials to the surface in Section 6.**

well at the beginning of Section 6. However, the uncompacted RAP layer may have been too thick for the 2-in.-thick surface layer, because the screed behind the paver was pushing the RAP materials to the surface toward the end of Section 6, as shown in Figure 1.31. The problem was immediately repaired in the field.

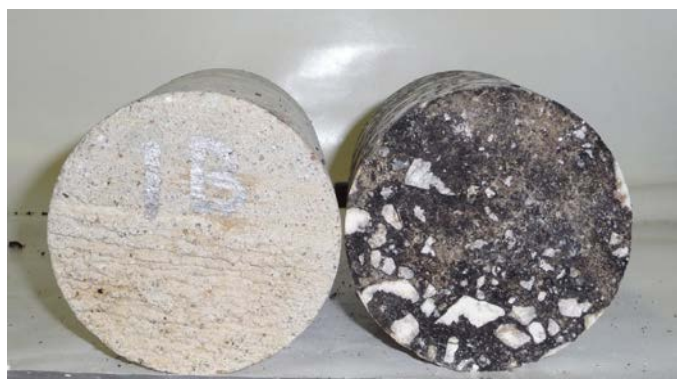
**Figure 1.32. Core 1 from Station 0+35 in Section 1.**

After the first round of laboratory and field evaluations under Task 6 in late October and November 2009, the research team extracted five cores to verify the interface conditions of the field test sections. Figure 1.32 shows two portions of Core 1 broke at a depth of approximately 5 in. from the pavement surface during coring. This confirmed that the baghouse fines placed on top of the concrete slab (at a depth of approximately 5 in. from the surface) caused the debonding problem at the interface, as was anticipated. Figure 1.33 shows Core 2 extracted from Section 2 (one

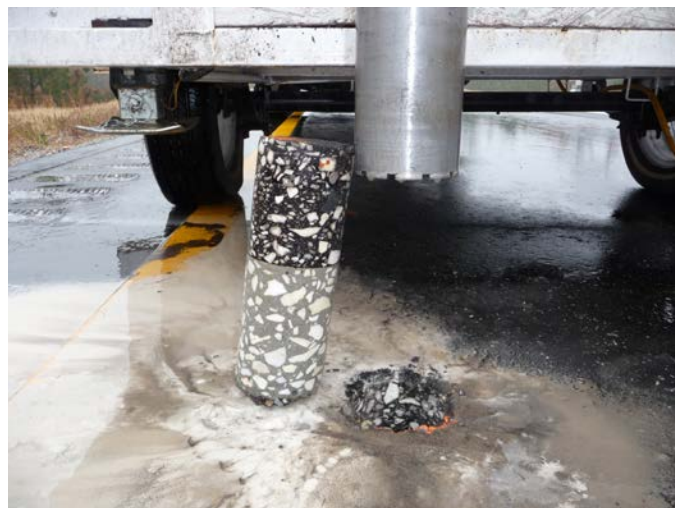
**Figure 1.33. Core 2 from Station 0+45 in Section 2.**

of the control sections), and this core showed no signs of delamination, as expected.

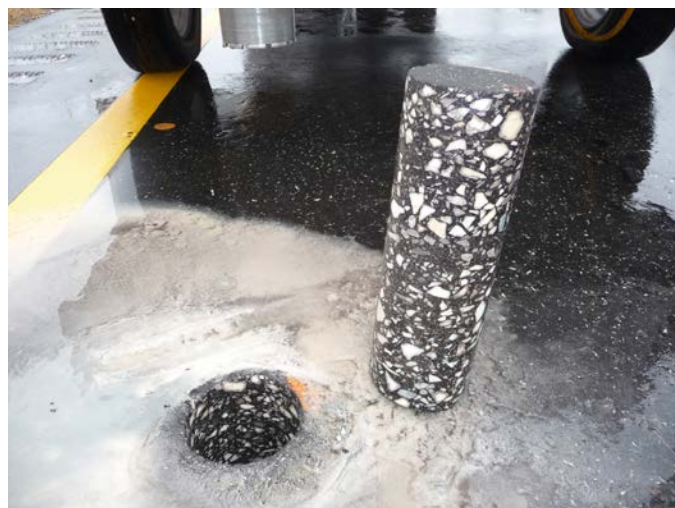
**Figure 1.34. Core 3 from Station 1+35 in Section 5.**

Figure 1.34 shows Core 3 extracted from Section 5. It was anticipated that the interface at approximately 2 in. depth from the pavement surface would break during coring; however, this interface was intact even though a thin layer of baghouse fines could be seen at the interface. More cores will be extracted from this test section to evaluate the delamination condition further.

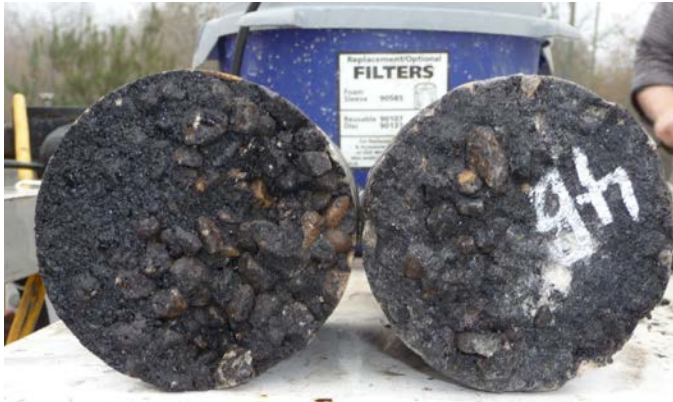
**Figure 1.35. Core 4 from Station 2+10 in Section 8.**

Core 4 shown in Figure 1.35 was extracted from Section 8. The interface at a depth of approximately 5 in. broke during coring. This interface was delaminated with an approximately 1-in.-thick, uncompacted RAP layer. The last core (Figure 1.36) was cut from Section 9. The core broke at the 5-in. interface where two layers of brown paper were used as a bond breaker. More cores will be extracted after all the field evaluations under Task 6 are completed.

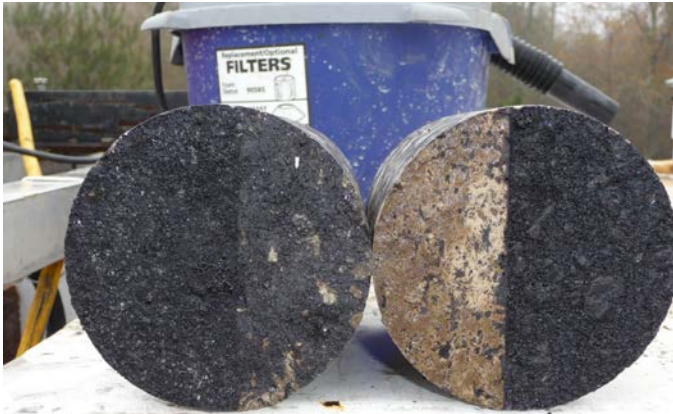
**Figure 1.36. Core 5 from Station 2+20 in Section 9.**

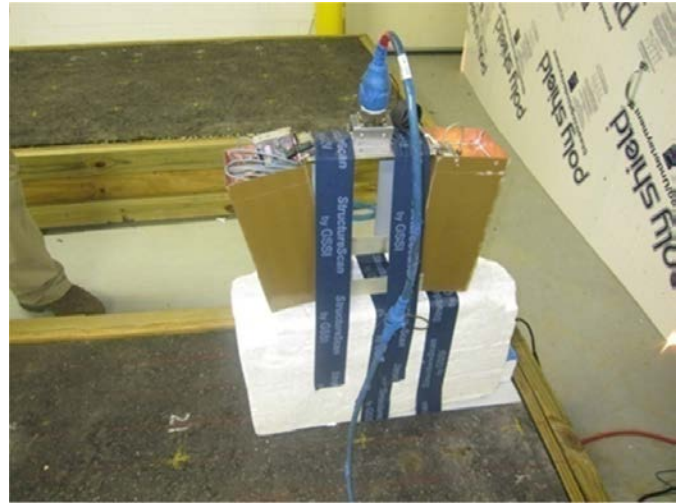
(a)

(b)

**Figure 2.1. Scanning of slabs with GSSI equipment: (a) 2.6-GHz ground-coupled antenna pair and (b) prototype 3-GHz horn antenna.**

Because the GSSI system involved individual antennae, a series of survey lines was marked on each test slab, and each slab was scanned by each antenna along these lines. The survey for each slab consisted of 15 parallel lines of data in the long direction, spaced 3 in. apart. The scanning process is shown in Figure 2.1. In Figure 2.1a, a small distance-encoder wheel was used to trigger data collection at regular distance intervals. In Figure 2.1b, the foam block was used to elevate the horn antenna above the slab surface, in lieu of a system for suspending the antenna over the slab.

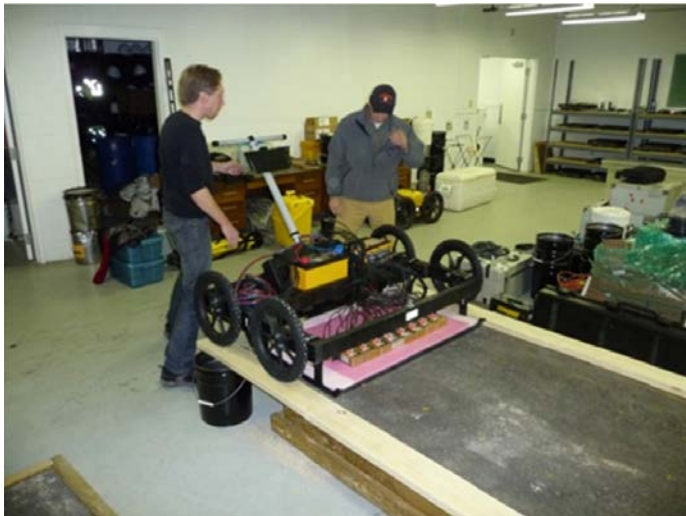
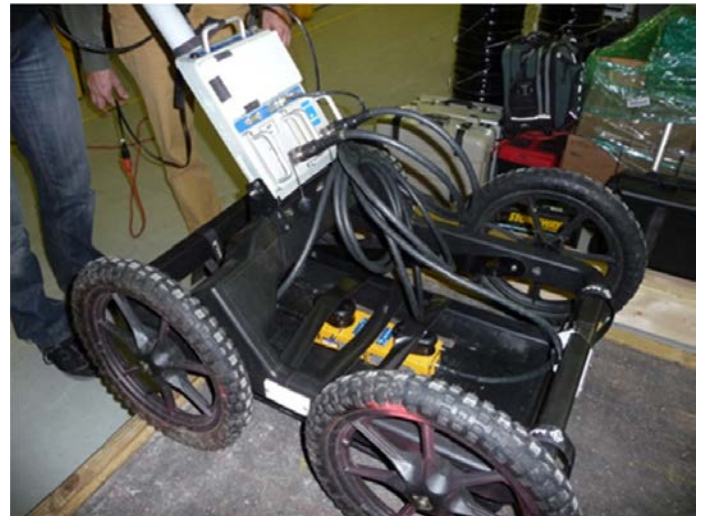
(a)

(b)

**Figure 2.2. Slab tests with MALA equipment: (a) MIRA system and (b) a pair of 2.3-GHz antenna.**

Tests were carried out with the 1.3-GHz MIRA array and with individual scans by using the 2.3-GHz antenna. Each test’s slab was surveyed with a single pass of the MIRA array. Figure 2.2a shows the MIRA setup. The size of the array was enough to cover a good percentage of the width of each slab. The wooden rails were set up on each side of the tested slab to support the wheels of the MIRA cart. In the first round of testing, three passes with a 2.3-GHz antenna pair were carried out by using the cart arrangement shown in Figure 2.2. In the second round of testing, the cart supported a four-antenna array, and a parallel series of seven profiles provided complete coverage of each slab.

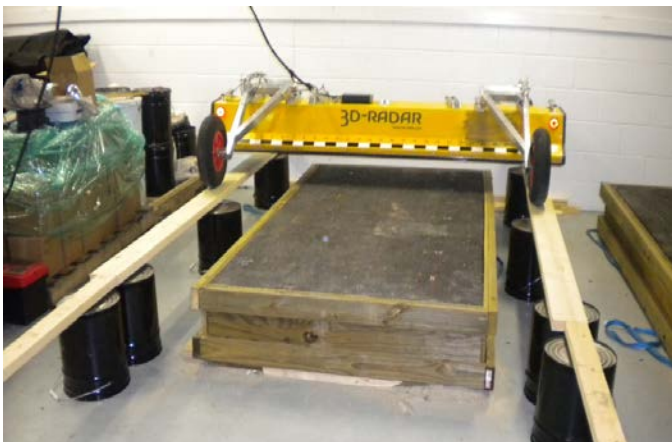
**Figure 2.3. 3d-Radar equipment setup for laboratory slabs.**

The 3d-Radar system was used for slab testing, as shown in Figure 2.3. Note that the system is fairly large for the laboratory scale. Therefore, the results were more sensitive to boundary and end conditions. Also, special arrangements for supporting the wheels of the unit were made by using wooden rails outboard off the slab.

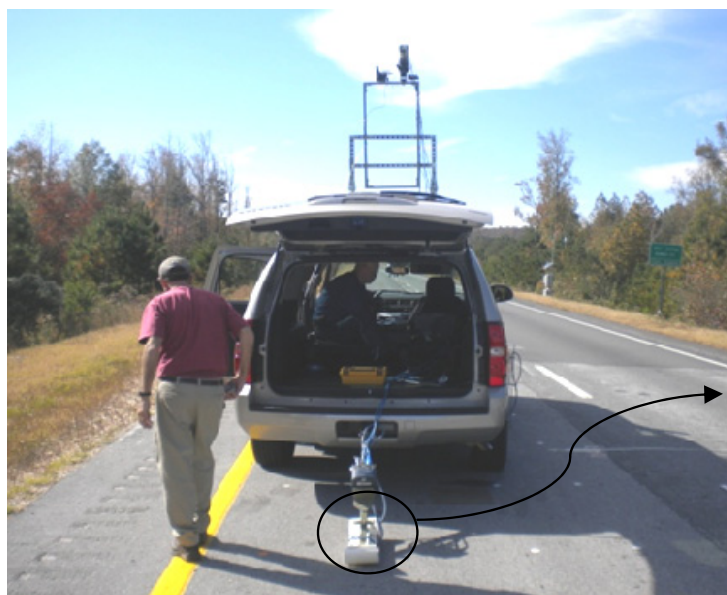
**Figure 2.4. Deployment of the GSSI 2.6-GHz ground-coupled antenna pair.**

GSSI tested the 2.6-GHz ground-coupled antenna pair and the prototype 3-GHz horn antenna at the test track. The initial tests used both systems, and the second round of tests focused on the 3-GHz horn. Initially, the tests were carried out on a series of data lines spaced at approximately 1 to 1.5 ft apart, with data-collection rates ranging from four to 12 scans per foot. Position of the data was registered by using a distance encoder mounted to the wheel of the test vehicle. The 2.6 GHz ground-coupled antenna pair was placed end-to-end on a skid plate, as shown in Figure 2.4. With this arrangement, both antennae were dragged along the ground at a speed of 2 to 3 mph. The horn antenna was suspended about 12 in. above the pavement surface by using a wooden beam for support, as shown in Figure 2.5. The alignment of the data lines was visually maintained by the vehicle driver using spacing markers painted on the pavement surface every 100 ft.

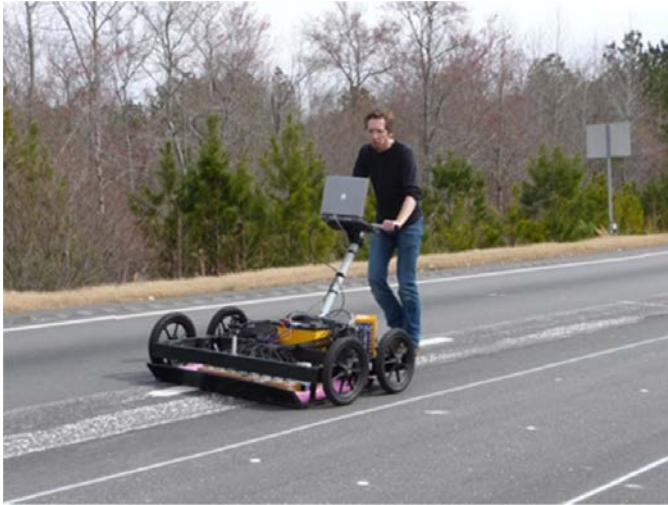
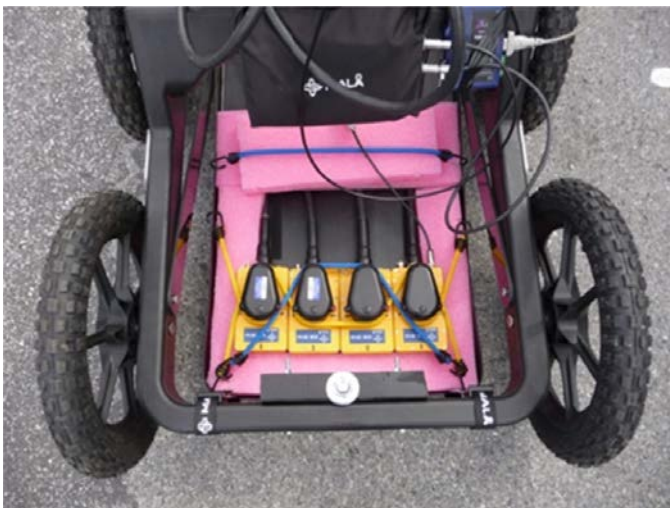
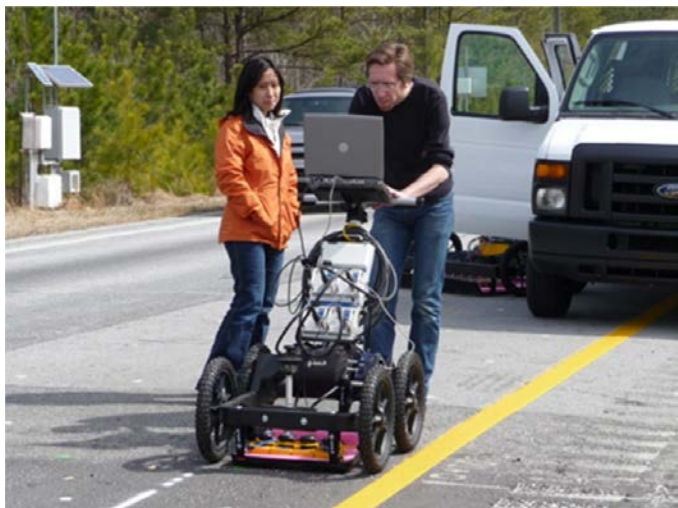
(a)

(b)

**Figure 2.6. Testing of MALA systems at the test track: (a) MIRA system and (b) 2.3-GHz antennae in a cart.**

30 in. wide, covered the full width of the test lane by using 6 overlapping passes. The MIRA data were collected with three transmit-receive antenna configurations: standard (monostatic), endfire array, and common midpoint (CMP) method. The MIRA system was deployed by using a wheeled cart and position of the data was obtained by using a total station (see Figure 2.6a).

The 2.3-GHz antennae were deployed with a wheeled cart, and position was recorded by using a linear distance encoder. Figures 2.6a and 2.6b show these two systems deployed on the

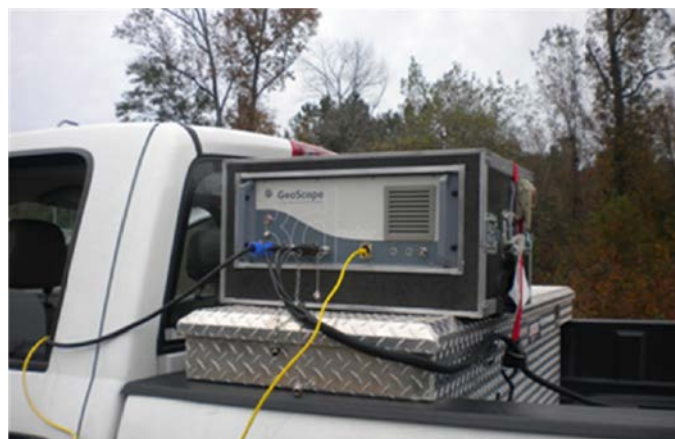
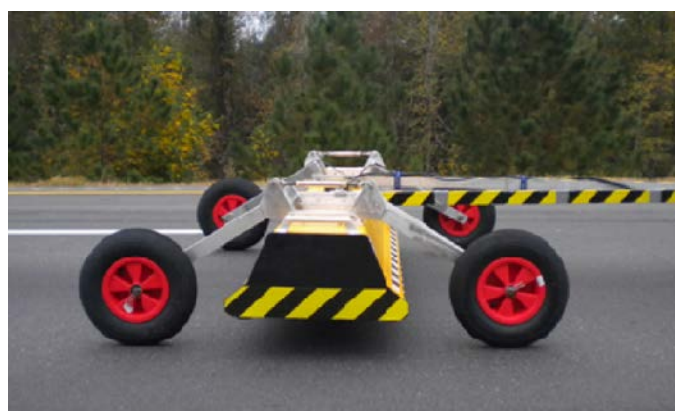
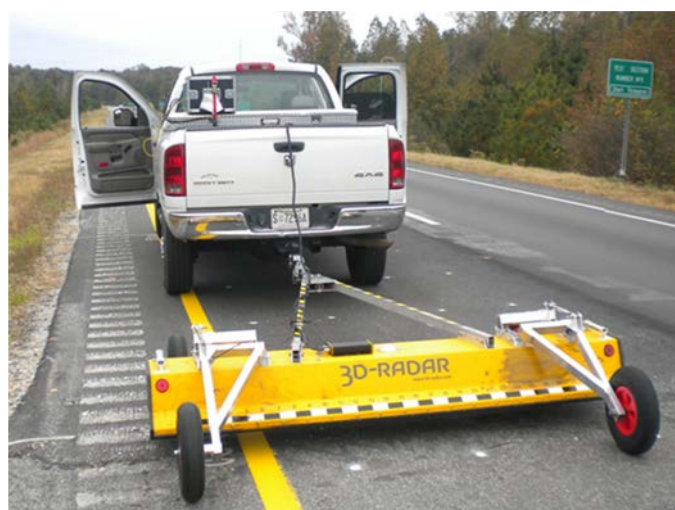
(a)

(b)

(c)

**Figure 2.7. 3d-Radar equipment: (a) GeoScope, (b) Side View, and (c) Rear View.**

In the first round of testing, 3d-Radar used a 2.3-m-wide antenna unit housing 29 antenna elements and producing 29 channels of data. The lateral coverage of this array was 2.25 m. The elements produced data by using a swept frequency with a range from 150 MHz to 2.69 GHz. A photograph of this equipment as it was deployed at the test track is shown in Figure 2.7. Signal generation and data acquisition were controlled by a unit called the “GeoScope,” which was mounted on top of a tool cabinet in the bed of the test vehicle. Data location was registered by using a linear distance encoder mounted to one

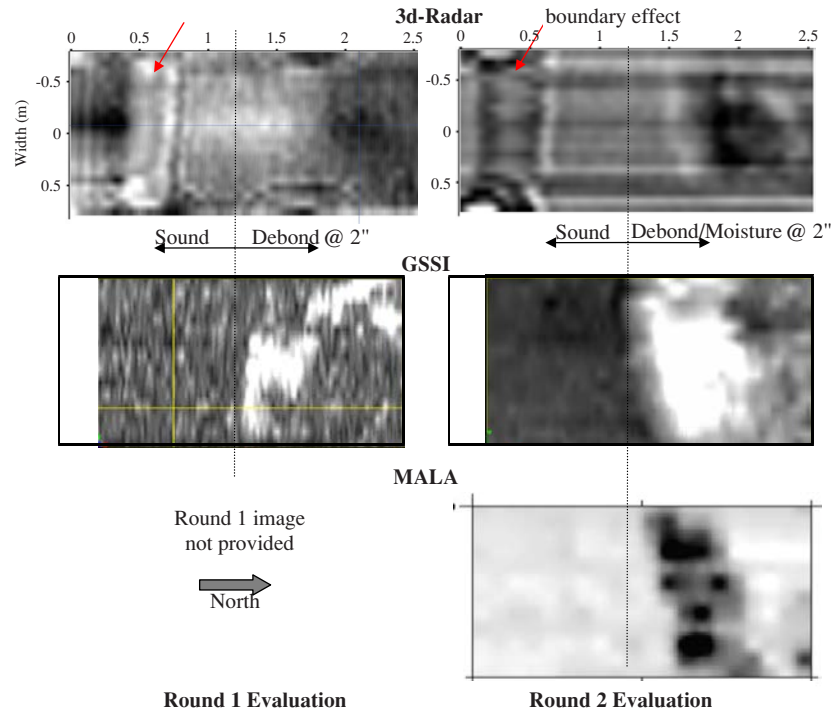
**Figure 2.8. Time-depth slices at 2 to 3 in. for first- and second-round testing of Slab A.**

Round 1 laboratory testing was carried out on the slabs as described in the construction report (see this volume, Chapter 1). For Round 2 laboratory testing, water was introduced into the delaminated areas to see whether its presence would affect their detection. The results of the first- and second-round testing on Slab A are shown in Figure 2.8.

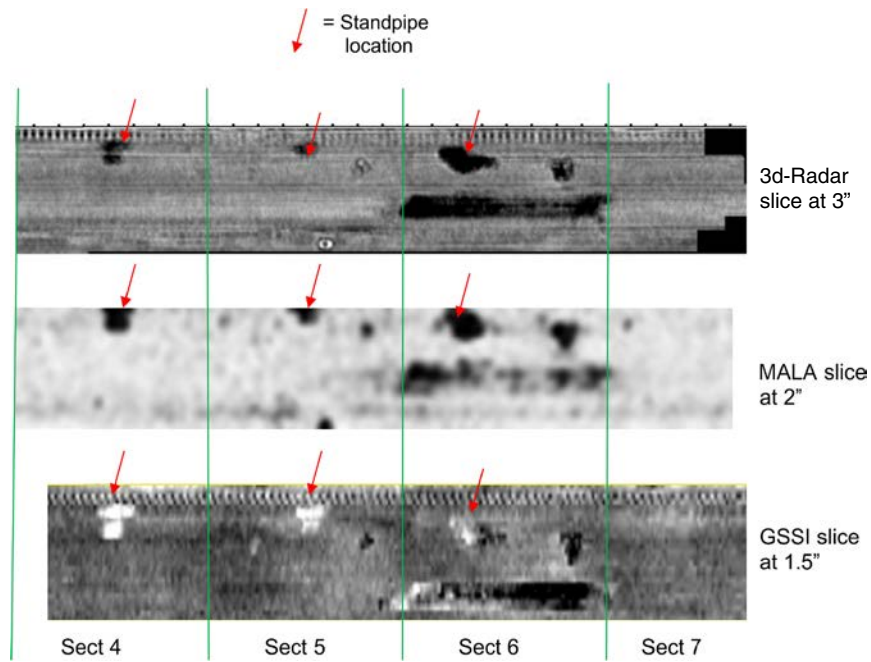
**Figure 2.10. GPR time-depth slices for Sections 4, 5, 6, and 7.**

Figure 2.10 shows the time-depth slices obtained for each GPR system in Sections 4, 5, 6, and 7 of the test track. Note that all systems were sensitive to the stripping condition located in Section 6 and to the presence of moisture in debonded areas, as noted by the standpipe locations. Other than by detecting the presence of moisture, the GPR systems were unable to detect the extensive presence of debonding at a 2-in. depth in Sections 4 and 5.

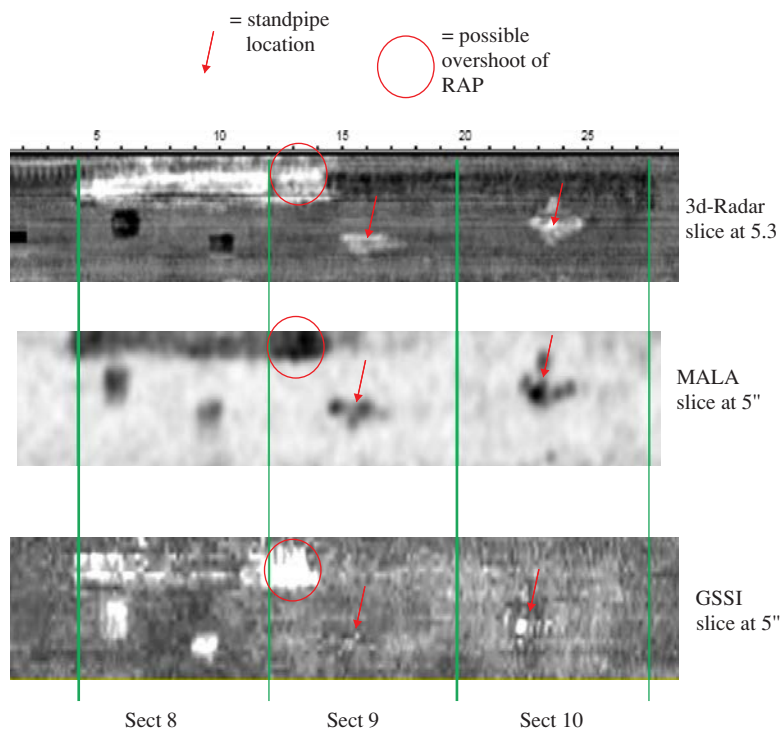
**Figure 2.11. GPR time-depth slices for Sections 8, 9, and 10.**

Figure 2.11 shows similar time-depth slices for Sections 8, 9, and 10. Once again, all systems were able to detect the stripping condition located in Section 8 at a depth of 4 in., as well as the presence of moisture in the 4-in.-deep debonded areas in Sections 9 and 10. None of the systems appeared capable of detecting extensive areas of debonding in Sections 9 and 10 where moisture was not present.

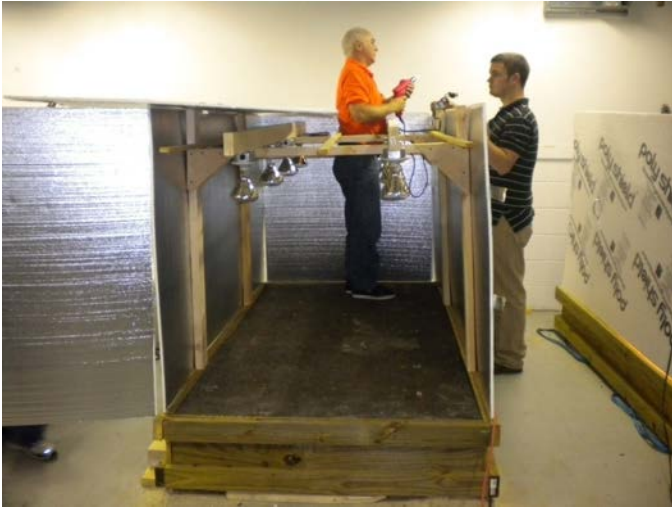
**Figure 3.1. Heating of test slabs with heat lamps.**

For each test slab, the IR cameras were operated from a ladder to provide sufficient height for a complete IR image view of the entire test slab. A series of still, IR images were recorded at specified times during the heating/cooling cycle of the test slab. The slabs were heated by using an array of eight high-intensity heat lamps, and surface and bottom slab temperature were continuously monitored during the heating process. A photograph of this heating setup is shown in Figure 3.1. During the heating process, the area around the heated slab was enclosed to contain the heat, as shown in Figure 3.2.

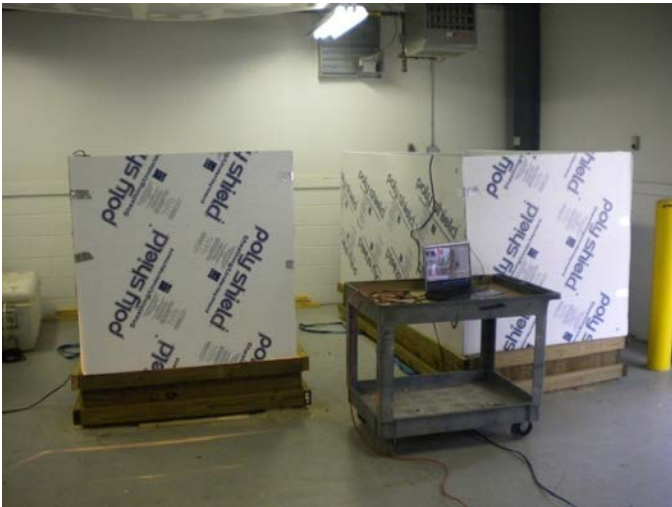
**Figure 3.2. Test slab enclosure during heating process.**

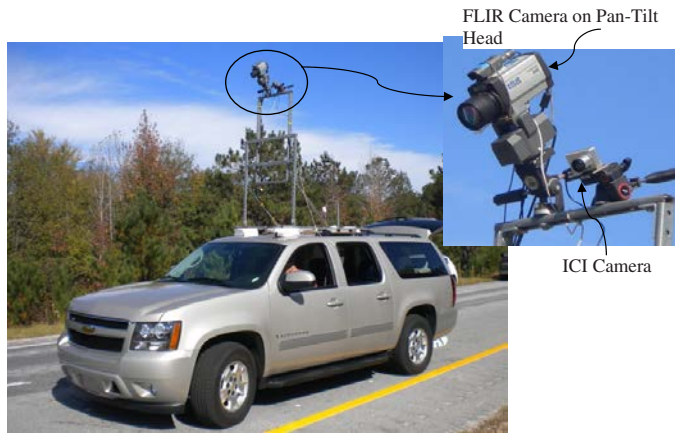
**Figure 3.5. IR thermography setup for track testing.**

The physical setup of the IR data-collection system is shown in Figure 3.5. Testing using the equipment shown in Figure 3.5 was carried out continuously by using a vehicle speed of approximately 3 mph. During each test, IR images were collected at 1-ft intervals and sequentially stored on the laptop hard drive. Simultaneously, a visual video image was recorded to a digital video recorder. The distance traveled was encoded with a counter and superimposed on the video image using a video overlay device. A sample pair of infrared and corresponding video images is shown in Figure 3.6. Note that because the video image was collected at the normal NTSC rate of 30 frames/s, the encoded distance on the video image

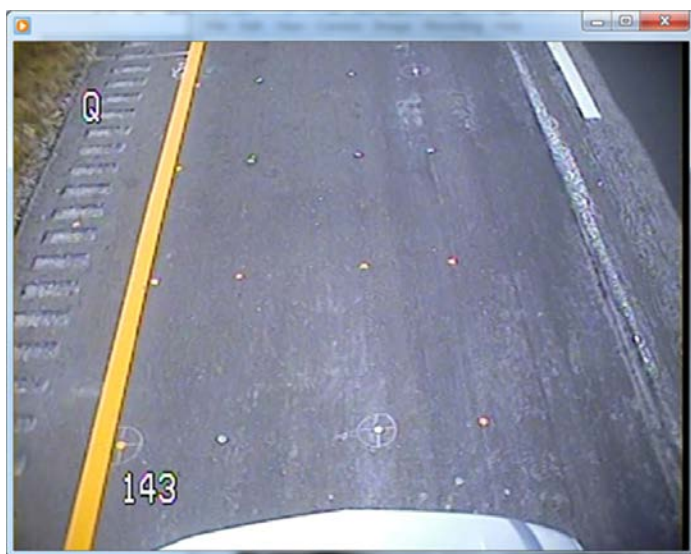
(a)

(b)

**Figure 3.6. Corresponding IR and video images: (a) video image with encoded distance and (b) IR image.**

provided distance registration. The corresponding IR image is Image 143, corresponding to 143 ft of travel.

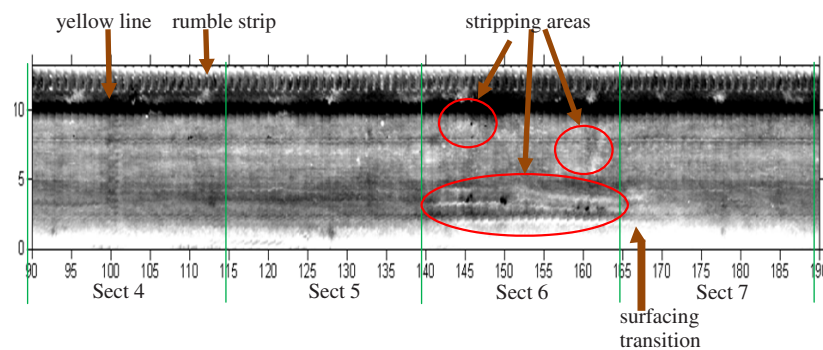
**Figure 3.8. IR strip image of Sections 4 through 7.**

Figure 3.8 shows an example of the analysis of the IR data. The figure shows a portion of the composite IR image representing Sections 4, 5, 6, and 7 at the test track. The image shows some anomalies in Section 6 in the area where 0.75 in. of reclaimed asphalt pavement was placed 2 in. down from the surface to represent stripping.

However, examination of the surface video shows that these anomalies correspond with surface features and tire marks rather than with subsurface features. In general, the IR image anomalies did not clearly correlate with the known subsurface defects in the test section.

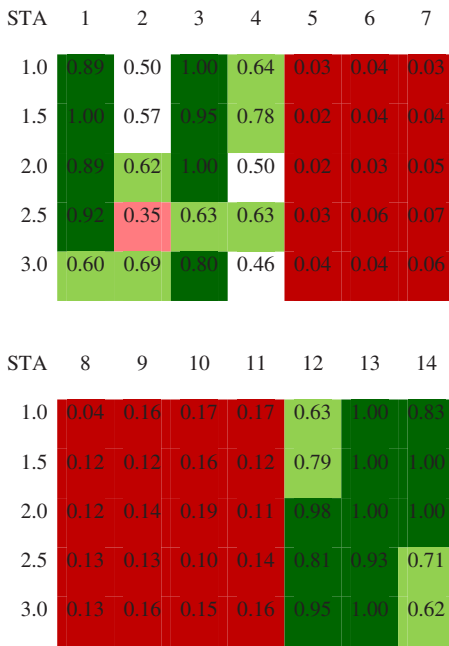
**Figure 4.3. Probabilities of laboratory slabs to be bonded.**

Further analysis was completed that identified the probability of each test point to be bonded. Vector distances between the waveform characteristics of the bonded and delaminated slabs were defined. The vector distances were

scaled as a probability measurement point being taken on a bonded slab. Since the conditions of the laboratory slabs were known, the area with the shallow delamination was used for calibration. This area was deemed to be the worst case and was scaled to give a 5% probability of being bonded. Average vector distances near zero were given a probability of 100% (bonded). Figure 4.3 shows a summary of the probabilities of each test point on the two laboratory slabs to be bonded. The red colors indicate a strong departure from energy being carried in surface waves (delamination), and the green colors indicate bonded areas.

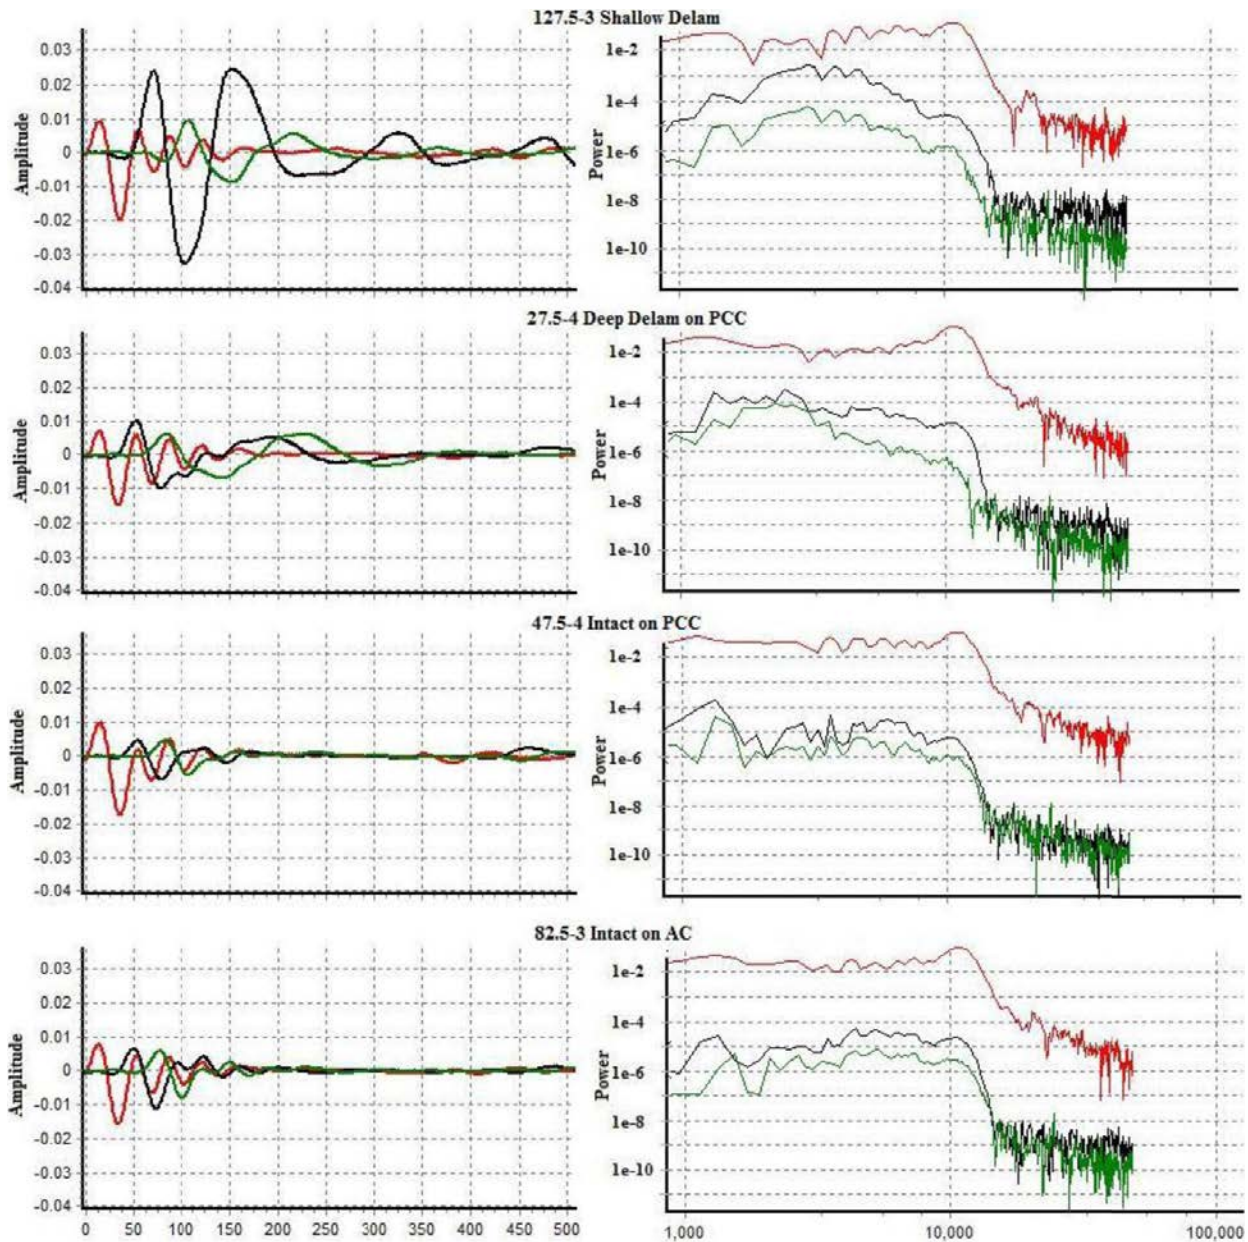
**Figure 4.4. Samples of time domain and frequency domain power spectra on test track in October 2009.**

The conditions of Sections 1, 2, 3, 5, and 8 were known to the vendor during the February testing and for the data analysis presented here. Figures 4.4 and 4.5 show the time and frequency domains of four conditions [i.e., shallow delamination, deep HMA delamination over portland cement concrete (PCC), bonded HMA over PCC, and bonded HMA] in the known areas on the test track for the October and February testing, respectively. The waveforms for each pavement condition at the warmer and cooler temperatures compare well with each other and with the slabs measured in the laboratory. The time domain waveforms of the delaminated areas have larger amplitudes with slower energy decay rates, while the bonded areas have smaller amplitudes with faster energy decay rates.
