## Nondestructive Testing to Identify Delaminations Between HMA Layers, Volume 3 - Controlled Evaluation Reports

**SHRP 2 REPORT S2-R06D-RW-3**

# Nondestructive Testing to Identify Delaminations Between HMA Layers

## Volume 3

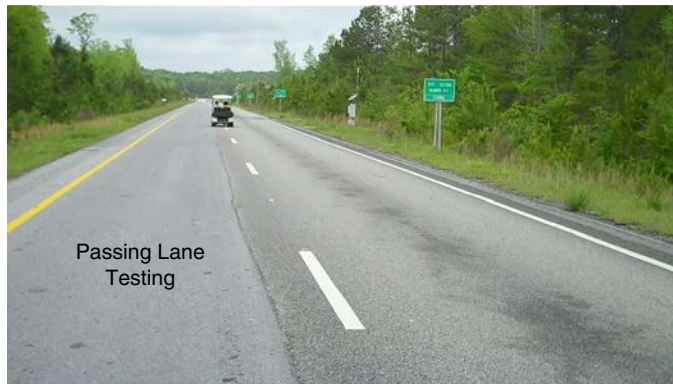
**Figure 5.1. NPTT blind test location.**

An ongoing SHRP 2 NCAT Pavement Delamination Project was initiated to investigate nondestructive methods of determining delamination between asphalt layers. The principal investigators of the project provided the testing layout where the ultrasonic tomography scans described below were carried out to determine the effectiveness of ultrasonic tomography in detection of delamination in asphalt. An ultrasonic tomography device, MIRA, was used to conduct a “blind test” of locations with various levels of fabricated distresses in the passing lane of the NPTT (see Figure 5.1).

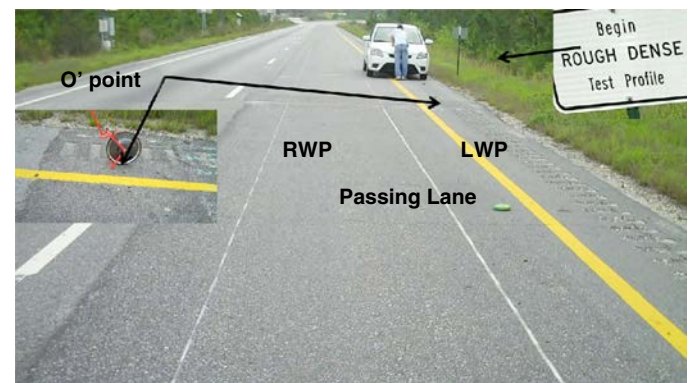
**Figure 5.4. Approximate longitudinal zero point location for MIRA testing.**

Auburn University personnel identified the general area where testing was needed to verify the capabilities of MIRA in delamination diagnostics (see Figure 5.4 for the approximate measurement zero point). The tested pavement was separated into ten 25-ft. sections for a total of 250 ft of scanning, with Section 1 starting at 15 ft in the longitudinal direction. MIRA scanning was conducted at various locations of the passing

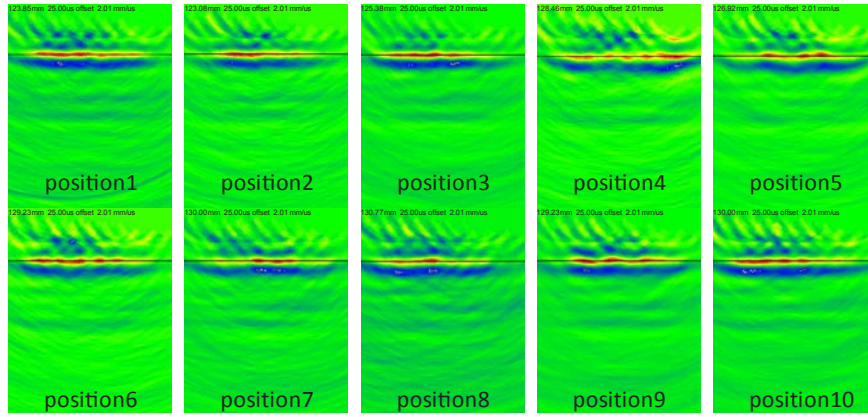
Section 1 Transverse Measurement (17' - 50 khz)

**Figure 5.14. SAFT-FW B-scans at a center frequency of 50 kHz taken from at 17 ft along the transverse direction starting at the LWP through a location just before the center of the passing lane.**

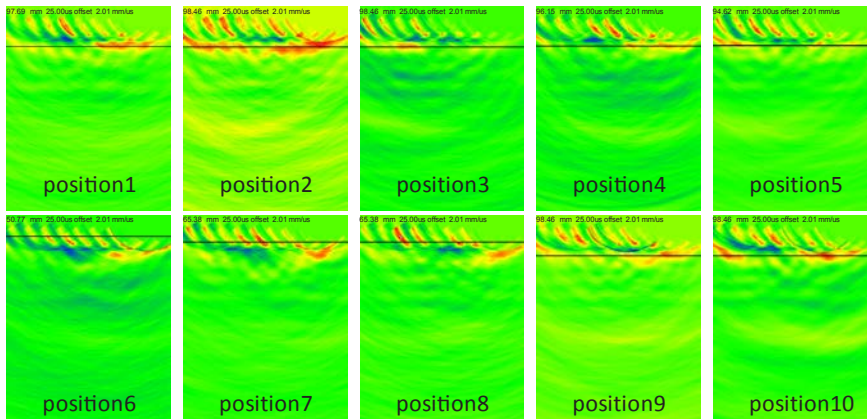
Section 7 Transverse Measurement (167' - 30 khz)

**Figure 5.49. SAFT-FW B-scans at a center frequency of 30 kHz taken from a location at 17 ft along the transverse direction starting at the LWP through a location just before the center of the passing lane.**

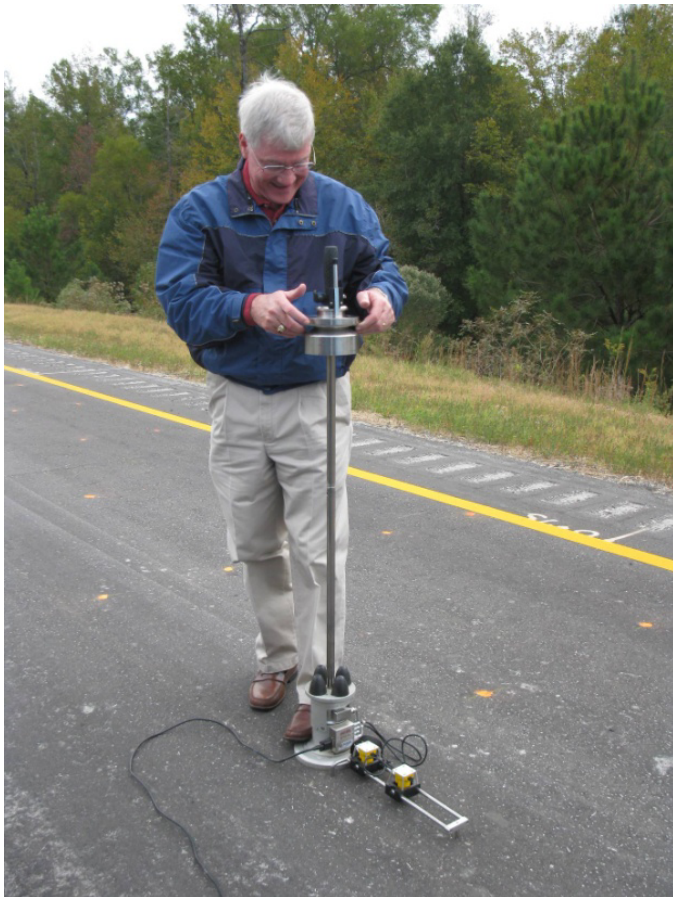
**Figure 6.1. LWD testing on HMA pavement.**

The lightweight deflectometer (LWD) is a nondestructive testing (NDT) device that provides a structural evaluation of pavement by using a drop weight and one to three sensors (Figure 6.1). The drop weights for the LWD are selected from 22, 33, or 44 lb, and the loading plate diameter can be adjusted to 3.8, 7.8, or 11.8 in. The weight is dropped from an adjustable height onto a rubber buffer located on top of a load cell. The results are presented as a plot of the time history of the load cell and the geophones. Peak deflection (recorded in mm) and surface modulus measurements of each sensor are recorded. Peak deflection is recorded in mils, and a mil is one thousandth of an inch.

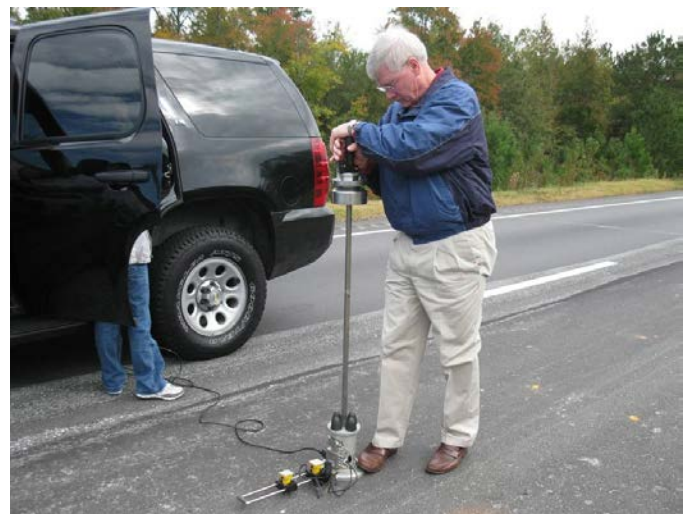
**Figure 6.2. LWD testing on NCAT test track.**

The pavement temperature at the beginning of the Round 1 tests was approximately 52°F, and the temperature at the end of the tests was approximately 70°F. For Round 2 testing, the pavement temperature ranged from 47°F to 56°F. Figure 6.2 shows the LWD testing on the test track. Significant differences were evident between the magnitude of the data collected on the test track and the data collected in the laboratory. The data collected at the track showed the deflections to be almost always less than 1 mil, whereas the laboratory measured deflections were generally above 4 to 5 mils. This

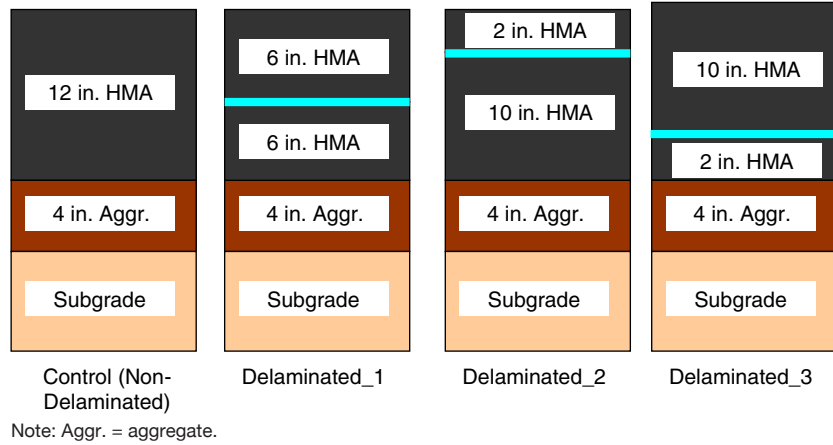
**Figure 7.1. Description of HMA pavements for Case 1, 12 in., scenario.**

Two case scenarios of HMA pavement structure under 9-kips FWD loading were modeled. As shown in Figure 7.1, Case 1, representing thicker HMA pavement structures, has a 12-in. HMA pavement structure without delamination and with delamination at different depths (2 in., 6 in., and 10 in. below the top HMA surface). Figure 7.2 illustrates Case 2, representing thinner HMA pavement structures. Case 2 has 6-in. HMA pavement structure without delamination and with delamination at different depths (2 in., 3 in., and 4 in. below the top HMA surface). The predicted vertical deflection results from BISAR for Cases 1 and 2 are presented in Figures 7.3 and 7.4. A difference in vertical deflection predictions between control (nondelamination) and delamination sections was observed in both cases. The greater deflections in both cases were observed in the HMA pavement structure with delamination at the middle of the HMA layer, denoted as “Delamination\_1” in Figures 7.3 and 7.4. These results indicate that BISAR can

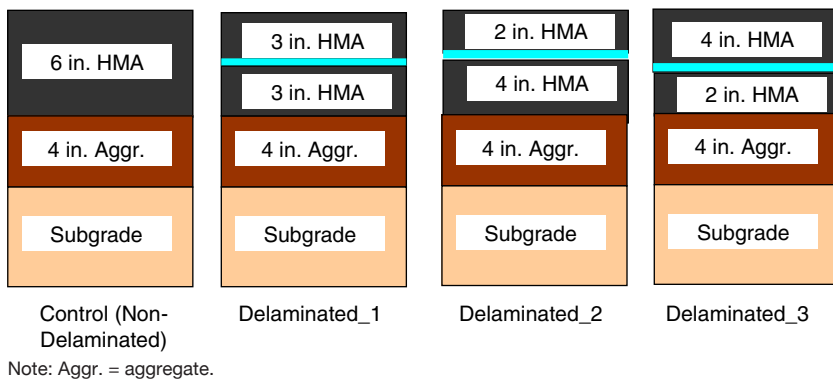
**Figure 7.2. Description of HMA pavements for Case 2, 6 in., scenario.**

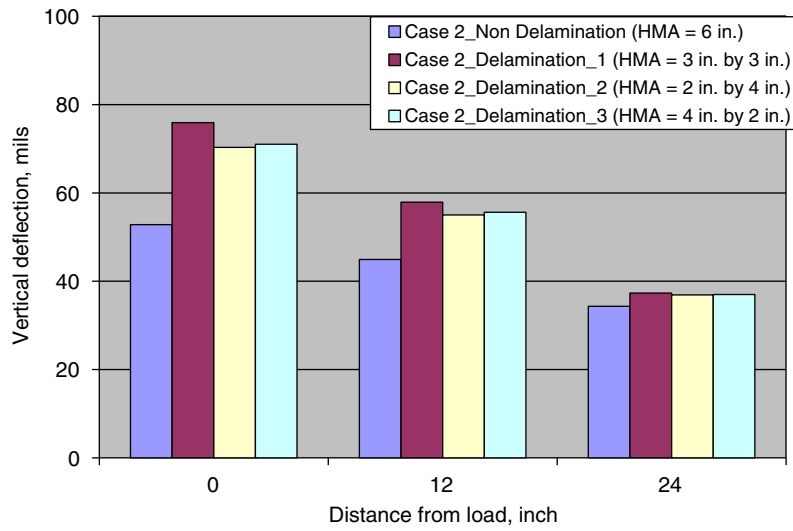
**Figure 7.4. Vertical 9-kips loading FWD deflections from BISAR for Case 2: (a) deflection bowls and (b) deflection measurements at distances of 0, 12, and 24 in. from FWD load plate.**

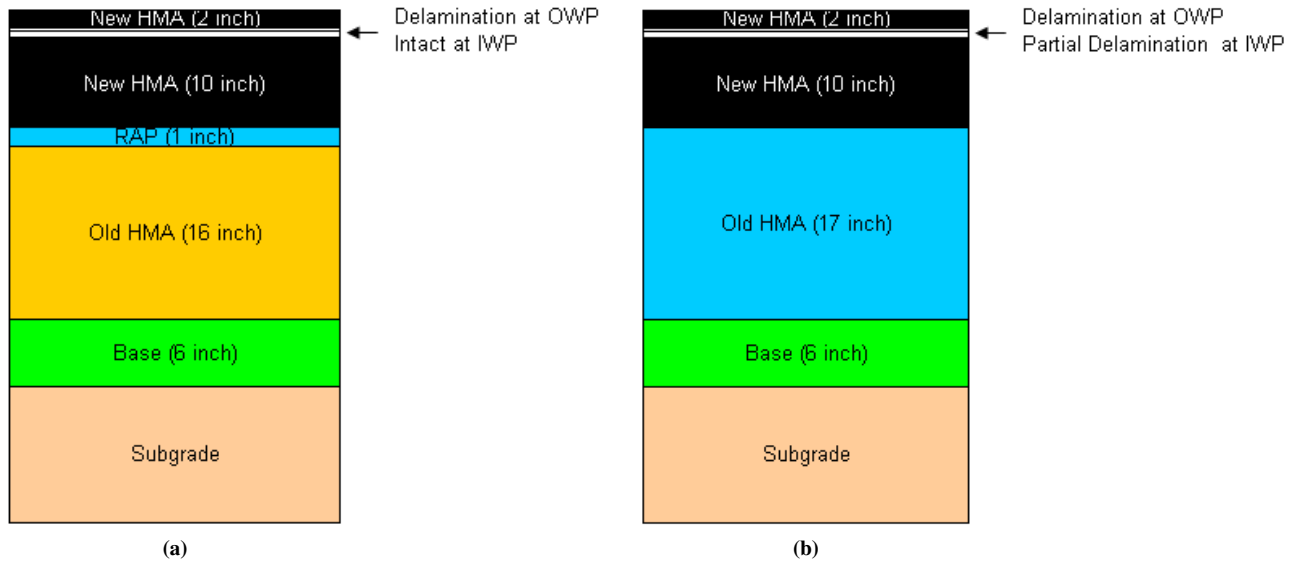
Figure 7.11. Pavement structure layout of NCAT Section 4 (not to scale) for (a) Test 6 and (b) Test 7.

Figure 7.11 illustrates the pavement structure layout of NCAT Section 4. Figures 7.12 and 7.13 present FWD measurements of FWD Tests 6 and 7 conducted on NCAT Section 4, respectively. NCAT Section 4 consisted of two parts: one part had no delamination in the IWP and delamination in the OWP for FWD Test 6. The other part had partial delamination in the IWP and delamination in the OWP for FWD Test 7. Similar FWD measurements were observed at delaminated and non-delaminated FWD testing locations.

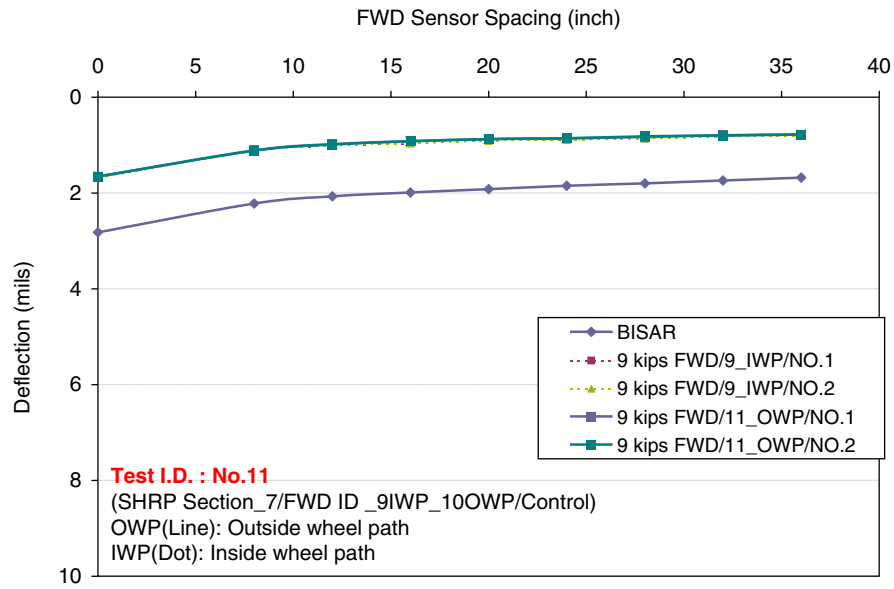
**Figure 7.51. Comparisons of BISAR results with 9-kips loading normalized FWD measurements for FWD Test 11 at NCAT Section 7.**
