Evaluation and Assessment of Environmentally Sensitive Stream Bank Protection Measures

NCHRP REPORT 822

**Evaluation and Assessment
of Environmentally Sensitive
Stream Bank Protection Measures**

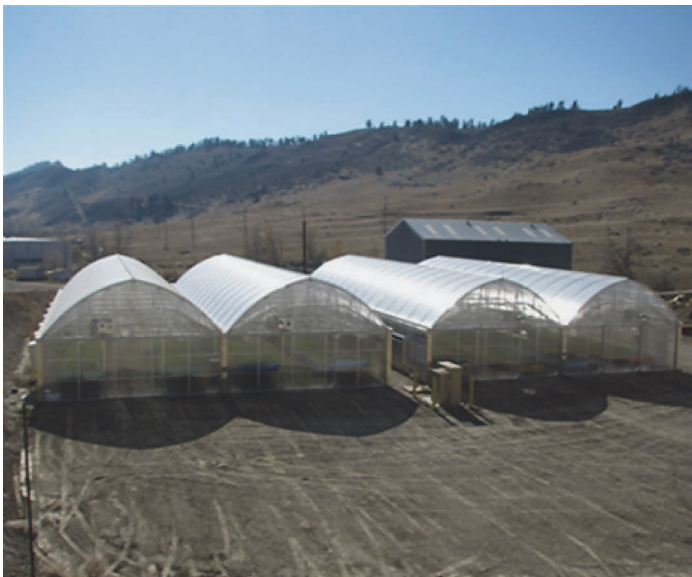
Figure 1.1. (Left) Climate-controlled greenhouses at CSU's Hydraulics Laboratory. (Right) Turf grass grown in large trays for subsequent hydraulic testing.

Two treatments were installed in large trays and nurtured in CSU's climate-controlled greenhouses, which provide customized light, temperature, and humidity conditions for year-round establishment and growth of many different types of vegetation. When vegetation was established to a predetermined condition, the trays were moved to a large outdoor flume for testing under the desired hydraulic conditions. Figure 1.1 provides an example of the greenhouse facility and vegetated trays used in hydraulic testing.

During this project, this deficiency was addressed by conducting well-planned, carefully controlled flume tests in the unique facilities at CSU described in Section 1.2.1 (see Figure 1.1). Tests would focus on a few selected but representative biotechnical measures that could be constructed with real plants in deep planter boxes. Plant materials would be given time to establish prior to installation on the banks of the experimental trapezoidal channel. Measurements of the flow field conducted during flume runs would then be used to calibrate an appropriate one-dimensional computer model.

1. The soil, rock, and stream bed materials required for each specific treatment will be installed in large planter trays in the CSU climate-controlled greenhouse (see Figure 1.1). Various treatments will be installed at the beginning of the Phase II program, selected in consultation with the NCHRP 24-39 project panel.

For Task 7, the extensive laboratory facilities and hydraulic modeling expertise of CSU were available. These included the unique greenhouse facilities where biotechnical treatments can be grown/installed to meet particular specifications for later testing at prototype scale in a large outdoor flume (see Figure 1.1). These tests provided specific hydraulic design parameters for the selected biotechnical treatments. The outdoor flume was made available on a priority basis at the appropriate time in the testing sequence. Testing included two representative biotechnical measures that were constructed with real plants in large planter boxes (6-ft wide by 20-ft long by either 12 or 18 in. deep). Plant materials were given time to establish prior to installation on the banks of the experimental trapezoidal channel.

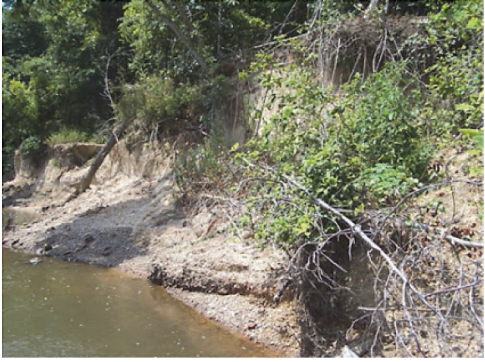
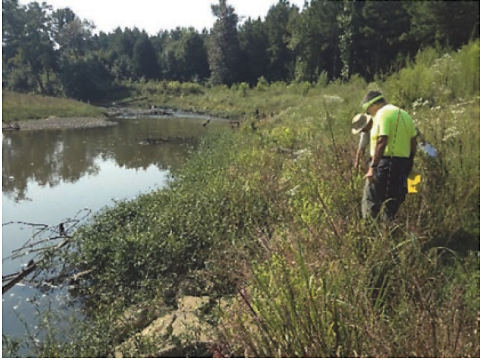
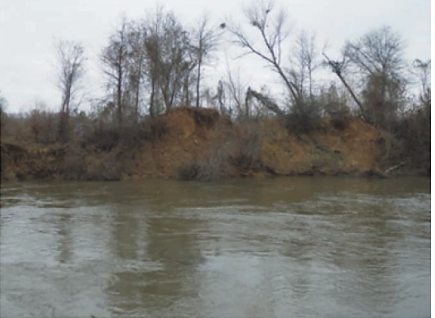
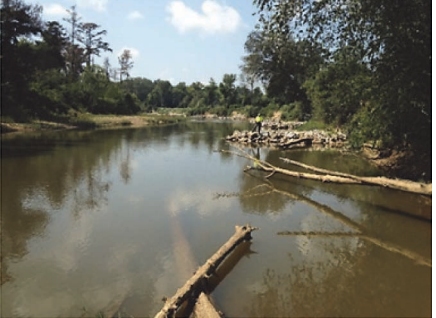
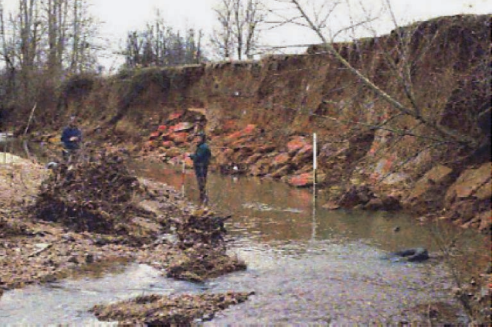
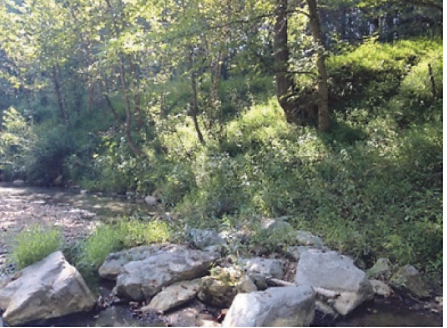
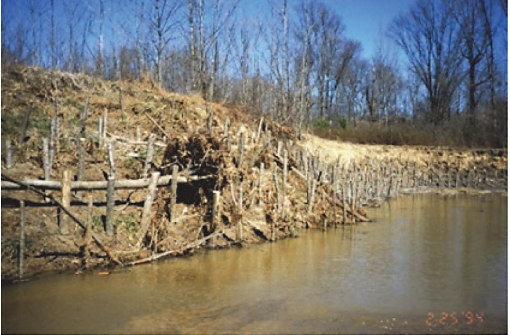
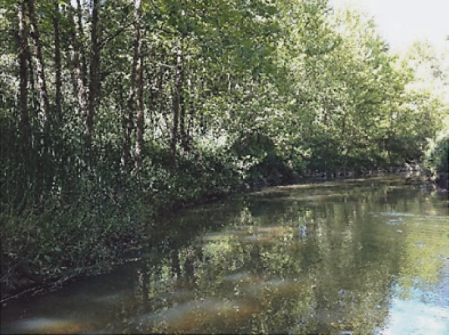
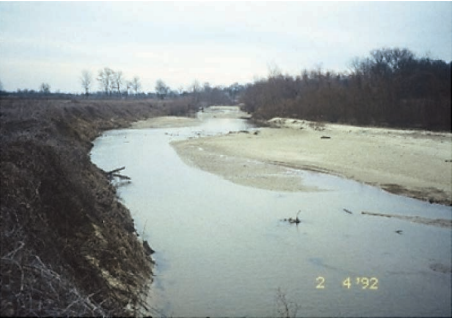
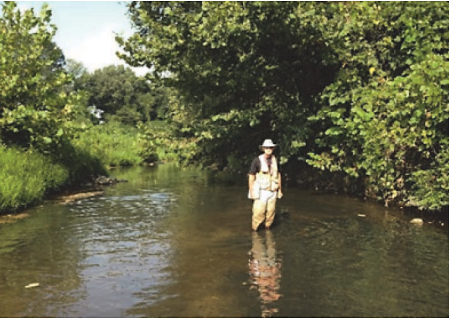
Site	Typical Before Project	Typical 2014 Conditions
Buttahatchee River Site MS1

Figure 2.3. Task 6 field site visits—southeastern field sites.

Sites MS1 through MS5 were suggested as typical of biotechnical stream bank treatments installed by many agencies throughout the Southeast (see Figure 2.3). A member of the research team has a unique historical perspective on these installations and notes that there are a number of open literature reports available covering design, installation, and monitoring of several of these sites. The research team member noted the following with reference to his knowledge and proximity to these sites:

Sites representative of the Southeastern U.S. were visited September 9–10, 2014. Typical site photos are shown in Figure 2.3. Value was added to these site visits by the presence of the original project designers and planners within the visit party at all sites. One site included two projects in the same reach of the Buttahatchee River, so a total of five projects were inspected, with construction dates ranging from 1992 to 2012. Treatments included stone toe, bendway weirs, rootwads, erosion control blanket, willow posts and poles (planted in a variety of ways), live staking, rootstock plantings, VMSE, and bank resloping. All projects were subjected to significant high flows within two years of construction. Banks at all project sites were stable with little damage or outstanding maintenance observed. However, one project (Site MS1 on the Buttahatchee) exhibited very poor performance of planted vegetation due to infertile, droughty soils exposed by bank grading. Older projects tended to have lush bank vegetation and a high level of ecological functionality within the riparian zone, but planted willow (primarily *Salix nigra*) had given way to planted or volunteer river birch (*Betula nigra*) and sycamore (*Platanus occidentalis*). The dominance of sycamore was impressive. Success of woody vegetation at one site was severely limited by the exotic vine, kudzu (*Pueraria lobata*). Design and construction best practices were noted at all sites. For more details on a typical Southeast site see Section 2.5.

- Southeast (Mississippi)—5 sites (Figure 2.3),
- Upper Midwest (Ann Arbor, Michigan)—5 sites (Figure 2.4), and
- West Coast (Northern California)—6 sites (Figure 2.5).

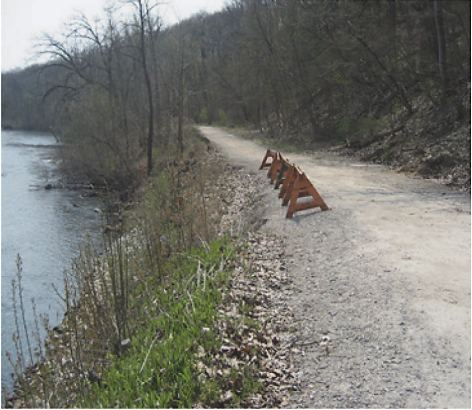
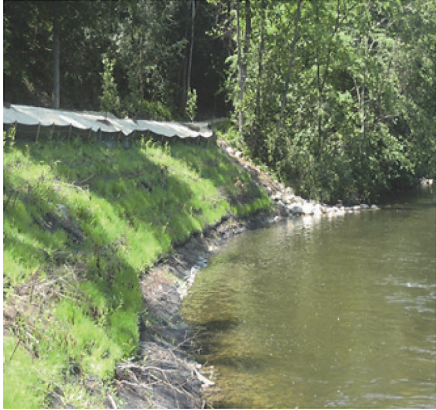
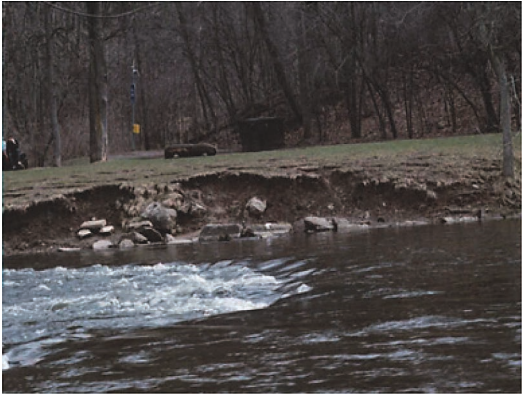
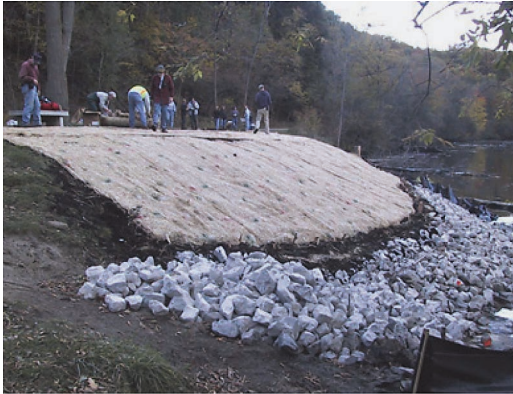
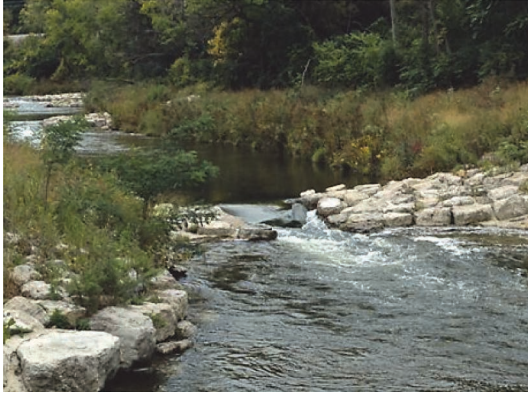
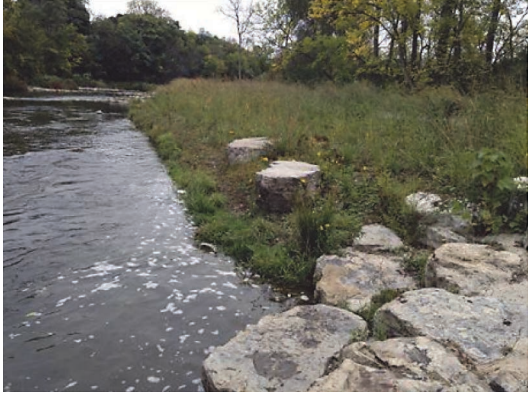
Site MI1: Huron River (Nichols Drive) Ann Arbor, Michigan

<p>Constructed 2008.</p> <ul style="list-style-type: none"> • Rock vanes • VMSE • Chimney drains • Revegetation
Site MI2: Huron River (Nichols Arboretum/River Landing) Ann Arbor, Michigan

<p>Constructed 2005.</p> <ul style="list-style-type: none"> • Vegetated riprap • Live fascine • ECB • Revegetation
Site MI3: Huron River (Argo Cascades) Ann Arbor, Michigan

<p>Constructed 2013.</p> <ul style="list-style-type: none"> • ECB w/grass seeding • Boulder spurs • Stepped pools

Figure 2.4. Task 6 field site visits—upper Midwest, Michigan field sites.

One of the *NCHRP Report 544* coauthors volunteered to assist the research team in visiting and inspecting the Ann Arbor sites. Representative photographs from each site are shown in Figure 2.4.

Conditions at Site MI2 on the Huron River are typical of those encountered during the Michigan site visits (see Figure 2.4). This site is also referenced as River Landing at Nichols Arboretum. The Nichols Arboretum project was intended to replace concrete rubble on the bank with a natural, less visually intrusive treatment with the help of trainees and volunteers. Another goal was to provide visitor access to the river at the site. Concrete rubble was removed from the site and the bank graded back to a stable 2H:1V slope. This project involved design of an environmentally sensitive, stream bank repair approach that also provides access to the river. The project provided hands-on opportunities for volunteer participation and training. Steps built into the bank at two locations in the protected reach now provide ready access to water’s edge. For more details on the upper Midwest sites see Sections 2.5 and 4.4.

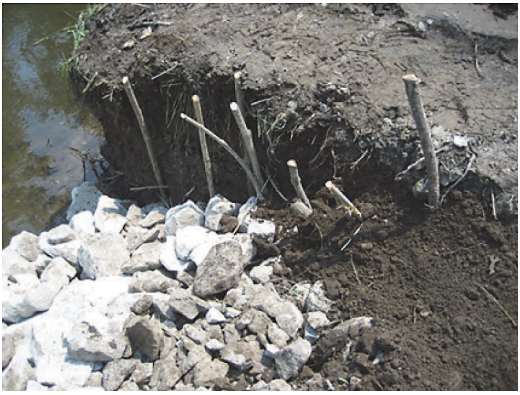
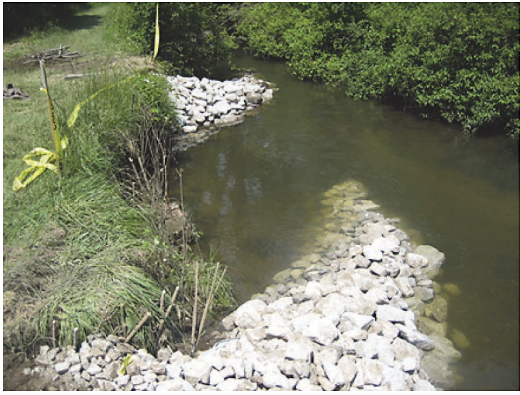
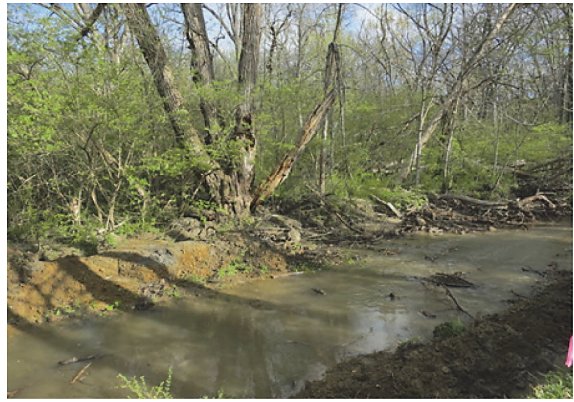
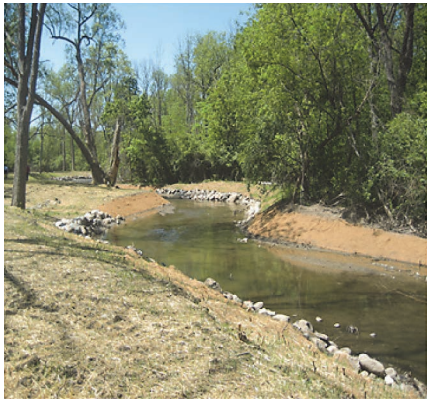
<p>Site MI4: Fleming Creek, Northfield Township, Michigan</p>

<p>Constructed 2006.</p> <ul style="list-style-type: none"> • Rock vanes • Willow pole planting
<p>Site MI5: Malletts Creek, Ann Arbor, Michigan</p>

<p>Constructed 2011.</p> <ul style="list-style-type: none"> • Rock vanes • Coir logs • ECB w/live stakes

Figure 2.4. (Continued).

The Compendium is provided with this Final Report as a companion to the detailed design guidelines in Chapter 4. As an introduction to the Compendium, the following section provides extracts of the information contained in a typical site visit report from each of the three regions referenced in Section 2.4. In addition, data and documentation from the Mallets Creek site visit in the upper Midwest region (see Figure 2.4, Site MI5) have been expanded to provide one of two application examples/case studies in Section 4.4.

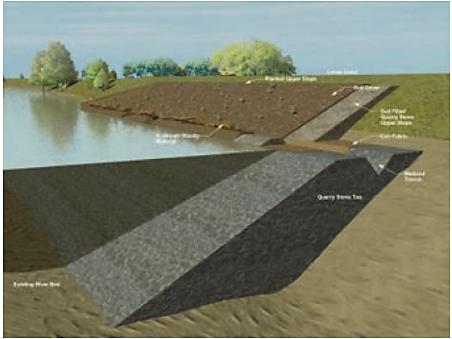
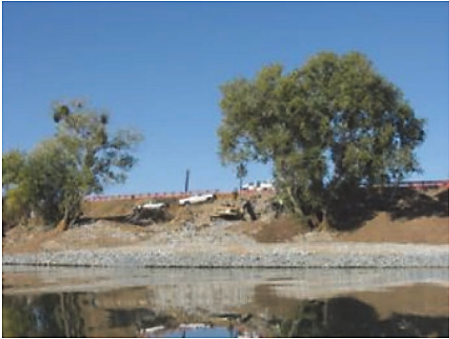
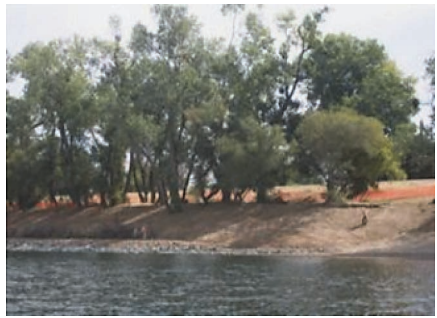
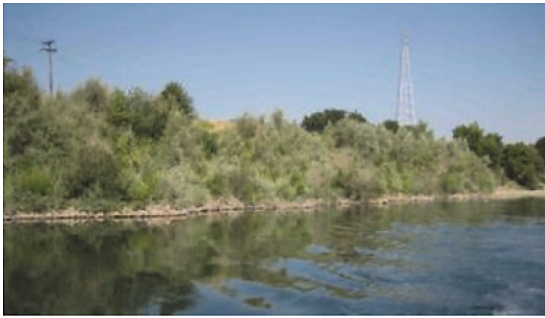
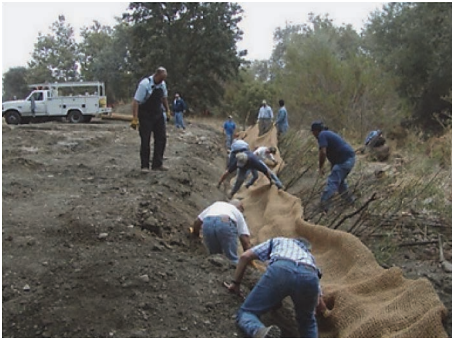
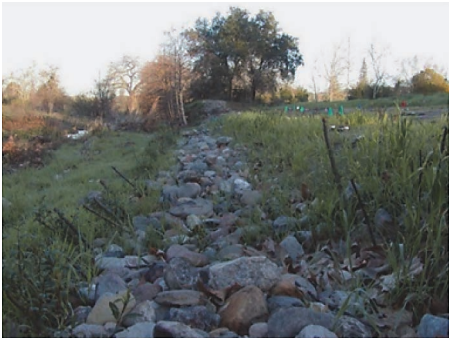
<p>Site(s) CA1: Sacramento River, California (two priority erosion sites downstream of Sacramento)</p>

<p>Constructed 2006.</p> <ul style="list-style-type: none"> ● Rock toe with scalloped bench ● Instream woody material ● Live staking ● Container plantings ● Beaver fence (temporary)
<p>Sites CA2 and CA3: LAR, Carmichael, California (two sites)</p>

<p>Constructed 1998.</p> <ul style="list-style-type: none"> ● Rock toe with scalloped bench ● Instream woody material ● Live staking ● Container plantings ● Beaver fence (temporary)
<p>Site CA4: Alamos Creek near San Jose, California</p>

<p>Constructed 2010.</p> <ul style="list-style-type: none"> ● Willow posts and poles ● Live siltation ● TRM ● Coir netting

Figure 2.5. Task 6 field site visits—West Coast (Northern California) field sites.
(continued on next page)

The Alamos Creek and Russian River sites (Sites CA4 and 6), while some distance away from the Guadalupe River sites, offered the opportunity to evaluate alternative treatments (rock toe and rock barbs with willow siltation and staking), and TRMs in a different geomorphic setting. Representative photographs from each site are shown in Figure 2.5.

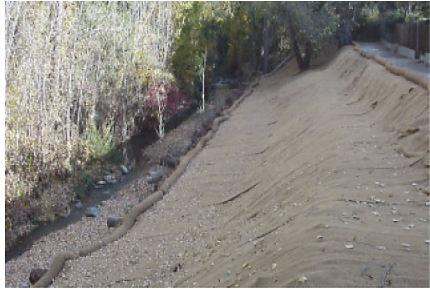
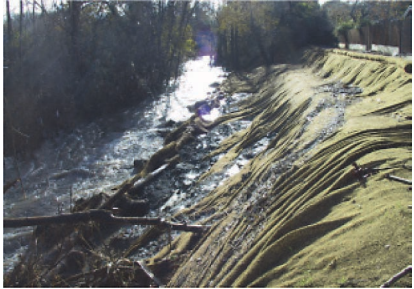
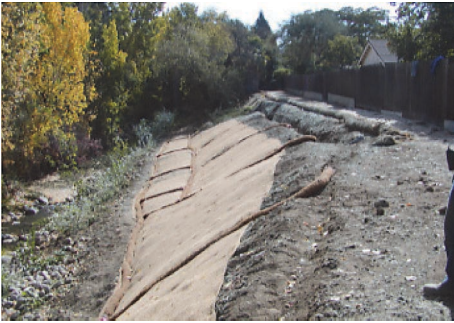
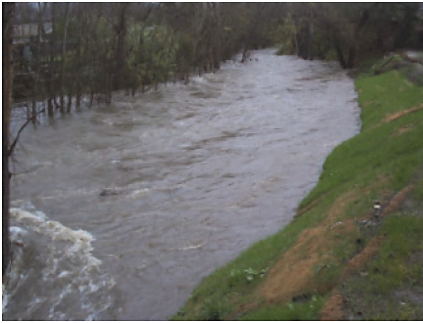
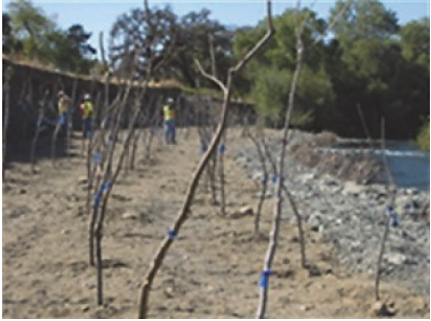
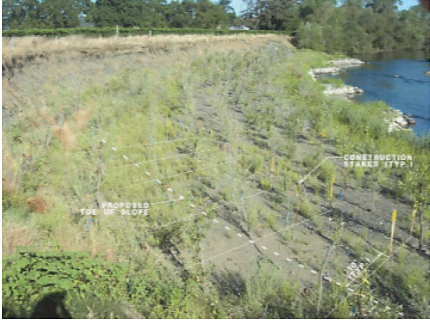
Site CA5: Guadalupe River at Alma Road, San Jose, California

<p>Constructed 2002.</p> <ul style="list-style-type: none"> ● Log toe ● Coir wattle ● ECB ● Native grass vegetation ● Failed in 2002, redesigned and rebuilt

<p>Reconstructed 2003.</p> <ul style="list-style-type: none"> ● Rock toe ● Live siltation ● ECB ● Native grass vegetation ● Coir wattles and cutoff trenches ● Survived large flood in 2004
Site CA6: Russian River at Geyserville Bridge, SR 128, Geyserville, California

<p>Constructed 2010.</p> <ul style="list-style-type: none"> ● Rock toe ● Rock barbs ● Live siltation ● Live staking

Figure 2.5. (Continued).

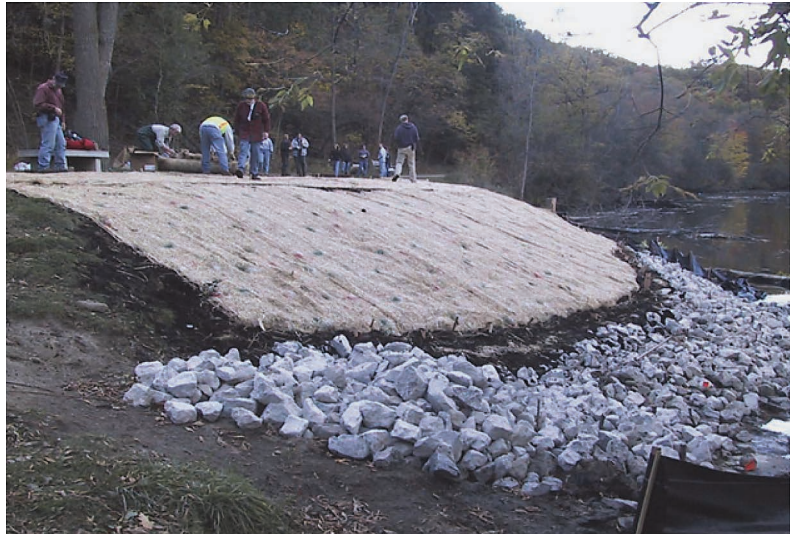
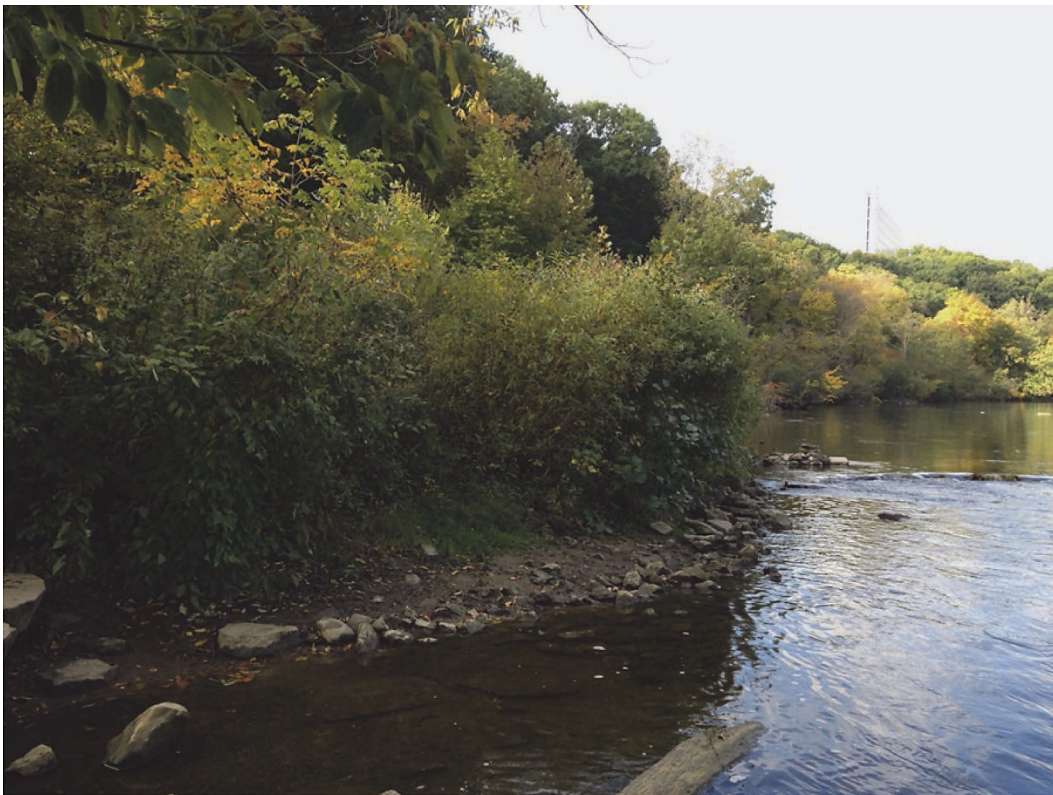
Figure 2.6. *Huron River at Nichols Arboretum.*

Vegetated riprap. The bank toe was armored with riprap. The riprap was vegetated using the joint-planting method, i.e., live stakes representing six to eight woody tree and shrub species were inserted between openings or interstices in the riprap: sandbar willow, red osier dogwood, ninebark, silky dogwood, and native roses. Not all stakes were dormant when planted. Some non-native white willow was also used, but the project coordinator said he would like to avoid using non-native species in the future.

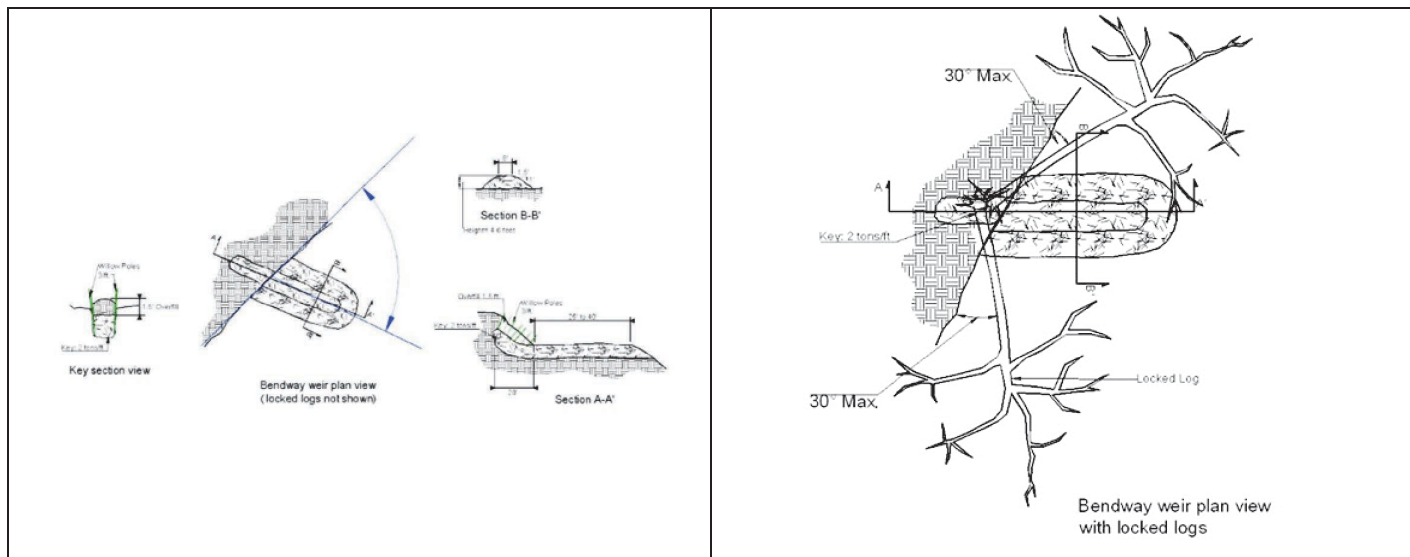
Figure 2.7. Bendway weirs with locked logs at Buttahatchee River site.

The functionality of the bendway weirs at this site was enhanced by the addition of embedded large wood “locked” logs (Figure 2.7).

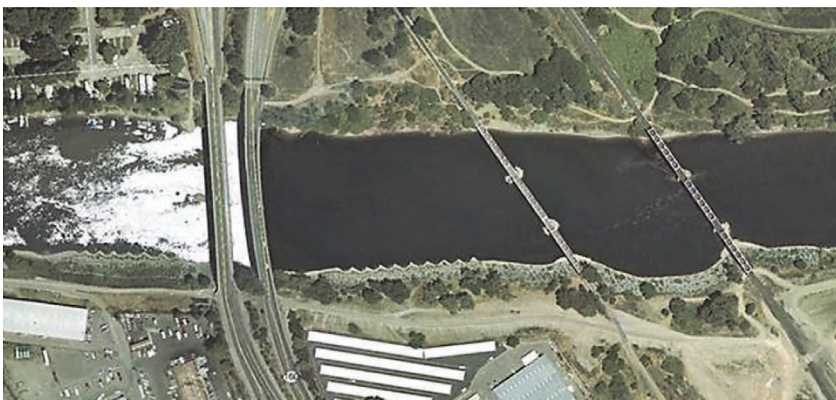
Figure 2.9. 2002 aerial photo of LAR reach RM 2.0L.

This site is approximately 2,200 ft. in total length and the bank-protection and mitigation features were constructed in 1999. The site is bound by four bridges: N 12th Street/Hwy 160, Lincoln Hwy, Pedestrian, and R/R. Mitigation features include instream woody material (IWM), an undulating, cobble-lined, low-berm soil trench, and plantings on the low-berm, middle-berm, and upper-slope planting surfaces (see Figure 2.9).

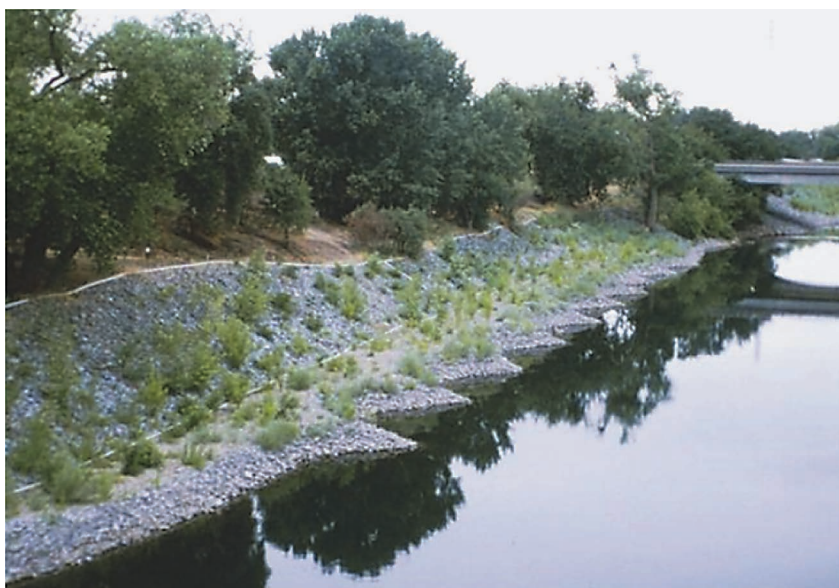
Figure 2.11. 2001 photo looking downstream at LAR reach RM 2.0L.

- 2-D Hydraulic Model (pre- and post-project),
- Topographic and bathymetric surveys,
- Slope stability analysis,
- Multiple benches for habitat enhancement,
- Lower benches submerged at specific environmental flows, and
- Embayments along lower bench for fish habitat (Figure 2.11).

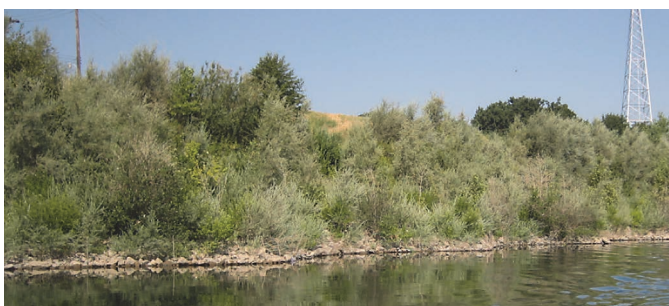
Figure 2.12. 2011 photo looking downstream at LAR reach RM 2.0L.

Vegetation at this site continued to grow well and many native plants, including cottonwood, alder, box elder, rose, and sandbar willow are naturally regenerating on the low berm (see Figure 2.12). Protecting the vegetation at this site from beavers has been an ongoing challenge and has required intensive beaver fence maintenance. Maintenance actions include repairing and replacing sections of fence that are in disrepair due to both natural degradation of the fencing over time and vandalism. This site has not received supplemental irrigation since 2004 and yearly monitoring confirms that the plants at this site have successfully established. Colonization by non-native woody vegetation is minimal at this site but was removed when found. This site was evaluated as “functional” during the 2014 site visit.

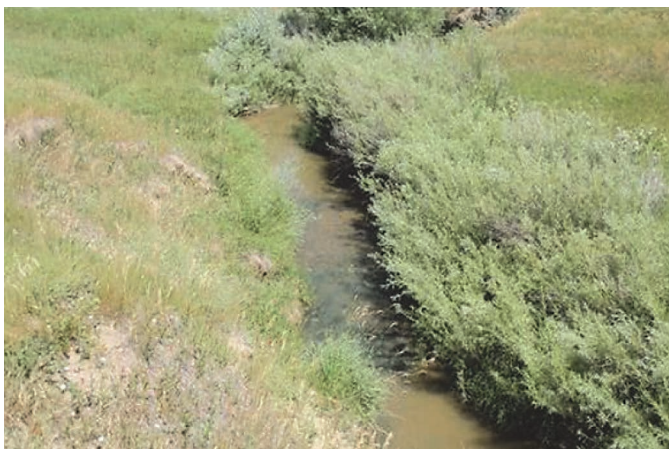
Figure 3.2. *Salix exigua* on Fossil Creek, Fort Collins, Colorado.

Figure 3.2 shows native *Salix exigua* at a local site in Fort Collins, Colorado, from which the cuttings for the test installations were obtained.

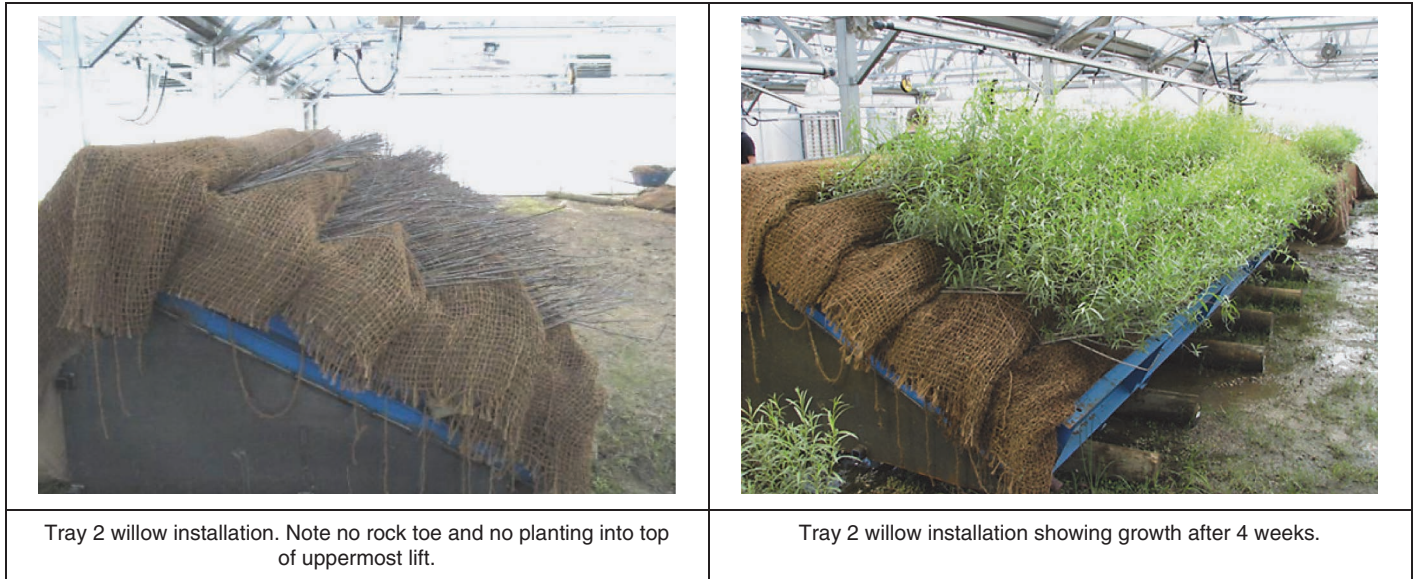
Figure 3.6. Tray 2 installation.

10. Tray 2: Willow spacing in Tray 2 consisted of rows of cuttings spaced 2 in. apart. Each row was sandwiched between successive lifts of fabric-wrapped soil 8 in. thick, having a back slope of 10 degrees into the slope. No soil staples were used in Tray 2. Cuttings were embedded the full 12-in. depth of Tray 2. No cuttings were placed into the top of the uppermost lift, nor into the vertical face of any lift. Figure 3.6 shows the completed installation in Tray 2.
11. Measurements of plant growth and root establishment for the vegetation were performed after 3 months and again after 7.5 months to ensure that a representative canopy and root system had established prior to testing. Figure 3.7 provides photographs of willow growth

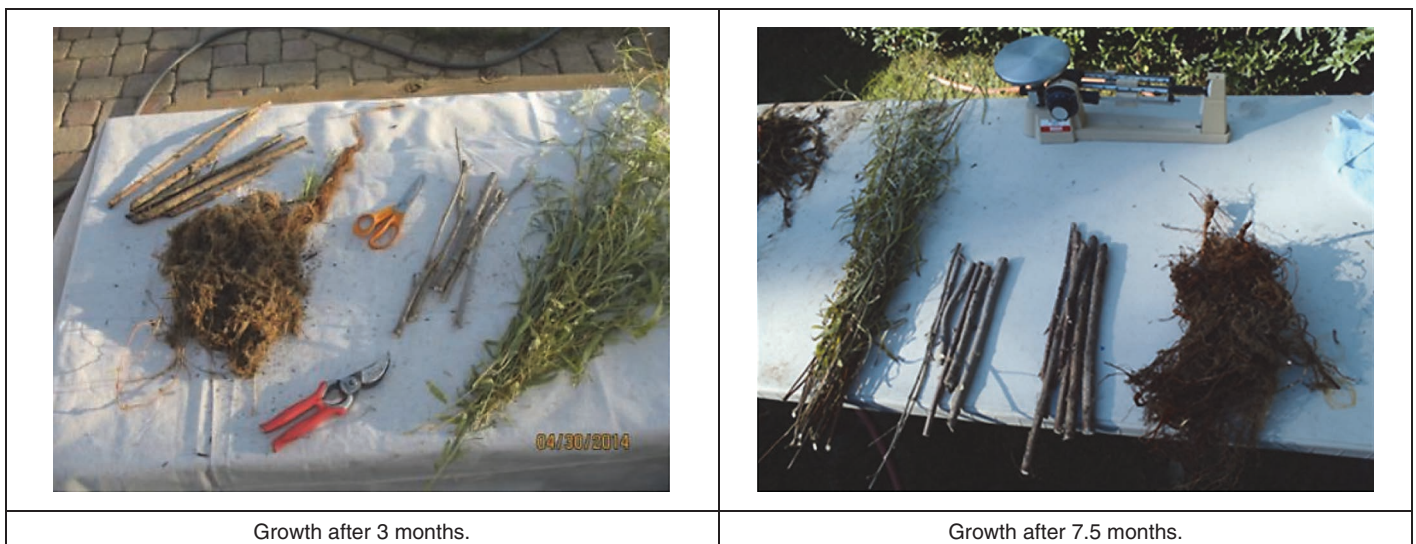
Figure 3.7. Willow growth determination.

determination and Table 3.1 presents the results of oven-dried weights of the biomass of the various above-ground and below-ground components.

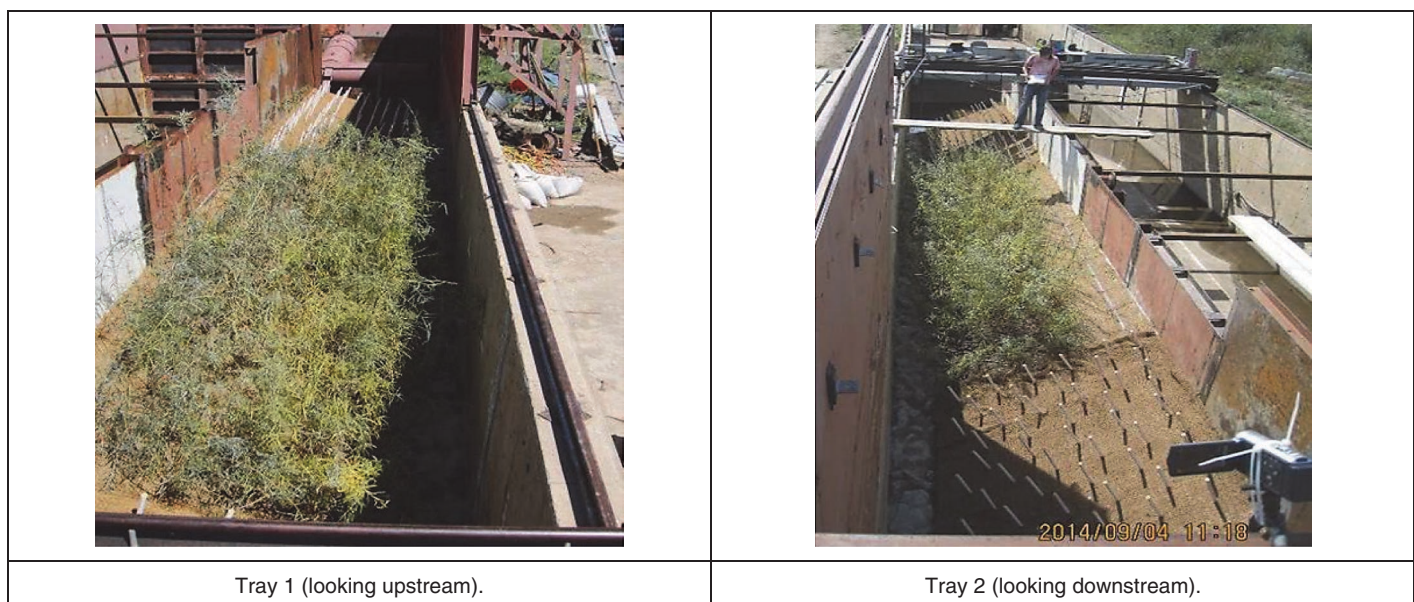
Figure 3.8. Trays 1 and 2 prior to testing.

14. Between the top edge of each tray and the opposite flume wall, metal flashing was used to seal the gap between the tray and the wall. The flashing was covered with a strip of coir fabric to give it the same roughness as the rest of the bed surface. Figure 3.8 shows both Trays 1 and 2 installed in the flume, prior to testing.

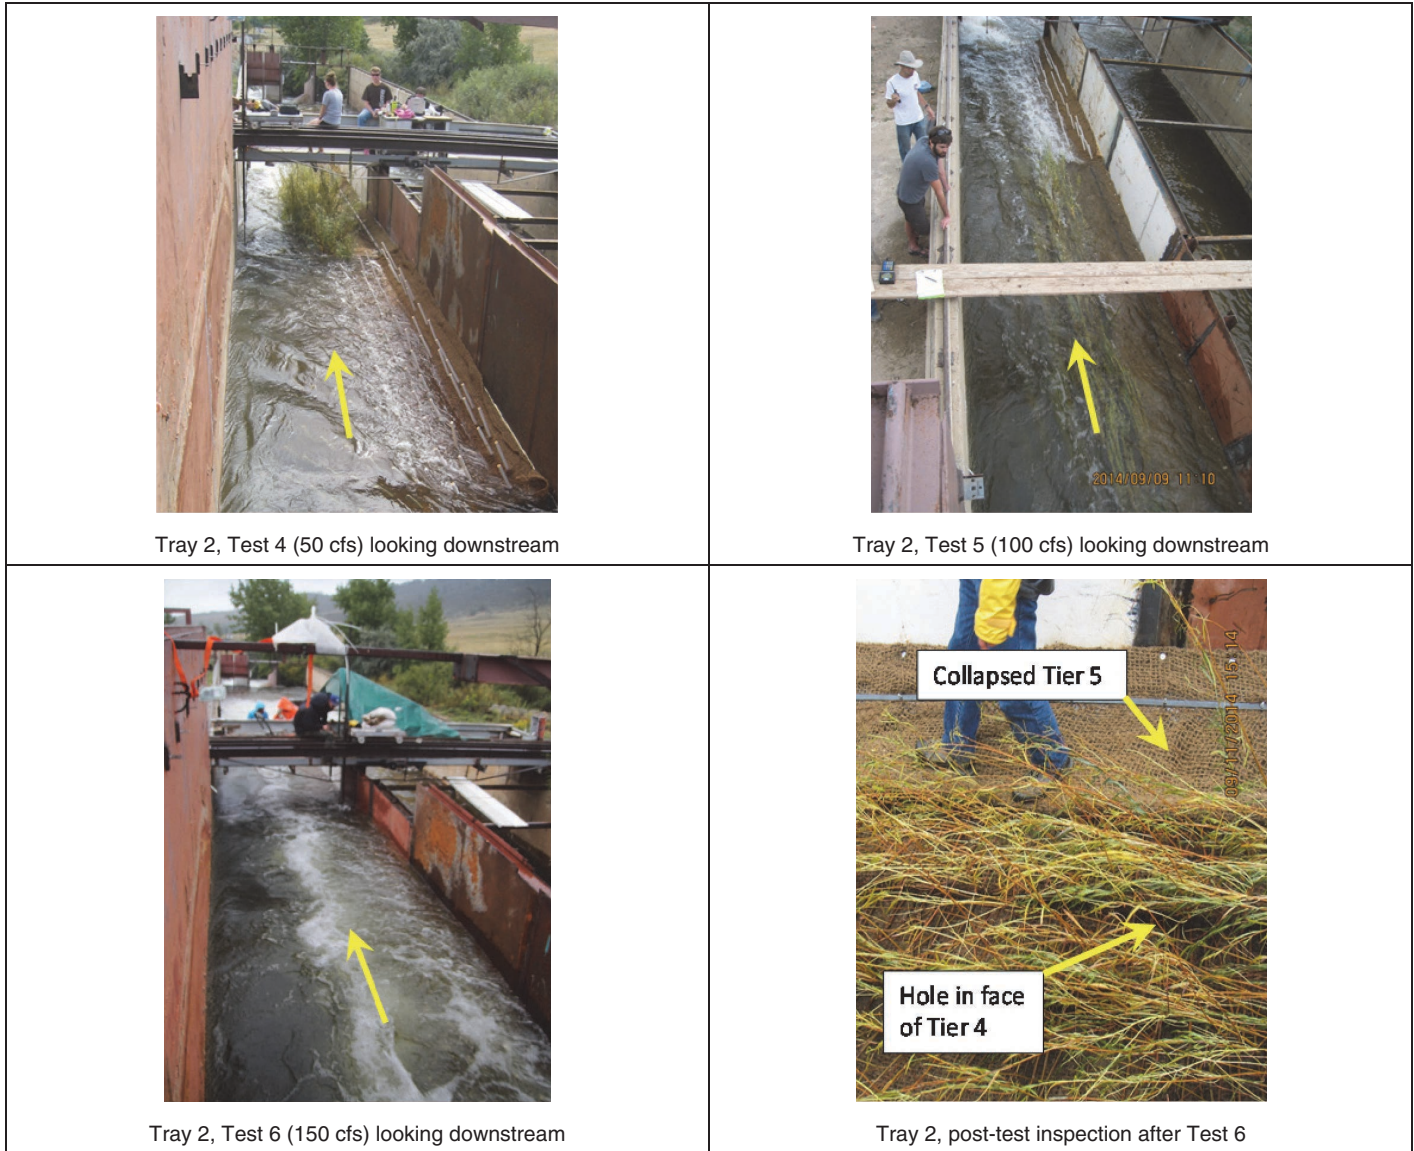
Figure 3.10. Tray 2 during testing.

is provided below, and Figure 3.10 provides photographs of the tests in progress. Discussion of the data analyses and results is provided in Section 3.5.

Test 4 was performed on September 4, 2014 for a duration of 4 hours. A free fall occurred at the downstream end of the exit section. The discharge was approximately 50 cfs, with water reaching midway up the vertical face of the uppermost soil lift. The lowermost two rows of willows were pronated, while the uppermost two rows remained upright.

A tear in the coir fabric, along with localized depressions indicating soil loss beneath the fabric at other locations, began forming on the test section during Test 4. The tear occurred in the face of the lowermost soil lift and was located 8 ft downstream of the upstream edge of Tray 2. The tear resulted in a 3-in. by 5-in. hole with 3 in. of soil loss measured back into the face of this lift, but was not apparent on the top surface of the lift.

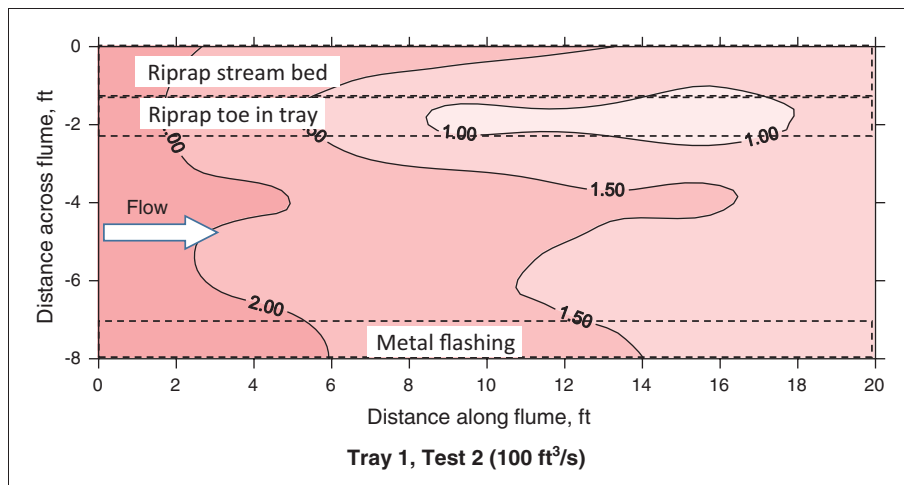
Figure 3.18. Shear stress contours, Trays 1 and 2 at 100 ft³/s.

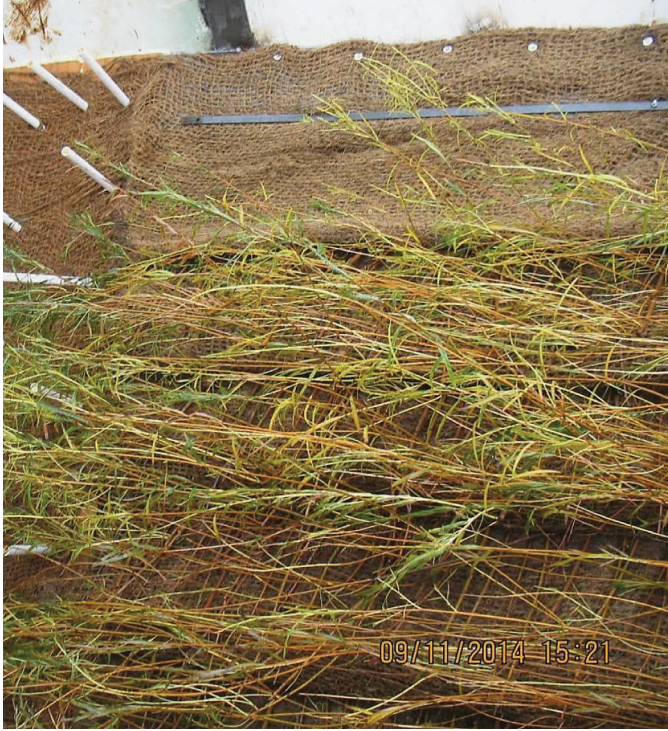
Figure 3.23. Tray 2 at the end of Test 6 (150 ft³/s). Note soil washout and collapse of the uppermost soil lift.

The contour maps in Figures 3.21 and 3.22 clearly indicate the severe washout of soil from within the uppermost soil lift of Tray 2 during the 100 and 150 ft³/s flows. The soil loss in the uppermost lift was evident along nearly the entire length of the test tray, as described previously in Section 3.4. A photo of the uppermost soil lift after Test 6 (150 ft³/s) is shown in Figure 3.23. Note that no willow staking was done in the top surface of this lift.

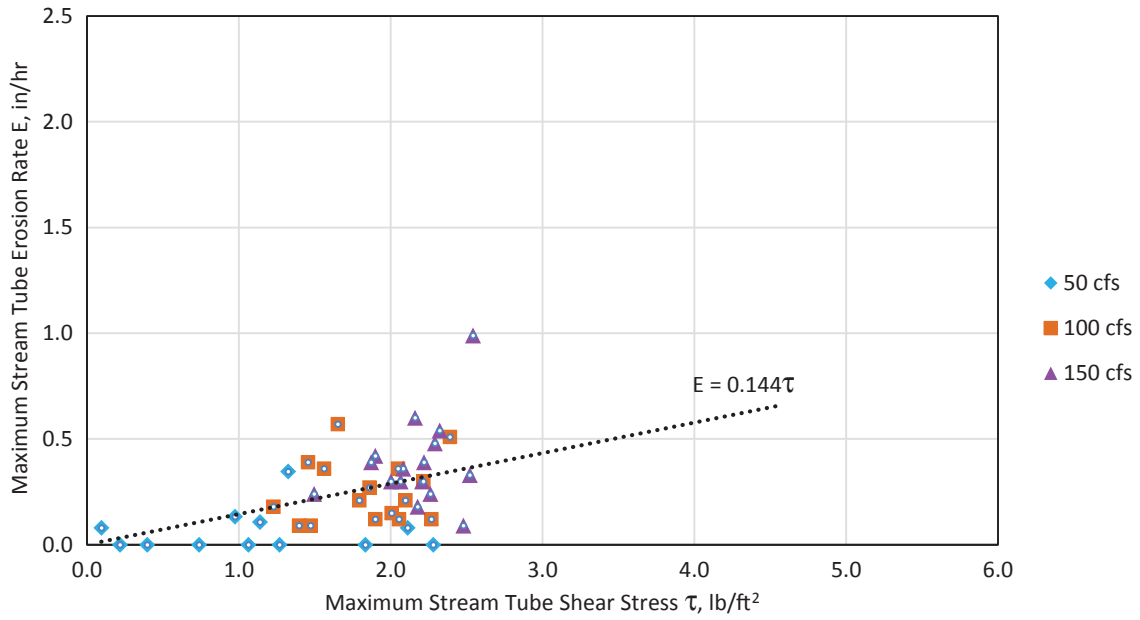
Figure 3.25. Erosion rate vs. shear stress, Tray 1.

Erosion rate in inches per hour was determined by taking the erosion depth and dividing by the duration of each test (4 hours, with the exception of Test 1 which was run for 4.5 hours). The results of this partitioning approach are shown in Figures 3.25 and 3.26 for Trays 1 and 2, respectively. In these figures, the x- and y-axes scales are consistent to facilitate comparison. The partitioning better shows the variability of erosion rate and shear stress and more clearly shows the clustering of data for the different discharges used in the full-scale laboratory testing program.

Comparing Figures 3.25 and 3.26, it can be seen that the stream-tube maximum shear stress in Tray 1 did not exceed a value of 2.6 lb/ft² for any of the tests, whereas it reached a maximum of about 5.4 lb/ft² in Tray 2.

Likewise, the maximum erosion rate in any stream tube in Tray 1 was 1.0 in. per hour, while in Tray 2 the maximum erosion rate was 2.0 in. per hour. Therefore, in general, doubling the shear stress results in a doubling of erosion rate. This again suggests a linear relationship between erosion and shear stress.

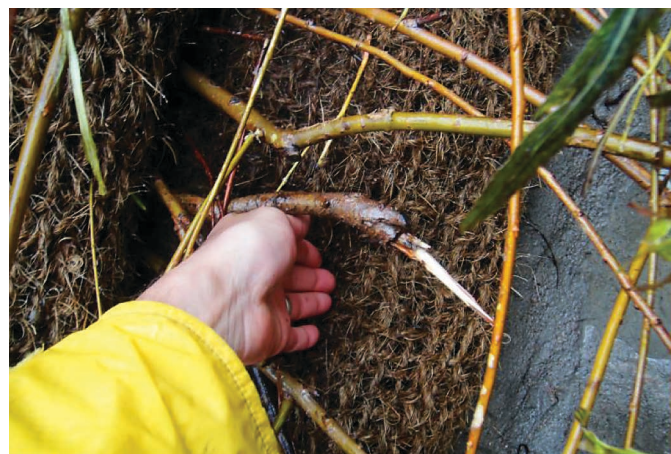
Figure 3.29. Photograph showing broken stem at the end of Test 6 (150 ft³/s).

Sandbar willow is extremely resilient and pliable, and resisted damage at all ranges of flow conditions tested. Characteristics of the willows at the time of testing included the biomass measurements presented in Table 3.1, typical stem diameters of $\frac{3}{8}$ to $\frac{5}{8}$ in., and typical above-ground stem heights of 3 to 5 feet. Figure 3.29 is a close-up photograph of the only stem that actually broke during the testing program (Test 6 at 150 ft³/s, near the toe of the slope at Cross Section 16 in Tray 2). The point velocity V_{60} and shear stress at this location during Test 6 were 11.4 ft/s and 3.5 lb/ft², respectively.

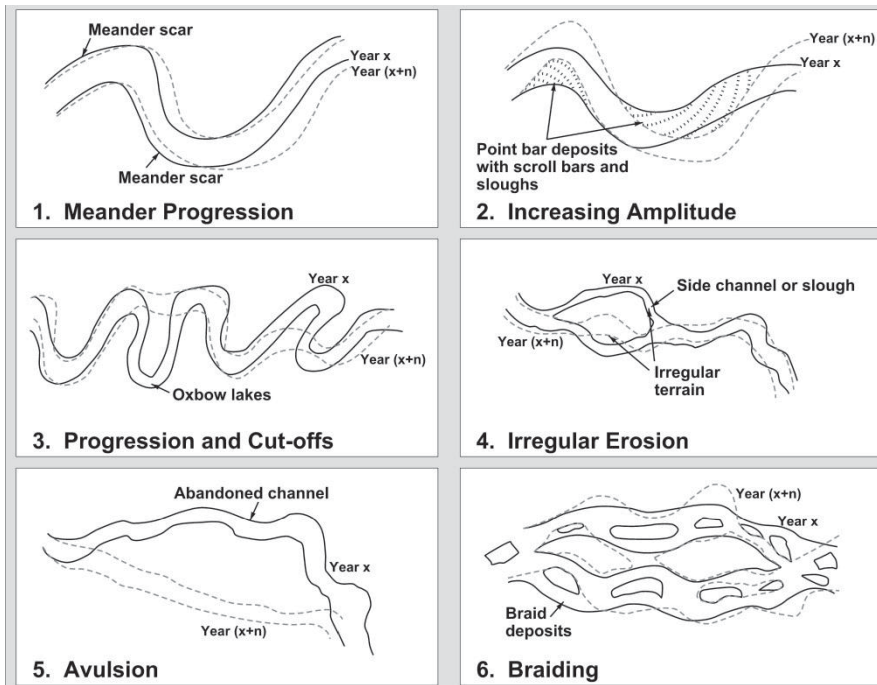
Figure 4.7. Types of lateral activity and typical associated floodplain features (Thorne 1998).

slope and cross section while posing a threat or hazard to engineered structures and both “hard” and “soft” countermeasures. Some types of lateral instability are shown in Figure 4.7.

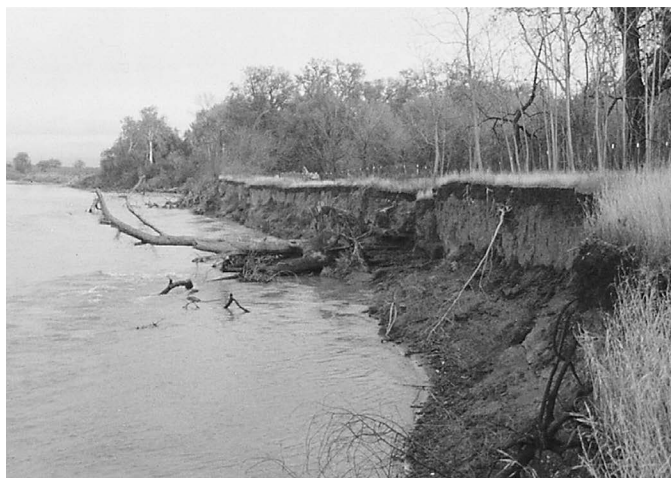
Figure 4.11. *Active bank erosion illustrated by vertical cut banks, slump blocks, and falling vegetation.*

Active bank erosion can be recognized by falling or fallen vegetation along the bankline, cracks along the bank surface, slump blocks, deflected flow patterns adjacent to the bankline, live vegetation in the flow, increased turbidity, fresh vertical faces, newly formed bars immediately downstream of the eroding area, and, in some locations, a deep scour pool adjacent to the toe of the bank. These indications of active bank erosion can be noted in the field and on stereoscopic pairs of aerial photographs. Color infrared photography is particularly useful in detecting most of the indicators listed above, especially differences in turbidity (Shen et al. 1981). Figure 4.11 illustrates some of the features that indicate that a bankline is actively eroding.

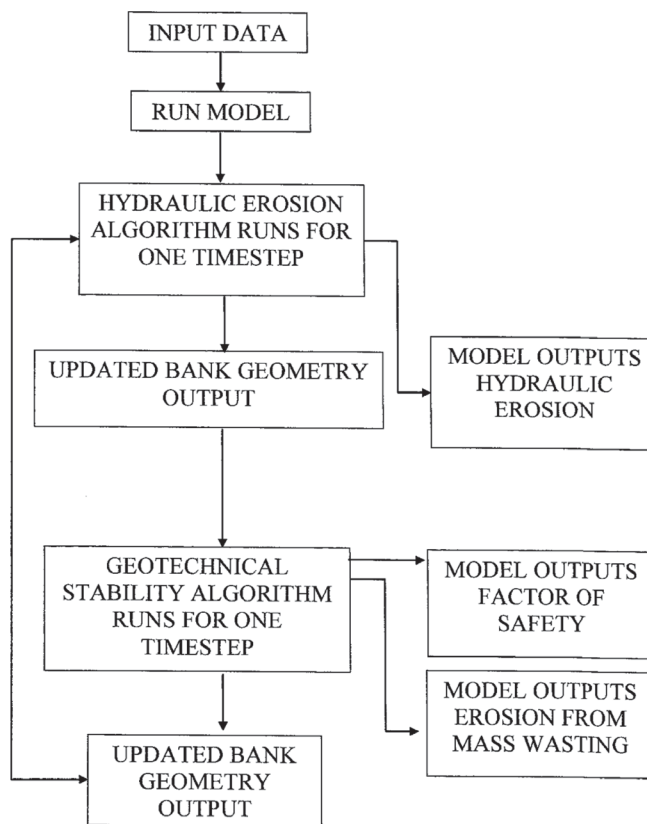
Figure 4.14. Flow chart illustrating the BSTEM inner workings and output (Bankhead et al. 2013).

Figure 4.14 provides a flow chart illustrating the bank stability model inner workings to output an Fs and erosion from both hydraulic and mass failure processes. Both beneficial and detrimental effects of vegetation on bank stability have been observed: plant roots reinforce soils and remove moisture by evapotranspiration, increasing matric suction, but very large trees impose weight loading on banks and woody vegetation may also enhance infiltration of precipitation (Simon and Collison 2002, Gray and Barker 2004, Pollen et al. 2004). Earlier models of root reinforcement of soils ignored the effects of soil type and moisture on root-soil bonds; root tensile strength was simply added to soil strength and roots were assumed to be oriented

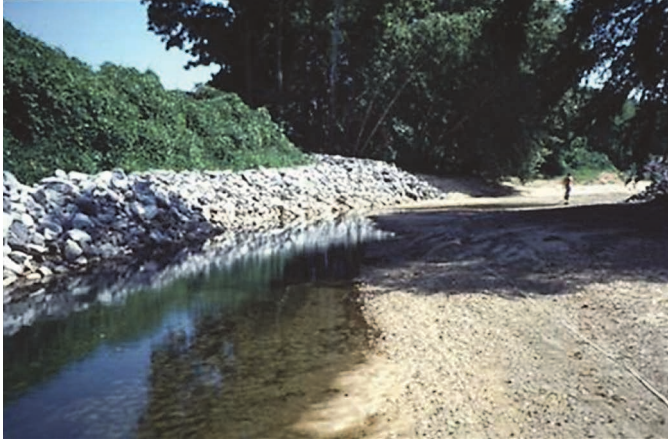
Figure 4.16. *Stone toe provides stable benthic habitat and cover for smaller fish, but little diversity or pool habitat (McCullah and Gray 2005).*

Human influences often result in simplification of stream habitats, making them more uniform and adversely impacting biological communities (see Figure 4.16). Meandering streams with deep pools on the outside of bends and gravelly riffles at thalweg crossings (inflection points) between bends are often straightened and channelized to improve alignments for bridges or

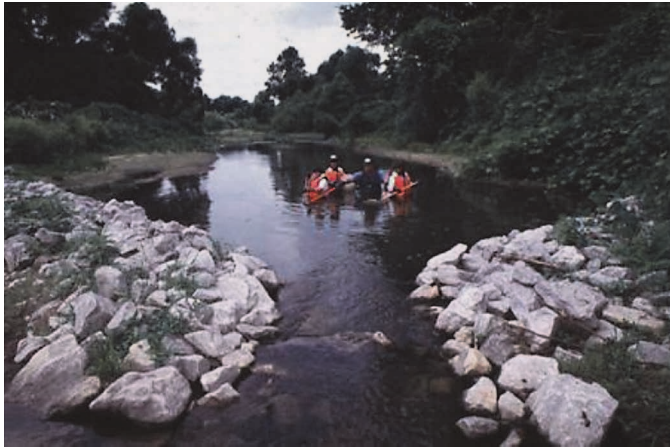
Figure 4.17. Weirs can create pool-riffle habitats and help stabilize beds, but should be designed carefully in streams with low bed slope to prevent eliminating current during low flow (McCullah and Gray 2005).
