Evaluation and Assessment of Environmentally Sensitive Stream Bank Protection Measures

NCHRP REPORT 822

**Evaluation and Assessment
of Environmentally Sensitive
Stream Bank Protection Measures**

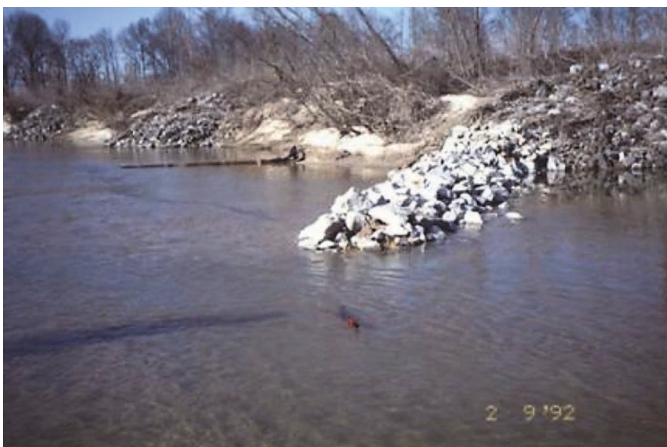
Figure 4.18. *Spurs, barbs, and bendway weirs provide local zones of low velocity that are effective refuges (McCullah and Gray 2005).*

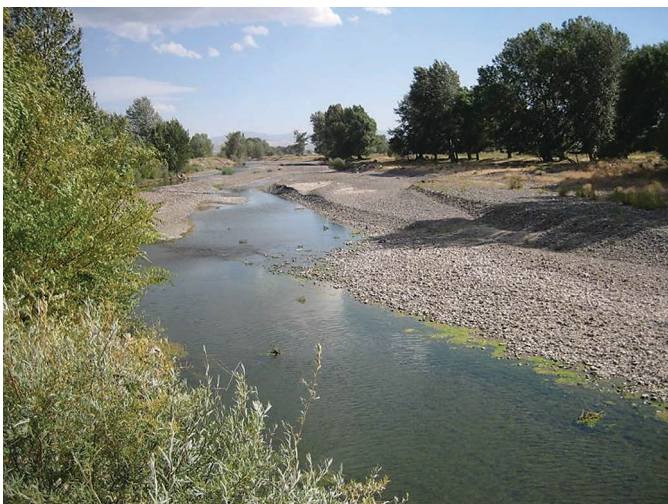
Figure 4.19. *Stable gravelly riffles that are free of fine material typically support rich communities of aquatic invertebrates.*

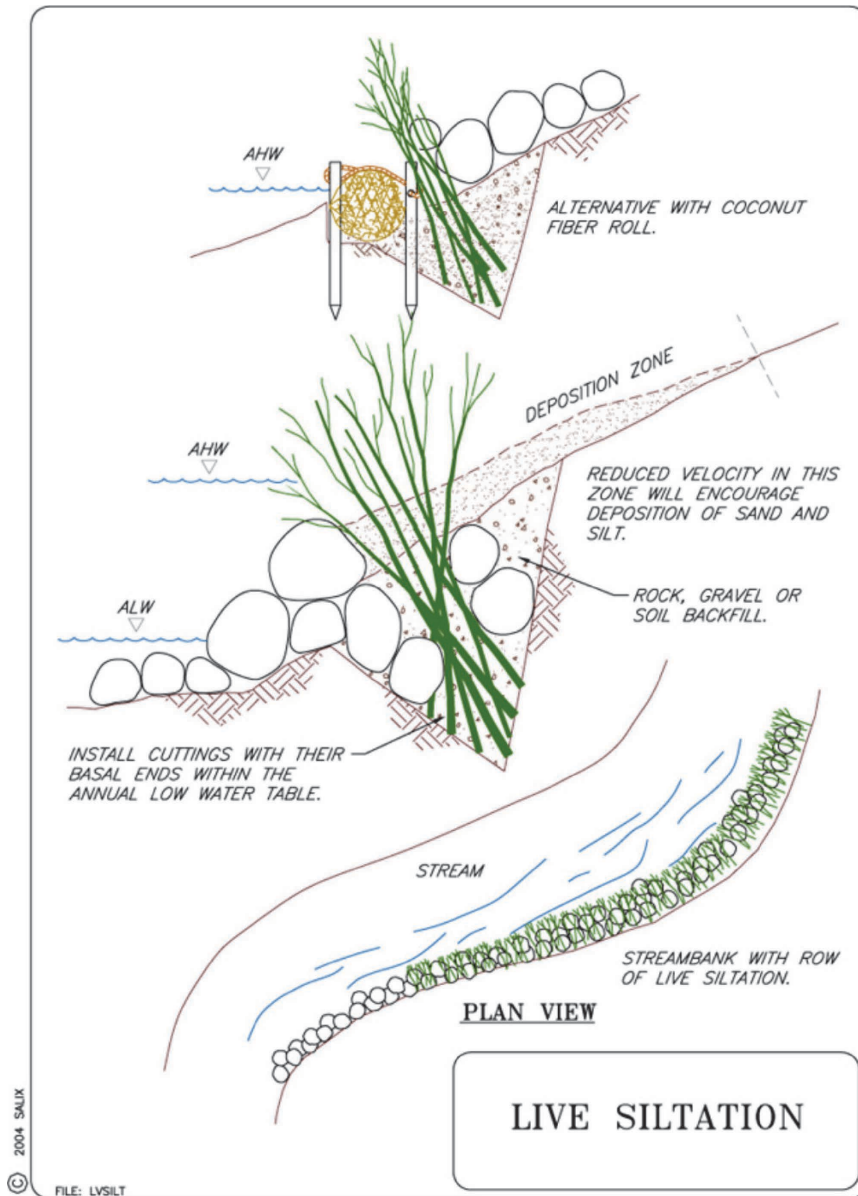
Figure 4.22. Live siltation typical drawing (McCullah and Gray 2005).

Design. A typical design drawing for live siltation is shown in Figure 4.22. Cuttings should be placed adjacent to the water’s edge to ensure effective sediment trapping and velocity reduction at the toe of the slope. At least 12 branches per foot (40 branches per m) should be installed. This technique may be used for velocities up to 6.6 ft/sec (2 m/sec), but velocities should be at least 0.8 ft/sec (0.25 m/sec) for the system to function properly. For additional data on permissible velocities and shear stresses see Chapter 3 and the laboratory testing summary below.

Construction and Installation. Construct a V-shaped trench at the AHW level, with hand tools or a backhoe. Excavate a trench so that it parallels the toe of the stream bank and is approximately 2 ft (0.6 m) deep. Lay a thick layer of willow branches in the trench so that one-third of the length of the branches is above the trench and the branches angle out toward the stream.

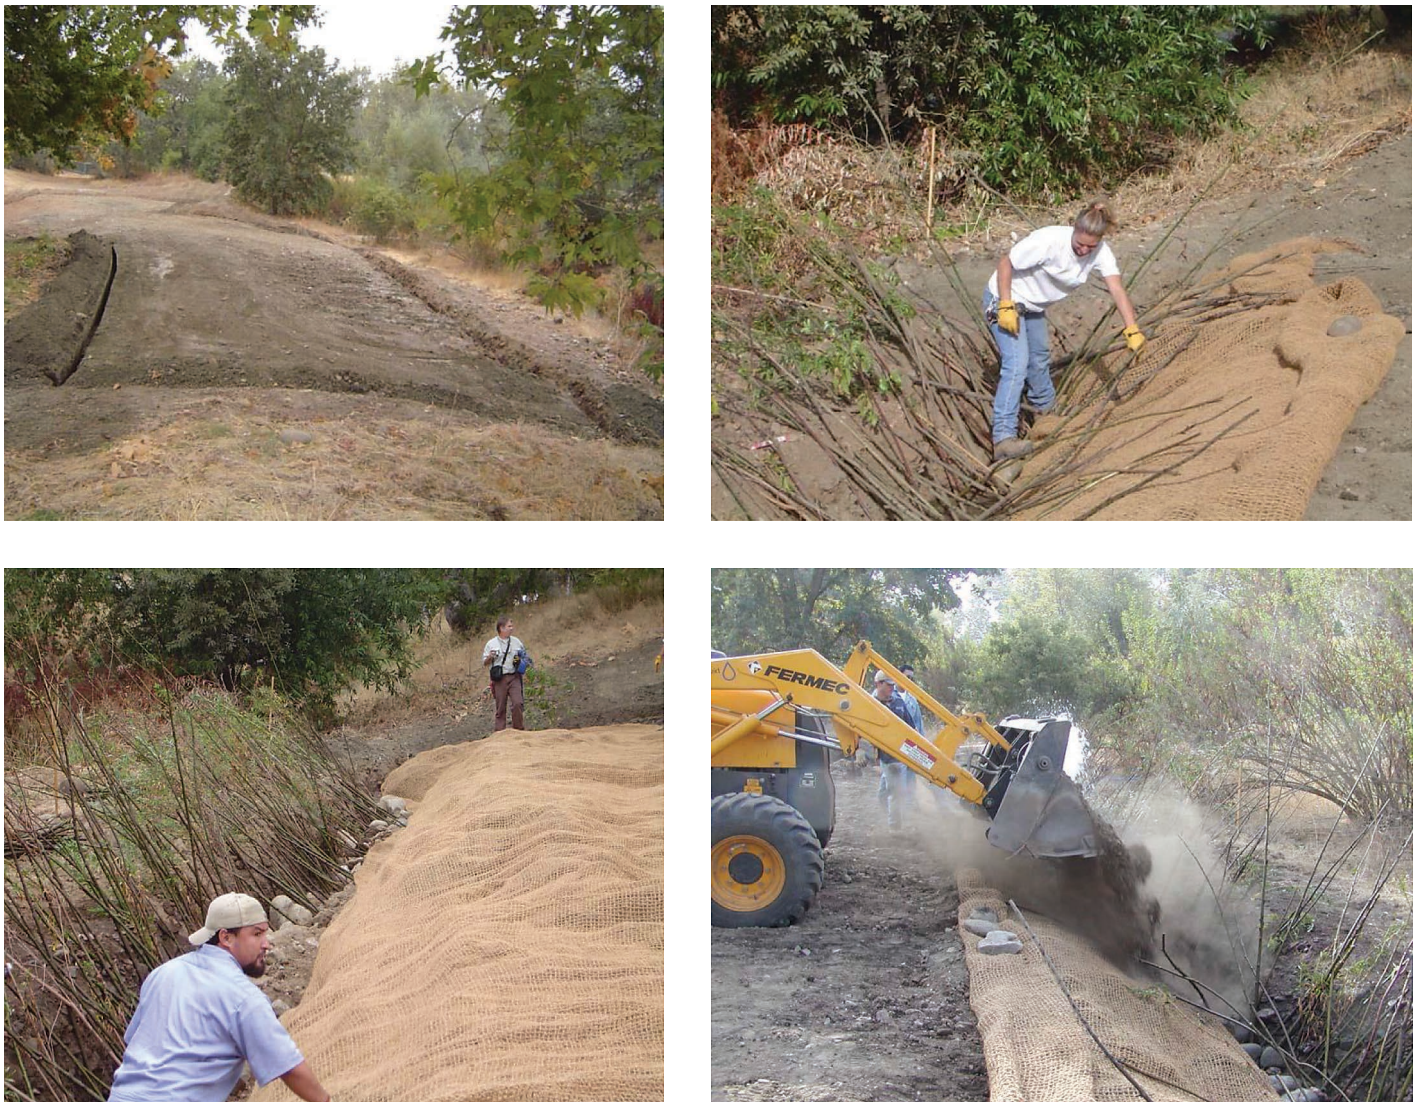
Figure 4.23. Construction and installation of live siltation on Alamitos Creek, CA (McCullah and Gray 2005).

Figure 4.23 illustrates the construction and installation process. This project included live siltation used in conjunction with TRM on Alamitos Creek in Santa Clara County, CA. The live siltation was installed in October 2003. This site was included as a Task 6 site visit under NCHRP Project 24-39 (see Figure 2.5). For additional information see Site CA4 in Tables 2.10 and 2.11 and the Compendium available with this report.

Cost. An estimated level of effort for installing live siltation ranges from 0.2 to 0.6 work hours per linear foot (0.7 to 2 work hours per linear m), plus willow stock if not readily available on site. For the Alamitos Creek site illustrated in Figure 4.23, the coir netting was readily available. The Alamitos Creek project had value added because it was constructed as part of a training workshop for Santa Clara Valley Water construction crews.

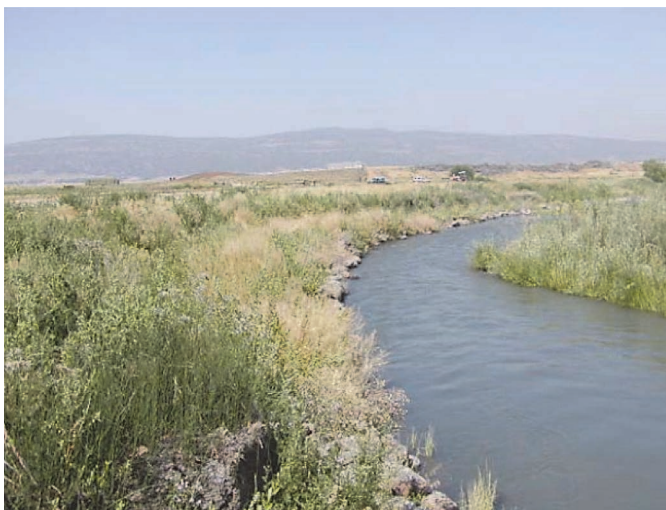
Figure 4.24. *Revegetation of eroding bank landward of stone toe (photo by J. McCullah).*

Longitudinal stone toe has proven cost effective in protecting lower banks and creating conditions leading to stabilization and revegetation of steep, caving banks (for example, see Shields et al. 1995). Stone toe is continuous bank protection consisting of riprap placed longitudinally at, or slightly streamward of, the toe of an eroding bank. The cross section of the stone toe is triangular in shape. The success of this method depends, in part, upon the ability of stone to self-adjust or “launch” into any scour holes formed on the stream side of the revetment. The stone toe does not need to follow the bank toe exactly, but should be designed and placed to form an improved or “smoothed” alignment (e.g., through the stream bend). The “smoothed” longitudinal alignment results in improved flow (less turbulence) near the toe of the eroding bank. This continuous bank-protection technique protects the toe from erosion. It is especially effective in streams where most erosion is due to relatively small but frequent events. It protects the toe so that slope failure of a steep bank landward of the stone toe will produce a stable angle. Such a bank is often rapidly colonized by natural vegetation (Figure 4.24).

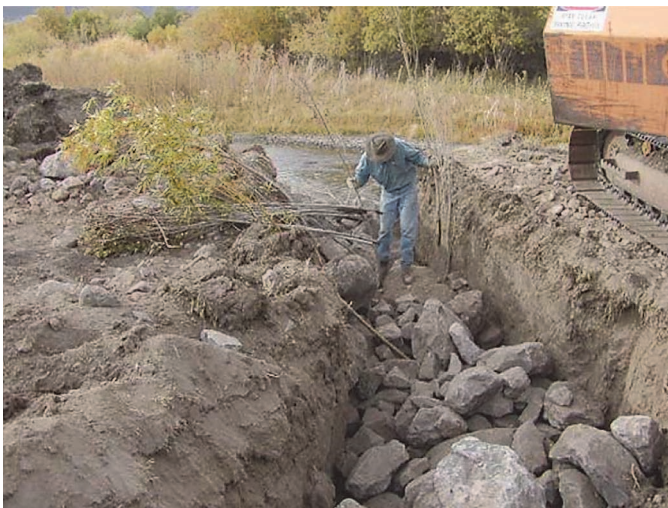
Figure 4.25. Construction of keys provides an opportunity for deep planting willow poles (McCullah and Gray 2005).

Longitudinal stone toe must be keyed deeply into the bank at both the upstream and downstream ends and at regular intervals along its entire length. On small streams, 75 to 100 ft (25 to 30 m) spacing between keys (tie-backs) is typical, while on larger streams and smaller rivers, one or two multiples of the channel width can be used as a spacing guide. Excavation of trenches for keys provides a good opportunity for deep planting willow (*Salix* spp) posts or poles (Figure 4.25).

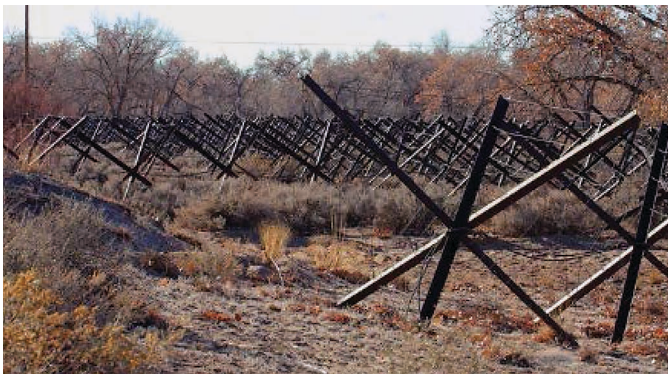
Figure 4.32. *Jetty-jacks on the Rio Grande.*

By the early 1980s the resultant post-dam degradation and the development of streambed armoring (Lagasse 1980, 1981) within the project reach created unfavorable conditions for further jetty-jack stabilization. By the early 1990s the loss of frequent inundation of flood plain areas and the control of major sediment source areas such as the Jemez River resulted in significant channel degradation (Figure 4.33) and, as a result, significantly reduced the effectiveness of the jetty-jack fields. This ongoing degradational environment and the significantly reduced sediment supply

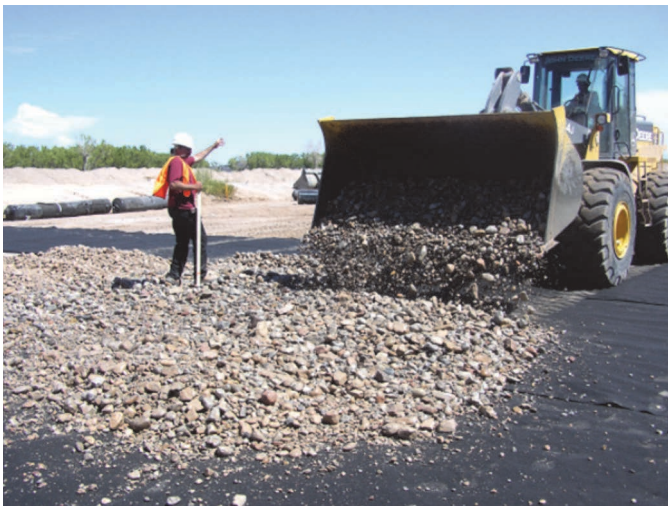
Figure 4.40. Granular filter placement over geotextile fabric.

For the invert of the channel beneath the GRFs, filtration and providing for the relief of hydrostatic pressures are not concerns. Consequently a bedding layer was used to protect the underlying soils from the potentially erosive velocities in the void spaces of the riprap. Since the magnitude of these forces is difficult to predict and the protection of the main channel revetment is essential, a dual layer of geotextile fabric and gravel was chosen for providing a protective bedding layer (Figure 4.40).

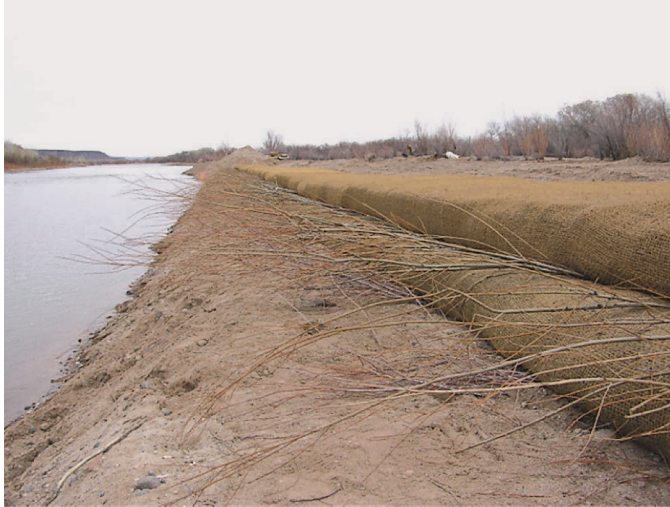
Figure 4.42. View of FES and willow plantings immediately after installation.

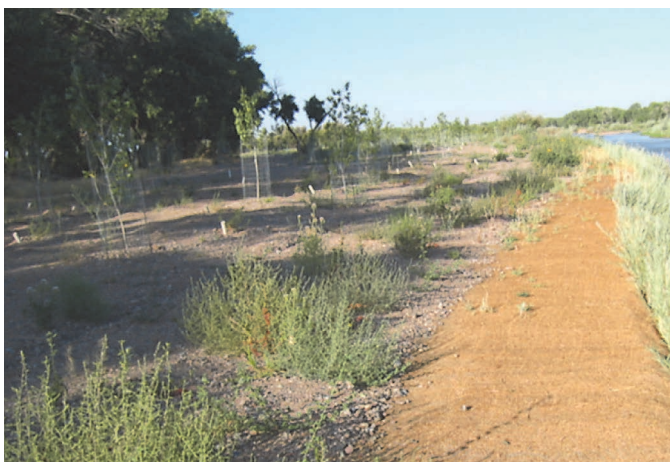
Figure 4.43. View of willow-planted FES bankline and planted willow poles in overbank area.

- Vegetation in overbank areas—Willows are a primary component of the guide banks that are part of the GRFs and Bed Sill and help maintain the desired alignment into the structures while still allowing flood flow to access the entire channel width. Vertical willow plantings (Figure 4.43) were also used because they are well adapted to fluctuating water tables, are resistant to erosional forces associated with flood flows, and can withstand anticipated deposition of sediments.

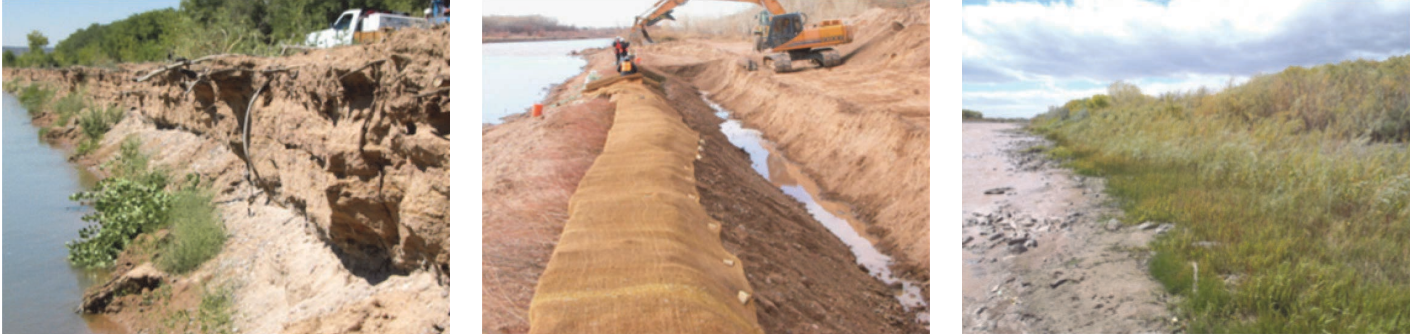
Figure 4.44. Before, during, and after views of willow-planted FES over rock riprap at GRF #3.

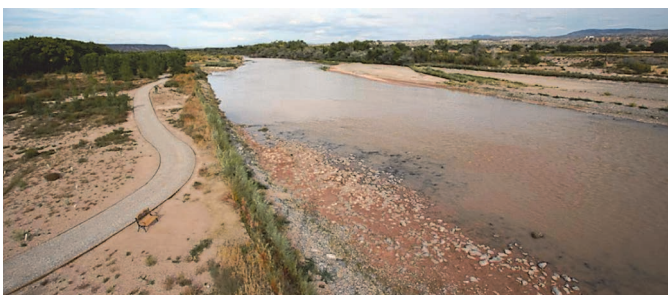
Figure 4.45. View looking upstream of upstream end of GRF #3 with vegetated FES along right bank, planted willow poles and vegetation in right overbank area, and left bank transition guide bank with planted willows.

Performance Assessment. Over the past 10 years (2005–2015) the structures have performed as anticipated. The structures are stable and a good growth of willows and other vegetation has naturally colonized the banks and bar surfaces at the structures. Within a year of construction, the willow branches planted between the FES lifts at both GRFs and the Bed Sill had become well established and have survived and thrived since then. Figure 4.44 shows the eroding bankline before treatment, construction of the willow-planted FES over rock riprap, and the well-established willow-planted FES after construction at GRF #3. Figure 4.45 provides an overview of the finished GRF #3 with the vegetated FES along the right bank, planted willow poles and vegetated right overbank area, and the left bank transition guide bank with the planted willows.

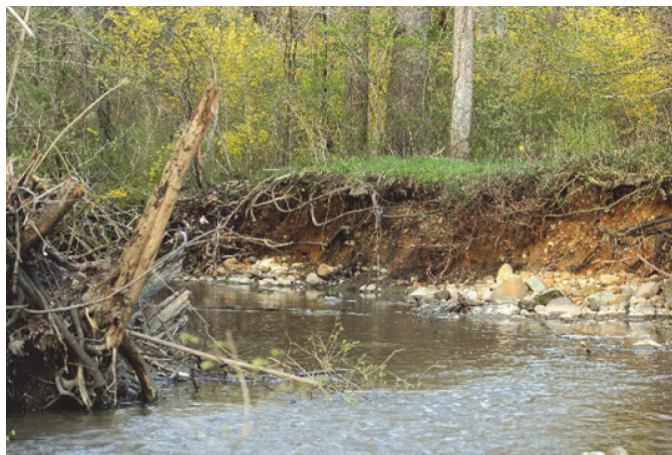
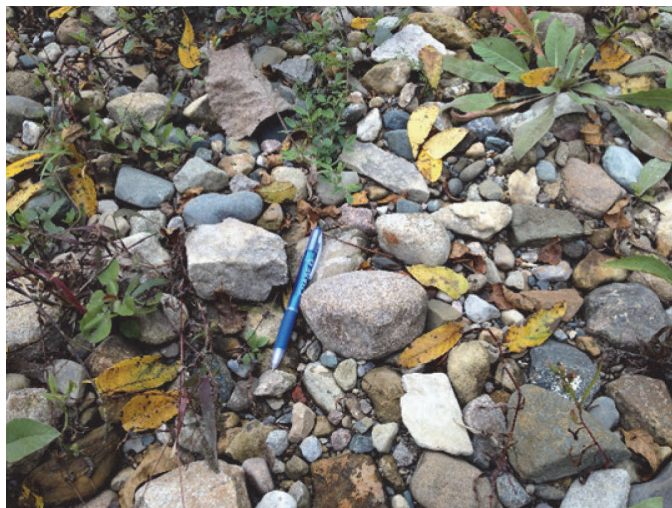
Figure 4.47. Bank soils and sediments, Malletts Creek: (a) preconstruction bank erosion, Malletts Creek. Photo courtesy of Harry Sheehan, environmental manager, Washtenaw County, MI. and (b) typical bar sediments, Malletts Creek.

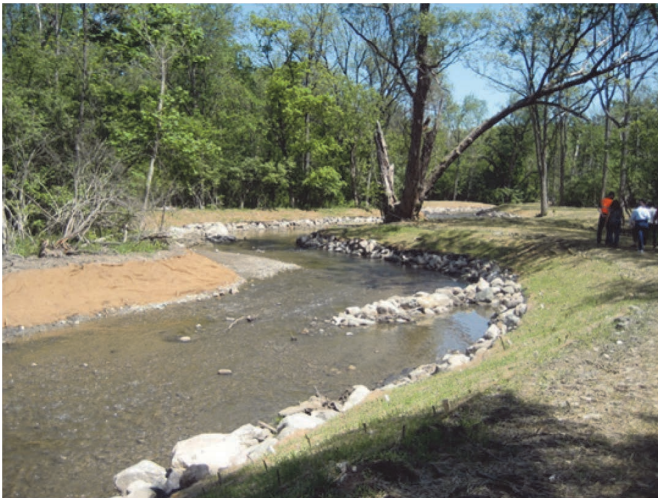
a. Graded bank, stone toe, and upstream-angled rock vane shortly after construction.

Channel. The channel geometry was modified in both the longitudinal and cross-channel directions to improve stream function. The channel width was widened along its bottom to accommodate increased flow; the sides were also graded back to a more stable 2H:1V angle (Figure 4.48a and b). Where space allowed, the stream bank was “stepped” to provide a shallow terrace or bench above the rock toe to accommodate and slow down intermediate flood flows (Figure 4.48e).

Rock Vanes and Stone Grade Controls. Rock vanes were placed at strategic locations to deflect impinging flow away from the bank. The vanes were oriented in an upstream direction at roughly 30 degree with the bank (Figure 4.48a and b). Cross vanes served a similar purpose but extended from both banks and created a V-upstream when viewed in plan (Figures 4.48c and d). They

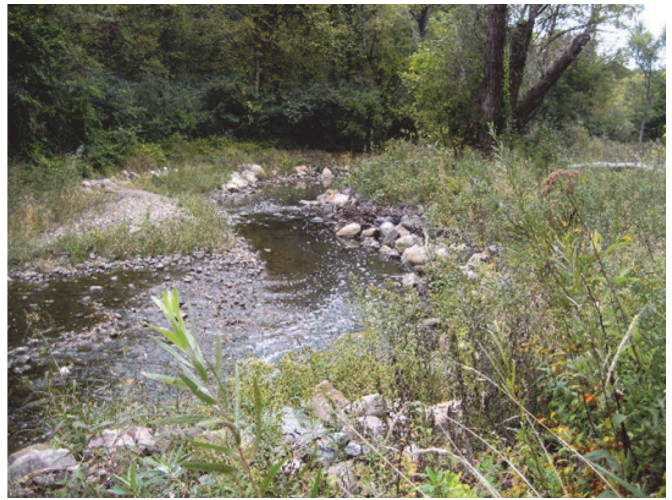
b. Same view as for (a), two years after construction. Note forked tree in right background.

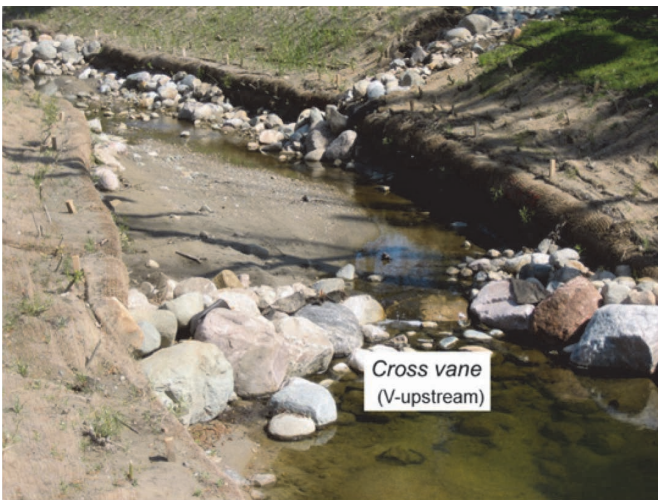
c. Graded bank with coir logs at toe and stone cross vane shortly after construction.

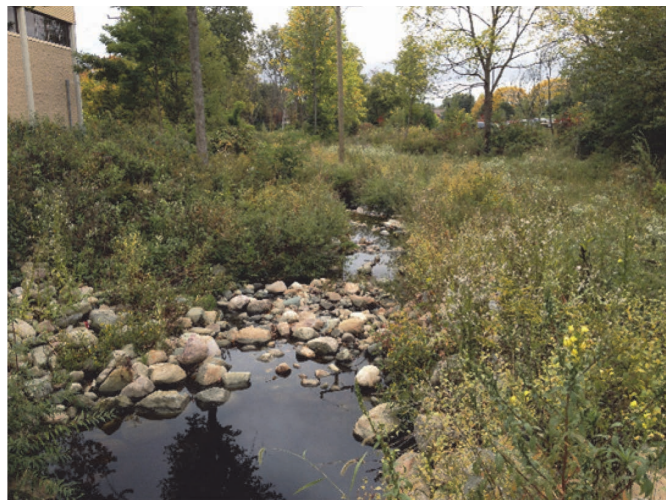
d. Stone cross vane two years after construction.

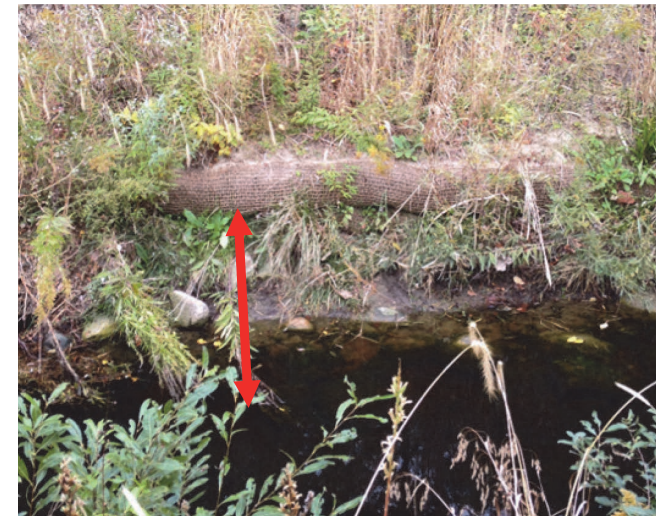
f. Close-up view of channel bank with coir log toe two years after construction. Red arrow indicates about 1.5 ft of bed degradation.

Coir Logs. Coir logs consisting of coir fiber rolls approximately 1 ft in diameter were staked in place at the toe of the stream bank with lumber stakes (Figures 4.48e and f). These were placed either singly or stacked vertically in a double row. Coir logs were used as an alternative to rock armor in lower-velocity reaches of the channel. Coir logs can be vegetated by inserting live stakes or cuttings; they also lend themselves to natural vegetation by volunteer plants. Coir logs were occasionally protected with rock as well.

The system performed well during and immediately after intense rainstorms shortly after construction in March 2012. This was a severe test for a stream bank protection system that was likely vulnerable at this time since the live cuttings and seedlings (under the ECBs) did not have sufficient time by then to grow and establish fully. The coir logs were still visible during the NCHRP Project 24-39 site visit in 2014 and appeared to have performed quite well. However, bed degradation (up to 1.5 ft) was noted along some coir logs (Figure 4.48f).

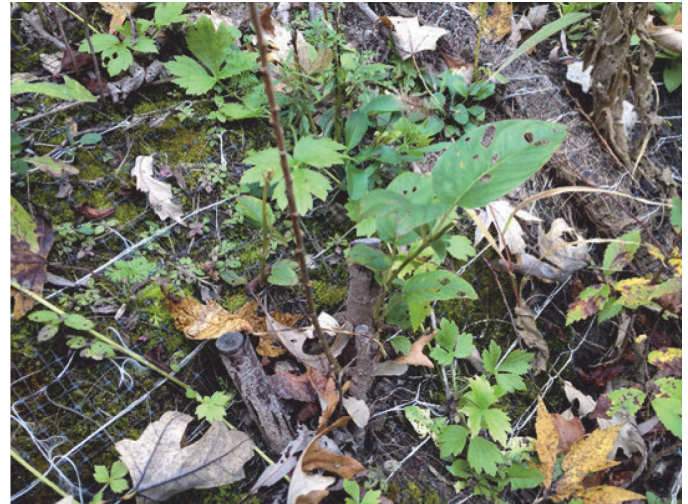
h. Cuttings and ECB two years after planting. One cutting appears to be dead, while the other shows minimal growth.

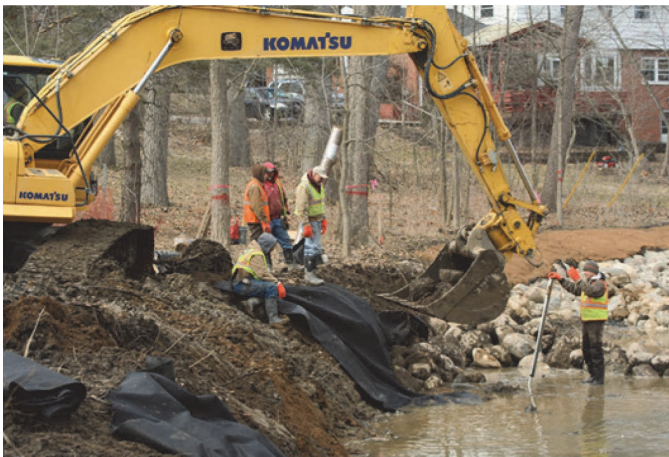
i. Construction crew installing filter fabric on graded bank prior to placing stone. Permission from OHM, Inc.

Riprap. Conventional rock armor (riprap) was widely used on this project as toe protection. Rock armor was used in higher-velocity (>5 ft/s) reaches and along outside bends. There was no attempt to purposely vegetate the rock with live cuttings using either the “joint-planting” or “bent willow pole” method (see Section 4.3.3). The rock selected was relatively rounded and attractive in appearance (Figure 4.48a, c, and d); however, angular rock is generally preferred for riprap. To compensate for the rounded characteristics of the rock, larger rocks were placed at the bottom and inset into the channel to forestall displacement and undermining during high-flow events. Geotextile fabric was placed on the stream bed under the vanes to prevent subsidence (Figure 4.48i).

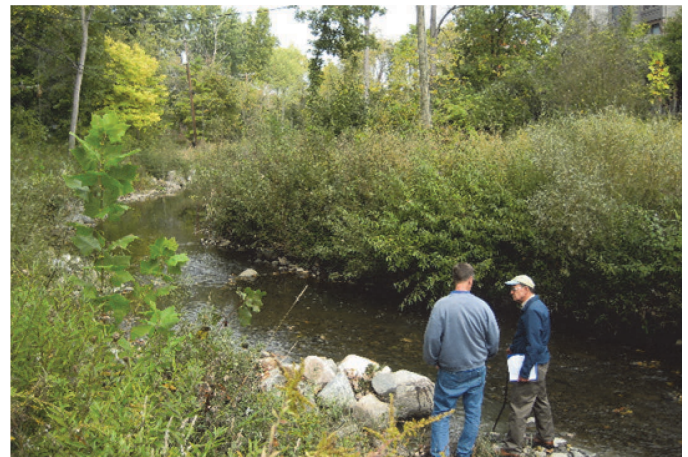
j. Reach similar to the one that includes the bank shown in (i), two years later.

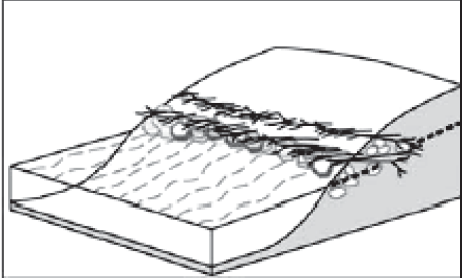
<p>Live brushlayers are rows of live woody cuttings that are layered, alternating with successive lifts of soil fill, to construct a reinforced slope or embankment.</p> <p>Remarks:</p>	<ul style="list-style-type: none"> <input type="checkbox"/> None <input type="checkbox"/> One <input type="checkbox"/> 2-5 <input type="checkbox"/> 6-20 <input type="checkbox"/> >20 <p>Number of years in service (typical):</p> <ul style="list-style-type: none"> <input type="checkbox"/> < 2 <input type="checkbox"/> 2-5 <input type="checkbox"/> > 5 	<p>Typical performance:</p> <ul style="list-style-type: none"> <input type="checkbox"/> Unknown <input type="checkbox"/> Complete failure <input type="checkbox"/> Partial success <input type="checkbox"/> Satisfactory <input type="checkbox"/> Excellent <p>Have any installations experienced a flood event?</p> <ul style="list-style-type: none"> <input type="checkbox"/> Yes <input type="checkbox"/> No <p>If yes, approx. ___ yr event</p> <p>Have any installations experienced multiple flood events?</p> <ul style="list-style-type: none"> <input type="checkbox"/> Yes <input type="checkbox"/> No <p>If yes, approx. number ___</p>	<ul style="list-style-type: none"> <input type="checkbox"/> None <input type="checkbox"/> Anecdotal <input type="checkbox"/> Sequential photos <input type="checkbox"/> Plans and specs <input type="checkbox"/> Reports <input type="checkbox"/> Publications <input type="checkbox"/> Survey data <input type="checkbox"/> Stage data <input type="checkbox"/> Discharge data <input type="checkbox"/> Velocity data <input type="checkbox"/> Sediment data <input type="checkbox"/> Biological data <input type="checkbox"/> Cost data <input type="checkbox"/> Model simulations 	<ul style="list-style-type: none"> <input type="checkbox"/> Unknown <input type="checkbox"/> Scour of bank face <input type="checkbox"/> Toe scour, undermining <input type="checkbox"/> Piping, subsurface erosion <input type="checkbox"/> Geotechnical slope failure <input type="checkbox"/> Ice <input type="checkbox"/> Flanking <input type="checkbox"/> Failure of u/s or d/s key <p>Plant mortality due to:</p> <ul style="list-style-type: none"> <input type="checkbox"/> Beaver damage <input type="checkbox"/> Large animal depredation <input type="checkbox"/> Insects <input type="checkbox"/> Disease <input type="checkbox"/> Vandalism <input type="checkbox"/> Erosion <input type="checkbox"/> Drought <p><input type="checkbox"/> Other _____</p> <p>_____</p>

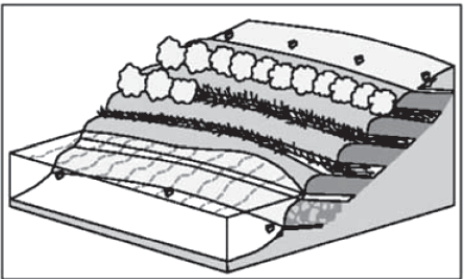
Measure	No. of sites	Overall performance	Monitoring Information	Failure mode(s)
VEGETATED MECHANICALLY STABILIZED EARTH

<p>Vegetated mechanically stabilized earth consists of live cut branches interspersed between lifts of soil wrapped in natural fabric, for example, coir, synthetic geotextiles (turf reinforcement mats, erosion control blankets, or geogrids).</p> <p>Remarks:</p>	<input type="checkbox"/> None <input type="checkbox"/> One <input type="checkbox"/> 2-5 <input type="checkbox"/> 6-20 <input type="checkbox"/> >20 Number of years in service (typical): <input type="checkbox"/> < 2 <input type="checkbox"/> 2-5 <input type="checkbox"/> > 5	Typical performance: <input type="checkbox"/> Unknown <input type="checkbox"/> Complete failure <input type="checkbox"/> Partial success <input type="checkbox"/> Satisfactory <input type="checkbox"/> Excellent Have any installations experienced a flood event? <input type="checkbox"/> Yes <input type="checkbox"/> No If yes, approx. ___ yr event Have any installations experienced multiple flood events? <input type="checkbox"/> Yes <input type="checkbox"/> No If yes, approx. number ___	<input type="checkbox"/> None <input type="checkbox"/> Anecdotal <input type="checkbox"/> Sequential photos <input type="checkbox"/> Plans and specs <input type="checkbox"/> Reports <input type="checkbox"/> Publications <input type="checkbox"/> Survey data <input type="checkbox"/> Stage data <input type="checkbox"/> Discharge data <input type="checkbox"/> Velocity data <input type="checkbox"/> Sediment data <input type="checkbox"/> Biological data <input type="checkbox"/> Cost data <input type="checkbox"/> Model simulations	<input type="checkbox"/> Unknown <input type="checkbox"/> Scour of bank face <input type="checkbox"/> Toe scour, undermining <input type="checkbox"/> Piping, subsurface erosion <input type="checkbox"/> Geotechnical slope failure <input type="checkbox"/> Ice <input type="checkbox"/> Flanking <input type="checkbox"/> Failure of u/s or d/s key Plant mortality due to: <input type="checkbox"/> Beaver damage <input type="checkbox"/> Large animal depredation <input type="checkbox"/> Insects <input type="checkbox"/> Disease <input type="checkbox"/> Vandalism <input type="checkbox"/> Erosion <input type="checkbox"/> Drought <input type="checkbox"/> Other _____ _____

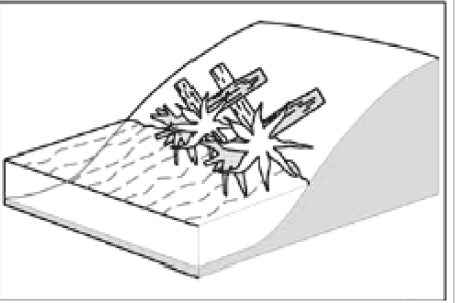
LARGE WOODY DEBRIS STRUCTURES

<p>Large wood (LWD) structures (also known as engineered log jams) made from felled trees may be used to deflect erosive flows and promote sediment deposition at the base of eroding banks.</p> <p>Remarks:</p>	<input type="checkbox"/> None <input type="checkbox"/> One <input type="checkbox"/> 2-5 <input type="checkbox"/> 6-20 <input type="checkbox"/> >20 Number of years in service (typical): <input type="checkbox"/> < 2 <input type="checkbox"/> 2-5 <input type="checkbox"/> > 5	Typical performance: <input type="checkbox"/> Unknown <input type="checkbox"/> Complete failure <input type="checkbox"/> Partial success <input type="checkbox"/> Satisfactory <input type="checkbox"/> Excellent Have any installations experienced a flood event? <input type="checkbox"/> Yes <input type="checkbox"/> No If yes, approx. ___ yr event Have any installations experienced multiple flood events? <input type="checkbox"/> Yes <input type="checkbox"/> No If yes, approx. number ___	<input type="checkbox"/> None <input type="checkbox"/> Anecdotal <input type="checkbox"/> Sequential photos <input type="checkbox"/> Plans and specs <input type="checkbox"/> Reports <input type="checkbox"/> Publications <input type="checkbox"/> Survey data <input type="checkbox"/> Stage data <input type="checkbox"/> Discharge data <input type="checkbox"/> Velocity data <input type="checkbox"/> Sediment data <input type="checkbox"/> Biological data <input type="checkbox"/> Cost data	<input type="checkbox"/> Unknown <input type="checkbox"/> Scour of bank face <input type="checkbox"/> Toe scour, undermining <input type="checkbox"/> Piping, subsurface erosion <input type="checkbox"/> Geotechnical slope failure <input type="checkbox"/> Ice <input type="checkbox"/> Flanking <input type="checkbox"/> Failure of u/s or d/s key Plant mortality due to: <input type="checkbox"/> Beaver damage <input type="checkbox"/> Large animal depredation <input type="checkbox"/> Insects <input type="checkbox"/> Disease <input type="checkbox"/> Vandalism <input type="checkbox"/> Erosion <input type="checkbox"/> Drought <input type="checkbox"/> Other _____ _____

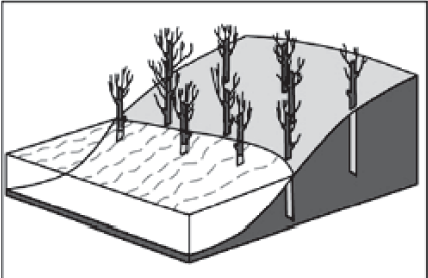
<p>Post and pole plantings are intended to provide mechanical bank protection. Willow and cottonwood species are recommended for their ability to root and grow, particularly if they are planted deep into control blankets or geogrids.</p> <p>Remarks:</p>	<input type="checkbox"/> None <input type="checkbox"/> One <input type="checkbox"/> 2-5 <input type="checkbox"/> 6-20 <input type="checkbox"/> >20 Number of years in service (typical): <input type="checkbox"/> < 2 <input type="checkbox"/> 2-5 <input type="checkbox"/> > 5	Typical performance: <input type="checkbox"/> Unknown <input type="checkbox"/> Complete failure <input type="checkbox"/> Partial success <input type="checkbox"/> Satisfactory <input type="checkbox"/> Excellent Have any installations experienced a flood event? <input type="checkbox"/> Yes <input type="checkbox"/> No If yes, approx. ____ yr event Have any installations experienced multiple flood events? <input type="checkbox"/> Yes <input type="checkbox"/> No If yes, approx. number ____	<input type="checkbox"/> None <input type="checkbox"/> Anecdotal <input type="checkbox"/> Sequential photos <input type="checkbox"/> Plans and specs <input type="checkbox"/> Reports <input type="checkbox"/> Publications <input type="checkbox"/> Survey data <input type="checkbox"/> Stage data <input type="checkbox"/> Discharge data <input type="checkbox"/> Velocity data <input type="checkbox"/> Sediment data <input type="checkbox"/> Biological data <input type="checkbox"/> Cost data <input type="checkbox"/> Model simulations	<input type="checkbox"/> Unknown <input type="checkbox"/> Scour of bank face <input type="checkbox"/> Toe scour, undermining <input type="checkbox"/> Piping, subsurface erosion <input type="checkbox"/> Geotechnical slope failure <input type="checkbox"/> Ice <input type="checkbox"/> Flanking <input type="checkbox"/> Failure of u/s or d/s key Plant mortality due to: <input type="checkbox"/> Beaver damage <input type="checkbox"/> Large animal depredation <input type="checkbox"/> Insects <input type="checkbox"/> Disease <input type="checkbox"/> Vandalism <input type="checkbox"/> Erosion <input type="checkbox"/> Drought <input type="checkbox"/> Other _____ _____

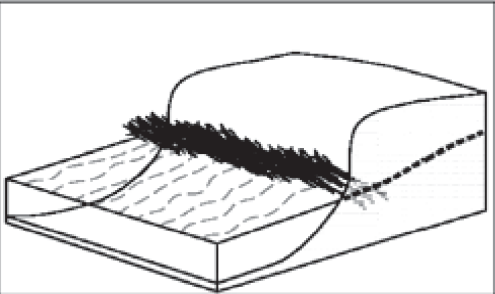
<p>Live siltation is a bioengineering technique involving the installation of a living or a nonliving brushy system at the water's edge.</p> <p>Remarks:</p>	<p> <input type="checkbox"/> None <input type="checkbox"/> One <input type="checkbox"/> 2-5 <input type="checkbox"/> 6-20 <input type="checkbox"/> >20 </p> <p>Number of years in service (typical):</p> <p> <input type="checkbox"/> < 2 <input type="checkbox"/> 2-5 <input type="checkbox"/> > 5 </p>	<p>Typical performance:</p> <p> <input type="checkbox"/> Unknown <input type="checkbox"/> Complete failure <input type="checkbox"/> Partial success <input type="checkbox"/> Satisfactory <input type="checkbox"/> Excellent </p> <p>Have any installations experienced a flood event?</p> <p> <input type="checkbox"/> Yes <input type="checkbox"/> No </p> <p>If yes, approx. ___ yr event</p> <p>Have any installations experienced multiple flood events?</p> <p> <input type="checkbox"/> Yes <input type="checkbox"/> No </p> <p>If yes, approx. number ___</p>	<p> <input type="checkbox"/> None <input type="checkbox"/> Anecdotal <input type="checkbox"/> Sequential photos <input type="checkbox"/> Plans and specs <input type="checkbox"/> Reports <input type="checkbox"/> Publications <input type="checkbox"/> Survey data <input type="checkbox"/> Stage data <input type="checkbox"/> Discharge data <input type="checkbox"/> Velocity data <input type="checkbox"/> Sediment data <input type="checkbox"/> Biological data <input type="checkbox"/> Cost data <input type="checkbox"/> Model simulations </p>	<p> <input type="checkbox"/> Unknown <input type="checkbox"/> Scour of bank face <input type="checkbox"/> Toe scour, undermining <input type="checkbox"/> Piping, subsurface erosion <input type="checkbox"/> Geotechnical slope failure <input type="checkbox"/> Ice <input type="checkbox"/> Flanking <input type="checkbox"/> Failure of u/s or d/s key </p> <p>Plant mortality due to:</p> <ul style="list-style-type: none"> <input type="checkbox"/> Beaver damage <input type="checkbox"/> Large animal depredation <input type="checkbox"/> Insects <input type="checkbox"/> Disease <input type="checkbox"/> Vandalism <input type="checkbox"/> Erosion <input type="checkbox"/> Drought <p> <input type="checkbox"/> Other _____ _____ </p>

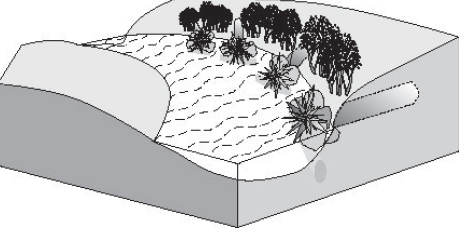
<p>ROOTWAD REVETMENT</p>

<p>Rootwad revetments are constructed by burying tree trunks in banks perpendicular to the flow direction with rootwads protruding into the channel.</p> <p>Remarks:</p>	<p> <input type="checkbox"/> None <input type="checkbox"/> One <input type="checkbox"/> 2-5 <input type="checkbox"/> 6-20 <input type="checkbox"/> >20 </p> <p>Number of years in service (typical):</p> <p> <input type="checkbox"/> < 2 <input type="checkbox"/> 2-5 <input type="checkbox"/> > 5 </p>	<p>Typical performance:</p> <p> <input type="checkbox"/> Unknown <input type="checkbox"/> Complete failure <input type="checkbox"/> Partial success <input type="checkbox"/> Satisfactory <input type="checkbox"/> Excellent </p> <p>Have any installations experienced a flood event?</p> <p> <input type="checkbox"/> Yes <input type="checkbox"/> No </p> <p>If yes, approx. ___ yr event</p> <p>Have any installations experienced multiple flood events?</p>	<p> <input type="checkbox"/> None <input type="checkbox"/> Anecdotal <input type="checkbox"/> Sequential photos <input type="checkbox"/> Plans and specs <input type="checkbox"/> Reports <input type="checkbox"/> Publications <input type="checkbox"/> Survey data <input type="checkbox"/> Stage data <input type="checkbox"/> Discharge data <input type="checkbox"/> Velocity data <input type="checkbox"/> Sediment data <input type="checkbox"/> Biological data <input type="checkbox"/> Cost data </p>	<p> <input type="checkbox"/> Unknown <input type="checkbox"/> Scour of bank face <input type="checkbox"/> Toe scour, undermining <input type="checkbox"/> Piping, subsurface erosion <input type="checkbox"/> Geotechnical slope failure <input type="checkbox"/> Ice <input type="checkbox"/> Flanking <input type="checkbox"/> Failure of u/s or d/s key </p> <p>Plant mortality due to:</p> <ul style="list-style-type: none"> <input type="checkbox"/> Beaver damage <input type="checkbox"/> Large animal depredation <input type="checkbox"/> Insects <input type="checkbox"/> Disease <input type="checkbox"/> Vandalism <input type="checkbox"/> Erosion <input type="checkbox"/> Drought <p> <input type="checkbox"/> Other _____ _____ </p>

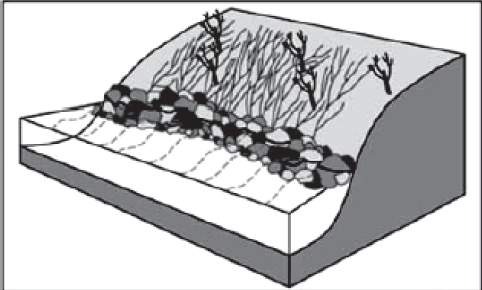
<p>A live brush mattress is a blanket of live brushy cuttings and soil fill 6 to 12 in. thick. The mattresses are usually constructed from live willow branches or other species that easily root from cuttings.</p> <p>Remarks:</p>	<input type="checkbox"/> None <input type="checkbox"/> One <input type="checkbox"/> 2-5 <input type="checkbox"/> 6-20 <input type="checkbox"/> >20	<p>Typical performance:</p> <input type="checkbox"/> Unknown <input type="checkbox"/> Complete failure <input type="checkbox"/> Partial success <input type="checkbox"/> Satisfactory <input type="checkbox"/> Excellent	<input type="checkbox"/> None <input type="checkbox"/> Anecdotal <input type="checkbox"/> Sequential photos <input type="checkbox"/> Plans and specs <input type="checkbox"/> Reports <input type="checkbox"/> Publications <input type="checkbox"/> Survey data <input type="checkbox"/> Stage data <input type="checkbox"/> Discharge data <input type="checkbox"/> Velocity data <input type="checkbox"/> Sediment data <input type="checkbox"/> Biological data <input type="checkbox"/> Cost data <input type="checkbox"/> Model simulations	<input type="checkbox"/> Unknown <input type="checkbox"/> Scour of bank face <input type="checkbox"/> Toe scour, undermining <input type="checkbox"/> Piping, subsurface erosion <input type="checkbox"/> Geotechnical slope failure <input type="checkbox"/> Ice <input type="checkbox"/> Flanking <input type="checkbox"/> Failure of u/s or d/s key <p>Plant mortality due to:</p> <input type="checkbox"/> Beaver damage <input type="checkbox"/> Large animal depredation <input type="checkbox"/> Insects <input type="checkbox"/> Disease <input type="checkbox"/> Vandalism <input type="checkbox"/> Erosion <input type="checkbox"/> Drought <input type="checkbox"/> Other _____

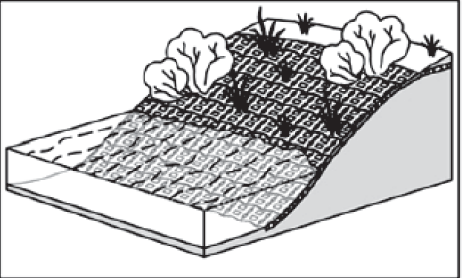
<p>VEGETATED ARTICULATED CONCRETE BLOCKS</p>

<p>An articulated concrete block (ACB) system consists of durable concrete blocks that are placed together to form a matrix overlay or armor layer. Articulated block systems are flexible and</p>	<input type="checkbox"/> None <input type="checkbox"/> One <input type="checkbox"/> 2-5 <input type="checkbox"/> 6-20 <input type="checkbox"/> >20	<p>Typical performance:</p> <input type="checkbox"/> Unknown <input type="checkbox"/> Complete failure <input type="checkbox"/> Partial success <input type="checkbox"/> Satisfactory <input type="checkbox"/> Excellent	<input type="checkbox"/> None <input type="checkbox"/> Anecdotal <input type="checkbox"/> Sequential photos <input type="checkbox"/> Plans and specs <input type="checkbox"/> Reports <input type="checkbox"/> Publications <input type="checkbox"/> Survey data <input type="checkbox"/> Stage data <input type="checkbox"/> Discharge data <input type="checkbox"/> Velocity data	<input type="checkbox"/> Unknown <input type="checkbox"/> Scour of bank face <input type="checkbox"/> Toe scour, undermining <input type="checkbox"/> Piping, subsurface erosion <input type="checkbox"/> Geotechnical slope failure <input type="checkbox"/> Ice <input type="checkbox"/> Flanking <input type="checkbox"/> Failure of u/s or d/s key <p>Plant mortality due to:</p> <input type="checkbox"/> Beaver damage <input type="checkbox"/> Large animal depredation <input type="checkbox"/> Insects <input type="checkbox"/> Disease <input type="checkbox"/> Vandalism <input type="checkbox"/> Erosion

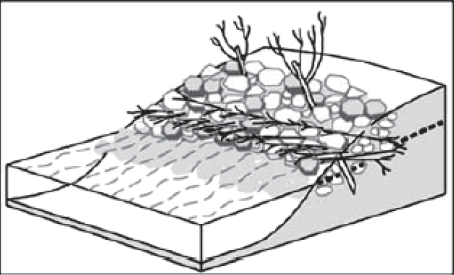
<p>Vegetative riprap is a layer of stone and/or boulder armoring that is vegetated, optimally during construction, using pole planting, brushlayering, and live-staking techniques. Remarks:</p>	<input type="checkbox"/> None <input type="checkbox"/> One <input type="checkbox"/> 2-5 <input type="checkbox"/> 6-20 <input type="checkbox"/> >20 Number of years in service (typical): <input type="checkbox"/> < 2 <input type="checkbox"/> 2-5 <input type="checkbox"/> > 5	<p>Typical performance:</p> <input type="checkbox"/> Unknown <input type="checkbox"/> Complete failure <input type="checkbox"/> Partial success <input type="checkbox"/> Satisfactory <input type="checkbox"/> Excellent <p>Have any installations experienced a flood event?</p> <input type="checkbox"/> Yes <input type="checkbox"/> No If yes, approx. ____ yr event <p>Have any installations experienced multiple flood events?</p> <input type="checkbox"/> Yes <input type="checkbox"/> No If yes, approx. number ____	<input type="checkbox"/> None <input type="checkbox"/> Anecdotal <input type="checkbox"/> Sequential photos <input type="checkbox"/> Plans and specs <input type="checkbox"/> Reports <input type="checkbox"/> Publications <input type="checkbox"/> Survey data <input type="checkbox"/> Stage data <input type="checkbox"/> Discharge data <input type="checkbox"/> Velocity data <input type="checkbox"/> Sediment data <input type="checkbox"/> Biological data <input type="checkbox"/> Cost data <input type="checkbox"/> Model simulations	<input type="checkbox"/> Unknown <input type="checkbox"/> Scour of bank face <input type="checkbox"/> Toe scour, undermining <input type="checkbox"/> Piping, subsurface erosion <input type="checkbox"/> Geotechnical slope failure <input type="checkbox"/> Ice <input type="checkbox"/> Flanking <input type="checkbox"/> Failure of u/s or d/s key <p>Plant mortality due to:</p> <input type="checkbox"/> Beaver damage <input type="checkbox"/> Large animal depredation <input type="checkbox"/> Insects <input type="checkbox"/> Disease <input type="checkbox"/> Vandalism <input type="checkbox"/> Erosion <input type="checkbox"/> Drought <input type="checkbox"/> Other _____ _____

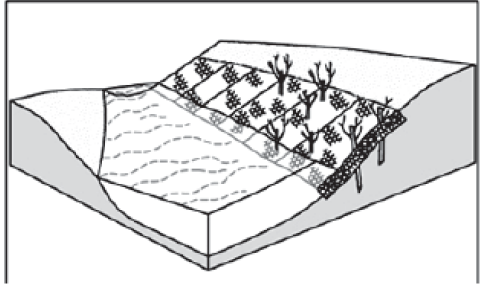
<p>VEGETATED GABION MATTRESS</p>

Measure	No. of sites	Overall performance	Monitoring Information	Failure mode(s)
<p>Gabion mattresses differ from gabion baskets as they are shallow (20 to 60 in. deep), rectangular containers made of welded wire mesh and filled with rock. Gabion mattresses are not stacked but placed directly and continuously on the prepared banks.</p> <p>Remarks:</p>	<p>Number of years in service (typical):</p> <input type="checkbox"/> < 2 <input type="checkbox"/> 2-5 <input type="checkbox"/> > 5	<p><input type="checkbox"/> Yes <input type="checkbox"/> No If yes, approx. ___ yr event</p> <p>Have any installations experienced multiple flood events? <input type="checkbox"/> Yes <input type="checkbox"/> No If yes, approx. number ___</p>	<input type="checkbox"/> Stage data <input type="checkbox"/> Discharge data <input type="checkbox"/> Velocity data <input type="checkbox"/> Sediment data <input type="checkbox"/> Biological data <input type="checkbox"/> Cost data <input type="checkbox"/> Model simulations	<input type="checkbox"/> Insects <input type="checkbox"/> Disease <input type="checkbox"/> Vandalism <input type="checkbox"/> Erosion <input type="checkbox"/> Drought <input type="checkbox"/> Other _____ _____

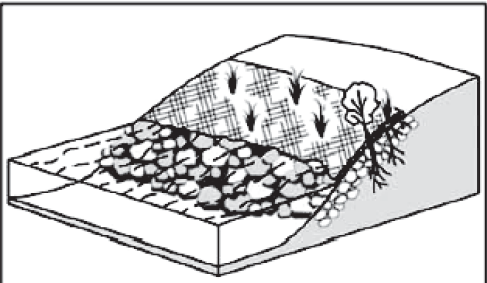
<p>SOIL AND GRASS COVERED RIPRAP</p>

<p>Soil and grass covered riprap refers to either: (1) an ordinary riprap blanket covered with a layer of soil or (2) a crown cap of soil and plant material placed over a riprap toe running along the base of a steep bank, effectively reducing the bank angle.</p> <p>Remarks:</p>	<input type="checkbox"/> None <input type="checkbox"/> One <input type="checkbox"/> 2-5 <input type="checkbox"/> 6-20 <input type="checkbox"/> >20	<p>Typical performance:</p> <input type="checkbox"/> Unknown <input type="checkbox"/> Complete failure <input type="checkbox"/> Partial success <input type="checkbox"/> Satisfactory <input type="checkbox"/> Excellent <p>Have any installations experienced a flood event? <input type="checkbox"/> Yes <input type="checkbox"/> No If yes, approx. ___ yr event</p> <p>Have any installations experienced multiple flood events? <input type="checkbox"/> Yes <input type="checkbox"/> No If yes, approx. number ___</p>	<input type="checkbox"/> None <input type="checkbox"/> Anecdotal <input type="checkbox"/> Sequential photos <input type="checkbox"/> Plans and specs <input type="checkbox"/> Reports <input type="checkbox"/> Publications <input type="checkbox"/> Survey data <input type="checkbox"/> Stage data <input type="checkbox"/> Discharge data <input type="checkbox"/> Velocity data <input type="checkbox"/> Sediment data <input type="checkbox"/> Biological data <input type="checkbox"/> Cost data <input type="checkbox"/> Model simulations	<input type="checkbox"/> Unknown <input type="checkbox"/> Scour of bank face <input type="checkbox"/> Toe scour, undermining <input type="checkbox"/> Piping, subsurface erosion <input type="checkbox"/> Geotechnical slope failure <input type="checkbox"/> Ice <input type="checkbox"/> Flanking <input type="checkbox"/> Failure of u/s or d/s key <p>Plant mortality due to:</p> <input type="checkbox"/> Beaver damage <input type="checkbox"/> Large animal depredation <input type="checkbox"/> Insects <input type="checkbox"/> Disease <input type="checkbox"/> Vandalism <input type="checkbox"/> Erosion <input type="checkbox"/> Drought <input type="checkbox"/> Other _____ _____

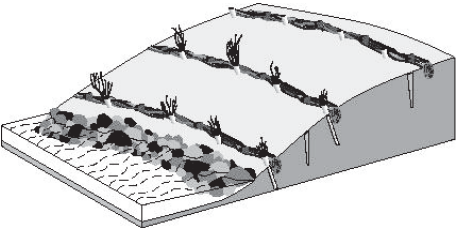
<p>Dormant branch cuttings bound together into long sausage-like, cylindrical bundles and placed in shallow trenches on slopes to reduce erosion and shallow sliding.</p> <p>Remarks:</p>	<ul style="list-style-type: none"> <input type="checkbox"/> None <input type="checkbox"/> One <input type="checkbox"/> 2-5 <input type="checkbox"/> 6-20 <input type="checkbox"/> >20 <p>Number of years in service (typical):</p> <ul style="list-style-type: none"> <input type="checkbox"/> < 2 <input type="checkbox"/> 2-5 <input type="checkbox"/> > 5 	<p>Typical performance:</p> <ul style="list-style-type: none"> <input type="checkbox"/> Unknown <input type="checkbox"/> Complete failure <input type="checkbox"/> Partial success <input type="checkbox"/> Satisfactory <input type="checkbox"/> Excellent <p>Have any installations experienced a flood event?</p> <ul style="list-style-type: none"> <input type="checkbox"/> Yes <input type="checkbox"/> No <p>If yes, approx. ___ yr event</p> <p>Have any installations experienced multiple flood events?</p> <ul style="list-style-type: none"> <input type="checkbox"/> Yes <input type="checkbox"/> No <p>If yes, approx. number ___</p>	<ul style="list-style-type: none"> <input type="checkbox"/> None <input type="checkbox"/> Anecdotal <input type="checkbox"/> Sequential photos <input type="checkbox"/> Plans and specs <input type="checkbox"/> Reports <input type="checkbox"/> Publications <input type="checkbox"/> Survey data <input type="checkbox"/> Stage data <input type="checkbox"/> Discharge data <input type="checkbox"/> Velocity data <input type="checkbox"/> Sediment data <input type="checkbox"/> Biological data <input type="checkbox"/> Cost data <input type="checkbox"/> Model simulations 	<ul style="list-style-type: none"> <input type="checkbox"/> Unknown <input type="checkbox"/> Scour of bank face <input type="checkbox"/> Toe scour, undermining <input type="checkbox"/> Piping, subsurface erosion <input type="checkbox"/> Geotechnical slope failure <input type="checkbox"/> Ice <input type="checkbox"/> Flanking <input type="checkbox"/> Failure of u/s or d/s key <p>Plant mortality due to:</p> <ul style="list-style-type: none"> <input type="checkbox"/> Beaver damage <input type="checkbox"/> Large animal depredation <input type="checkbox"/> Insects <input type="checkbox"/> Disease <input type="checkbox"/> Vandalism <input type="checkbox"/> Erosion <input type="checkbox"/> Drought <p><input type="checkbox"/> Other _____</p>

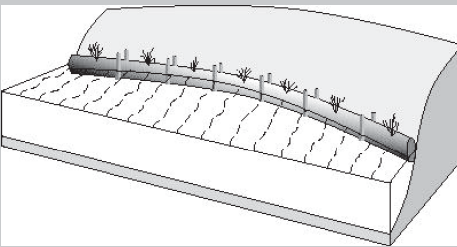
<p>COCONUT FIBER ROLL</p>

<p>Coconut fiber rolls are cylindrical structures composed of coconut husk fibers bound together with twine. Rolls are placed along lower slopes for erosion control while trapping sediment which encourages plant growth within the fiber roll.</p> <p>Remarks:</p>	<ul style="list-style-type: none"> <input type="checkbox"/> None <input type="checkbox"/> One <input type="checkbox"/> 2-5 <input type="checkbox"/> 6-20 <input type="checkbox"/> >20 <p>Number of years in service (typical):</p> <ul style="list-style-type: none"> <input type="checkbox"/> < 2 <input type="checkbox"/> 2-5 <input type="checkbox"/> > 5 	<p>Typical performance:</p> <ul style="list-style-type: none"> <input type="checkbox"/> Unknown <input type="checkbox"/> Complete failure <input type="checkbox"/> Partial success <input type="checkbox"/> Satisfactory <input type="checkbox"/> Excellent <p>Have any installations experienced a flood event?</p> <ul style="list-style-type: none"> <input type="checkbox"/> Yes <input type="checkbox"/> No <p>If yes, approx. ___ yr event</p> <p>Have any installations experienced multiple flood events?</p> <ul style="list-style-type: none"> <input type="checkbox"/> Yes <input type="checkbox"/> No <p>If yes, approx. number ___</p>	<ul style="list-style-type: none"> <input type="checkbox"/> None <input type="checkbox"/> Anecdotal <input type="checkbox"/> Sequential photos <input type="checkbox"/> Plans and specs <input type="checkbox"/> Reports <input type="checkbox"/> Publications <input type="checkbox"/> Survey data <input type="checkbox"/> Stage data <input type="checkbox"/> Discharge data <input type="checkbox"/> Velocity data <input type="checkbox"/> Sediment data <input type="checkbox"/> Biological data <input type="checkbox"/> Cost data <input type="checkbox"/> Model simulations 	<ul style="list-style-type: none"> <input type="checkbox"/> Unknown <input type="checkbox"/> Scour of bank face <input type="checkbox"/> Toe scour, undermining <input type="checkbox"/> Piping, subsurface erosion <input type="checkbox"/> Geotechnical slope failure <input type="checkbox"/> Ice <input type="checkbox"/> Flanking <input type="checkbox"/> Failure of u/s or d/s key <p>Plant mortality due to:</p> <ul style="list-style-type: none"> <input type="checkbox"/> Beaver damage <input type="checkbox"/> Large animal depredation <input type="checkbox"/> Insects <input type="checkbox"/> Disease <input type="checkbox"/> Vandalism <input type="checkbox"/> Erosion <input type="checkbox"/> Drought <p><input type="checkbox"/> Other _____</p>
