Evaluation and Assessment of Environmentally Sensitive Stream Bank Protection Measures

NCHRP REPORT 822

**Evaluation and Assessment
of Environmentally Sensitive
Stream Bank Protection Measures**

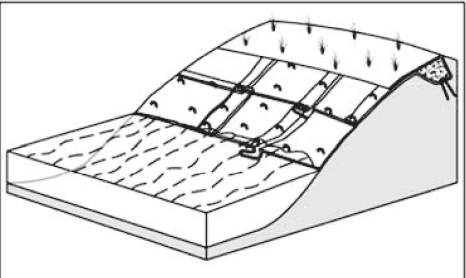
<p>Turf reinforcement mats (TRMs) are relatively permanent blankets, usually specified for banks subjected to flowing water. TRMs are intended to work with vegetation (roots and shoots) in a mutually reinforcing manner. As such, vegetated TRMs can resist higher tractive forces than either vegetation or TRMs can alone.</p> <p>Remarks:</p>	<ul style="list-style-type: none"> <input type="checkbox"/> None <input type="checkbox"/> One <input type="checkbox"/> 2-5 <input type="checkbox"/> 6-20 <input type="checkbox"/> >20 <p>Number of years in service (typical):</p> <ul style="list-style-type: none"> <input type="checkbox"/> < 2 <input type="checkbox"/> 2-5 <input type="checkbox"/> > 5 	<p>Typical performance:</p> <ul style="list-style-type: none"> <input type="checkbox"/> Unknown <input type="checkbox"/> Complete failure <input type="checkbox"/> Partial success <input type="checkbox"/> Satisfactory <input type="checkbox"/> Excellent <p>Have any installations experienced a flood event?</p> <ul style="list-style-type: none"> <input type="checkbox"/> Yes <input type="checkbox"/> No <p>If yes, approx. ___ yr event</p> <p>Have any installations experienced multiple flood events?</p> <ul style="list-style-type: none"> <input type="checkbox"/> Yes <input type="checkbox"/> No <p>If yes, approx. number ___</p>	<ul style="list-style-type: none"> <input type="checkbox"/> None <input type="checkbox"/> Anecdotal <input type="checkbox"/> Sequential photos <input type="checkbox"/> Plans and specs <input type="checkbox"/> Reports <input type="checkbox"/> Publications <input type="checkbox"/> Survey data <input type="checkbox"/> Stage data <input type="checkbox"/> Discharge data <input type="checkbox"/> Velocity data <input type="checkbox"/> Sediment data <input type="checkbox"/> Biological data <input type="checkbox"/> Cost data <input type="checkbox"/> Model simulations 	<ul style="list-style-type: none"> <input type="checkbox"/> Unknown <input type="checkbox"/> Scour of bank face <input type="checkbox"/> Toe scour, undermining <input type="checkbox"/> Piping, subsurface erosion <input type="checkbox"/> Geotechnical slope failure <input type="checkbox"/> Ice <input type="checkbox"/> Flanking <input type="checkbox"/> Failure of u/s or d/s key <p>Plant mortality due to:</p> <ul style="list-style-type: none"> <input type="checkbox"/> Beaver damage <input type="checkbox"/> Large animal depredation <input type="checkbox"/> Insects <input type="checkbox"/> Disease <input type="checkbox"/> Vandalism <input type="checkbox"/> Erosion <input type="checkbox"/> Drought <p><input type="checkbox"/> Other _____</p> <p>_____</p>
