**A Landslide Risk Rating System for the Baguio City, Philippines Area**

Submitted to the Department of Civil and Environmental Engineering  
in Partial Fulfillment of the Requirements for the Degree of  
Master of Engineering in Civil and Environmental Engineering

Massachusetts Institute of Technology

June 2004

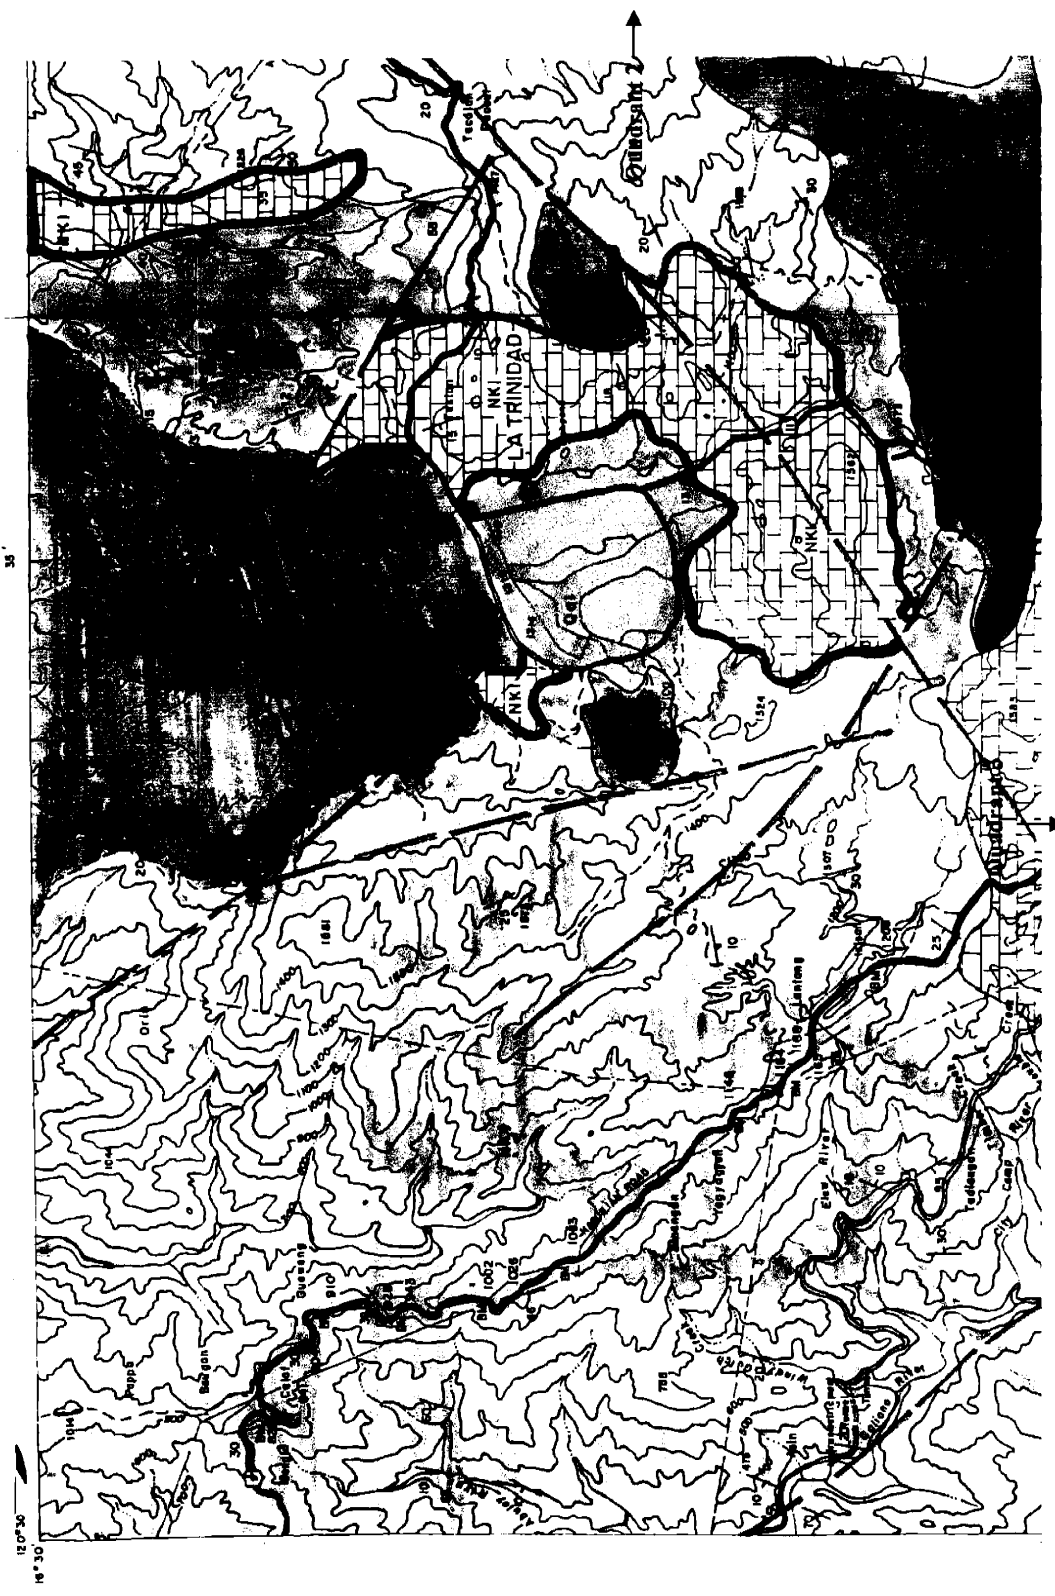
Figure 2.5 Quadrant 1 of Geologic Map of the Bagoio City Quadrangle, 1995

In terms of stratigraphy, there are seven significant geologic units that are present in the Baguio City area (Figures 2.2 to 2.8). These are (from oldest to youngest) the Pugo Formation (KPPf), the Zigzag Formation (PNzf), the Central Cordillera Diorite Complex (Pcdc), the Kennon Formation (Nkl), the Klondyke Formation (Nkf), Mirador Limestone (Nml), and the Baguio Formation (NQbf). Quaternary Alluvium (Qal) is also found outside the City proper.

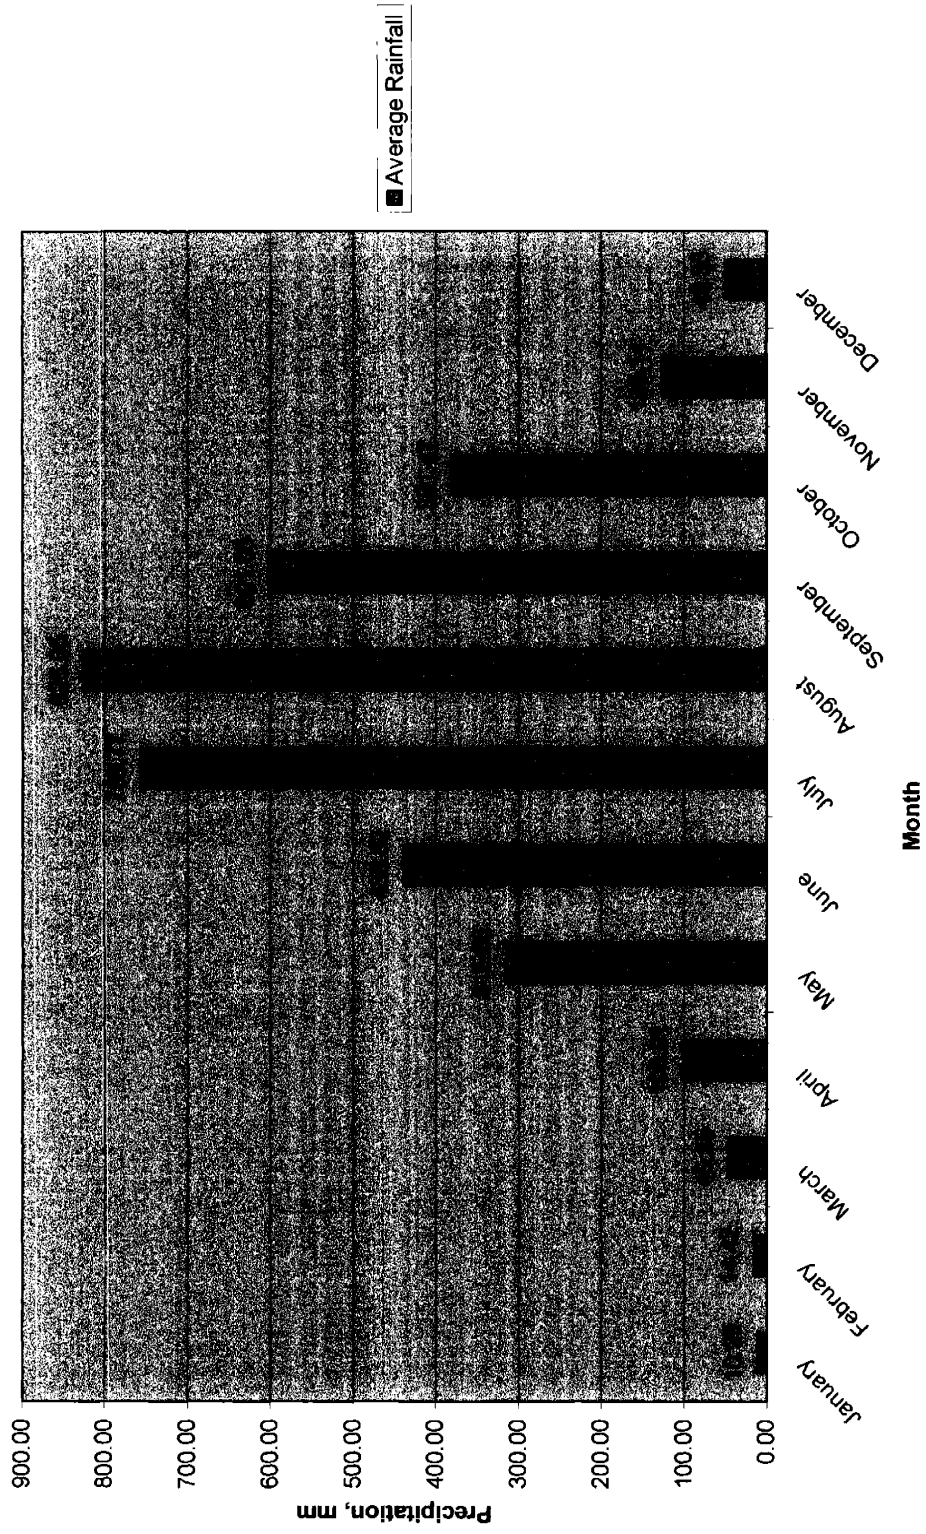
Figure 2.10 Average Monthly Rainfall in the Baguio City Area

Baguio falls under the Type 1 weather classification characterized as having a pronounced rainy season and dry season (Montgomery Consulting Engineers, 1974). From November to April of each year, conditions are hot and dry. From May to October, rainfall is extremely high, resulting from strong southwest monsoons and tropical cyclones (Figure 2.10). This weather is typical throughout the western side of the country. Average annual rainfall in Baguio City is 3648 millimeters (1950-2003). Variations from this average can be as high as 196 percent. An average of five tropical cyclones, with a maximum recorded number of nine tropical cyclones, affect Baguio every year (Rillon, 1992).

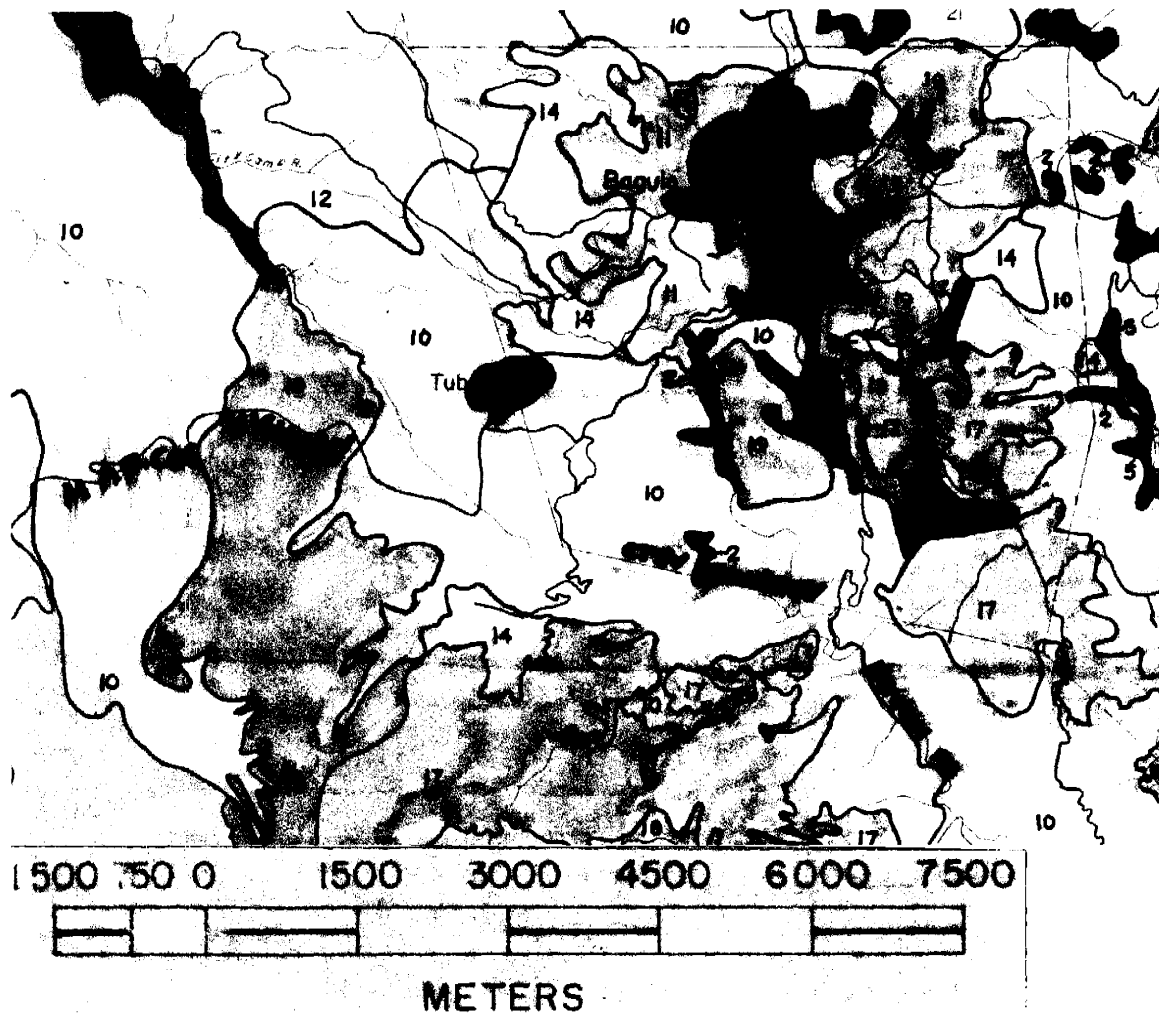
Figure 2.13 Baguio Area Land Use (Present Land Use Map, Benguet Province, 1980)

Table 2.2 shows the distribution of land use within the limits of Baguio City. Table 2.3 shows the mapping unit legend for Figure 2.13, the land use map of the greater Baguio area shown at a scale of 1:75,000.

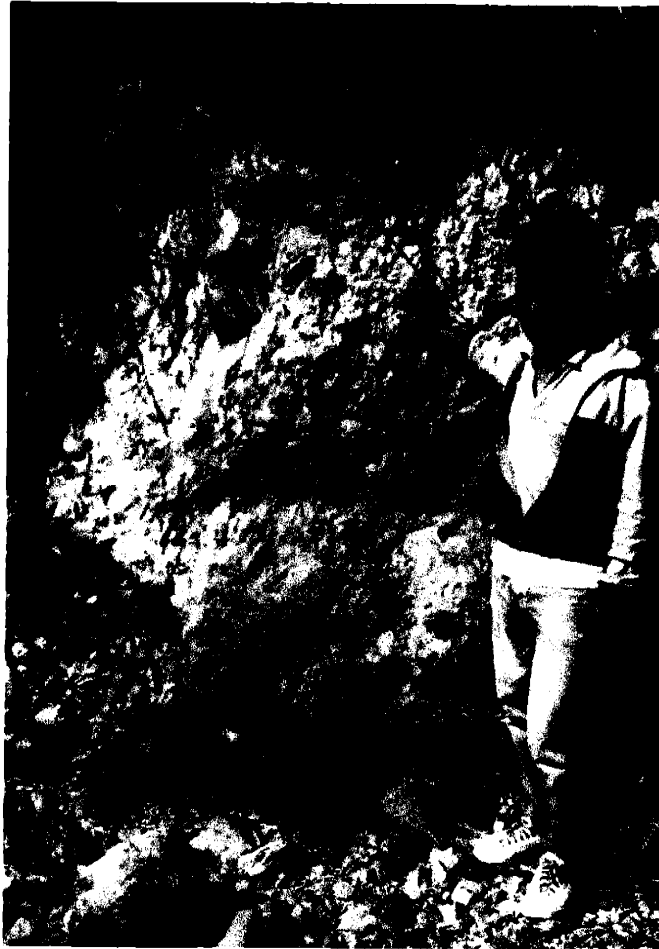
**Figure 3.10 Failure Plane (Geotecnica, 1987)**

Figure 3.10 shows a close-up of the thick residual soil typical of the pyroclastics underlying the area (Baguio Formation).

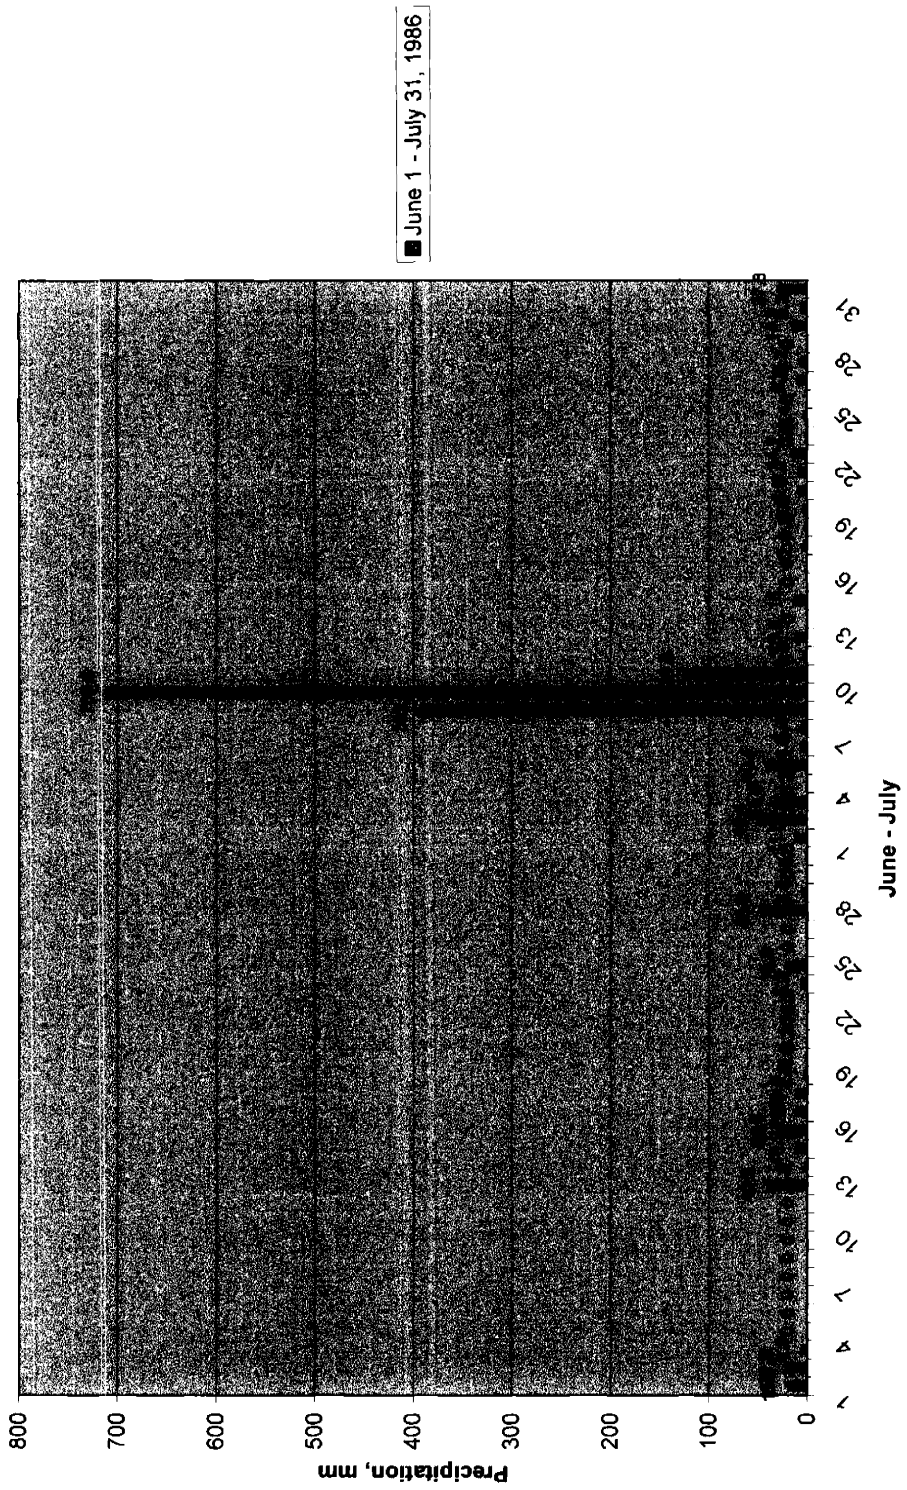
Figure 3.12 Daily Precipitation From June 1 – July 31, 1986

Figure 3.12 presents daily precipitation from June 1 to July 31, 1986. It is recorded that Typhoon Gading delivered unusually high amounts of rainfall from July 8 to 10. Landslides in the area were observed to occur when the cumulative rainfall is greater than 150-200 mm in a 24-hr period (Geotecnica, 1987). Goodman (1993) states that debris flows and slides during the rainy season in the tropics and subtropics occur when precipitation has an intensity of either 70 mm/hr (or greater) or 100 mm per 24-hr period

(or greater). Based on these criteria, the apparent triggering factor for Slide XI was the 392.1 mm of precipitation on July 8, 1986.

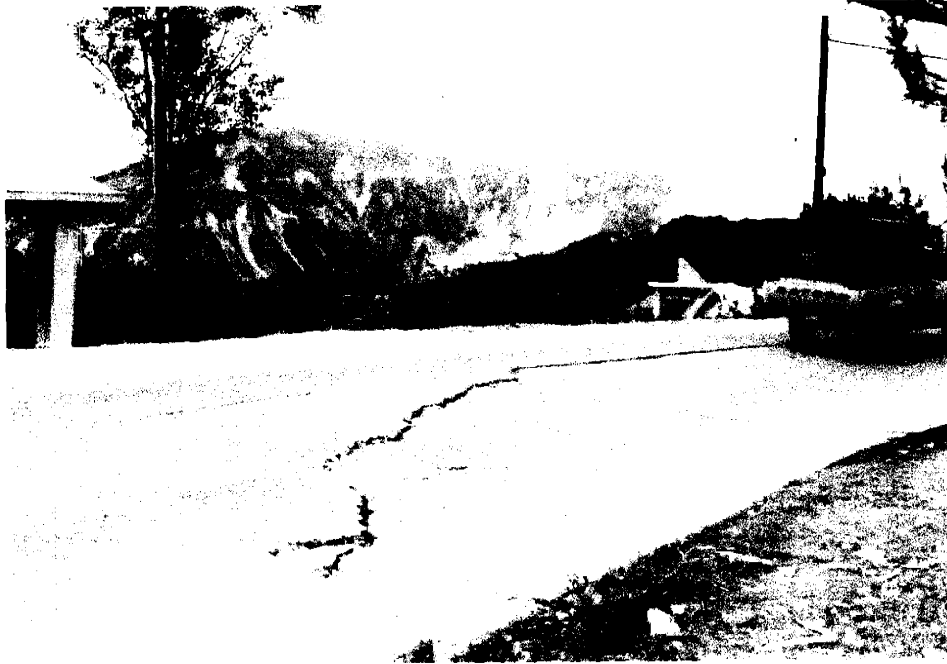
**Figure 3.14 Effects of the 16 July 1990 Earthquake (Geotecnica, 1990)**

The background of Figure 3.14 shows the landslides in the Mirador Limestone after the earthquake. The mid-ground shows rocks of the Baguio Formation. The foreground of the photograph shows the tension cracks found on Marcos Highway after the earthquake.

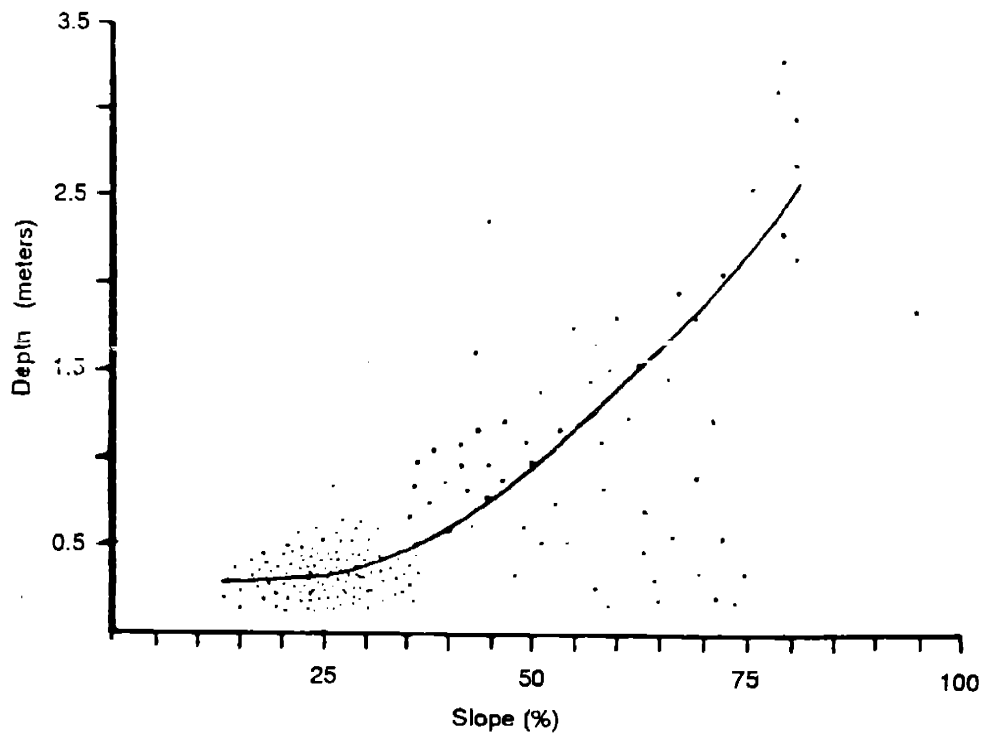
**Figure 3.20 Graph of Depth of Landslide vs. Slope Gradient (Arboleda & Regalado, 1992)**

Plots of slope inclination versus depth reveal that as the slope gets steeper, the depths of the earthquake-induced landslides increase (Figure 3.20). This is because the shallow slides involved surficial materials (topsoil) with minimal cohesion. They were, therefore, mobilized even on very shallow slopes once strong ground motion occurred. The deeper slides, on the other hand, were composed of surficial and residual soils as well as bedrock fragments. These materials would have greater inherent cohesion, and thus the more unstable condition of a steeper slope would be needed for the deeper landslides to occur as a result of ground shaking (Arboleda & Regalado, 1992).

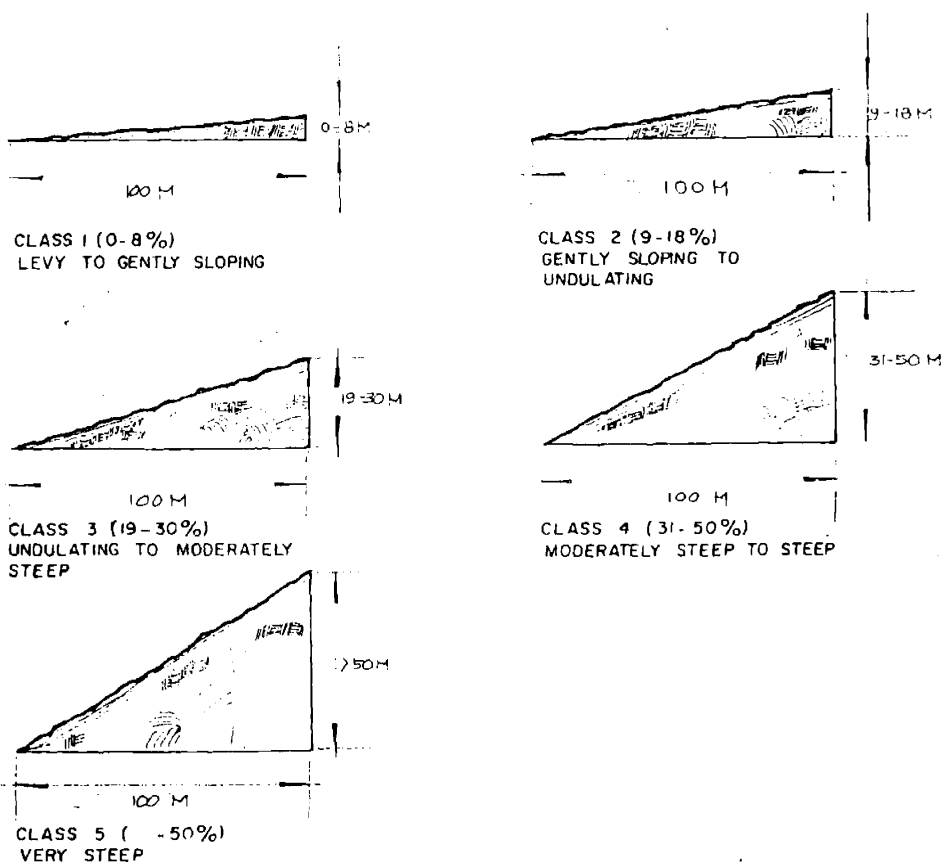
**Figure 4.1 Slope Classes According to Percent Gradient (Rillon, 1992)**

Five slope classifications were created (by the Department of Environment and Natural Resources) according to gradients: Class I (0-8%)—level to gently sloping, Class II (9-18%)—gently sloping to undulating, Class III (19-30%)—undulating to moderately steep, Class IV (31-50%)—moderately steep to steep, Class V (>50%)—very steep (Rillon, 1992). These are shown in Figure 4.1.

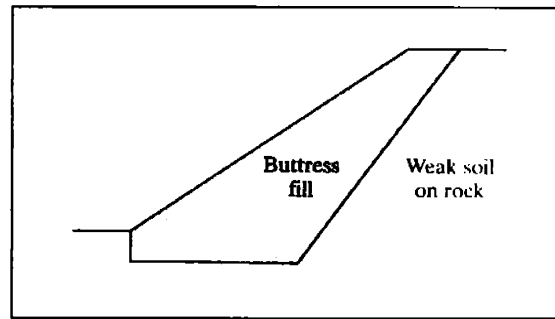
**Figure 4.3 Overexcavation and Replacement of Cut Slopes (Coduto, 1999)**

- e. Slope-stabilization of existing and proposed slopes. The Factor of Safety of a slope is defined as the ratio of the shear strength to the shear stress. Stabilization measures must either decrease the shear stress, increase the shear strength, or both.
- Cut slopes such as those found along roads and highways often expose daylighted bedding planes in the soft sedimentary rocks in the Baguio area. These can be stabilized by overexcavation and replacement with a compacted fill (with better strength properties than the natural slope materials) to buttress the slope (Coduto,

1999). Such fills would be stronger than the original slope material because they would not contain the weak bedding planes. This is shown schematically in Figure 4.3.

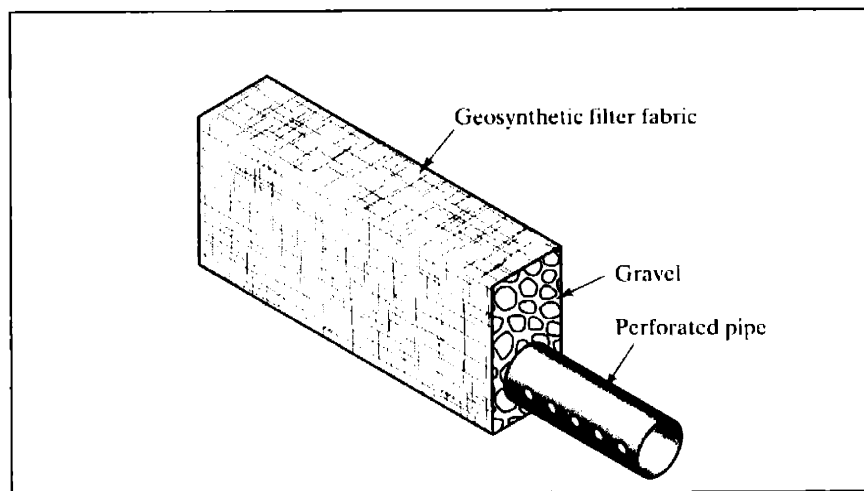
**Figure 4.4 Perforated Pipe Drains (Coduto, 1999)**

- Perforated pipe drains consisting of pipes with holes, buried in the ground to collect the water and remove it from the slope. The pipes should be surrounded by gravel and a filter fabric (Coduto, 1999). The gravel increases hydraulic permeability around the pipe, thereby increasing drainage. The filter fabric prevents fines from entering the pipes and clogging them (Figure 4.4).
