**CORROSION BEHAVIOUR OF AZ31
MAGNESIUM ALLOY IN HIGHLY ALKALINE ENVIRONMENTS**

A THESIS SUBMITTED IN PARTIAL FULFILLMENT OF
THE REQUIREMENTS FOR THE DEGREE OF

MASTER OF APPLIED SCIENCE

(Mechanical Engineering)

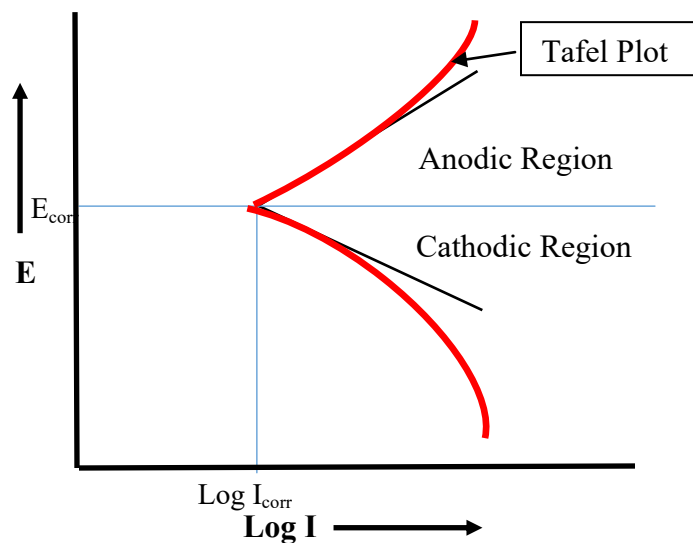
Equation 4 provides another method to calculate the corrosion current in a system. However, the accuracy of the equation depends on the existence of a linear Tafel region, as indicated in Figure 2.1 below.

Figure 2.1: A typical potentiodynamic polarization curve. [15]

and anodic current densities are equal). [14] The Tafel plot is a logarithm of the current with respect to the applied potential (shown in Figure 2.1), which can be explained with the help of Butler-Volmer Equation 3. [14]

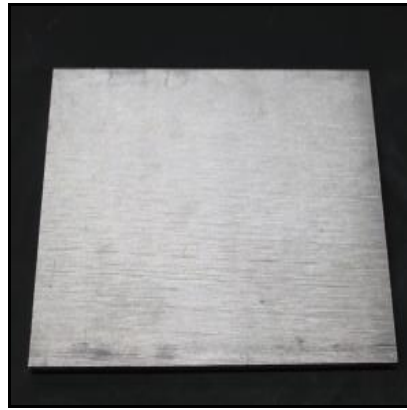
Figure 3.1 shows the virgin AZ31 plate (a 10 mm thick rectangular plate) obtained from ZincNyx Energy Solutions, Canada. This plate was new, unused and hermetically sealed AZ31 magnesium alloy. The chemical composition of the virgin AZ31 alloy is provided in Table 3.1.

Figure 3.1: Virgin AZ31 magnesium alloy plate.

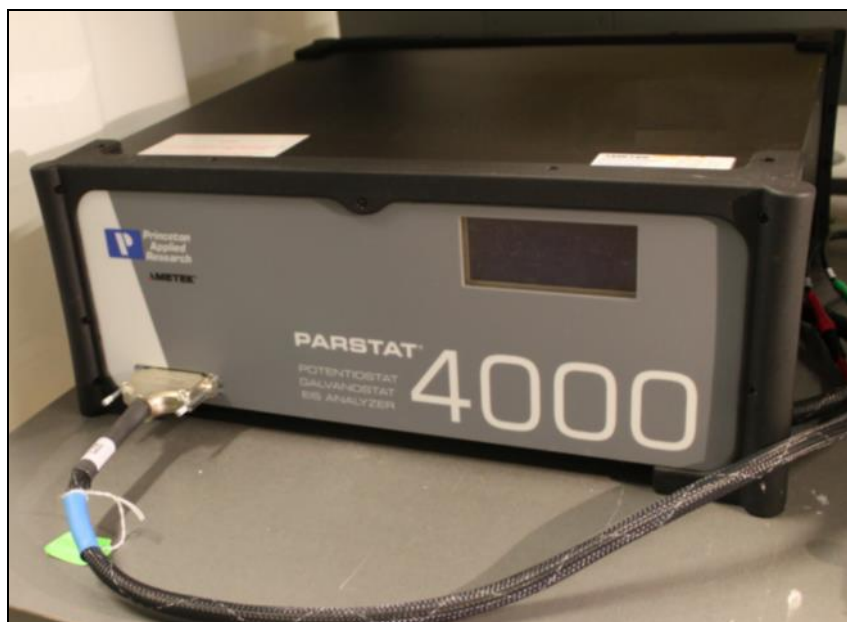
Tafel analysis and Electrochemical Impedance Spectroscopy (EIS) were performed using a Parstat 4000 potentiostat connected to a P.A.R. flat cell (model K0235) were used for all electrochemical studies. Figure 3.6 shows the image of the PARSTAT 4000 potentiostat. Versa Studio software was used to collect data points and to operate the potentiostat.

Figure 3.6: PARSTAT 4000 potentiostat.

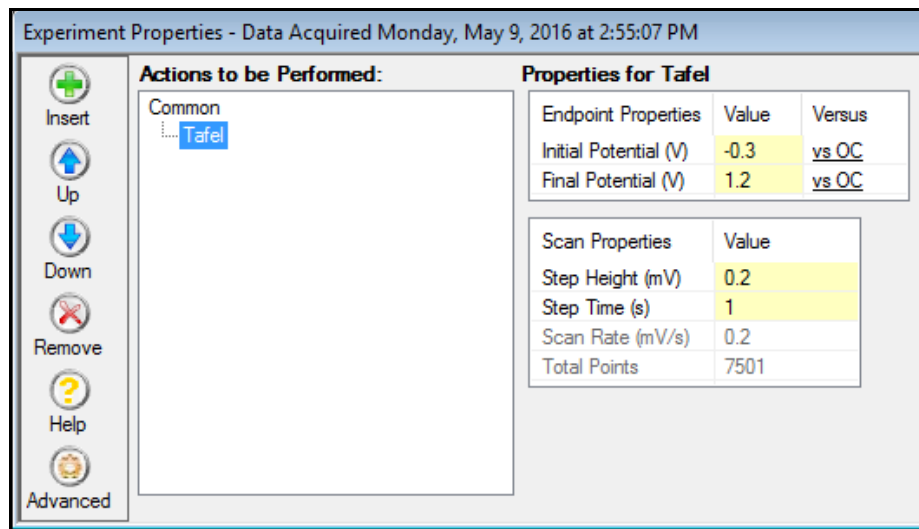
A polished sample of the virgin AZ31 plate was cleaned with acetone prior to a corrosion test. The sample was then placed in the flat cell and no external potential was applied for 15 minutes. Open Circuit Potential (OCP) was stabilized so that a stable layer of corrosion products formed before the electrochemical experiment was started. For Tafel analysis, the applied potential was varied from -0.3 to 1.2 mV with respect to the OCP. The scan rate was fixed to a value of 0.2 mV/sec, as outlined in Figure 3.9.

Figure 3.9: Experimental set-up for Tafel analysis.

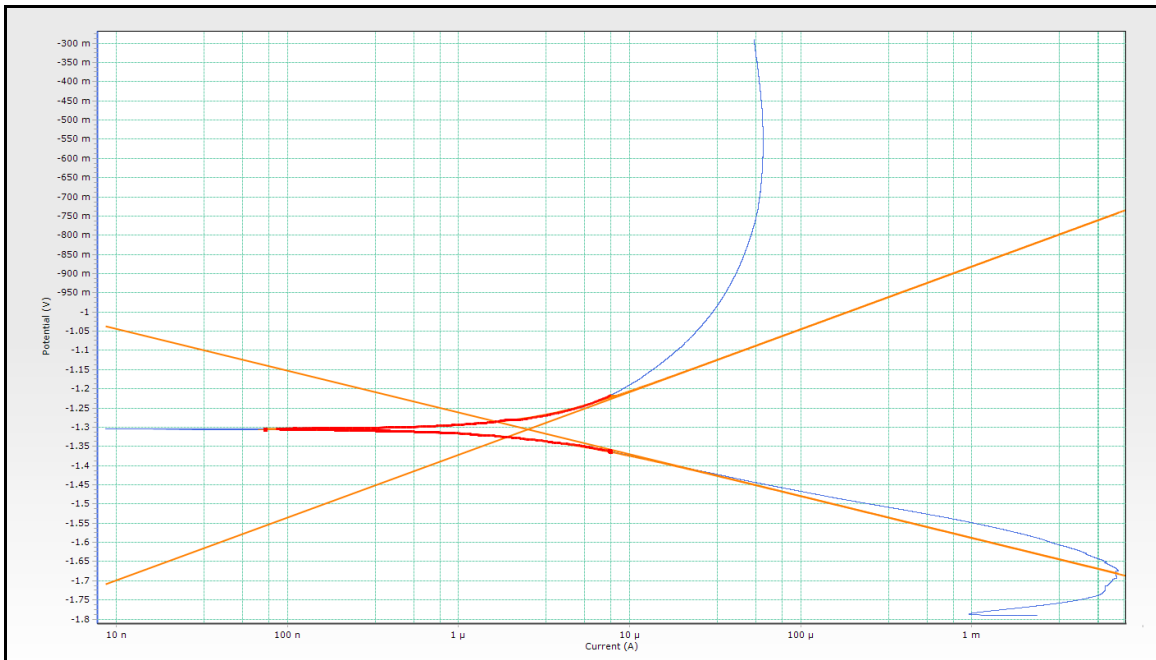
Once the Tafel polarization experiment was concluded, a plot of the applied potential vs. the logarithmic value of the measured current was generated. Extrapolating the anodic and cathodic curves yielded the value of the corrosion current density (measured in $\mu\text{A}/\text{cm}^2$), as illustrated in Figure 3.10. The corrosion current was determined from tangents drawn on the polarization curve seen in Figure 3.10. The Tafel experiments were repeated two times for each sample and electrolyte to ensure statistical validity of the results.

Figure 3.10: Extrapolation of potentiodynamic polarization curves.

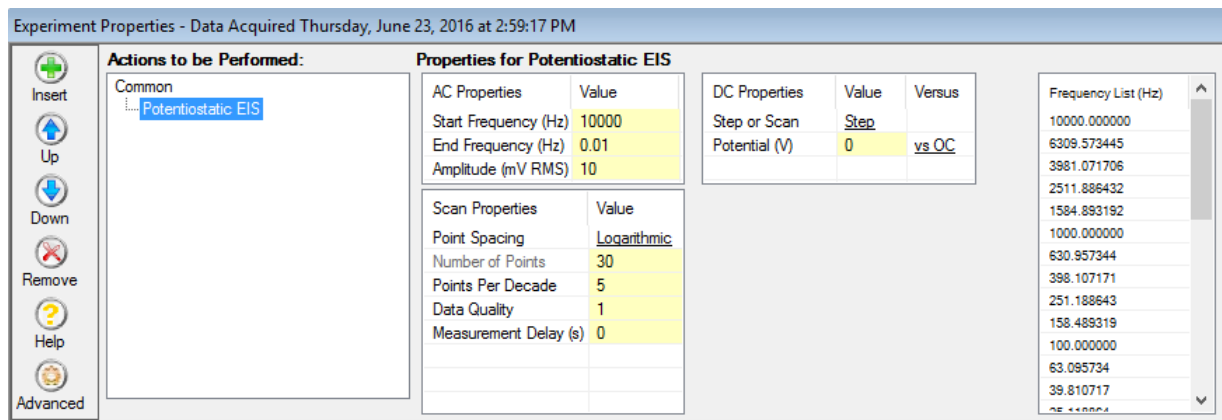
EIS was performed using the standard three electrode configuration. The signal frequency ranged from 10,000 Hz to 0.01 Hz at a fixed amplitude of 10 mV. Nyquist and Bode plots from the raw data were obtained by Versa Studio. The details of the EIS experimental set-up are included in Figure 3.11.

Figure 3.11: Experimental set-up for EIS test.

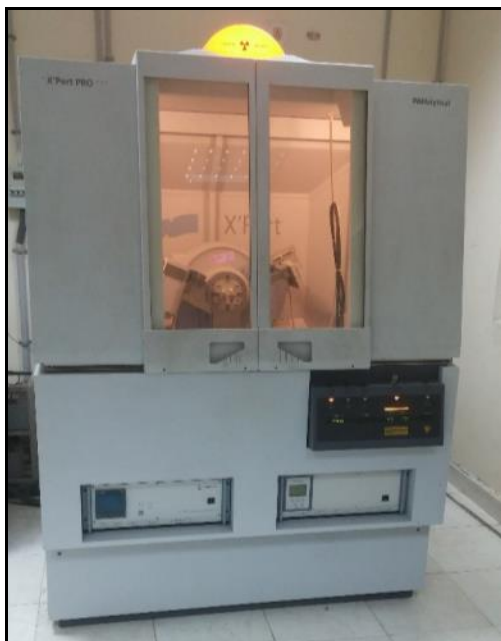
XRD analysis of the virgin AZ31 was performed using a Panalytical X-ray diffractometer (Figure 3.12) with a Cu K- α radiation at the Indian Institute of Technology, Chennai, India. Scans were performed from 10° to 90° with a step size 0.008° and a time per step of 40 seconds. Both virgin and corroded AZ31 samples (Sample I (1, 20), Sample I (2, 20)) were analyzed.

Figure 3.12: X-ray Diffractometer at IIT Chennai, India.

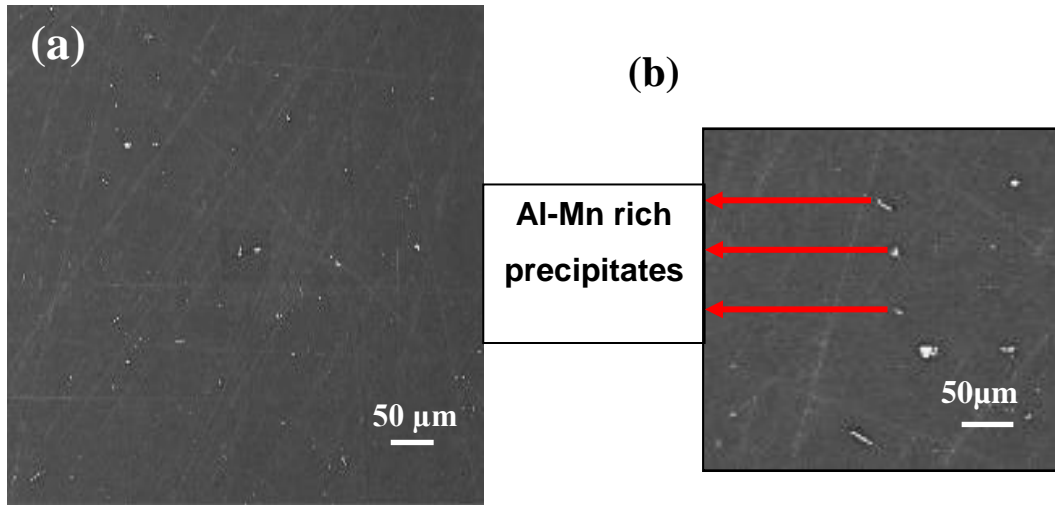
Figure 4.1 shows the top surface of the polished virgin AZ31 plate. The microstructure consisted of Mg solid solution ($\alpha\text{-Mg}$) and white precipitates. The precipitates were dispersed across the entire sample and had a particle size in the range of 1 – 30 μm .

Figure 4.1: General microstructure of virgin AZ31 top surface: (a) Low magnification, (b) Al-Mn rich precipitates.

Figure 4.16 shows the surface of Sample I (1, 10). The morphology of the pits often had similar geometry (shape and diameter) as that of the large Al-Mn precipitates (or agglomerates of fine Al-Mn precipitates) found in the virgin AZ31 alloy (Figure 4.1). Also, it was seen in Figure 4.16(b) that some of the corrosion products remained attached to the AZ31 substrate. These were sites of Al-Mn precipitates of diameter greater than $\sim 20 \mu\text{m}$. Figure 4.16(b) shows regions similar to those observed in the in-service AZ31 electrode with “clean” and “dirty” corroded regions (discussed in Section 4.1.3). In this corroded AZ31 sample, the “clean” corroded region had corrosion products still attached to the AZ31 substrate, while the “dirty” corroded region exhibited subdued attack. It was also observed that the fine ($<15 \mu\text{m}$) Al-Mn precipitates were absent from the surface after 10 days of immersion, as noted in Figure 4.16(c). Elemental mapping (Figure 4.17) was performed on sites with corrosion products still attached to the pits.

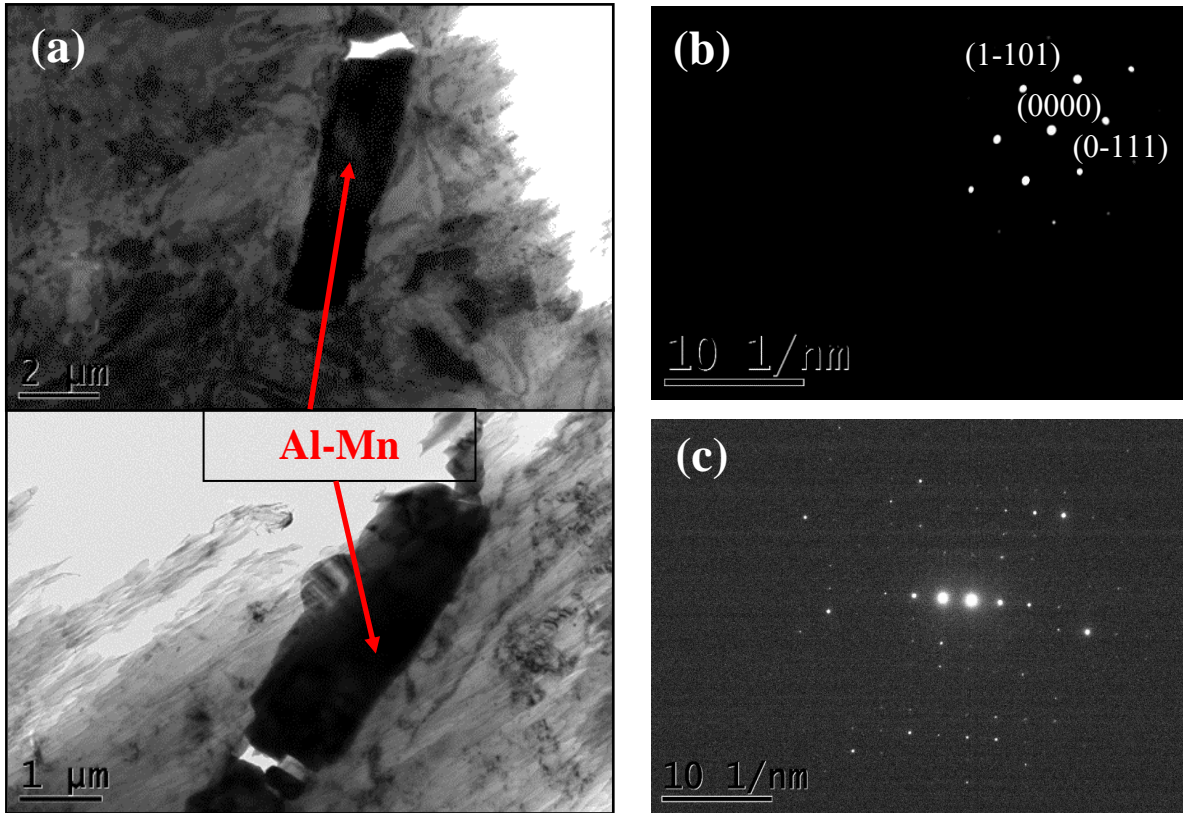
The Al-Mn precipitates in the virgin AZ31 matrix were studied using a transmission electron microscope (TEM) and selected area diffraction technique in order to determine the precise stoichiometry of the precipitates. Figure 4.4 shows the TEM images as well as Selected Area Diffraction Pattern (SADP) obtained from the matrix and the Al-Mn precipitate.

Figure 4.4(a) shows a representative bright field image of the precipitates. The TEM micrographs reveal that the precipitates were well attached to the matrix. However, they were brittle and readily fractured. Figures 4.4(b) and (c) show the diffraction patterns for the precipitates and the matrix, respectively.

Figure 4.4: TEM analysis of Al-Mn precipitates: (a) Al-Mn precipitate, (b) SADP of AZ31 matrix, (c) SADP of Al-Mn precipitate obtained from TEM analysis.

The distance between two diffraction points in the matrix SADP was 619.643 units and 622.535 units, yielding a ratio of 0.995. The matching set of planes for this ratio was (0-111) and (1-101). These planes were indexed, with indices in Figure 4.4(b). Indexing was done with the help of standard available indexing patterns for hexagonal symmetry of planes. [57] Interestingly the presence of impurities (Ni, Fe and Cu) did not affect the SADP, perhaps due to their low concentrations.

A representative SADP obtained from the Al-Mn precipitates is shown in Figure 4.4(c). The SADP was consistent to those found in the literature for the Al_8Mn_5 phase in the Al-Mn phase diagram (Figure 2.5). [58] The ratio of concentration of Al to Mn obtained from the TEM-EDS analysis (~1.68) was similar to the ratio of Al_8Mn_5 phase (1.6). The crystal structure of this phase was rhombohedral, [59] as was verified by the two fold symmetry of planes seen in Figure 4.4(c). However, indexing of the precipitate patterns was challenging due to signal interference with the matrix, resulting in the SADP being a combination of DP's from the matrix and the precipitates. Similar challenges were reported in published literature as well. [58] [59] [60]

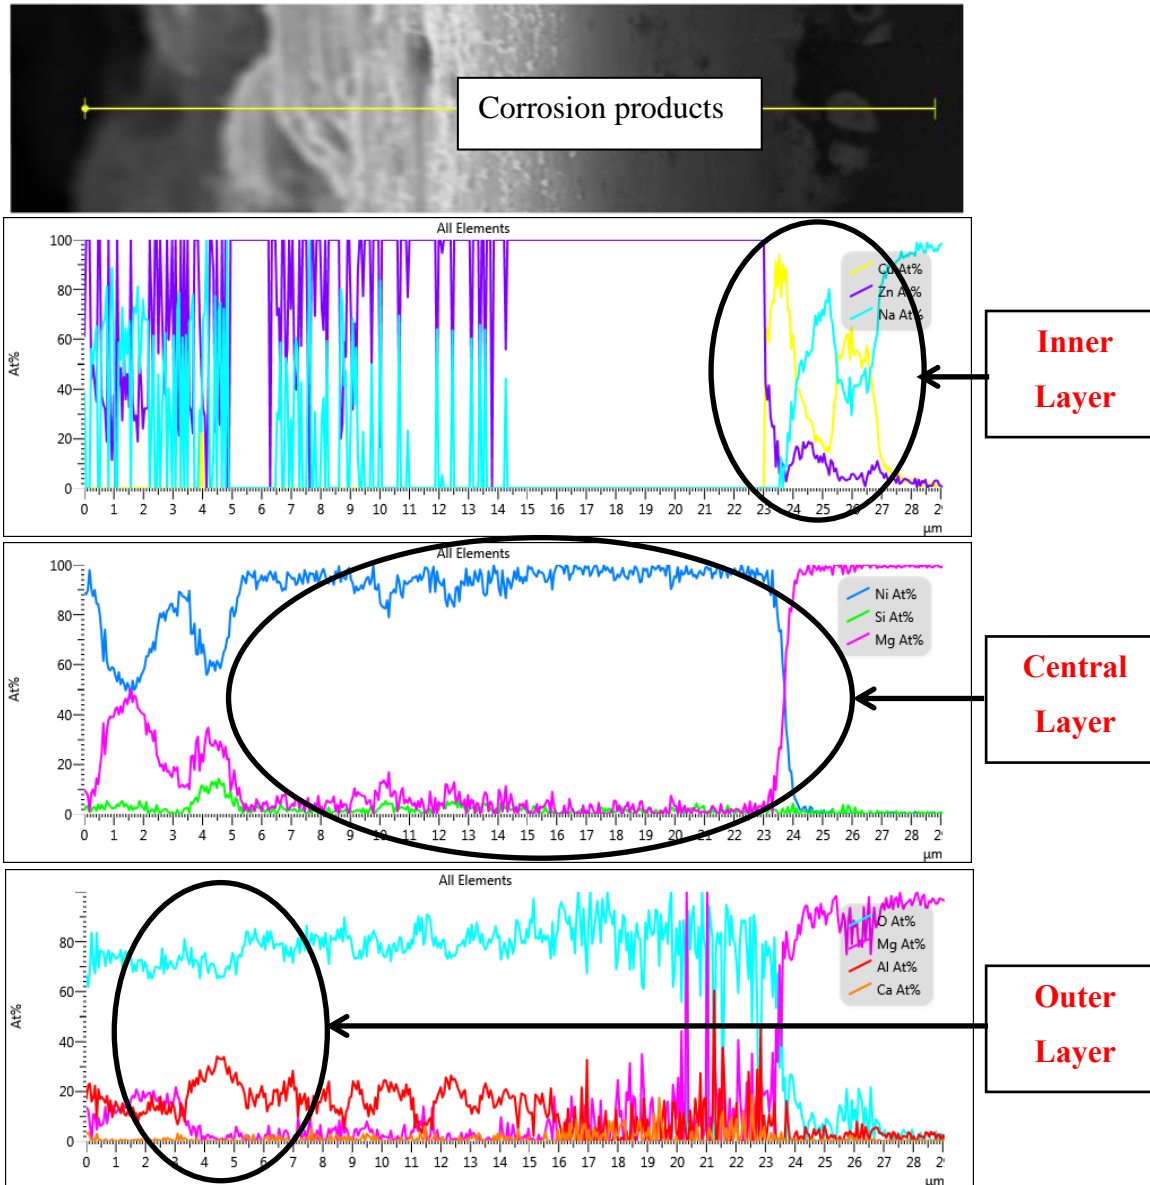
Figure 4.14 shows the results of a linescan across the corrosion product layer of in-service AZ31 electrode. In this linescan, Si and Mg had a similar profile, suggesting a possible formation of magnesium silicates, which was confirmed by XRD analysis.

Figure 4.14: Linescan across the corrosion products on in-service AZ31 electrode's cross-section.

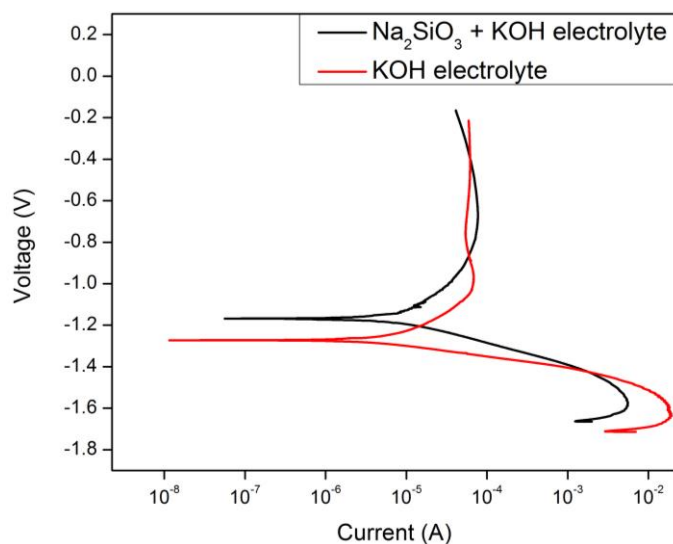
The polarization tests were repeated to maintain statistical significance of data. The second repeat of Tafel polarization is included in figure A1.1. The corrosion potentials were similar in value as those obtained in the 1st set of experiments. Also, the results obtained from EIS analysis are included in Figure A1.2. and A1.3. The change in value of frequency at 0.01 was possibly due to formation of an unstable layer of corrosion products till a frequency of 0.1 was reached. After 0.1, the resistance value increased drastically possibly due to polarization of the material. The electrochemical parameters obtained from EIS analysis are included in Table A1.1. The values of electrical parameters obtained are similar as those obtained in 1st set of experiments. However, the value of R_s was considerably high in this case, this indicated a possibility of presence of a bubble in the electrolyte, which may have resulted in high resistance of the solution. This bubble could possibly be formed due to hydrogen evolution in the system. [10]

Figure A1.1 Tafel plots for Sample T (1) and Sample T (2).

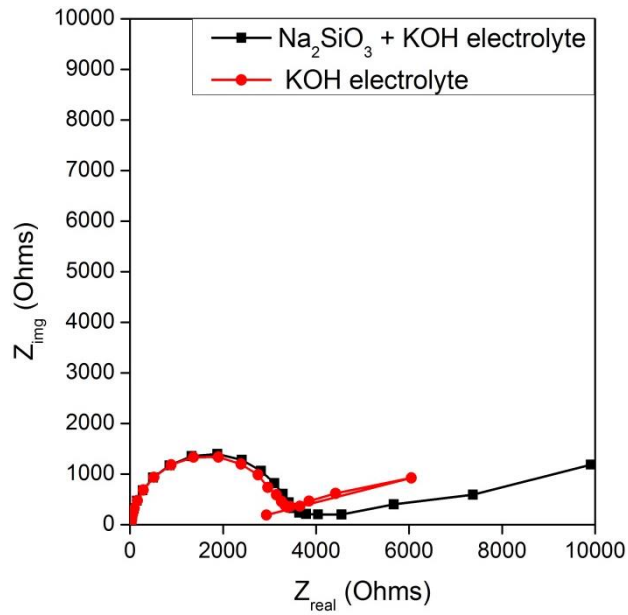
Figure A1.2 Nyquist plots for Sample E (1) and Sample E (2).
